ERA25LA210

## INVESTIGATION PHOTOGRAPHS

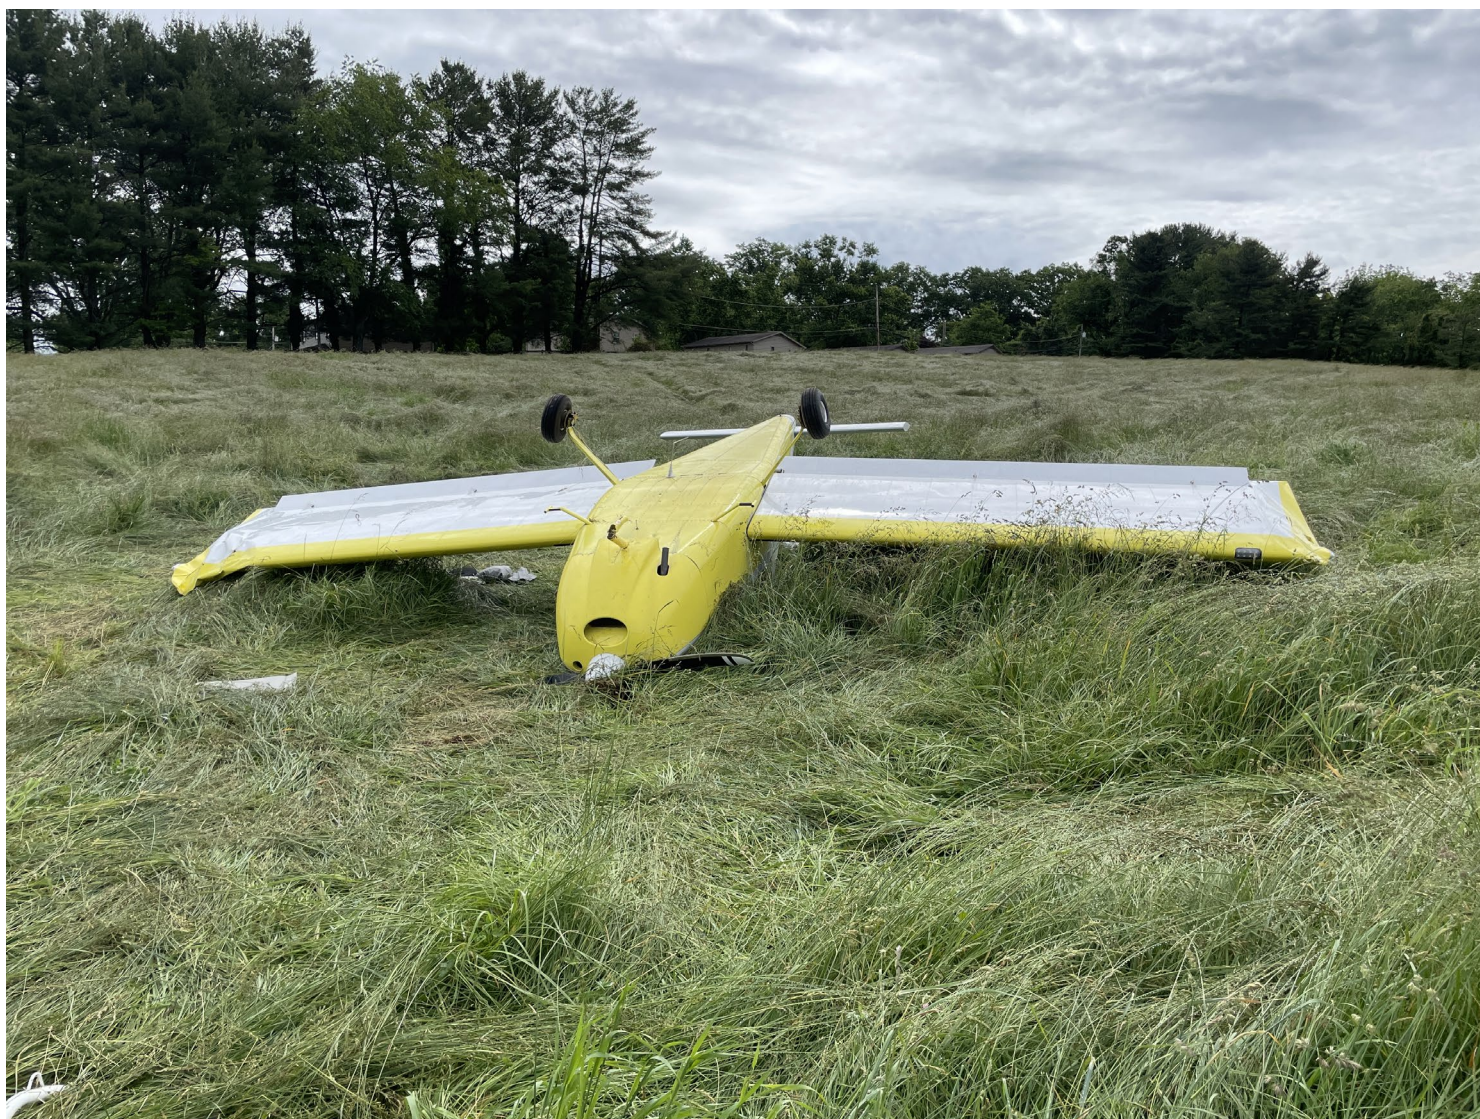
**Photograph 1 - View of the airplane at the accident site. (Courtesy of FAA)**

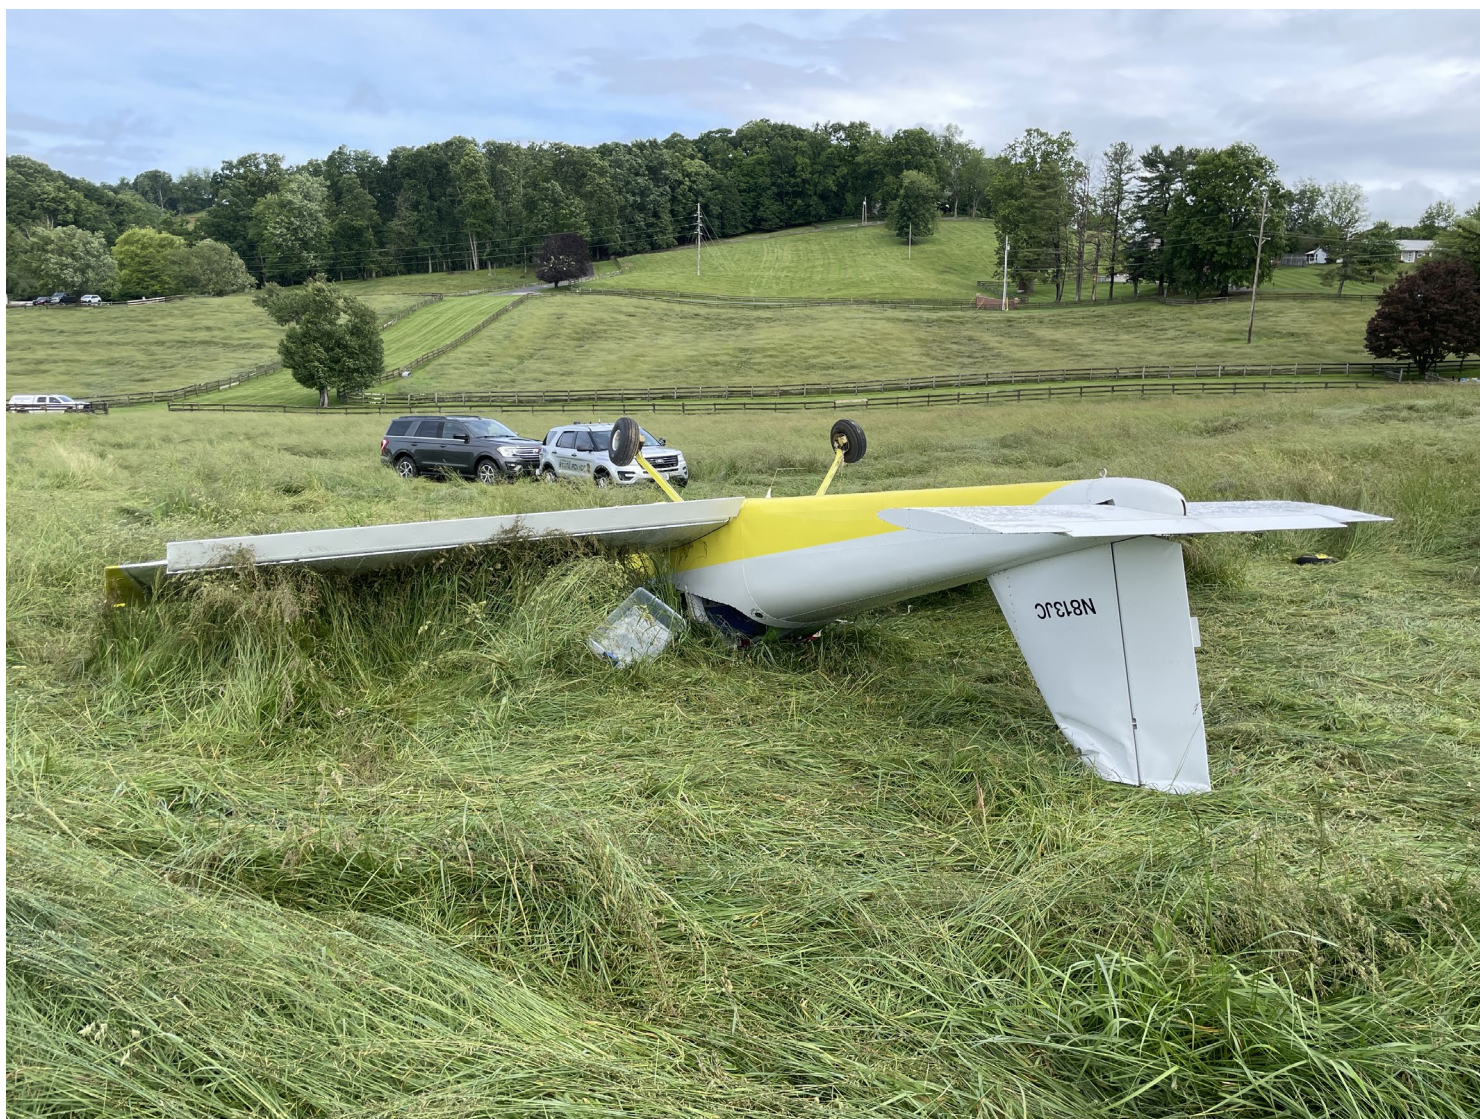
**Photograph 2 - View of damage to the vertical stabilizer and rudder. (Courtesy of FAA)**
