ERA25LA213

## INVESTIGATION PHOTOGRAPHS

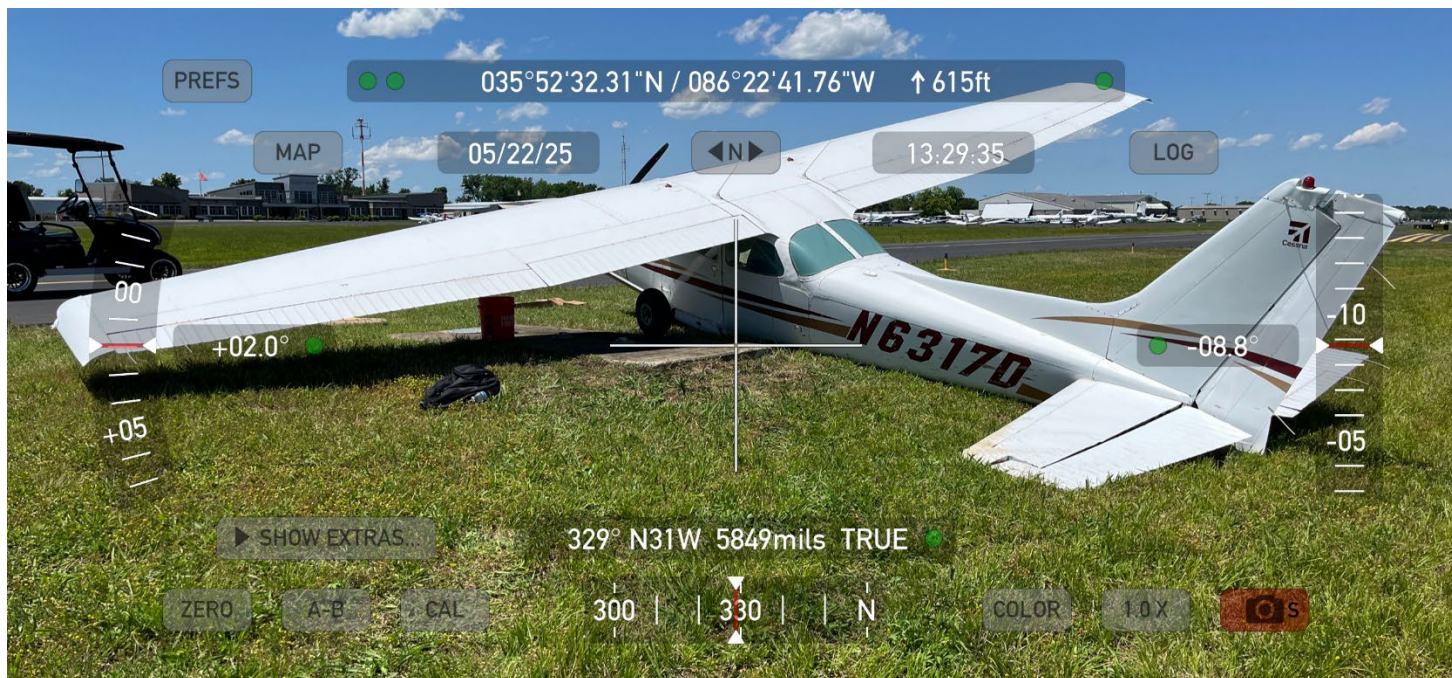
**Photograph 1 - Left aft quarter view of airplane at rest. Note collapsed left landing gear.  
(Courtesy of FAA)**

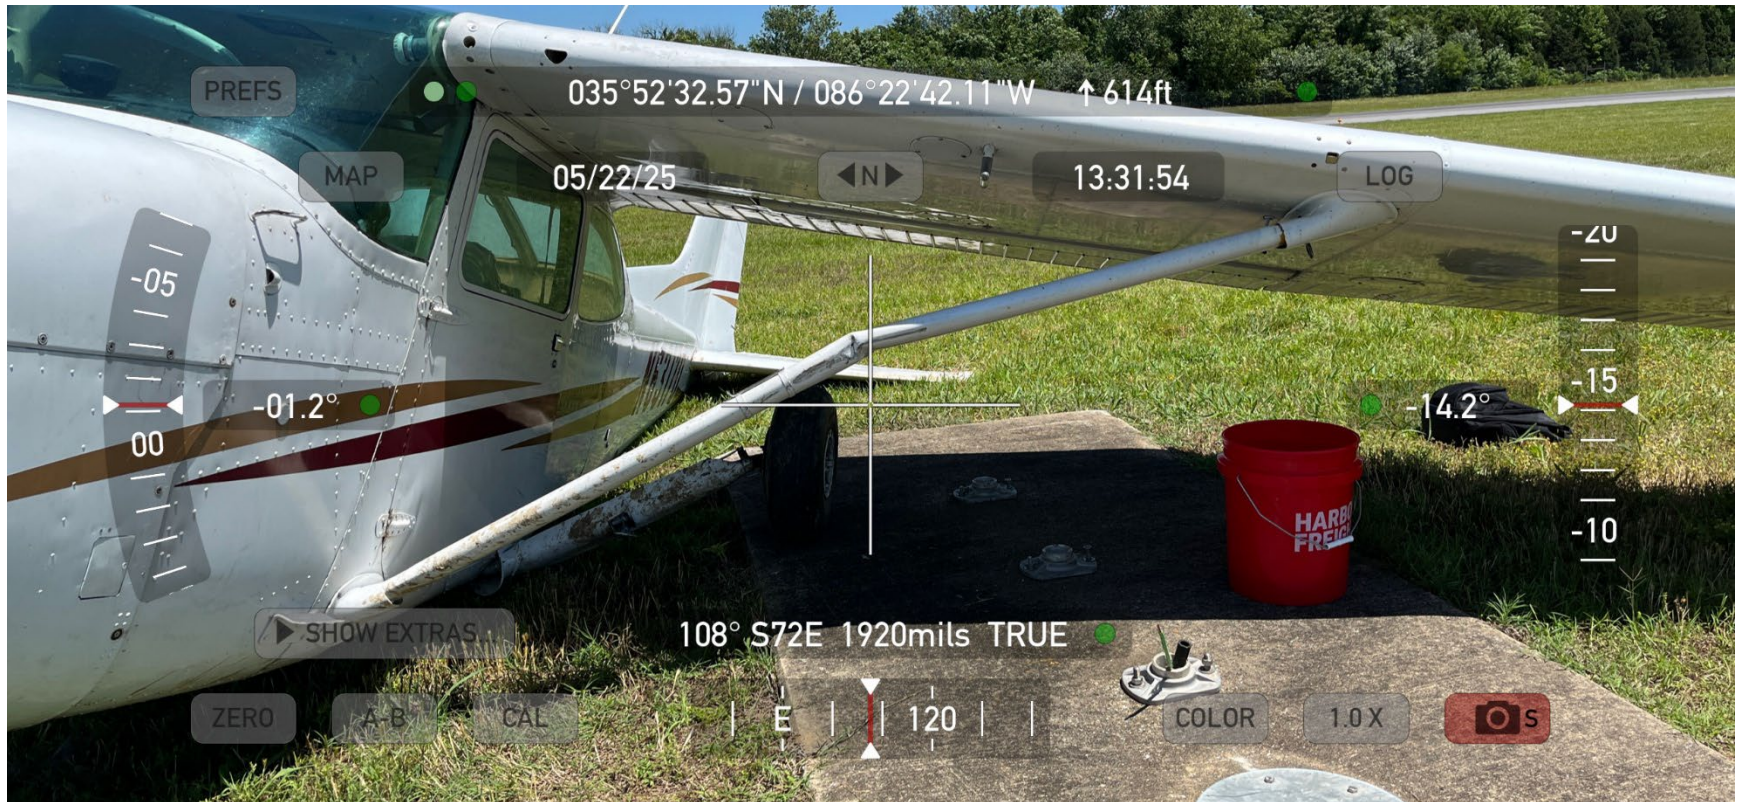
**Photograph 2 - Closeup view of left side of airplane damage. (Courtesy of FAA)**

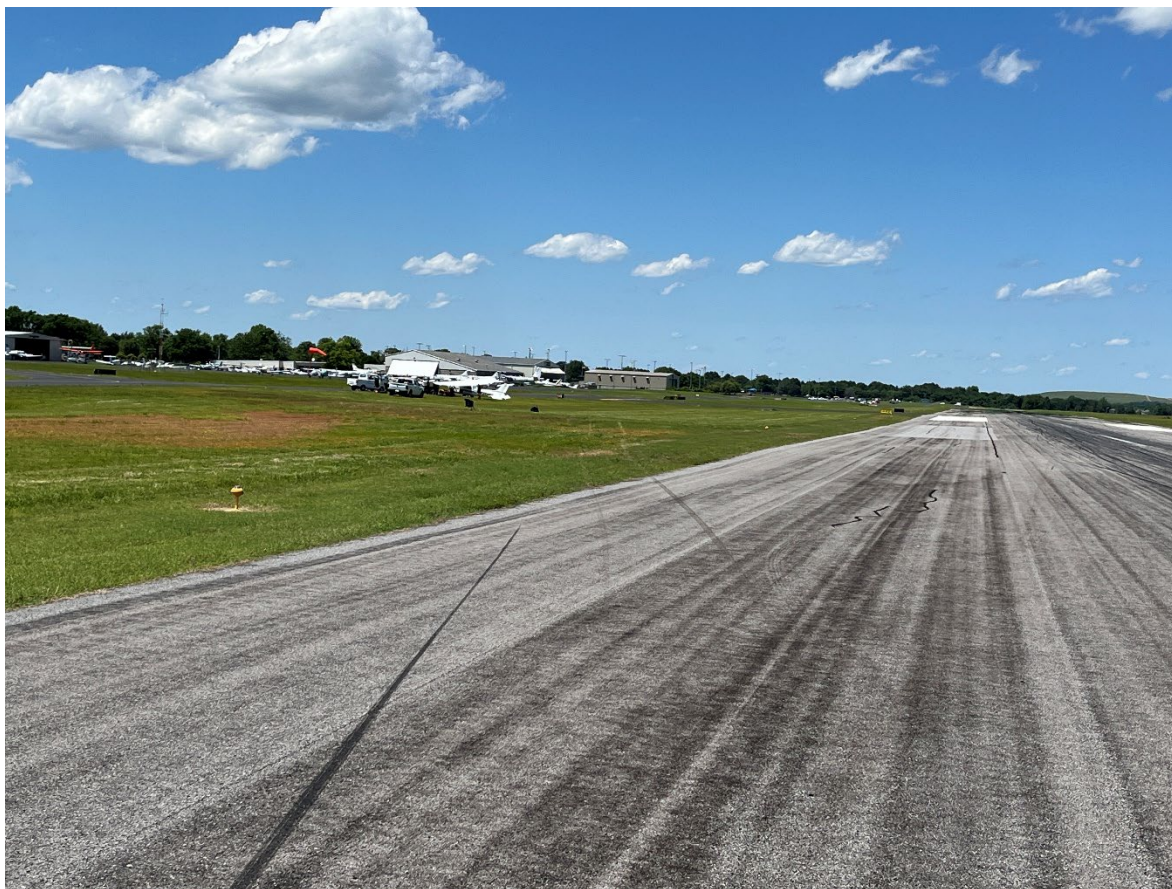
**Photograph 3 - View of tire skid marks into the grass of the left side of the runway. (Courtesy of FAA)**

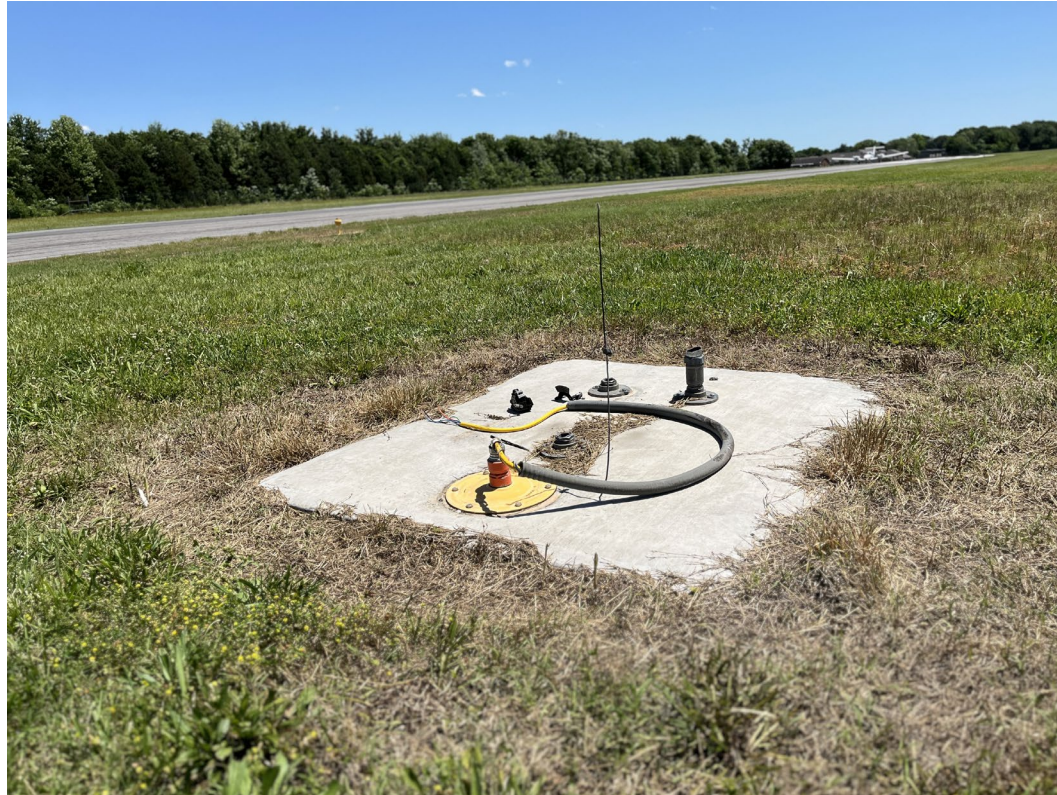
**Photograph 4 - View of damaged runway light. (Courtesy of FAA)**
