# National Transportation Safety Board

ERA25LA226

## **WRECKAGE EXAMINATION**

Location: Murfreesboro, Tennessee  
Date: June 10, 2025  
Time: 11:24 CDT  
16:24 UTC  
Airplane: N15PM Beech A36, SN E-1016

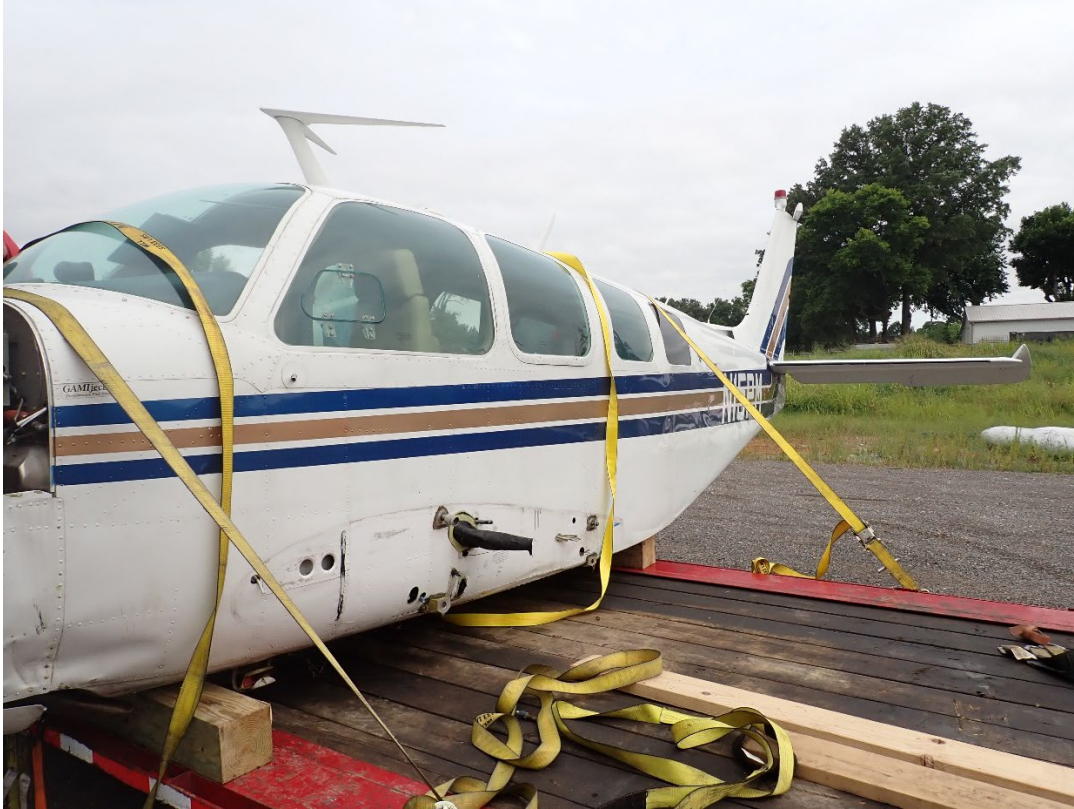
**Figure 1: Left Side Fuselage**

The fuselage remained intact but received substantial damage to the lower forward structure on the left and right-side skins. The wings were removed at the accident location for recovery purposes. The empennage remained attached to the fuselage.

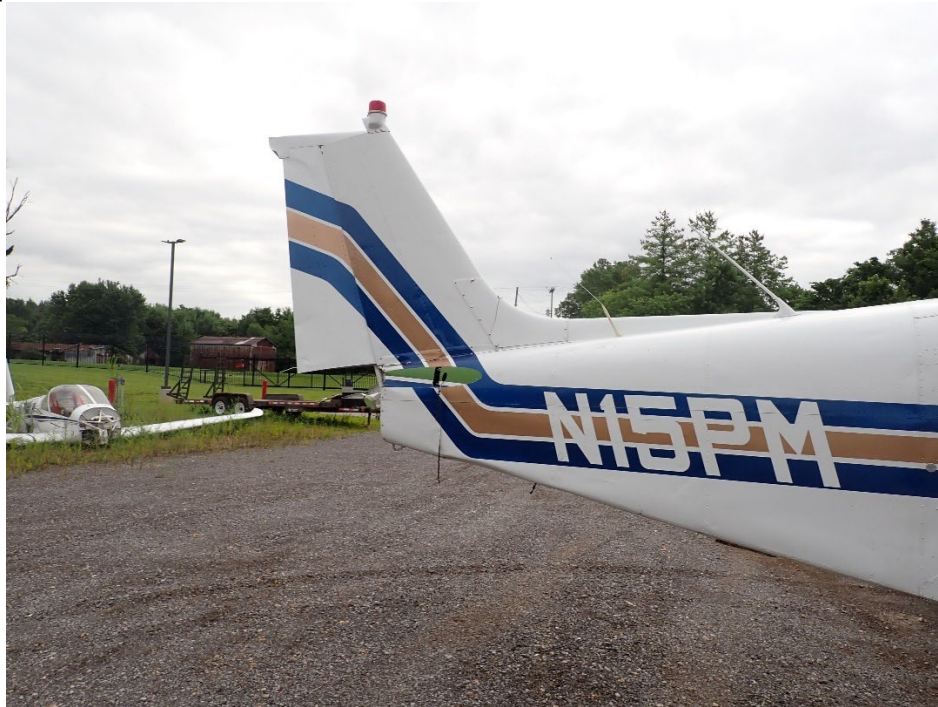
**Figure 3: Empennage Overview**

The empennage remained attached to the fuselage. The vertical stabilizer was undamaged and the rudder had evidence of minor wrinkling. The horizontal stabilizer and elevator surface were undamaged. The right horizontal stabilizer and elevator were separated from the fuselage and were substantially damaged. The airplane's ELT remained installed in the empennage and was found in the "armed" position. The battery expiration was dated November 15, 2029.

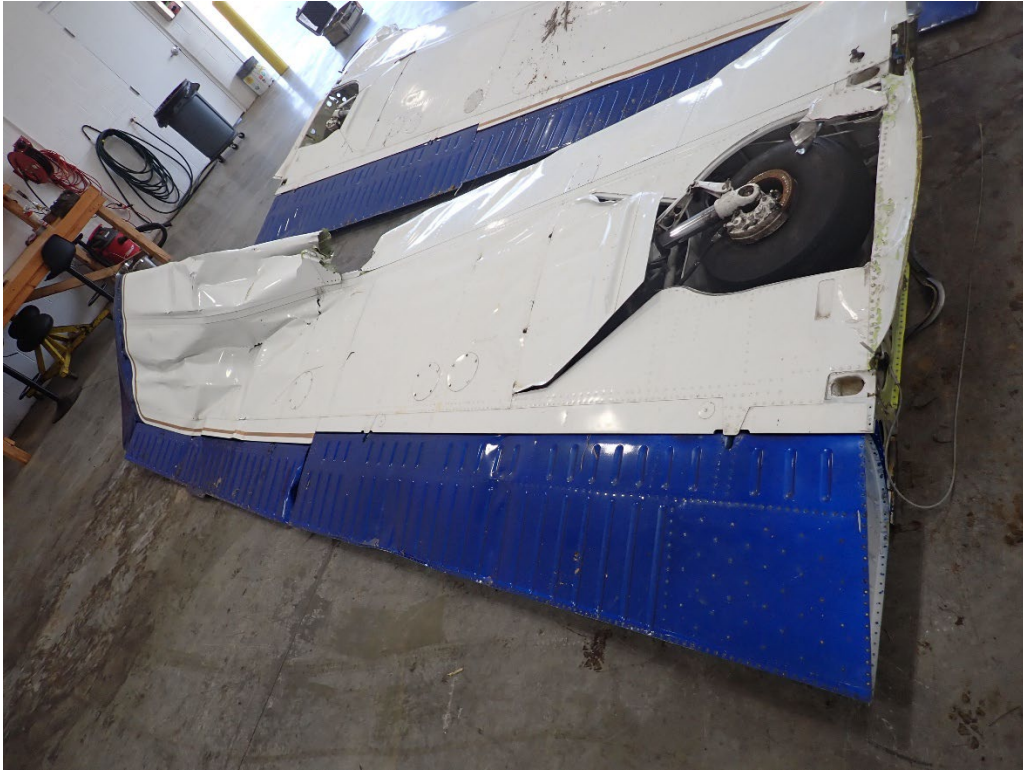
**Figure 5: Damage to Right Wing**

Both wings displayed leading edge damage consist with tree impact from the accident sequence. The outboard portion of the right aileron was damaged from the collision with trees. The flaps were in the up position. The landing gear was extended but stowed by recovery personnel to transport the airplane.

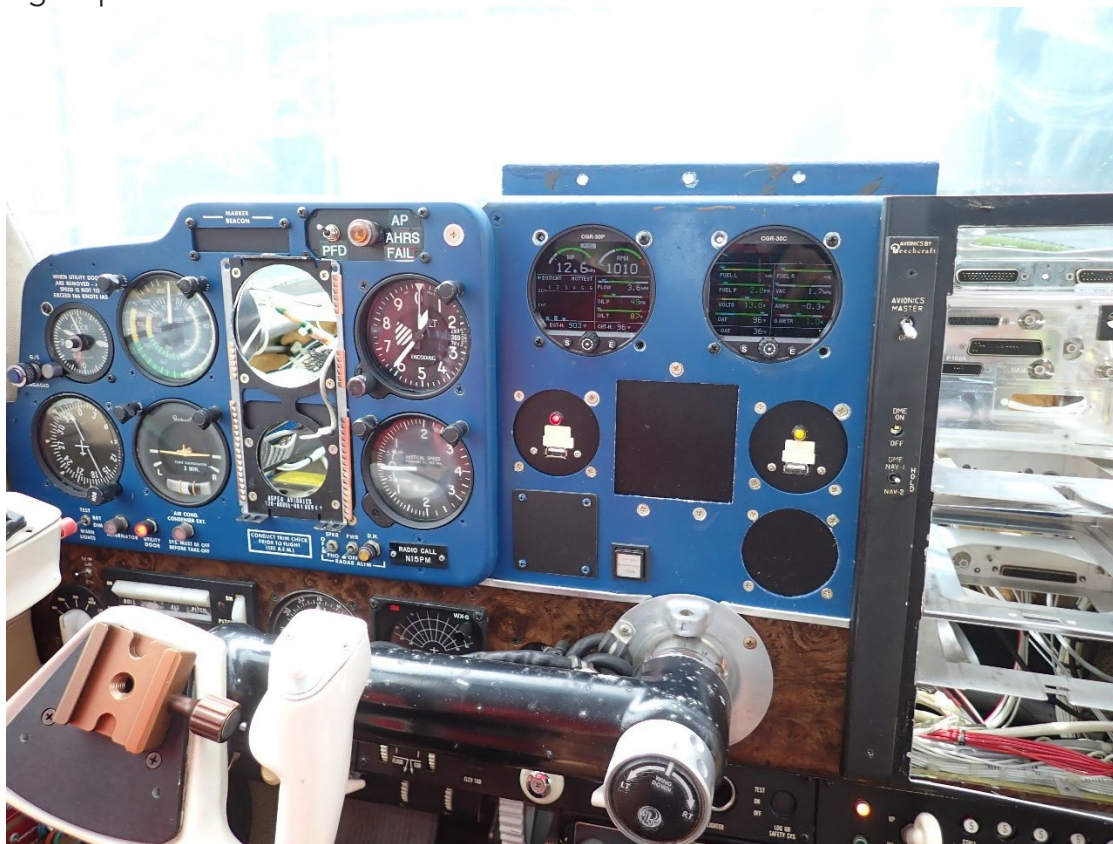
Figure 7: Cockpit Instrumentation During Engine Run

The navigational radios were removed from the airplane for storage. The airplane was equipped with a CGR-30P and CGR-30C engine monitors. The monitors were undamaged and the accident flight data, along with flight data from the engine test runs were recovered in the field from the units. The accident flight showed that at 11:23:35, fuel flow was recorded at 16.4 gph at 2200 RPM consistent with the previous 2 minutes of flight. At 11:23:36, fuel flow began to decrease, before going to 0 gph at 11:23:47. Subsequent drops in engine RPM, oil pressure, and EGT's followed the drop in fuel flow. Fuel flow was not regained for the duration of the data. During the engine test run, the engine idled satisfactorily. The engine was operated to 1700 RPM but could not be run higher due to safety concerns from vibrations from the damaged propeller.

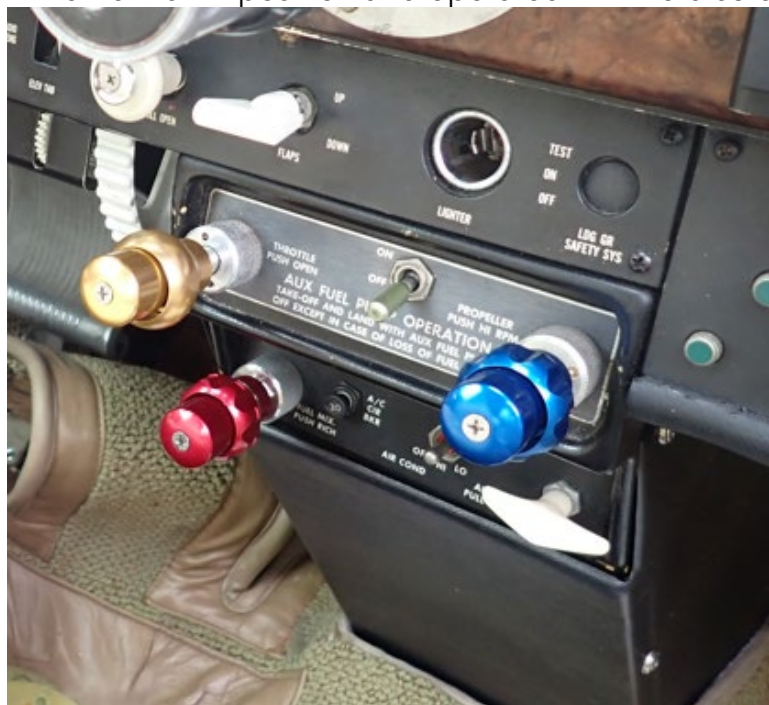
**Figure 8: Aux Fuel Switch**

All the circuit breakers were in, with the exception of the "TRIM" circuit breaker which was popped. The landing gear handle was in the down position. The flap handle was in the up position. The throttle, mixture, and propeller levers were in their full positions. The auxiliary fuel pump was in the "off" position.

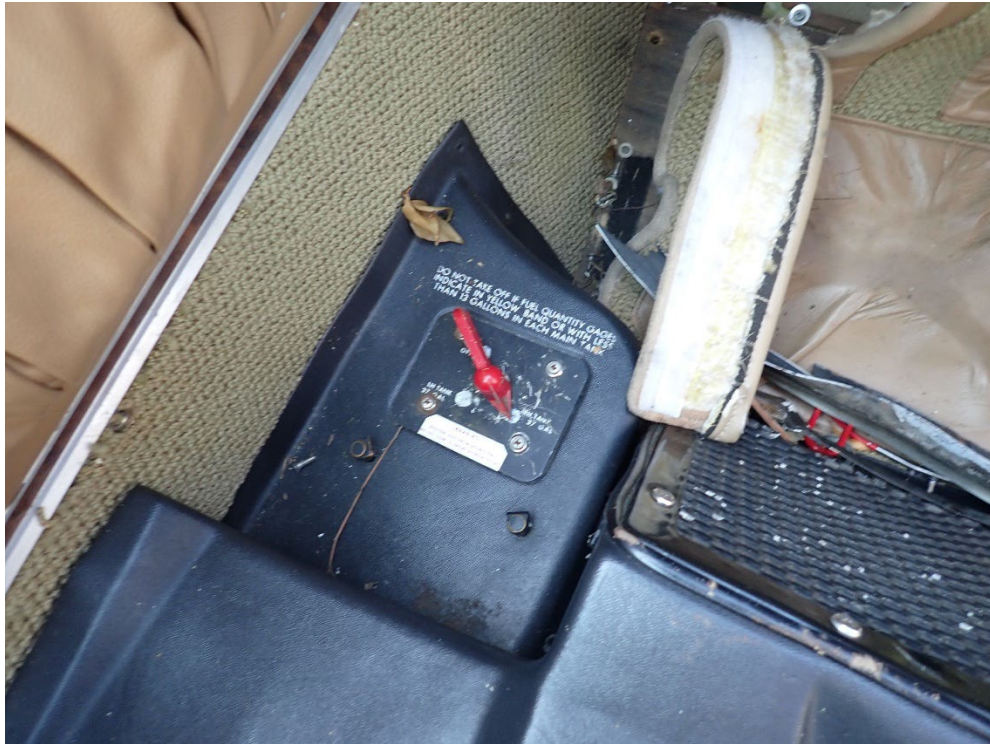
**Figure 9: Fuel Selector in Right Tank Position**

The airspeed indicator read "0". The altimeter read 600 ft and had a barometric setting of 30.0. The vertical speed gauge read "0". The fuel selector was in the "right" position.

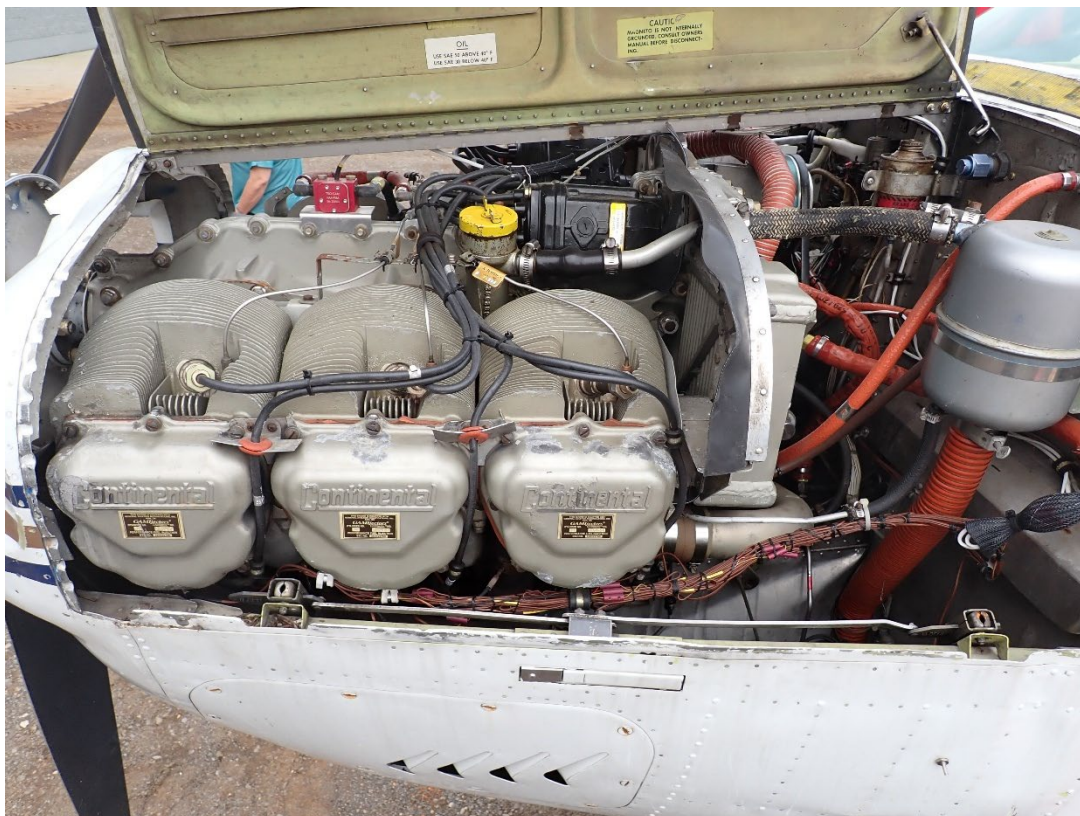
**Figure 10: Left Side of the Engine**

The engine remained attached to the engine mount. The propeller remained attached to the engine crankshaft flange. The engine did not appear to be damaged, with the exception of minor scuffing on the number 6 engine rocker box cover. The top spark plugs were removed, and the cylinders were borescope inspected prior to the engine test run. The top spark plugs electrodes had normal wear and coloration consistent with lean engine operation. The cylinder combustion chambers, and valve sets were unremarkable. The sparkplugs were reinstalled to facilitate the engine test run.

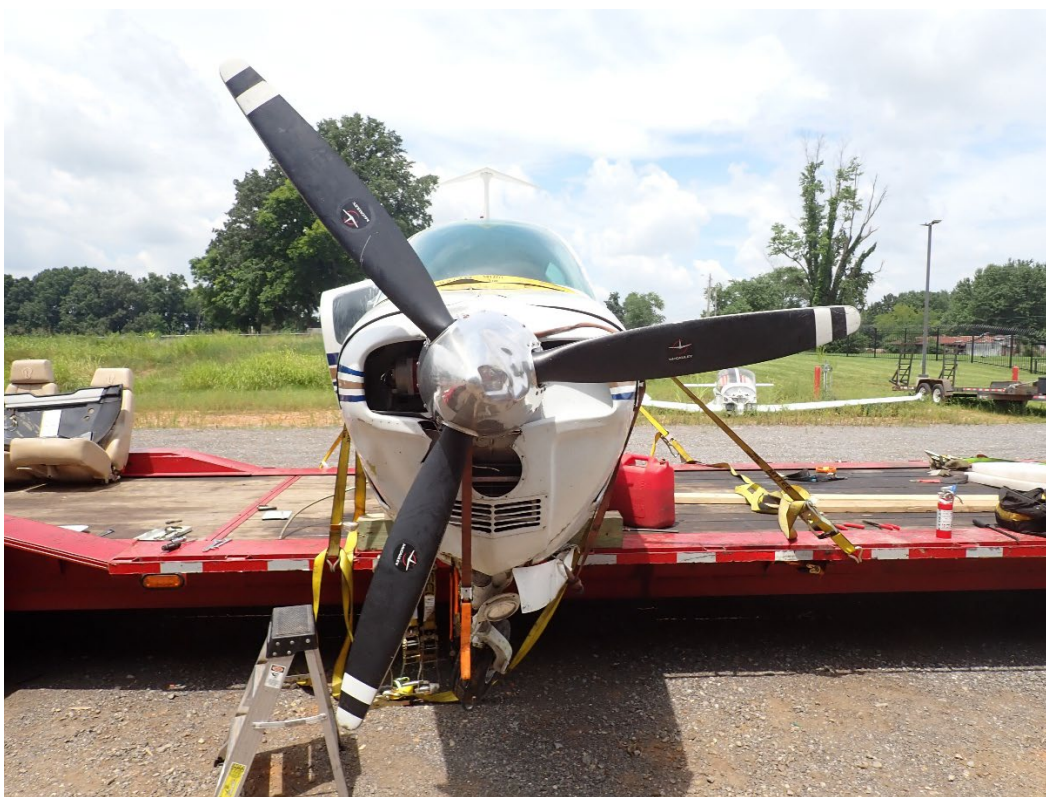
**Figure 13: Propeller Overview**

The airplane was equipped with a three-bladed metal McCauley propeller that remained attached to the engine crankshaft flange. Two of the propeller blades were undamaged. The third propeller blade was bent aft about 10 degrees mid span. There were no rotational signatures or rotational bending observed.
