ERA25LA232

## INVESTIGATION PHOTOGRAPHS

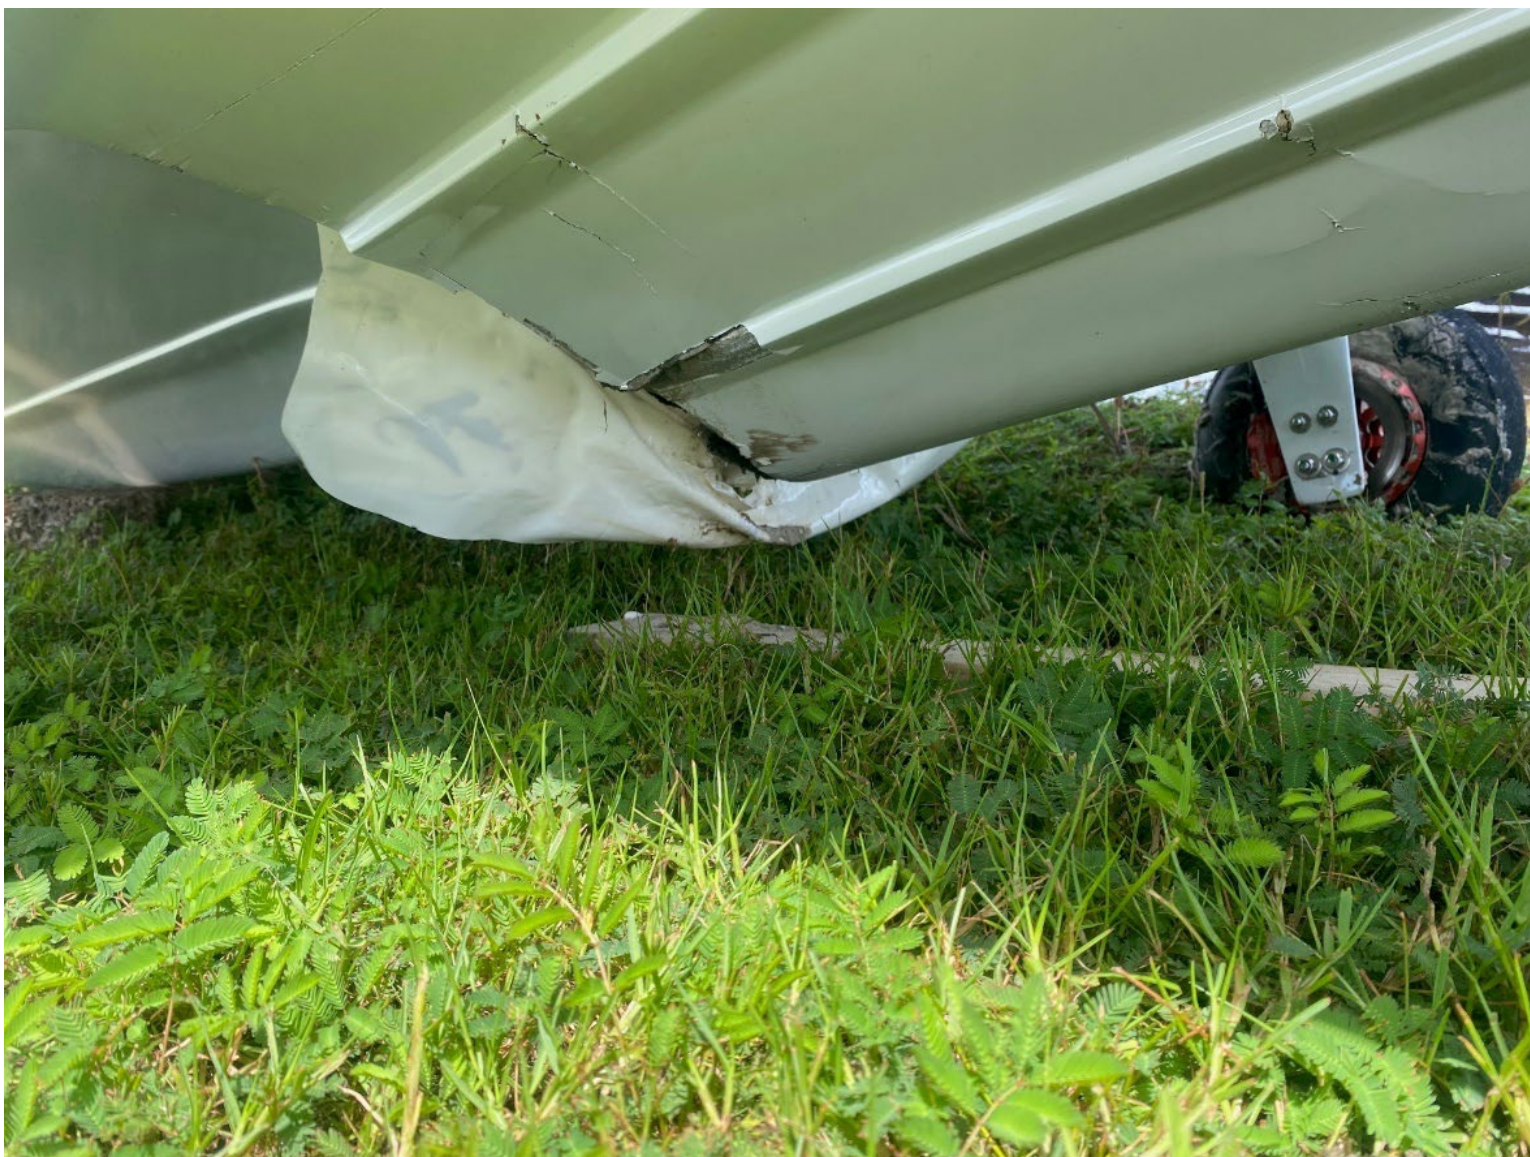
**Photograph 1 - View of damage to the fuselage/hull. (Courtesy of FAA)**

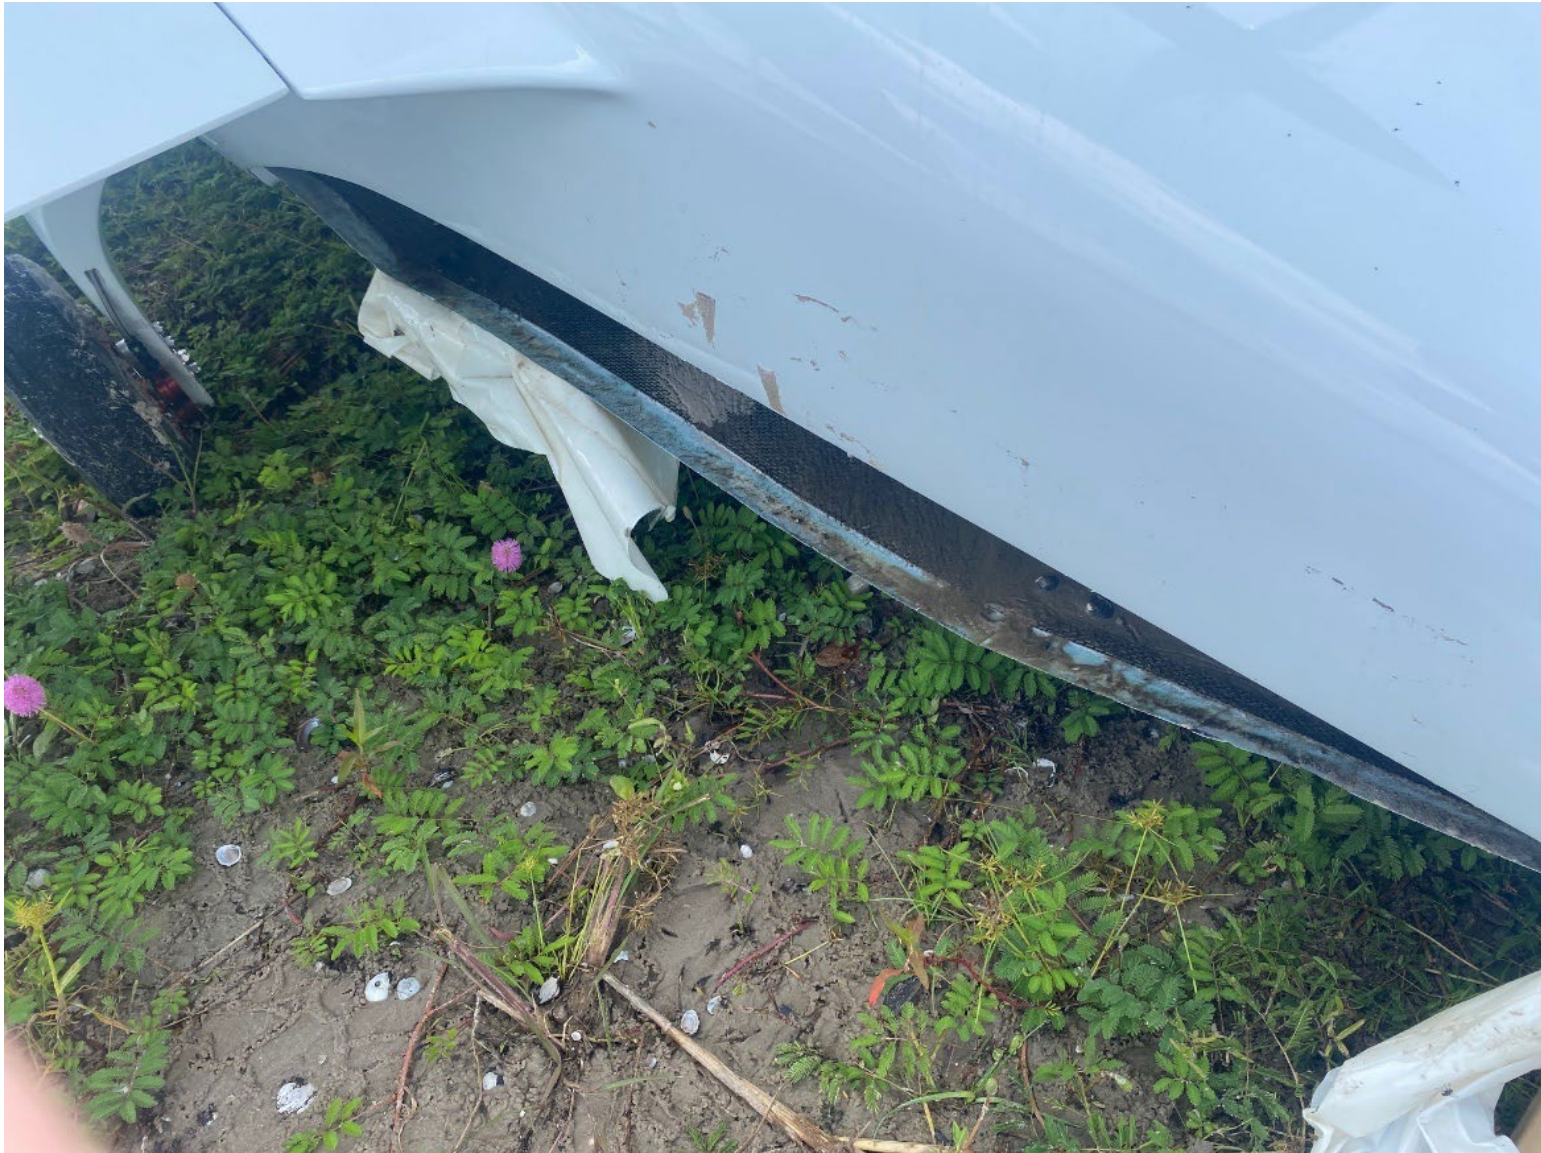
**Photograph 2 - View of damage to the left side of the fuselage/hull. (Courtesy of FAA)**

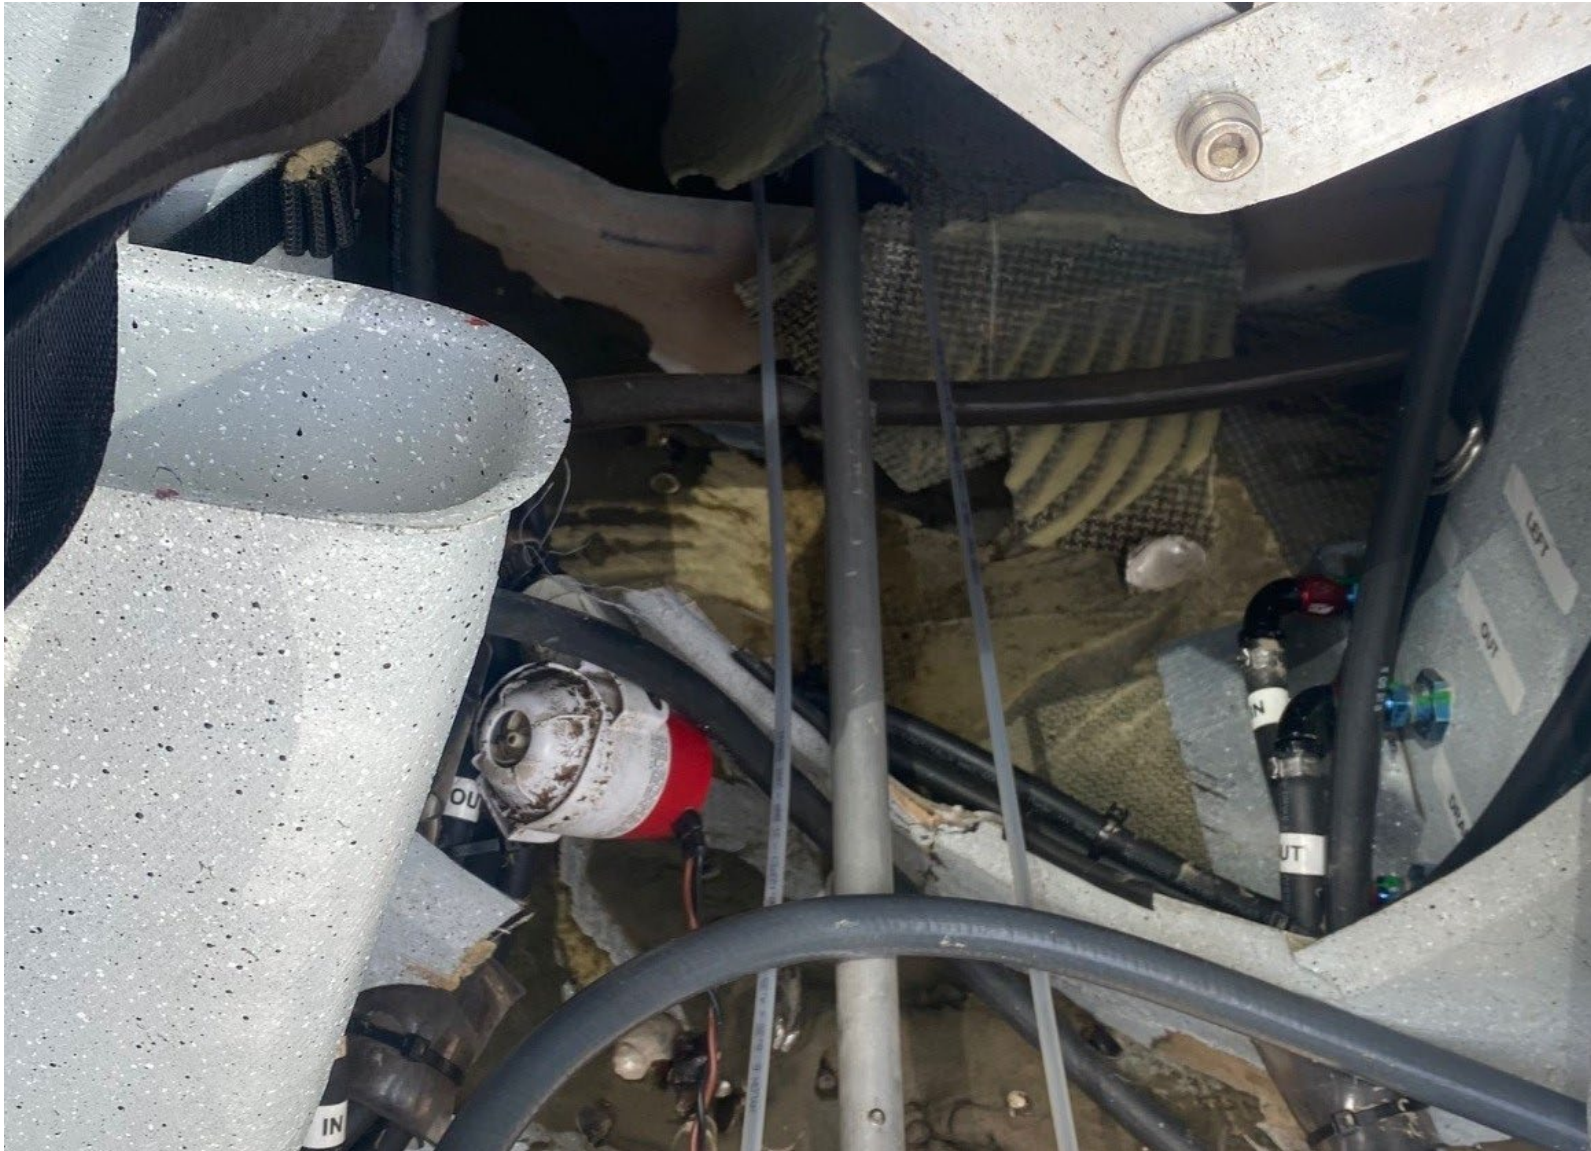
**Photograph 3 - View of damage to the internal fuselage/hull structure. (Courtesy of FAA)**
