ERA25LA241

## INVESTIGATION PHOTOGRAPHS

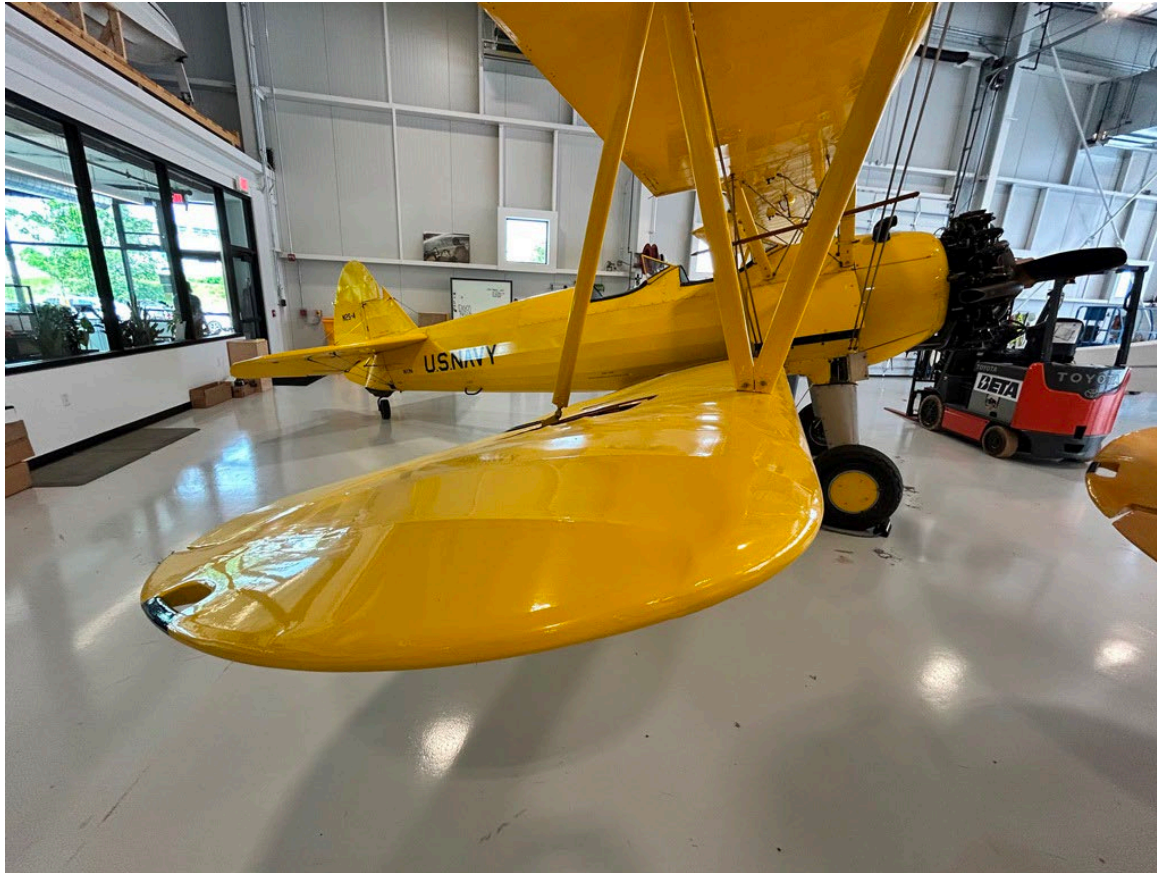
**Photograph 1 - Right Side View of Airplane (Courtesy of FAA)**

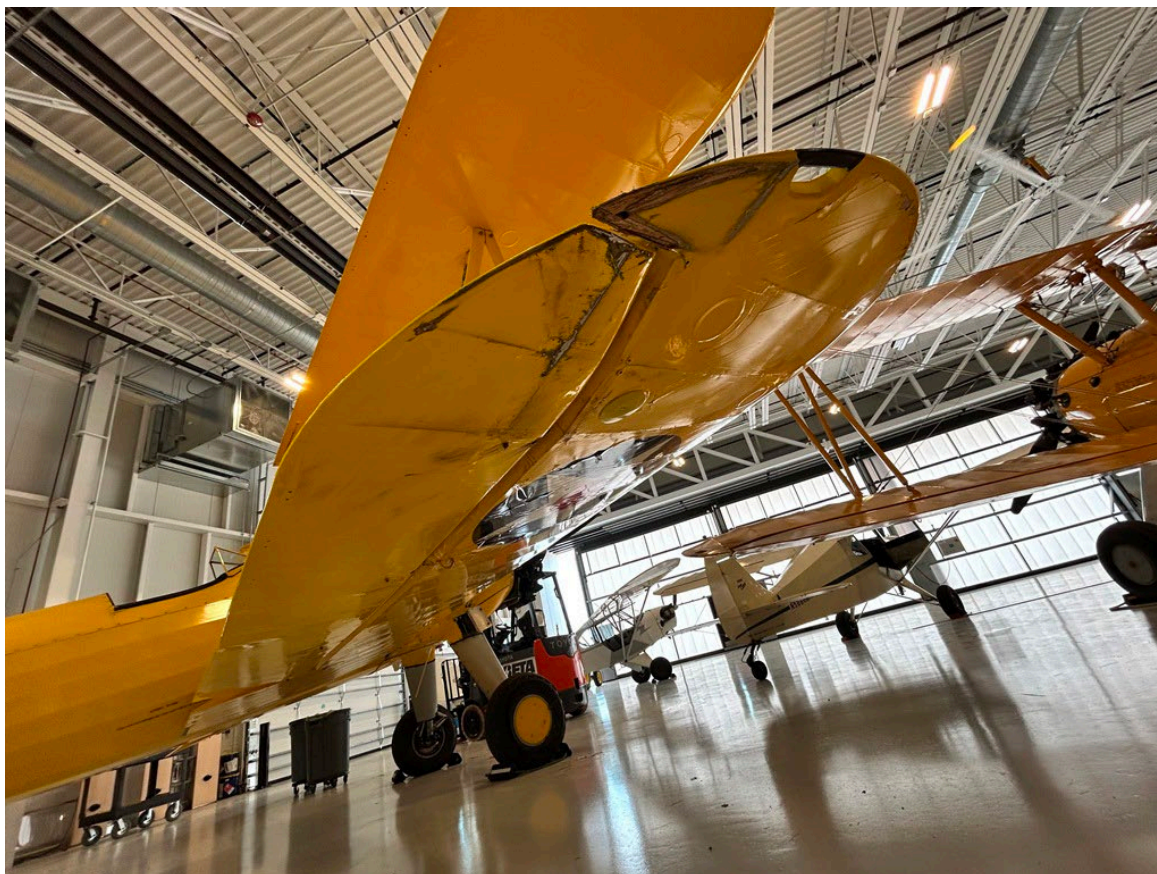
**Photograph 2 - Exterior Damage to Lower Right Wing (Courtesy of FAA)**

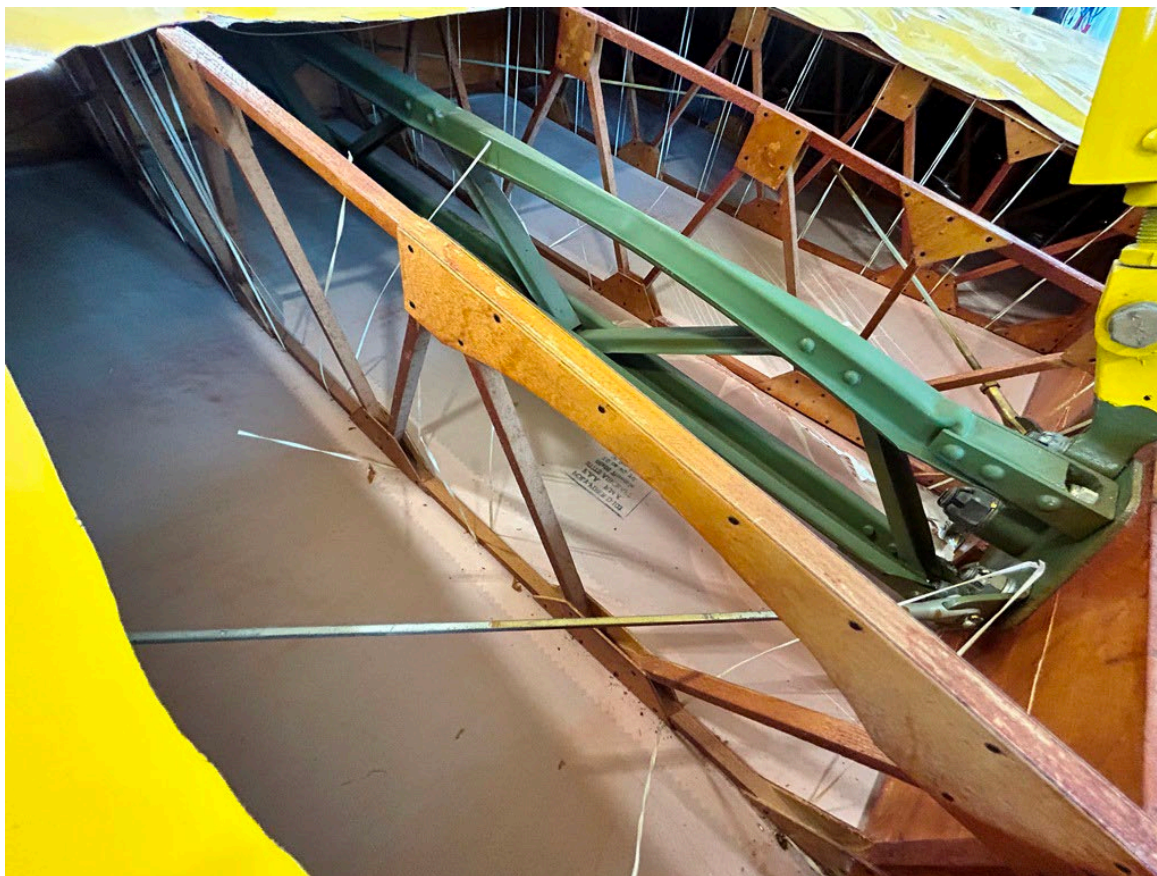
**Photograph 3 - Damaged Lower Right Wing Spar (Courtesy of FAA)**
