ERA25LA256

## INVESTIGATION PHOTOGRAPHS

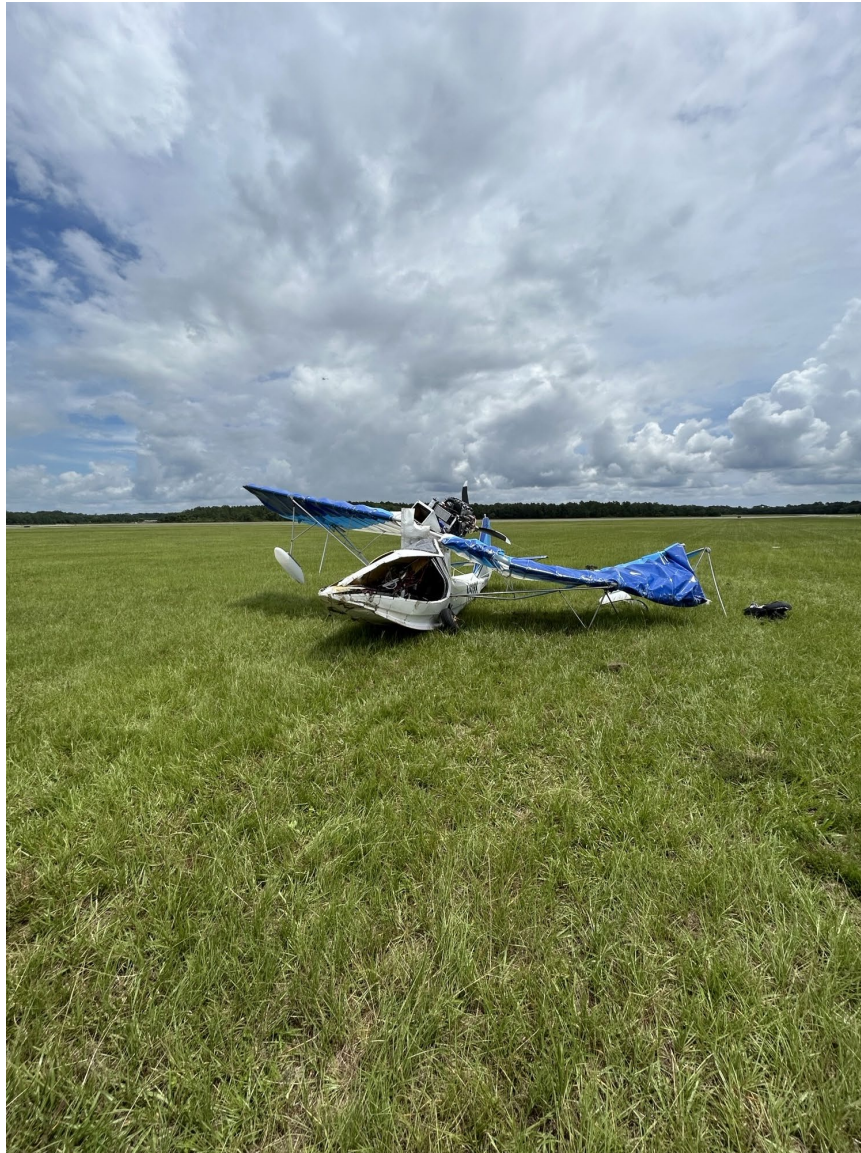
**Photograph 1 - View of the airplane at the accident site. (Courtesy of Airport Manager)**

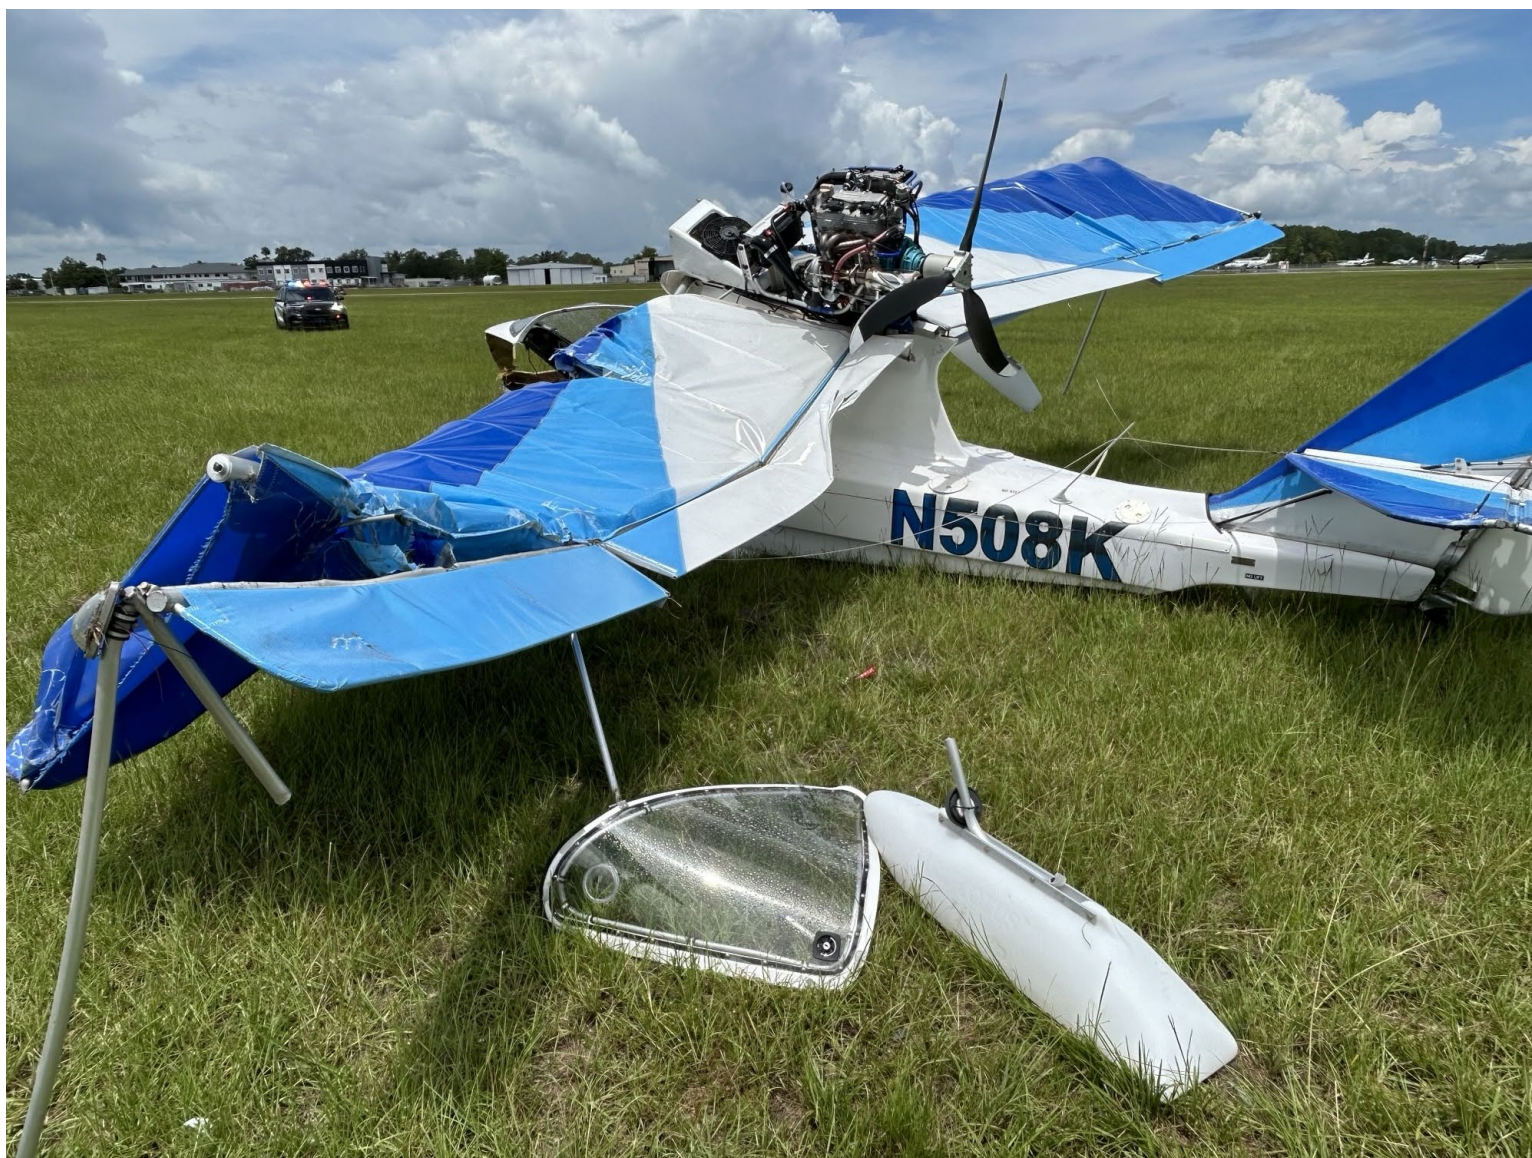
**Photograph 2 - View of damage to the airplane. (Courtesy of Airport Manager)**

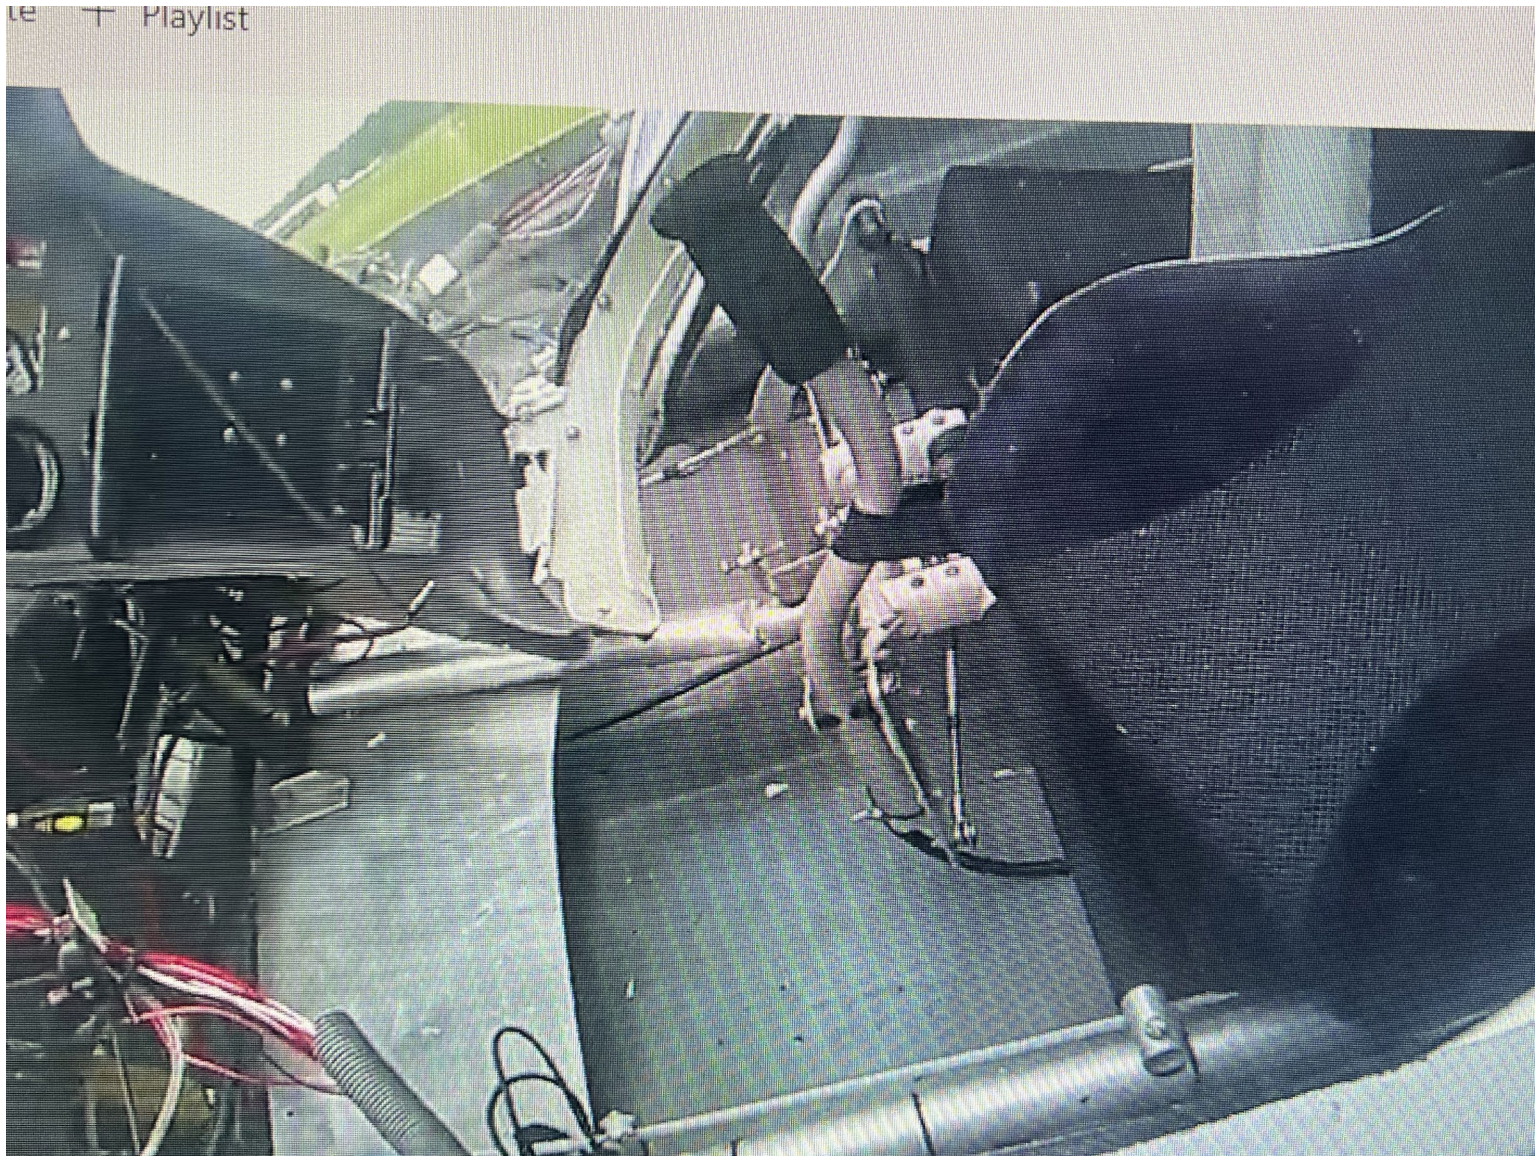
**Photograph 3 - View of the seat cushion strap around control stick. (Courtesy of VCSO)**
