Joshua Young  
Air Safety Investigator  
AS-ERA

**Subject:** ERA25LA256, Flap actuator examination

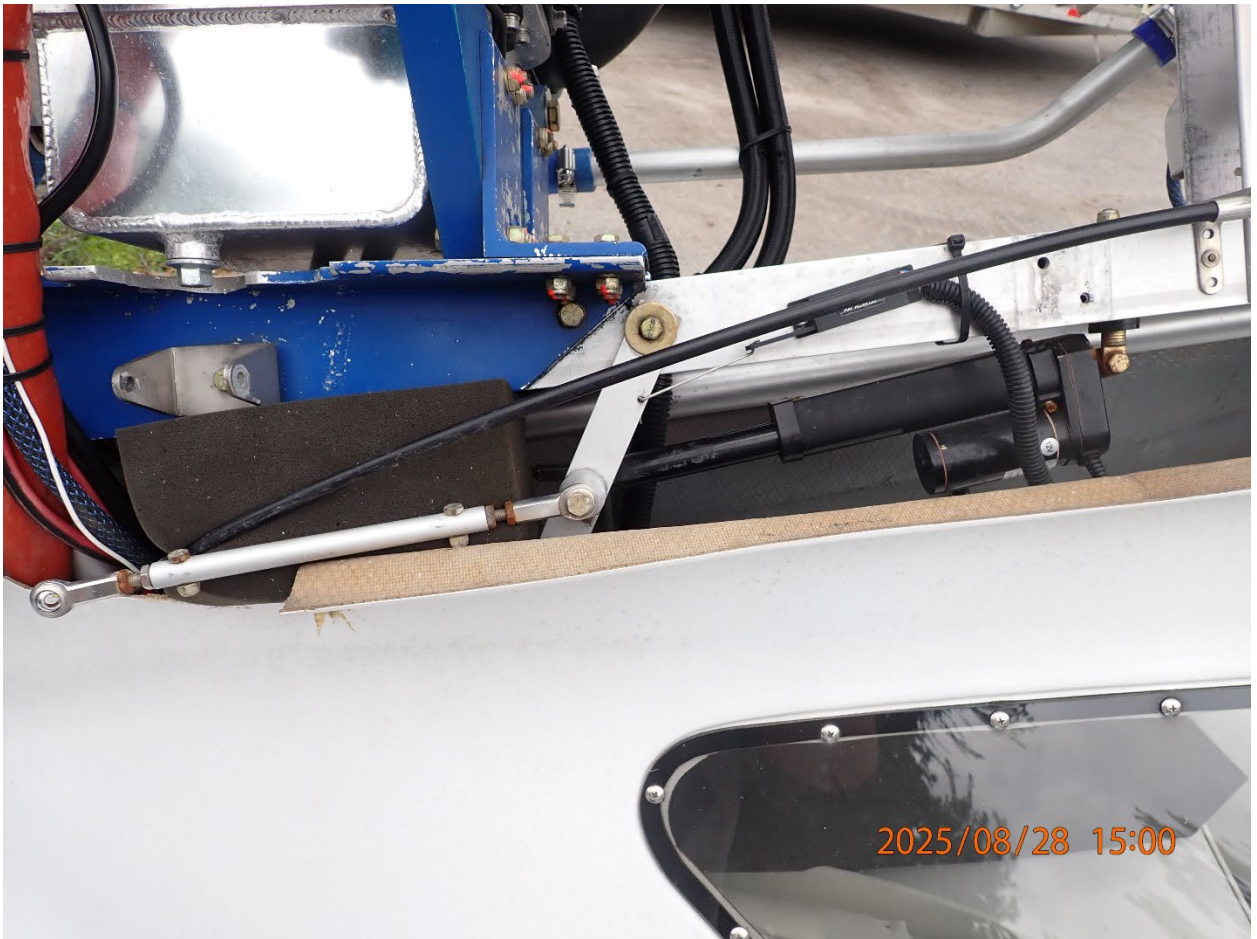
On August 28, 2025, the IIC examined the flap actuator and motor at the recovery facility. The flap actuator was partially extended. The flap actuator remained in place and did not move up or down the sleeve when pressure was applied by hand. Power was applied to the flap motor, and it moved the actuator piston smoothly in both directions. Based on photographs of an exemplar airplane the position of the flap actuator was consistent with the flaps being in the UP position.

*Figure 1: View of the flap actuator and motor as found.*
