ERA25LA257

## INVESTIGATION PHOTOGRAPHS

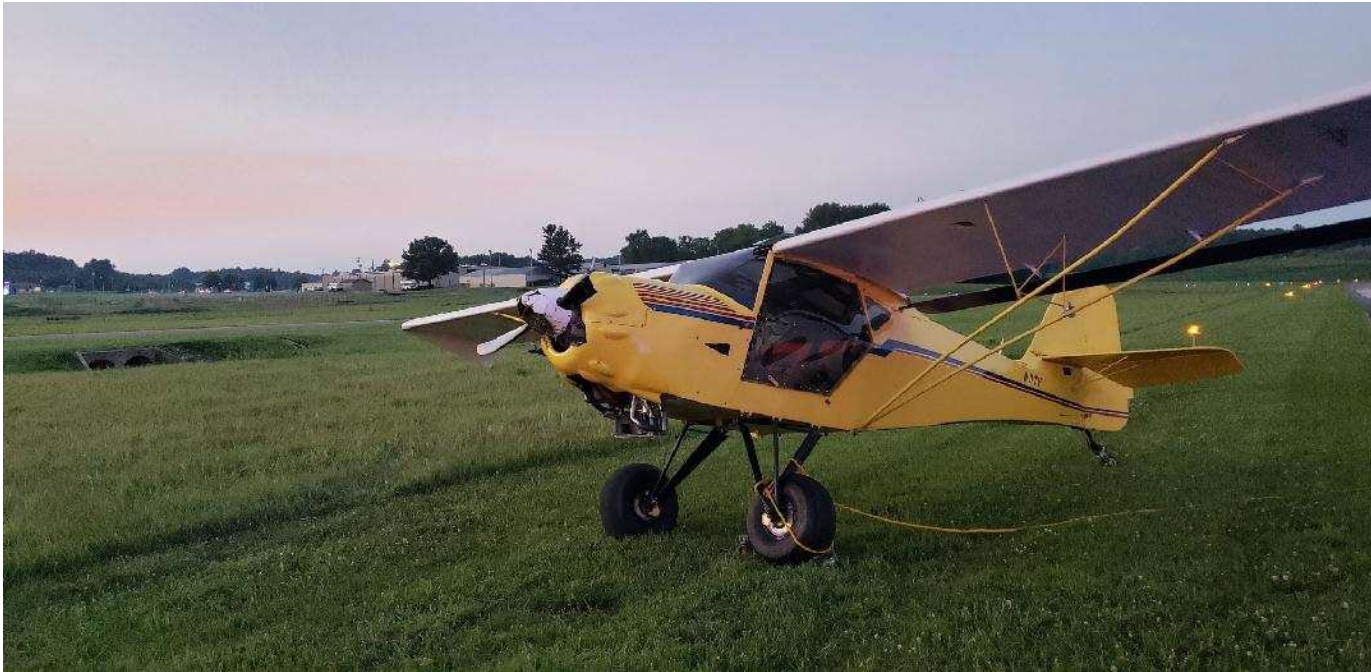
**Photograph 1 - Airplane postaccident (Courtesy of Airport Ops)**

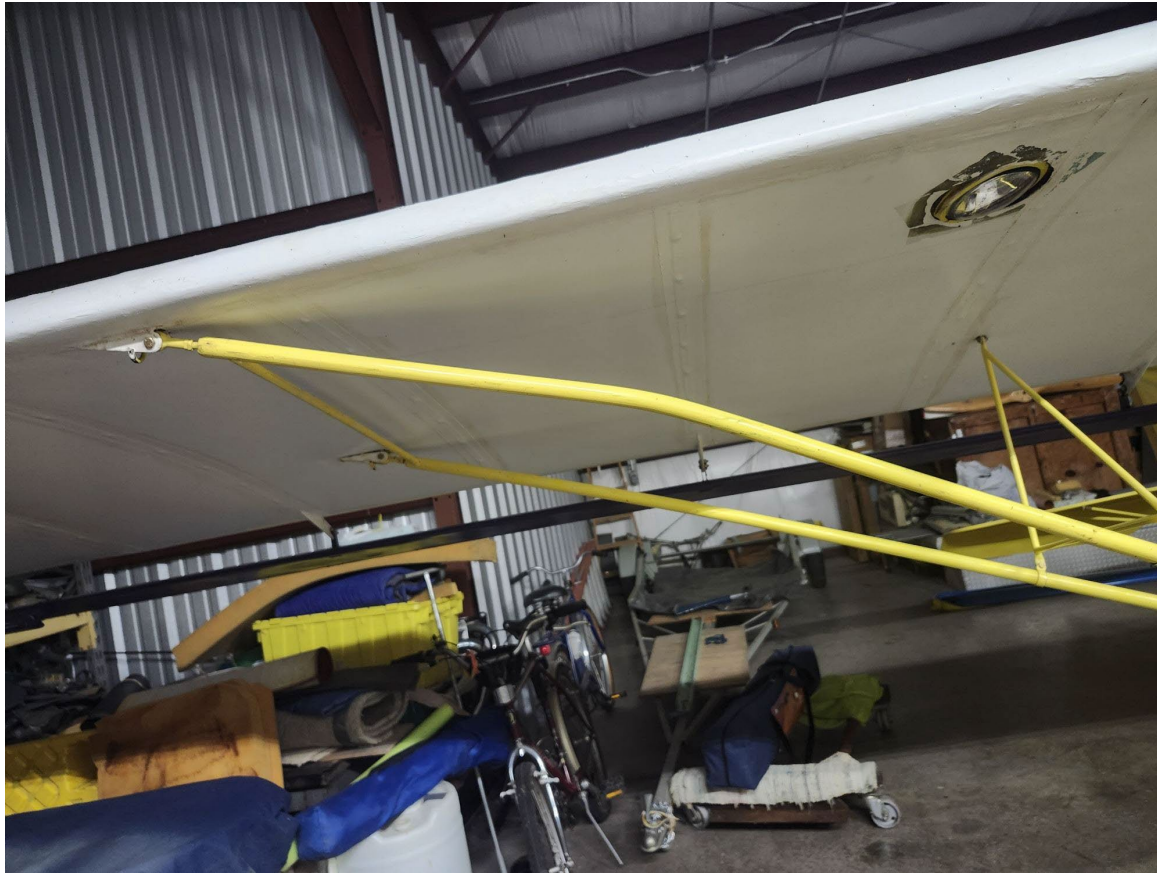
**Photograph 2 - Right wing strut accident damage (Courtesy of Pilot)**

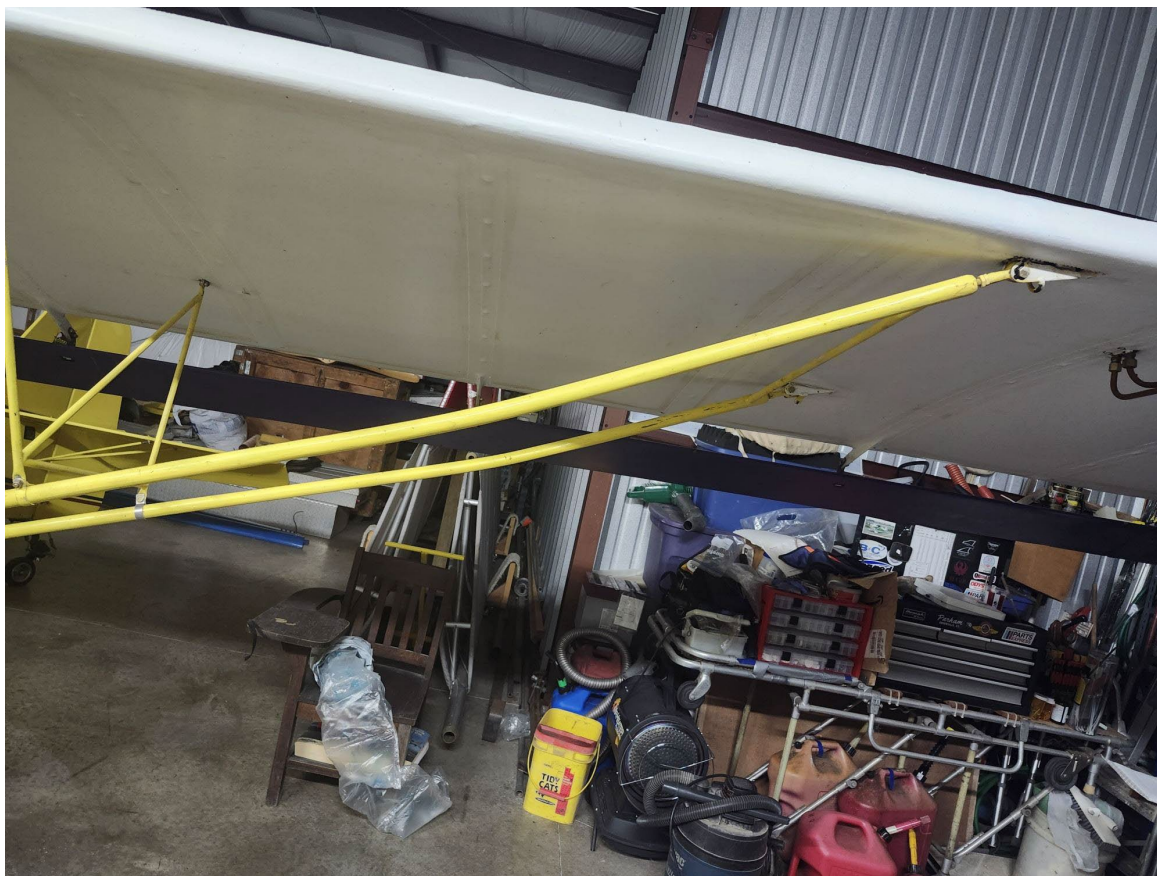
**Photograph 3 - Left wing strut accident damage (Courtesy of Pilot)**

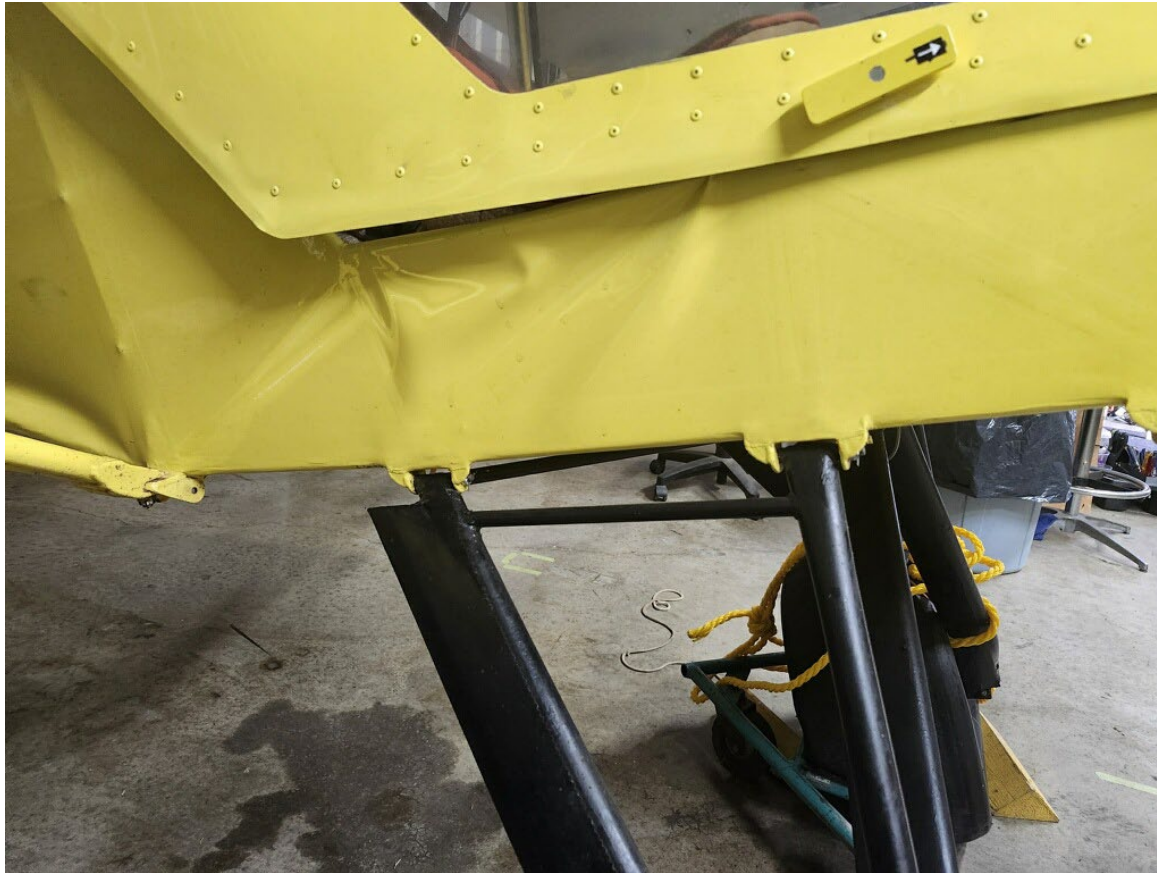
**Photograph 4 - Right side fuselage buckling (Courtesy of Pilot)**

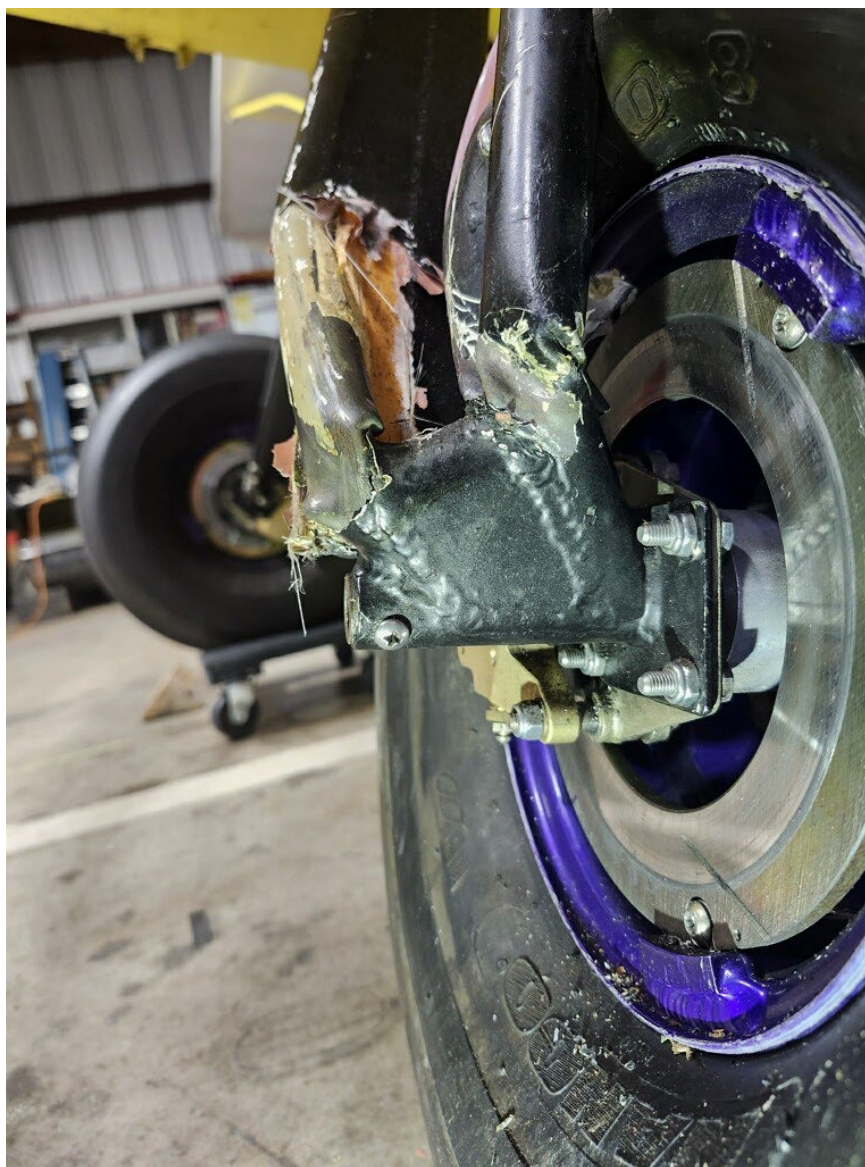
**Photograph 5 - Left main landing gear damage (Courtesy of Pilot)**
