## **FAA IIC Inspector visit to Greenville, KY**

**James R. Zehr FAA AFG-300 CE-17 FSDO**

For N11TY accident.

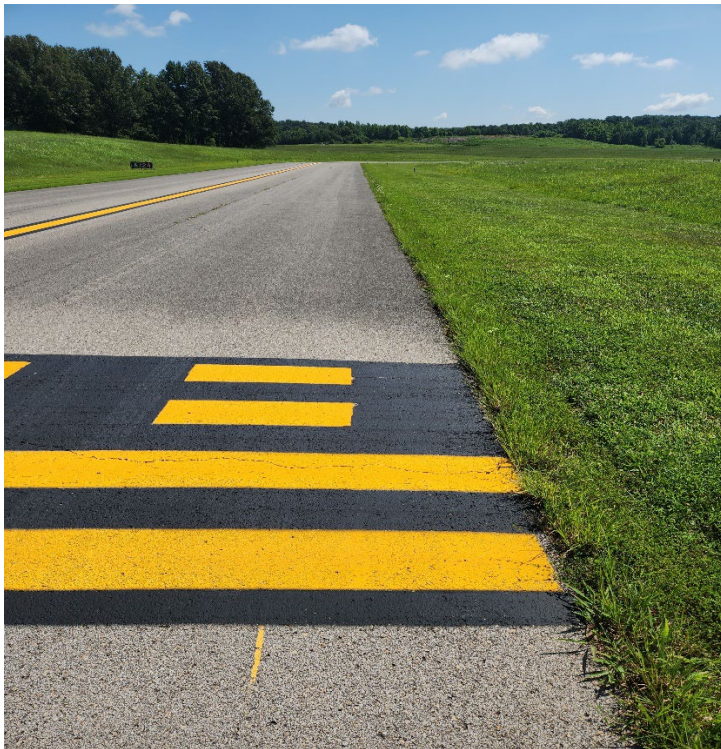
Heading towards runway 6 View #1

I inspected the area where he turned around and the grassy area to each side of the taxi way is very smooth with a smooth transition from turf to pavement. The estimated distance away from the pavement was 8 feet. The difference between the two surfaces is negligible. The two pictures below show the exact area where he exited and re-entered the pavement in his turn-around procedure.
