ERA25LA263

## INVESTIGATION PHOTOGRAPHS

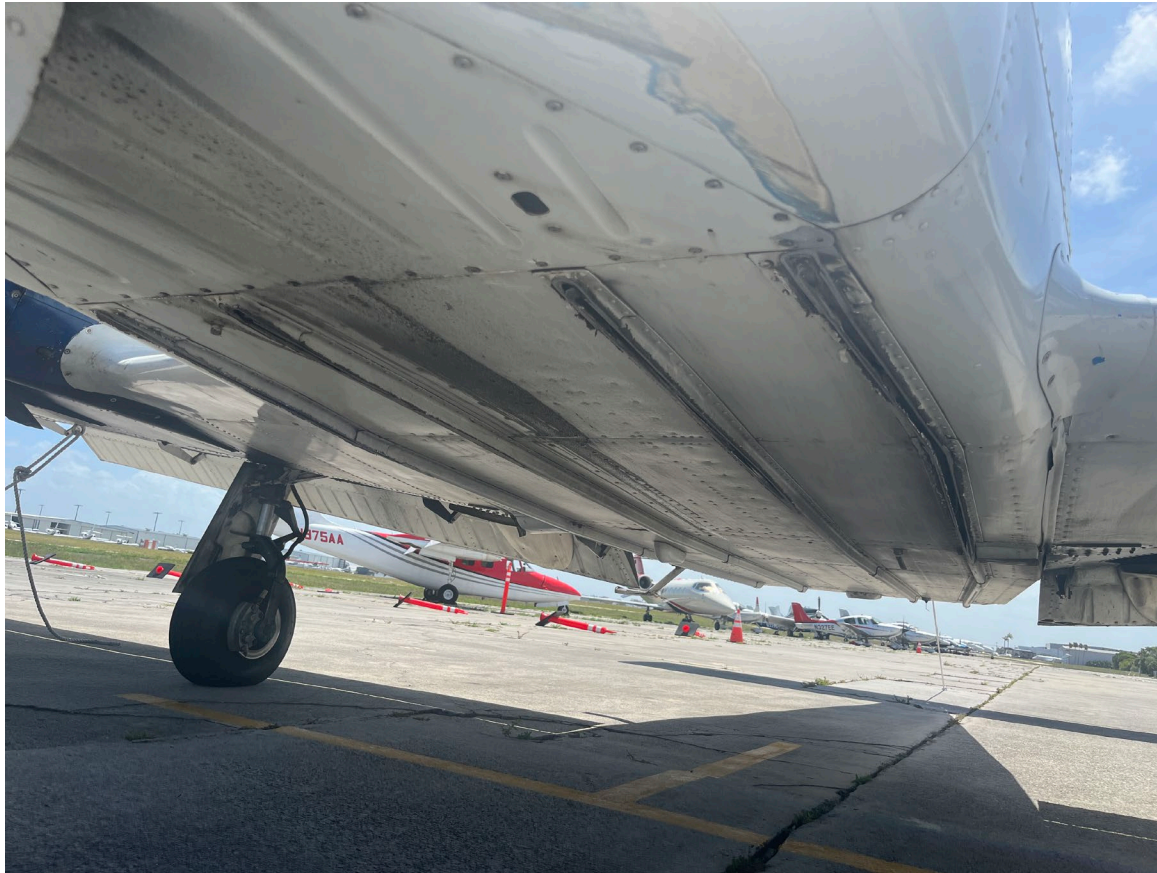
**Photograph 5 - View of the Fuselage Bottom Noting Damage to External Longerons (Courtesy of FAA)**

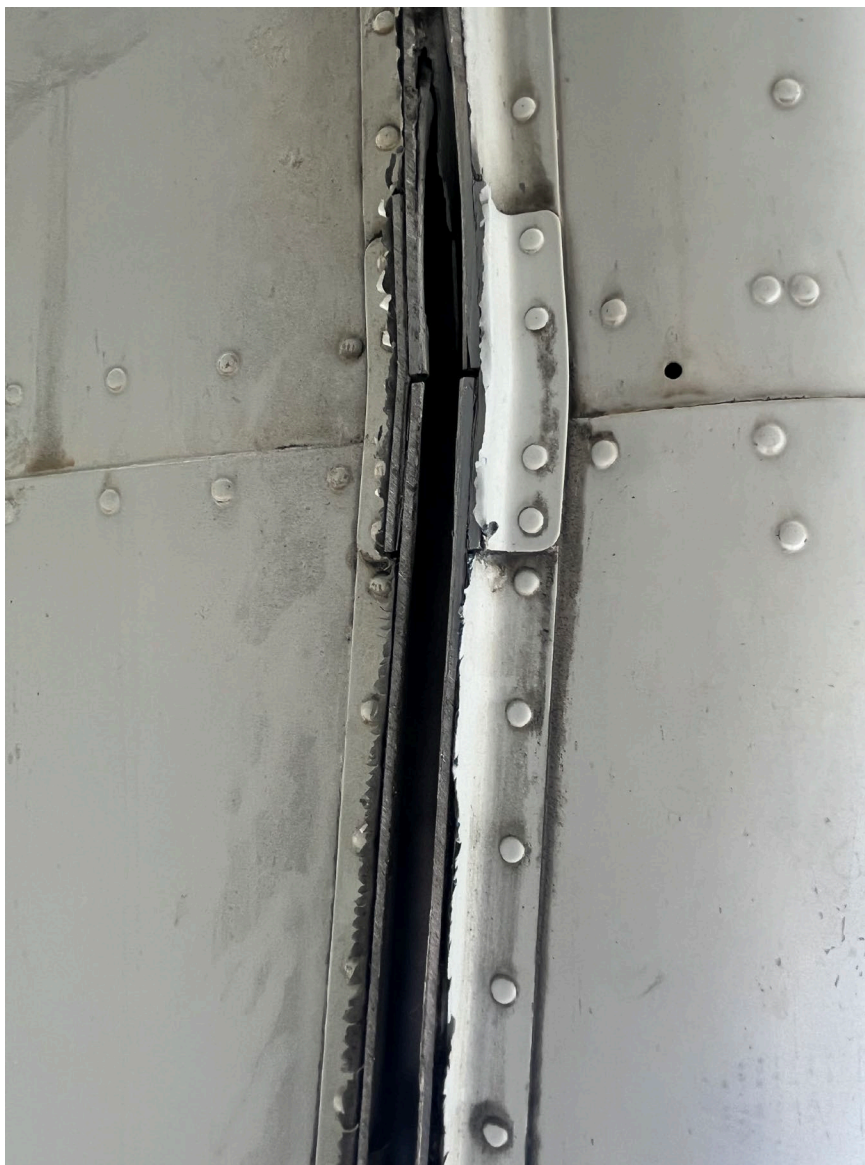
**Photograph 6 - Close-Up View Showing Damage to External Longeron (Courtesy of FAA)**
