ERA25LA268

## INVESTIGATION PHOTOGRAPHS

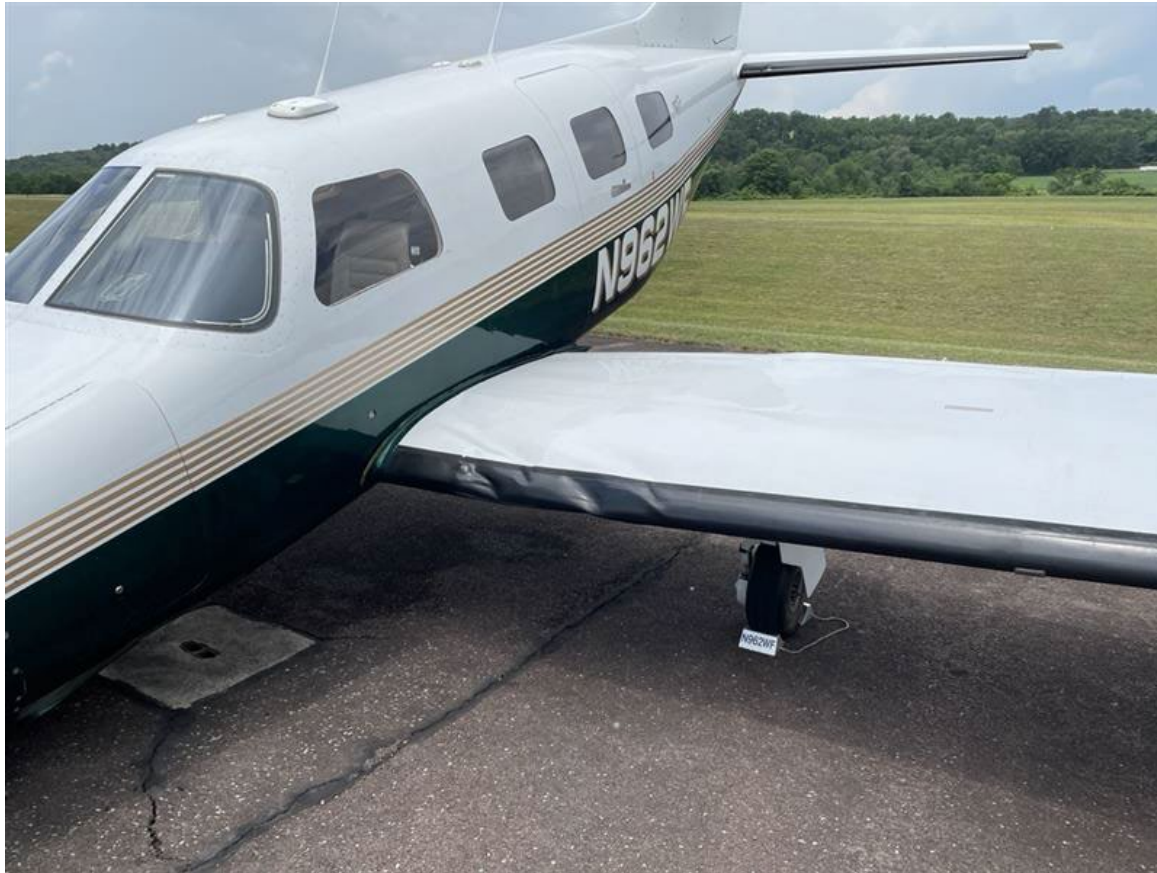
**Photograph 1 - Left Wing Damage (Courtesy of FAA)**

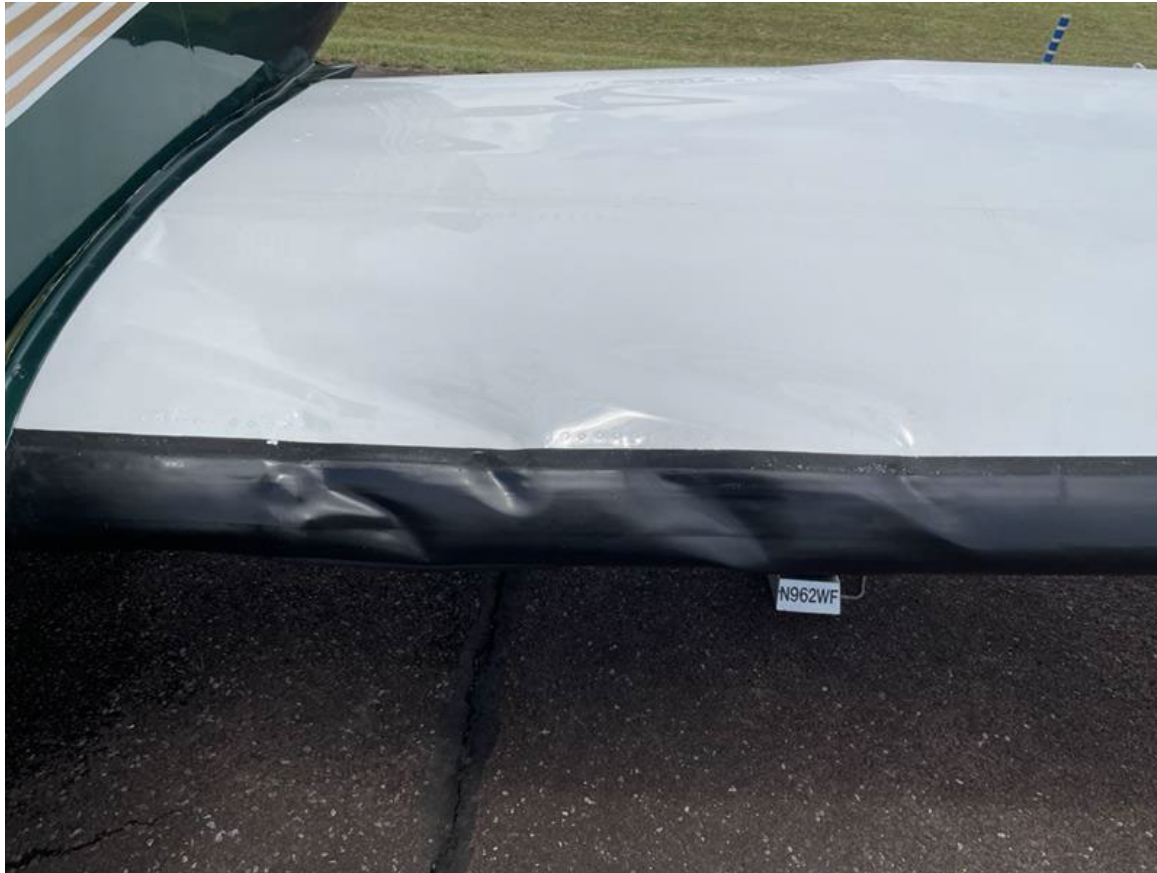
**Photograph 2 - Left Wing Damage (Courtesy of FAA)**

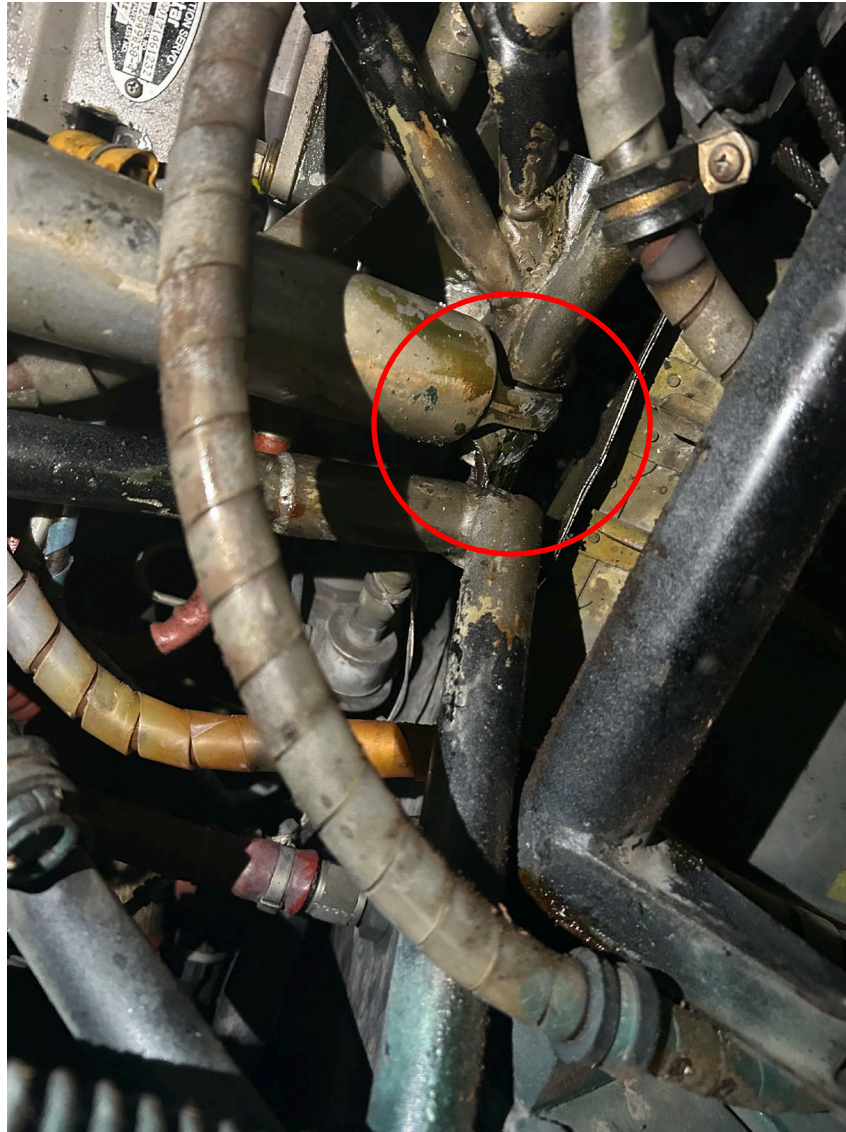
**Photograph 3 - Broken Engine Mount Beside Nose Gear Retract Cylinder (Courtesy of Mechanic)**
