# National Transportation Safety Board

ERA25LA295

## **MATERIALS LABORATORY**

Factual Report 25-078

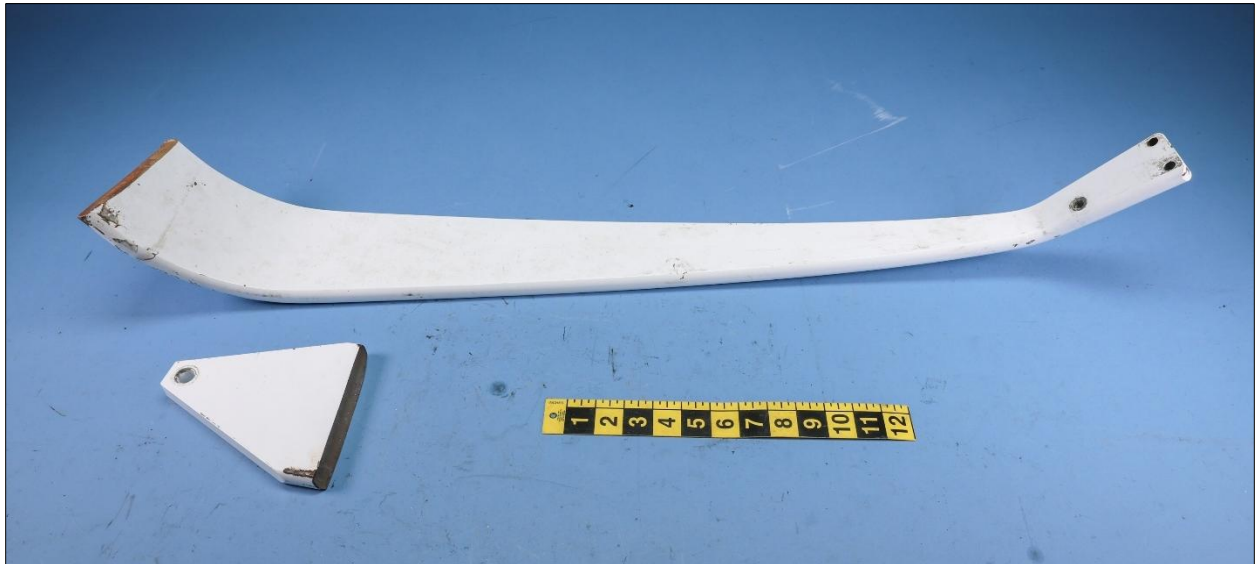
As-received photo documentation was taken of the Spring, shown in **Figure 1**. The gear fractured approximately 6 inches away from the inboard end of the spring, seen in **Figure 2-Figure 3**. Surface regions around this area exhibited a rubbed appearance with missing paint. Some of these regions had exposed base metal with a reddish-brown oxidation (**Figure 4**). The majority of this damage was primarily sustained at the corners of the spring, both forward and aft. This damage was consistent with contact wear from the outboard supporting bracket.

**Figure 1.** As-received photographs of the Cessna 195B left MLG Leg.

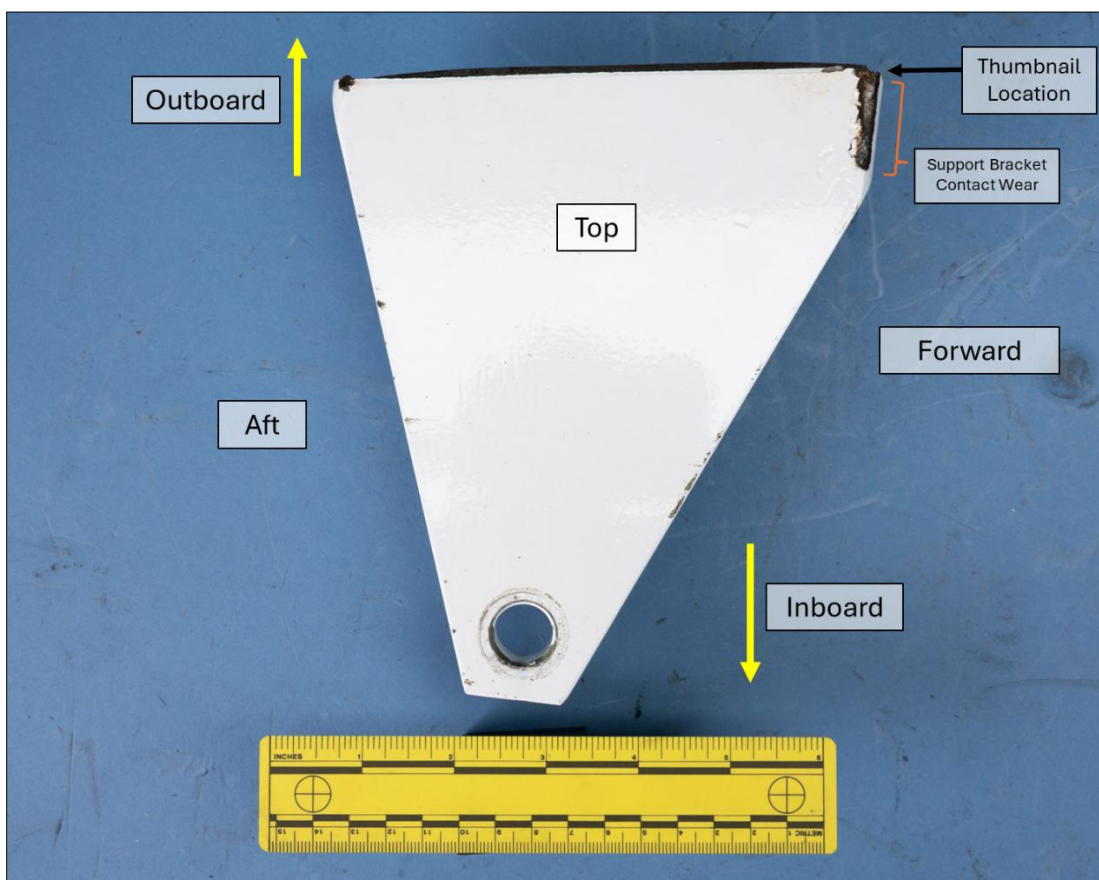
**Figure 2.** As-received photograph of the top surface of the inboard fracture segment.

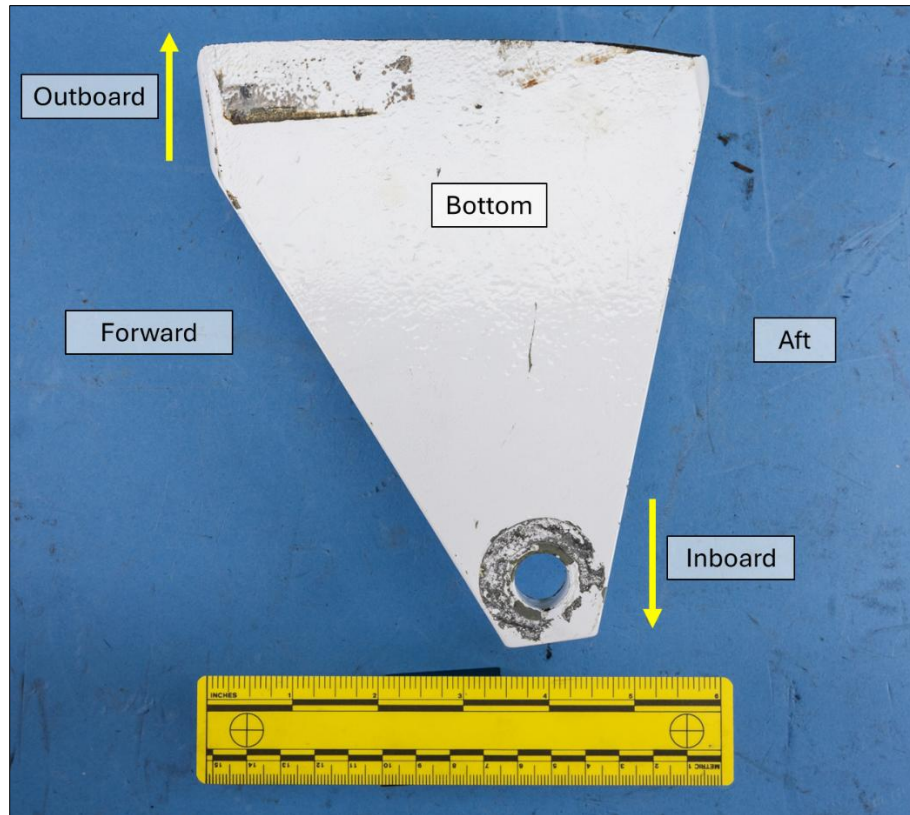
**Figure 3.** As-received photograph of the bottom surface of the inboard fracture segment.

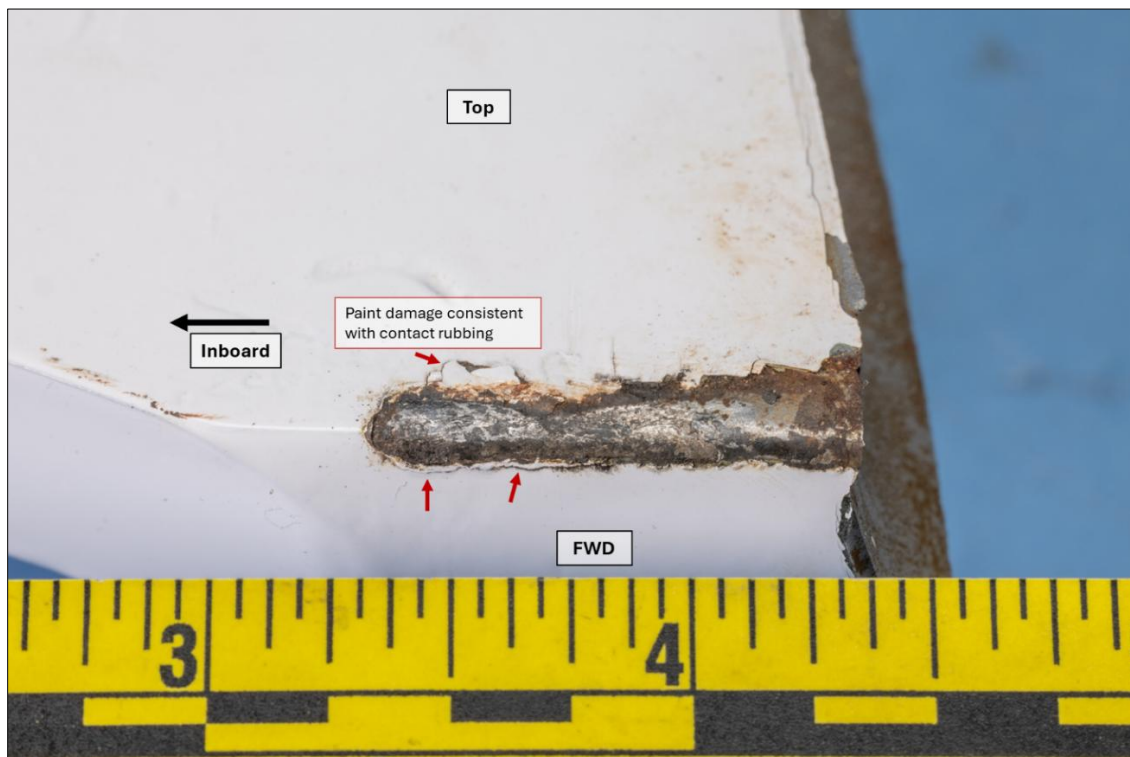
**Figure 4.** As-received photograph of the wear region adjacent to the thumbnail crack.

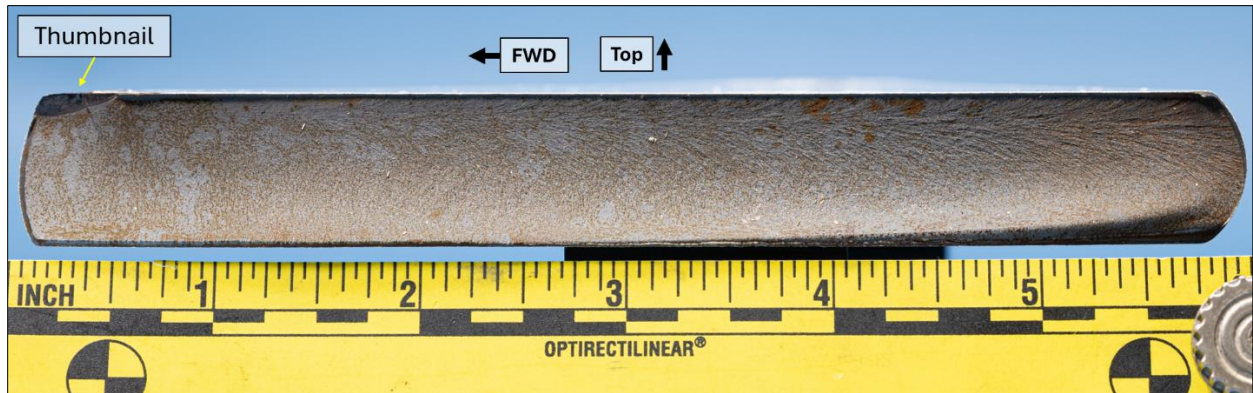
The inboard fracture surface was photographed and visually examined, shown in **Figure 5**. The mating fracture surface on the outboard piece was largely corroded and damaged, and thus the examination focused on the inboard segment. The fracture featured curved surface micromorphology, transitioning from an orthogonal angle on the top surface of the spring towards a steeper curvature towards the bottom surface of the spring. Oblique lighting was used to reveal chevron and radial markings leading back to a thumbnail region on the forward upper corner of the landing gear. The thumbnail region spanned approximately 0.375 inches in the forward / aft direction and 0.100 inches in the through-thickness direction. Most of the fracture surface, excluding the thumbnail region, exhibited a dull gray

**Figure 5.** As-received photograph of the fracture surface using oblique lighting to highlight the chevron and radial marks pointing back to the thumbnail.

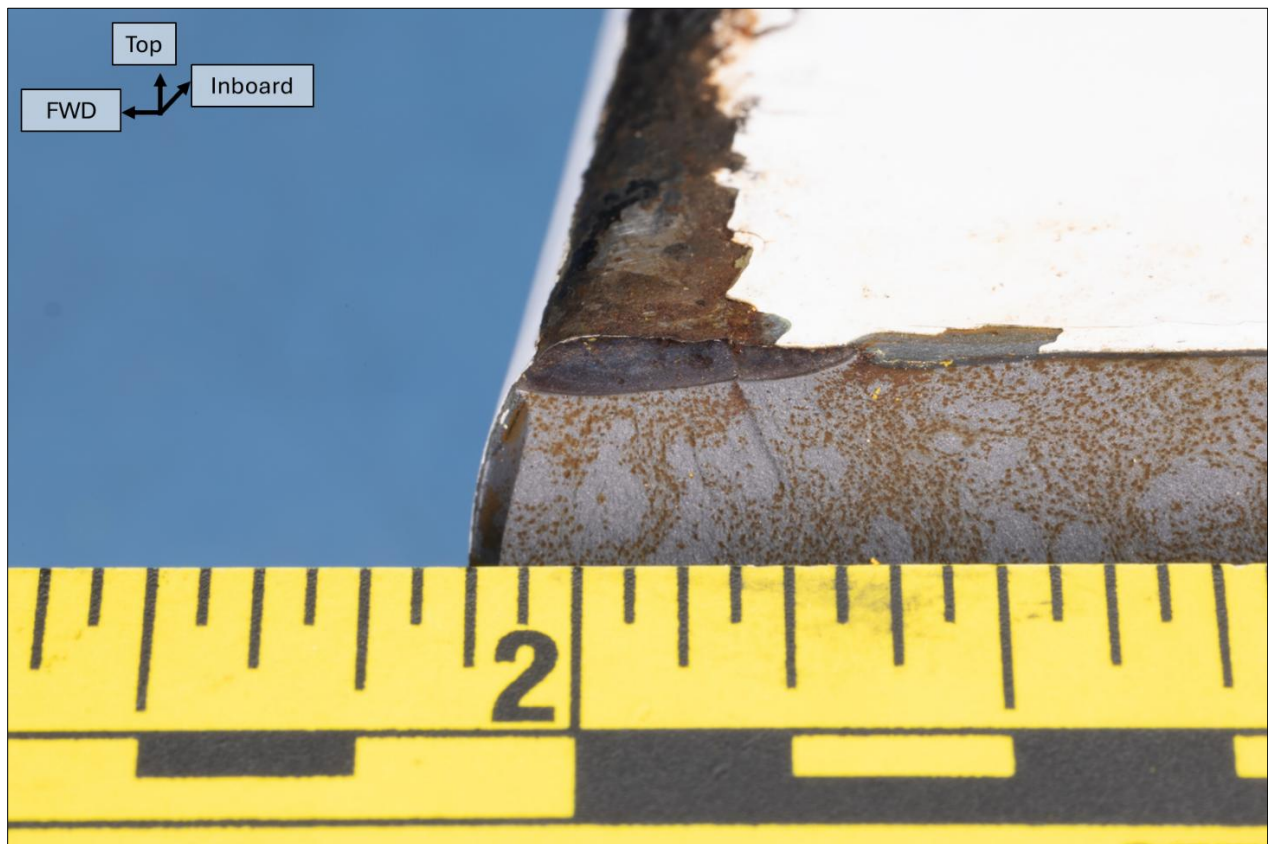
appearance and was rimmed with a small 45 degree shear lip, consistent with an overstress region and fast fracture. The thumbnail region exhibited a dark oxide that had numerous ratchet marks along the surface, progressing inward (**Figure 6**). A beachmark was observed around the curvilinear boundary of the region, consistent with a progressive crack (**Figure 7a**). The remainder of the fracture surface appeared to be moderately oxidized. The corresponding component surface adjacent to the fracture was devoid of paint and heavily corroded (**Figure 7b**).

**Figure 6.** As-received photograph at an oblique angle of the thumbnail crack and wear surface.

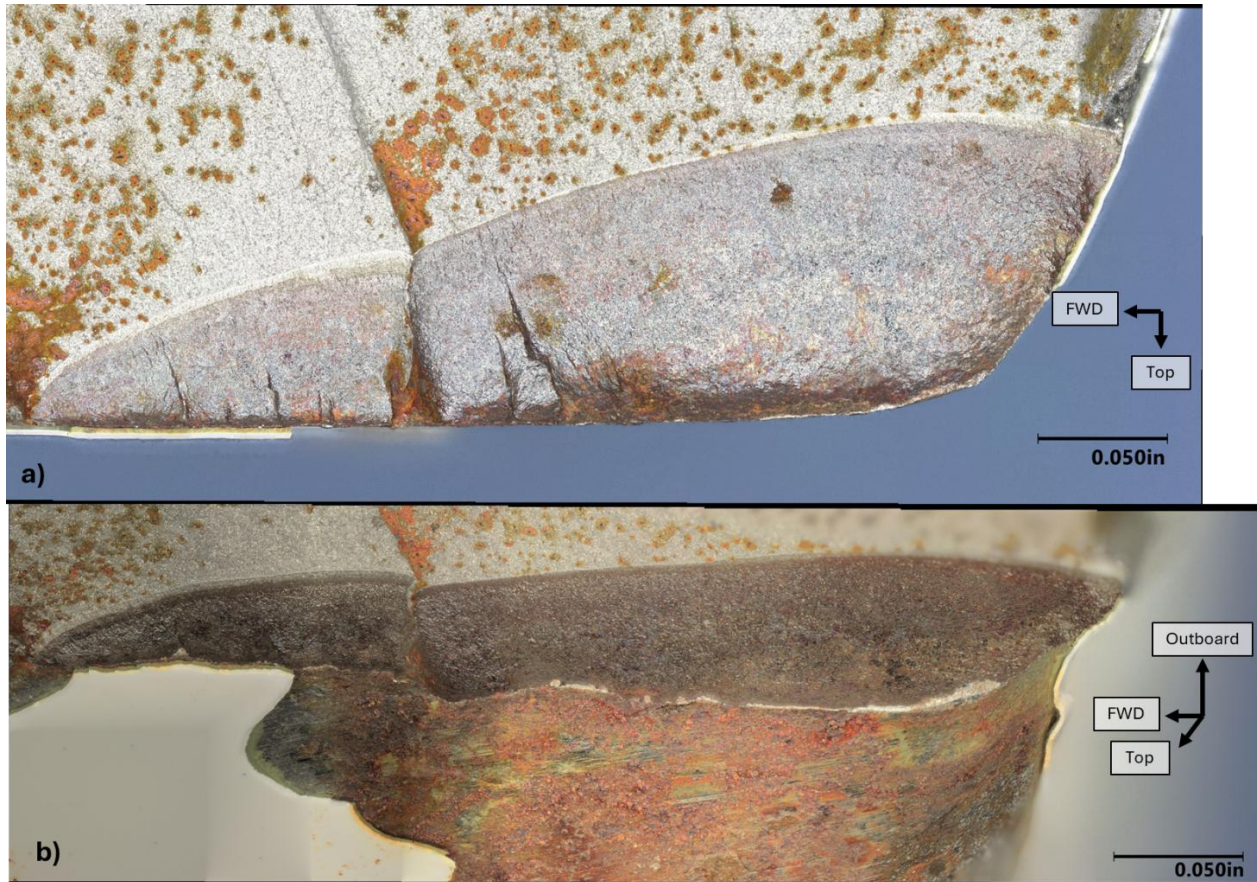
**Figure 7.** Digital microscopic images of the thumbnail crack a) top down highlighting the region and beachmark at the crack tip, and b) oblique angle to show adjacent component surface.

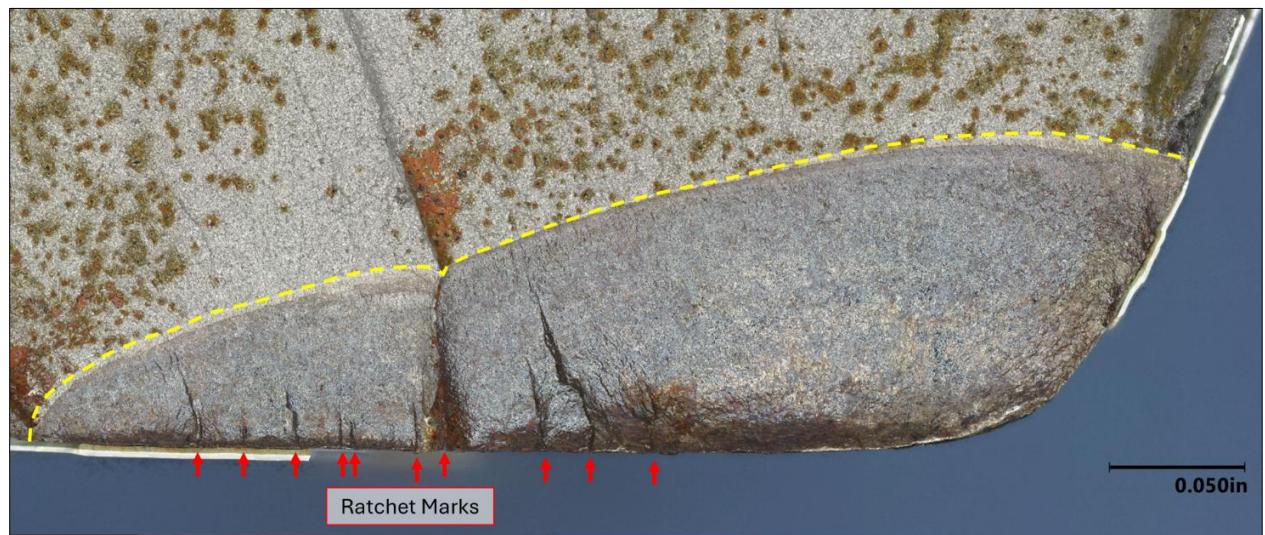
The inboard segment of the main landing gear was sectioned approximately 1.5 inches away from and parallel with the fracture surface to facilitate electron microscope examination. The fracture segment was ultrasonically cleaned for 5 min in a solution of Alconox and water and subsequently rinsed in ethanol. The thumbnail region was further documented under a digital microscope as well as the damaged surface condition adjacent to the crack. Numerous ratchet marks, indicating the boundary between two propagating cracks, were observed along the initiation edge of the crack (**Figure 8**).

**Figure 8.** Digital microscopic images of the thumbnail crack with a yellow dashed line denoting the crack tip boundary line and red arrows identifying ratchet marks.

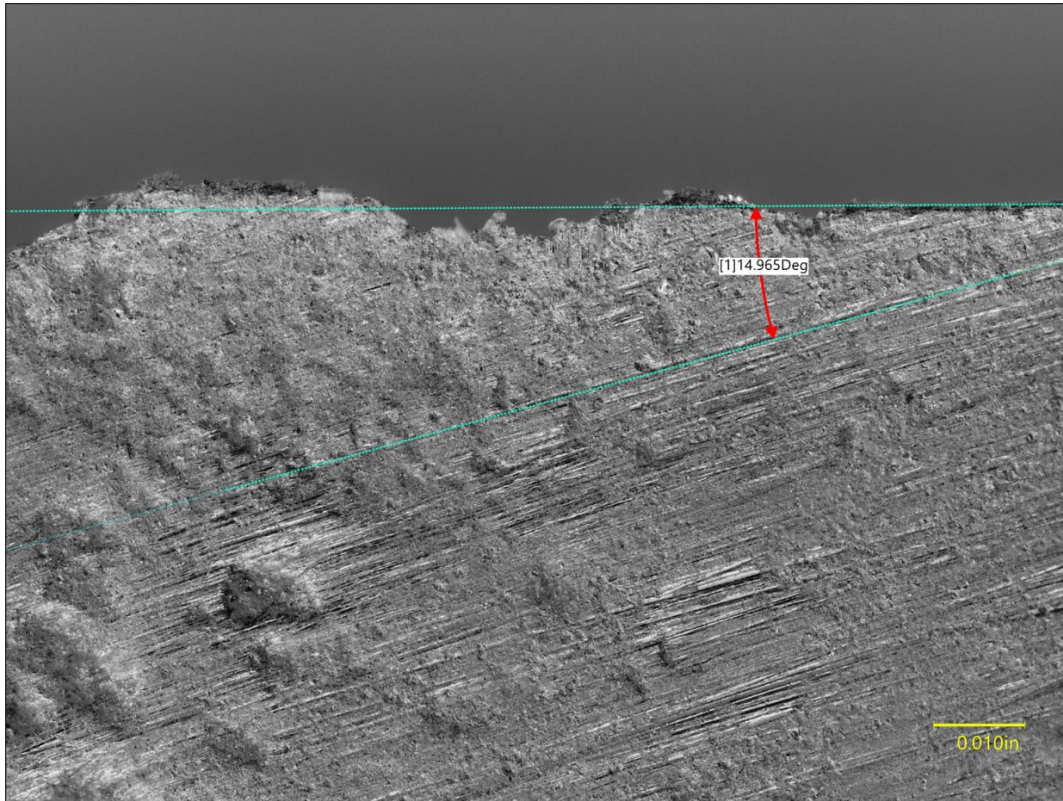
The surface of the component adjacent to the crack appeared oxidized with significant corrosion product buildup present. In regions where substrate material could be observed, grind marks angled at an approximately 15 degree angle from the transverse fracture surfaces were found (**Figure 9**). The manufacturing specification requirements deem transverse grinding marks as impermissible on edges and flats of the landing gear. While the profile of the primary crack was flat, several secondary crack initiation sites appeared to align closely along the angle of these grind marks (**Figure 10**).

**Figure 9.** Digital microscopic monochrome image of the gear leg upper surface adjacent to the fracture, with oblique lighting textural enhancement for measuring purposes.

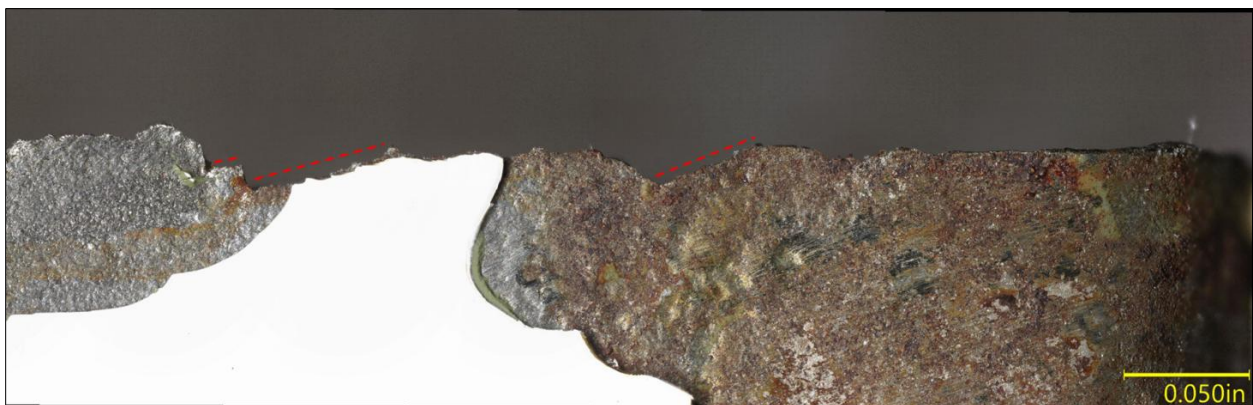
**Figure 10.** Digital microscopic montage of the gear leg upper surface adjacent to the fracture (also see figure 7b). Regions along the fracture profile with red dashed lines identify secondary initiations exhibiting a similar angle as the observed grind marks shown in Figure 9.

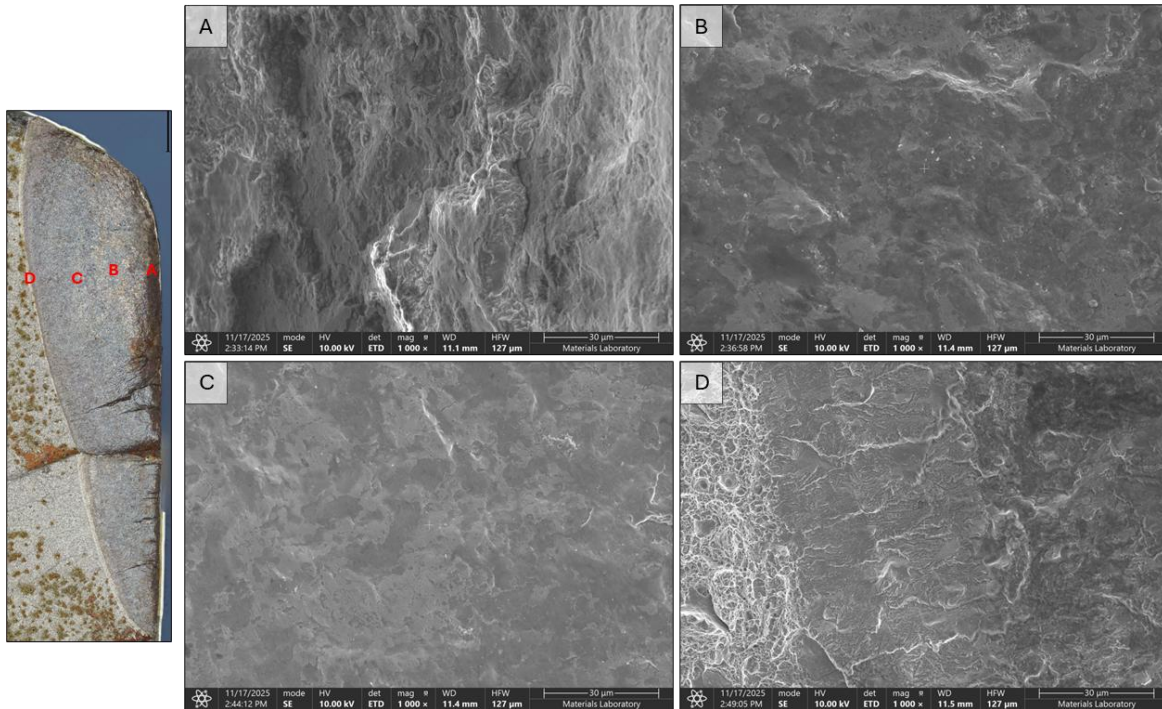
Further SEM examination found the fracture surface in the thumbnail region was still largely corroded and damaged, exhibiting pancaking and compressive damage. This was consistent with loading of the top surface of the MLG in compression during landing and ground load bearing activities. However, near the crack tip boundary two bands of a feathery progressive fracture region were observed, consistent with fatigue in martensitic steels (**Figure 11**). Progressive tearing and secondary cracks were observed suggesting a high propagation rate. These bands were observed across the entire crack tip on both cracks, and exhibited

minimal corrosion damage, consistent with formation during cycles not long before final overstress.

**Figure 11.** Scanning electron microscopic images of the progressive fracture progression. At Site D, two bands of feathery fracture were observed prior to final overload.

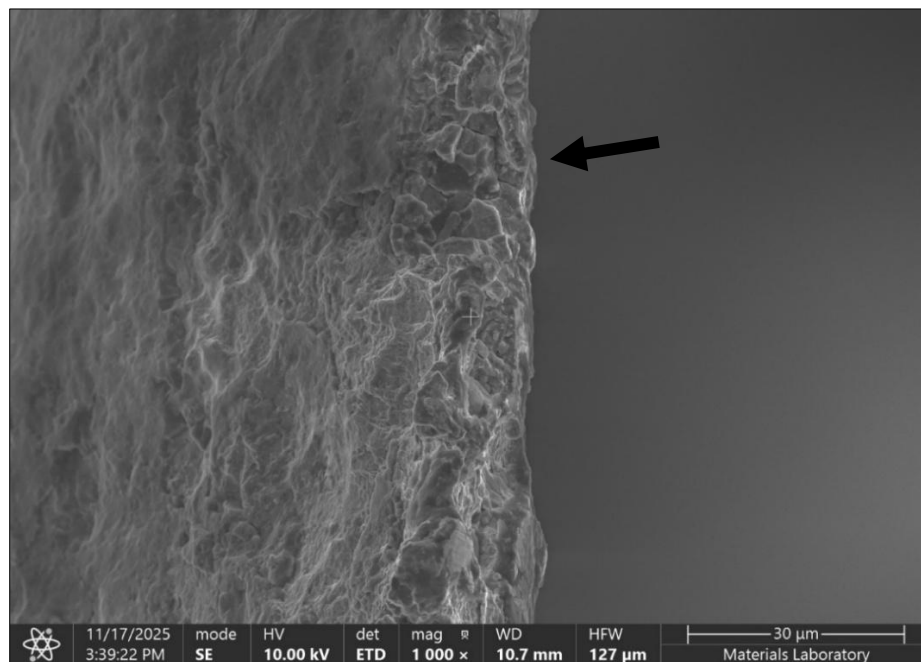
Much of the initiation region of the fracture was degraded by post-fracture damage and corrosion. However, several pits and pockets of intergranular attack (IGA) were observed, characterized by a rock-candy appearance and secondary cracking (**Figure 12**). Much of the surfaces surrounding the area exhibited evidence of corrosion and grinding damage.

**Figure 12.** Scanning electron microscopic images of the initiation site, exhibiting corrosion and intergranular attack (IGA), highlighted by the arrow.

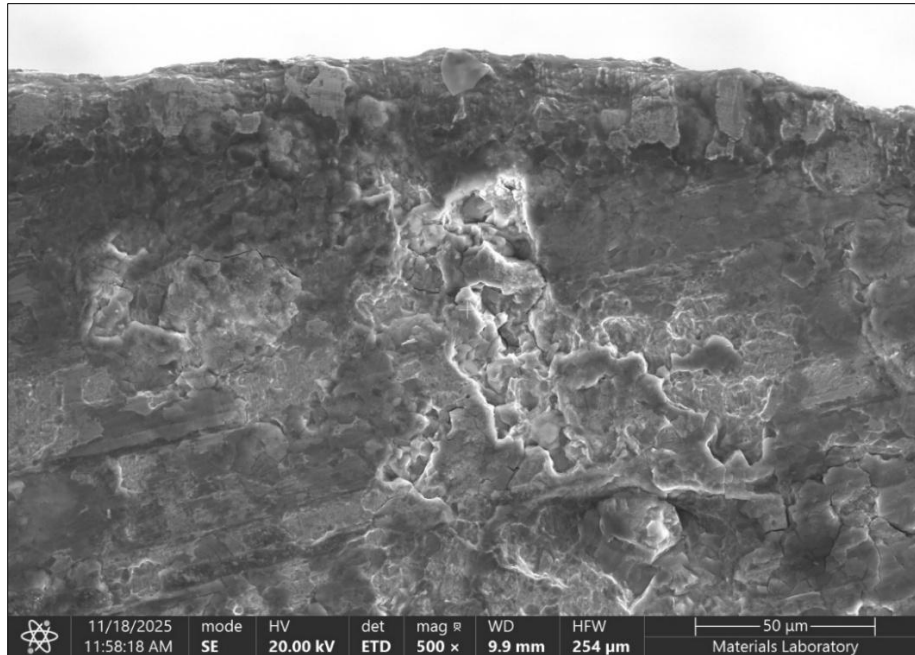
SEM examination of the component surface adjacent to the initiation site after oxide removal revealed both significant pitting damage and grind marks (**Figure 13**). Along the crack profile edge, severe corrosion appeared to have led to a significant amount of material loss from the surface of the part. In some places the corrosion appeared to have attacked along the pre-existing grind marks, while other locations pitting had formed large cavities in the material. At the secondary crack locations, the profile appeared to align with the angularity of the grinding marks, suggesting influence from the surface damage (**Figure 14**). However, significant pitting was still present on these surfaces as well.

**Figure 13.** Scanning electron microscopic images of the component surface adjacent to the initiation site, exhibiting pitting and corrosion damage. Grind marks can be observed at an approximate 15-degree angle, however are partially obscured by the corrosion.

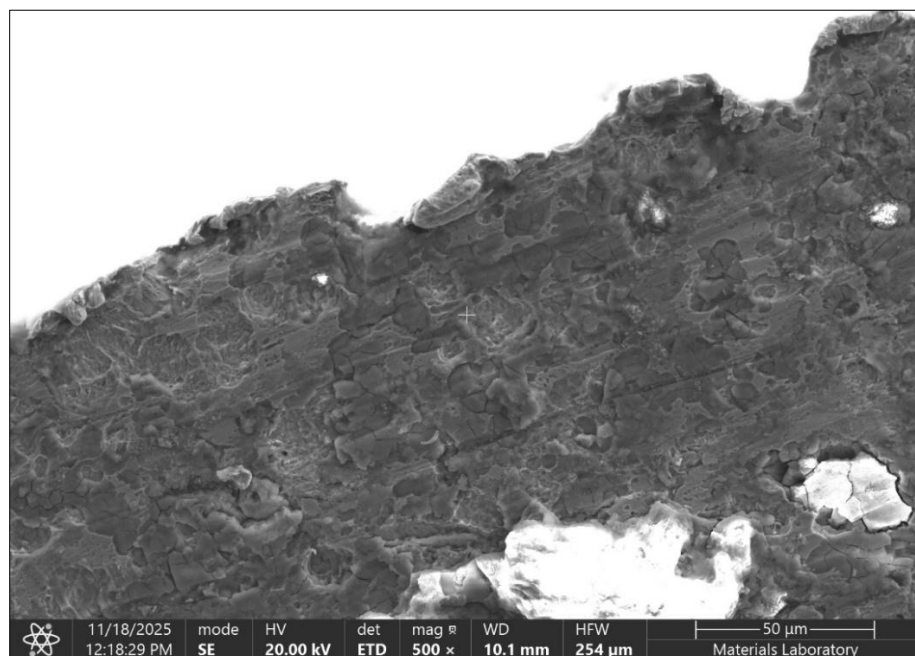
**Figure 14.** Scanning electron microscopic images of the surface adjacent to a secondary initiation site, exhibiting a similar angle to the grind marks, as well as pitting corrosion.

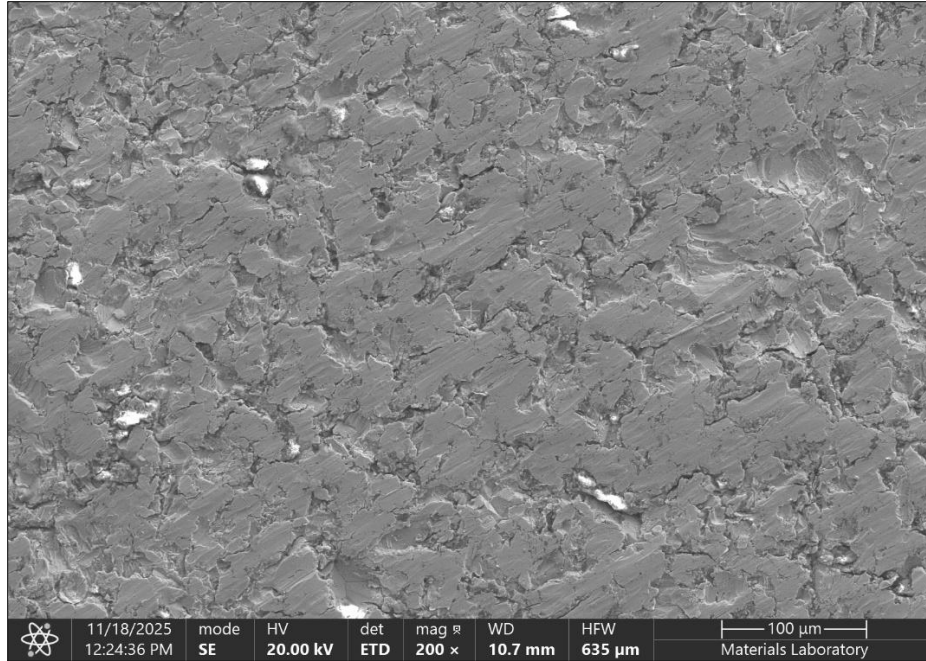
In a region away from the worn crack initiation area, a segment of paint was flaked off and removed in the laboratory setting, revealing the bare metal substrate unaffected by the heavy oxidation (**Figure 15**). However, a texture was observed across this area that was partially obscured by islands of smeared metal, similar to the grinding marks observed adjacent to the crack. Material was observed smearing over many of these cavities-like features, suggesting they were present prior to the grinding operation. Additionally, what appeared to be primer material was observed in many of these cavities, suggesting that they were present at the time of the most recent coating of the part (**Figure 16**). It is to note that surface grinding is not permitted at any time after final media blasting of the landing gear.

**Figure 15.** Scanning electron microscopic images of an area away from the crack and worn region, exhibiting a pit-like texturing partially ground away by similarly angled grind marks.

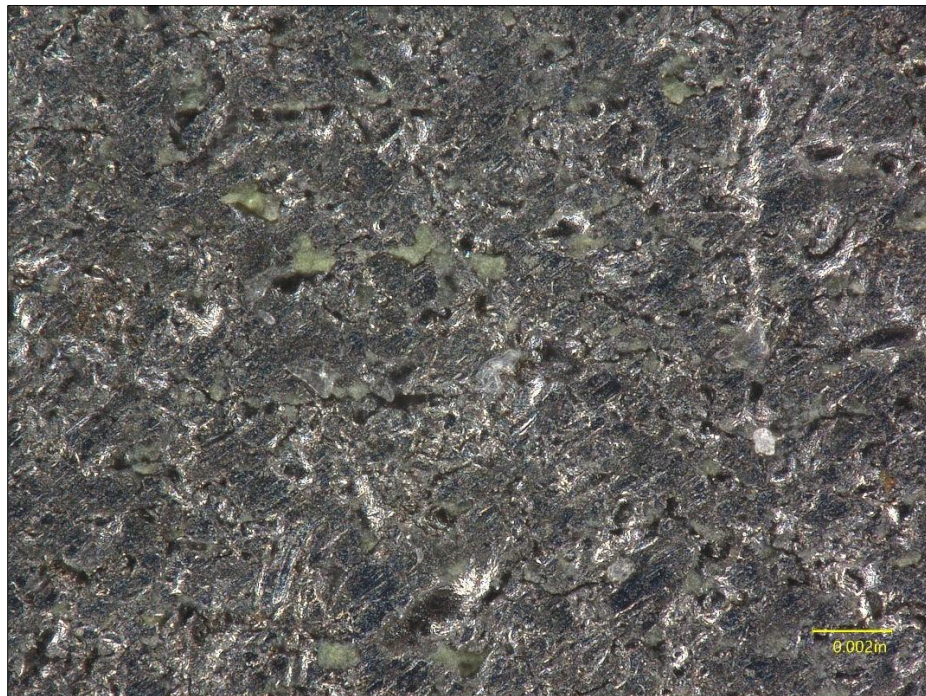
**Figure 16.** Digital microscopic image of an area away from the crack and worn region, exhibiting pit-like texturing. Remnant primer material can be observed in the cavities of the surface, suggesting the pits were present at time of primer application.
