ERA25LA295

## INVESTIGATION PHOTOGRAPHS

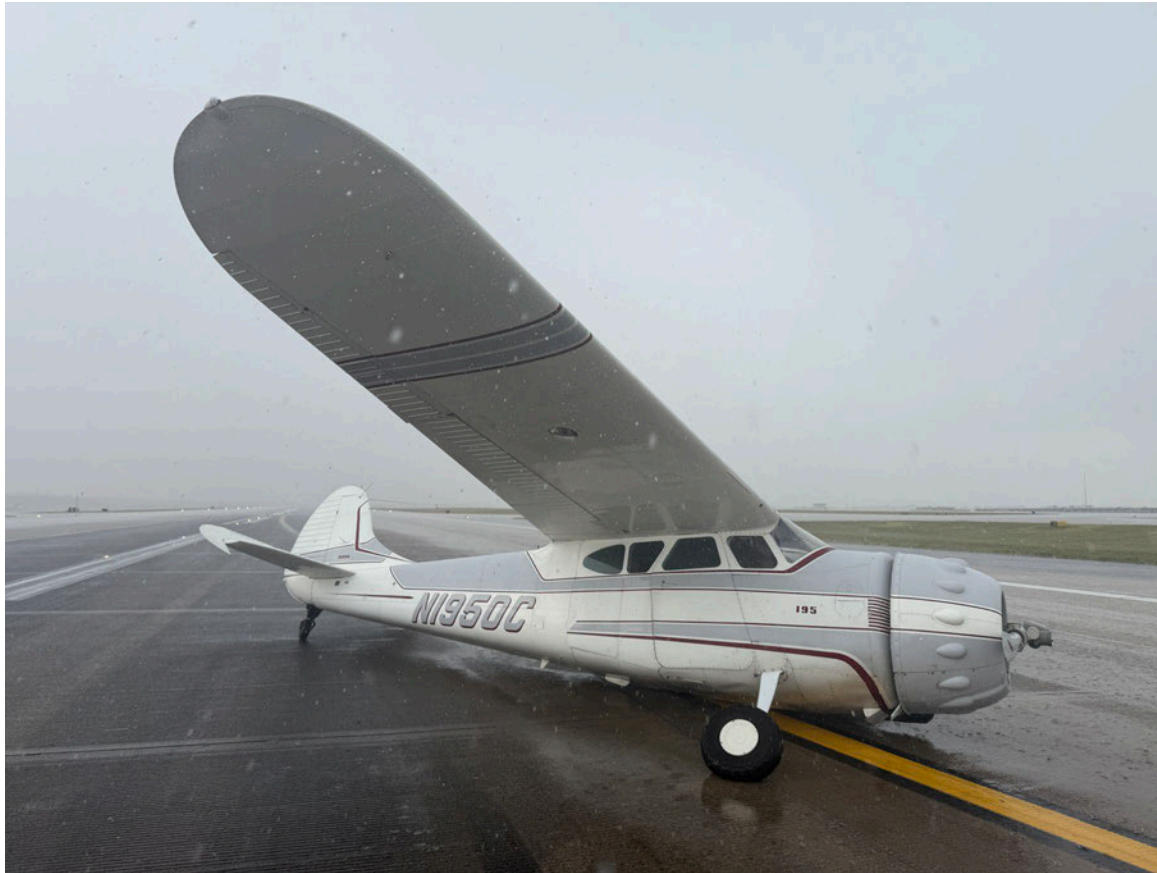
**Photograph 1 - Picture of Accident Aircraft (Courtesy of FAA)**

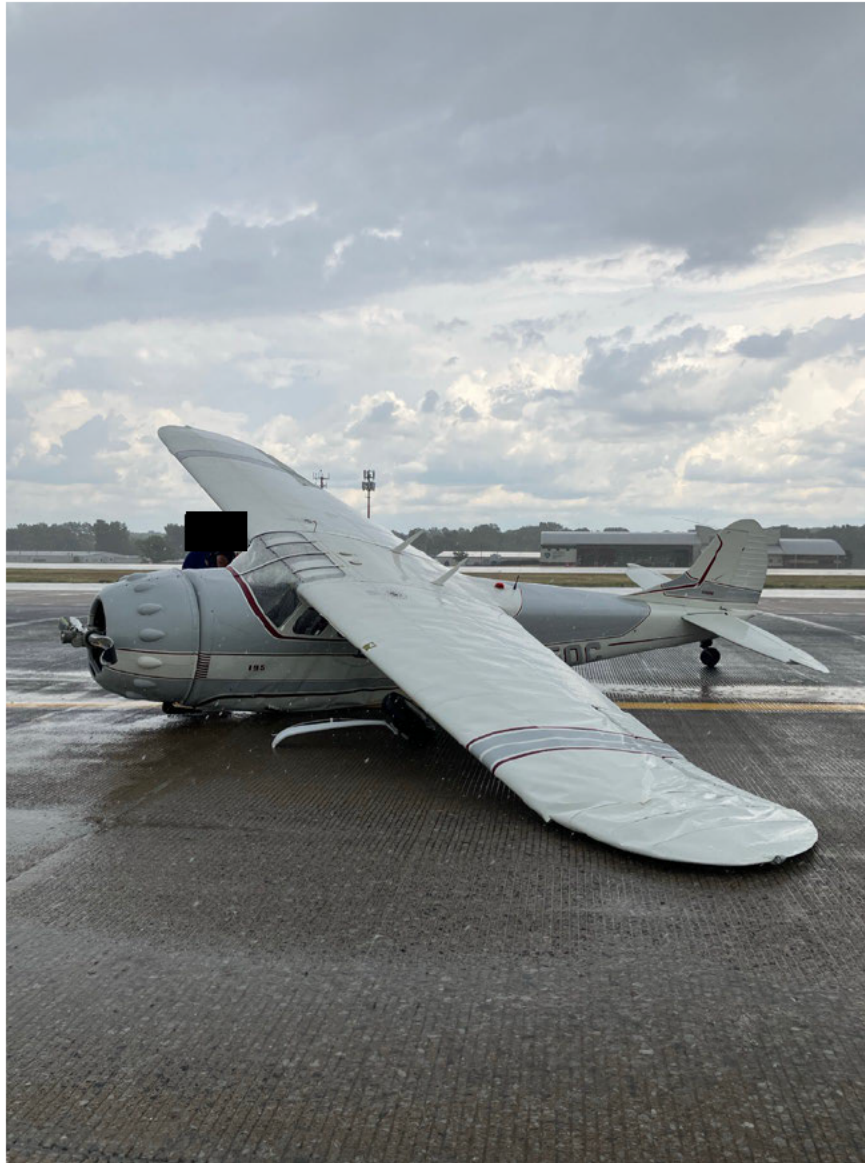
**Photograph 2 - Damage to Left Wing, Fuselage, and Landing Gear (Courtesy of FAA)**

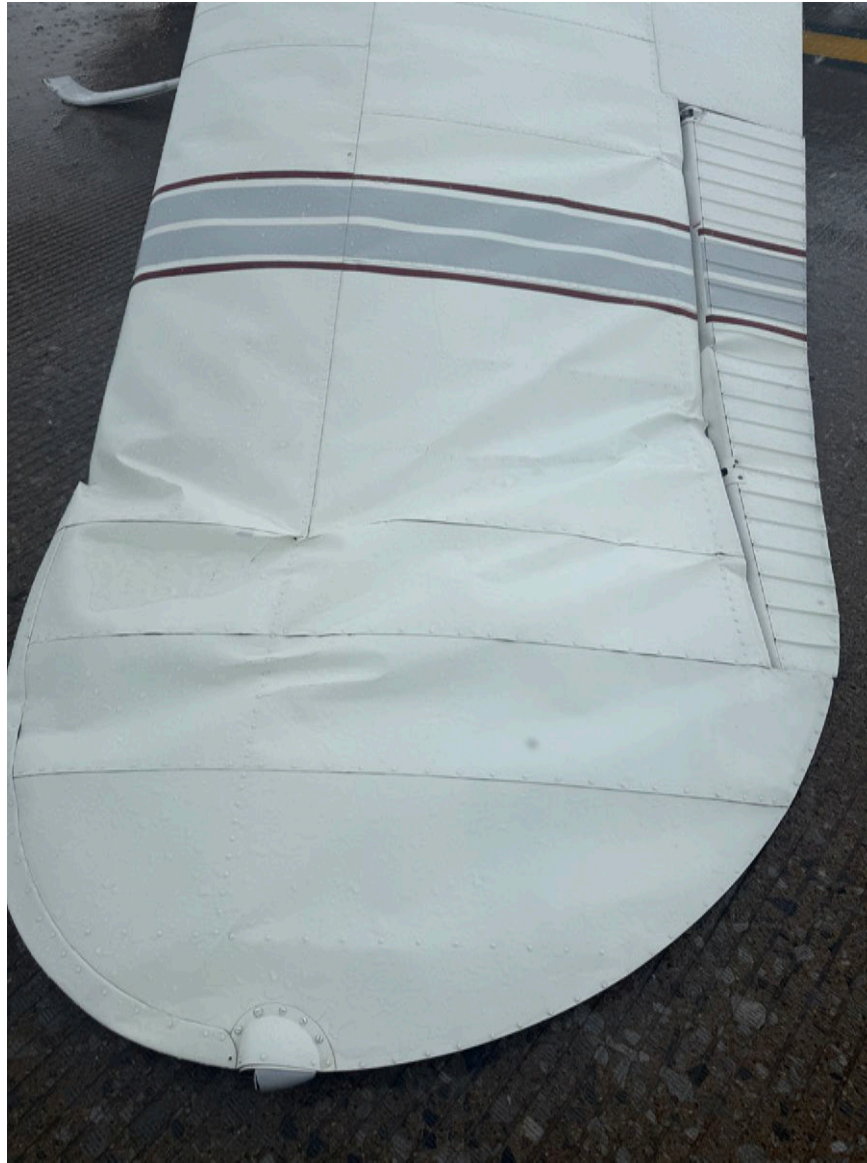
**Photograph 3 - Left Wing Damage (Courtesy of FAA)**
