ERA25LA298

## INVESTIGATION PHOTOGRAPHS

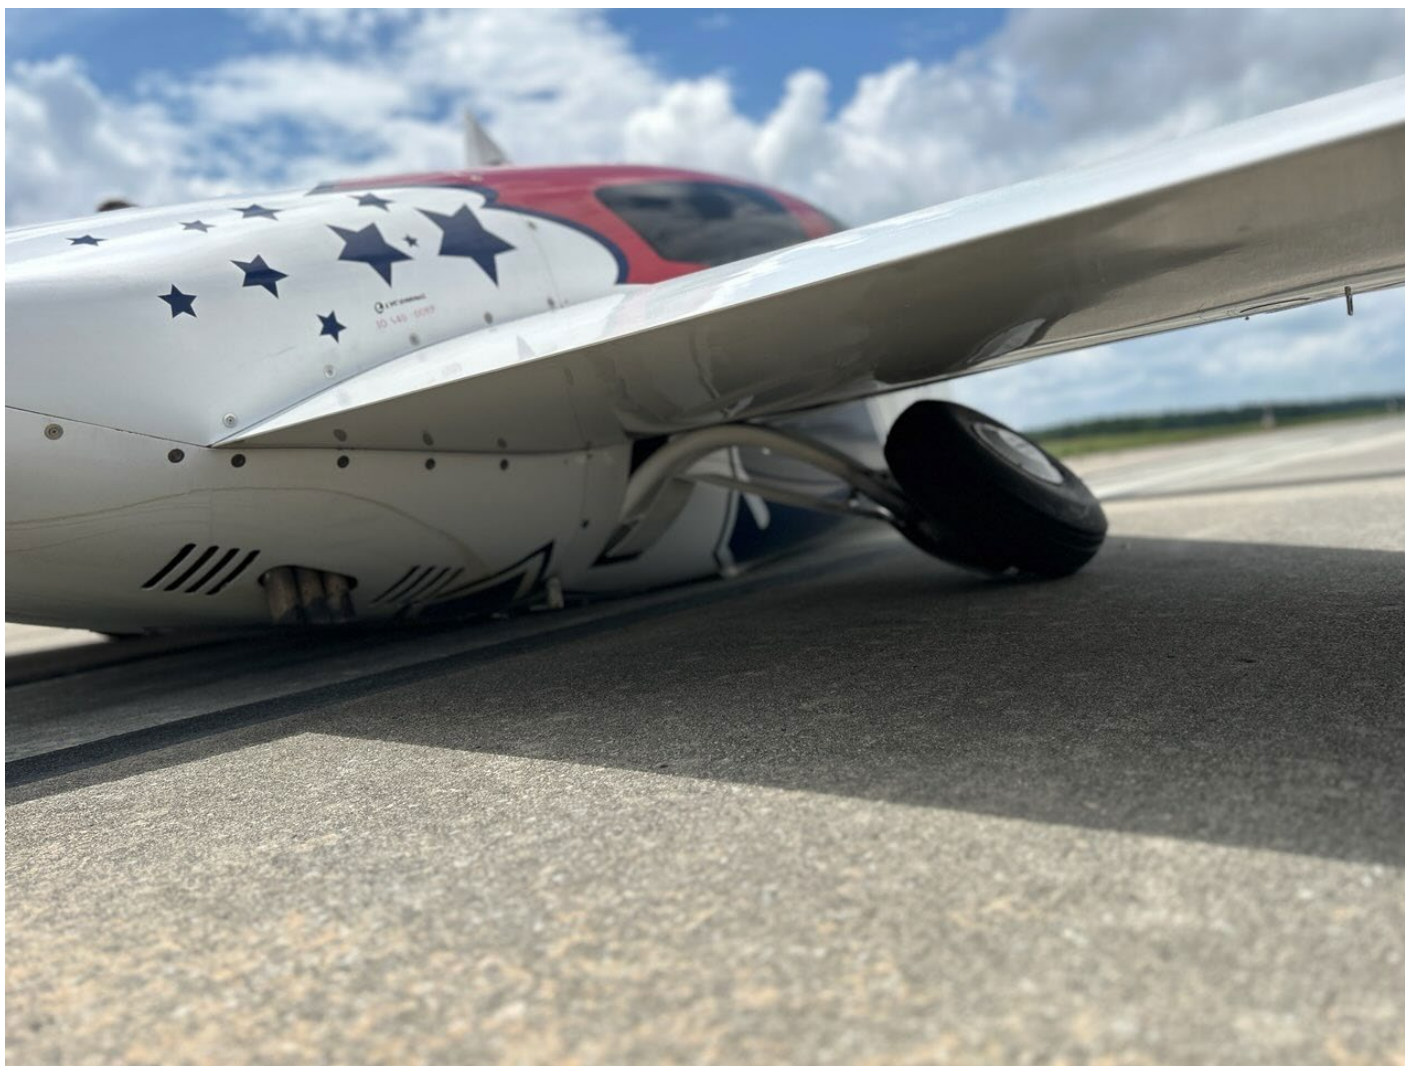
**Photograph 1 -Main wreckage (Courtesy of FAA)**

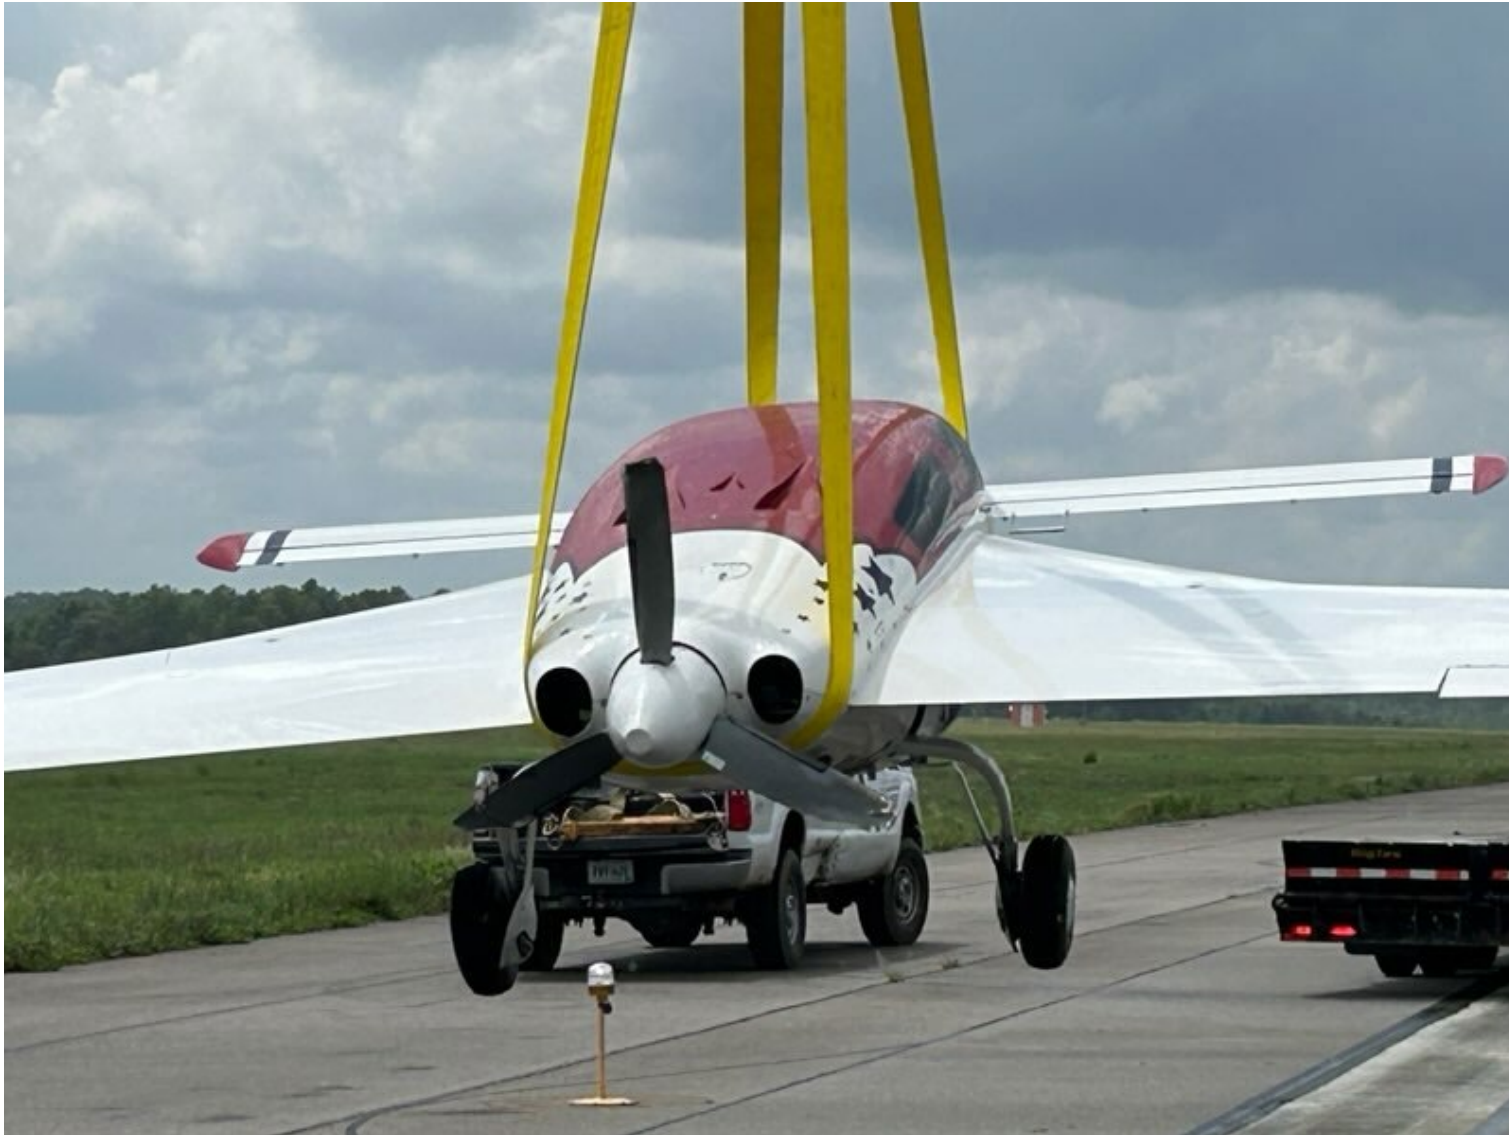
**Photograph 2 - Airplane being lifted on runway, NOTE: landing gear down and locked (Courtesy of FAA)**

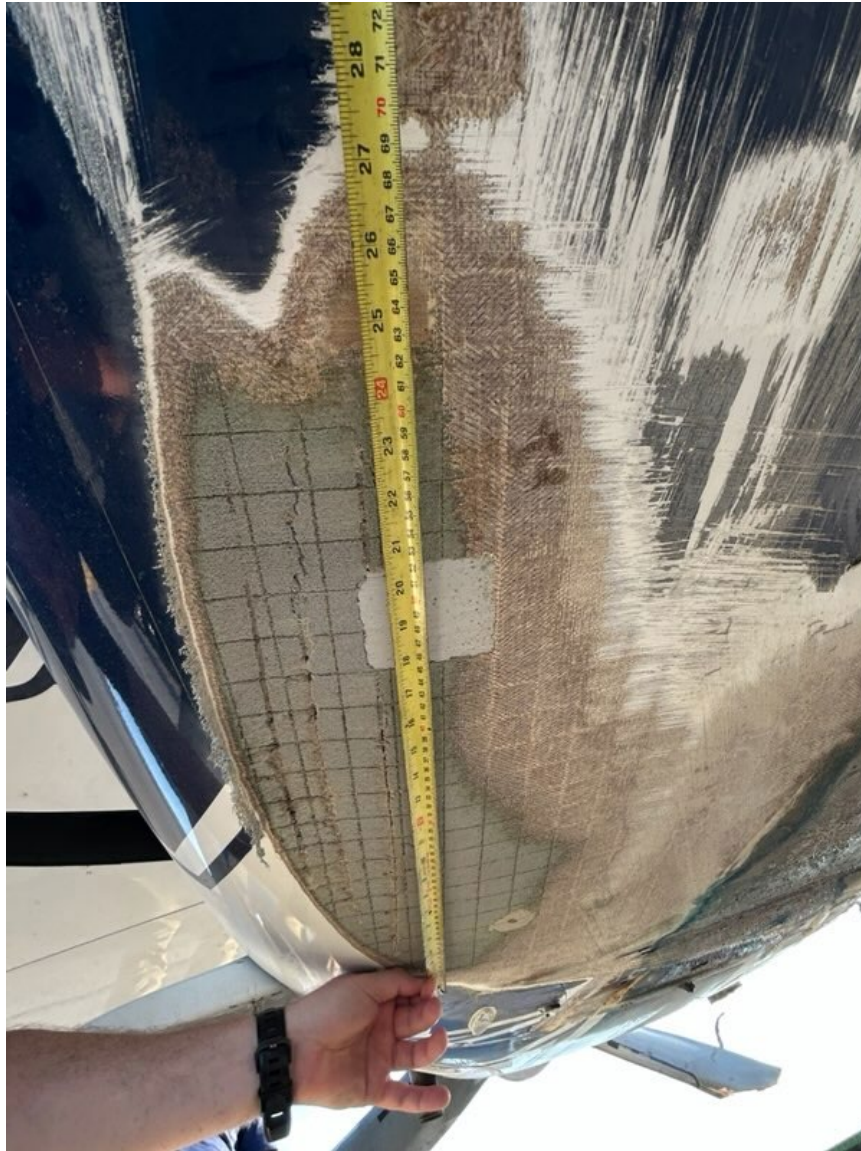
**Photograph 3 - Damage to underside of airplane (Courtesy of FAA)**

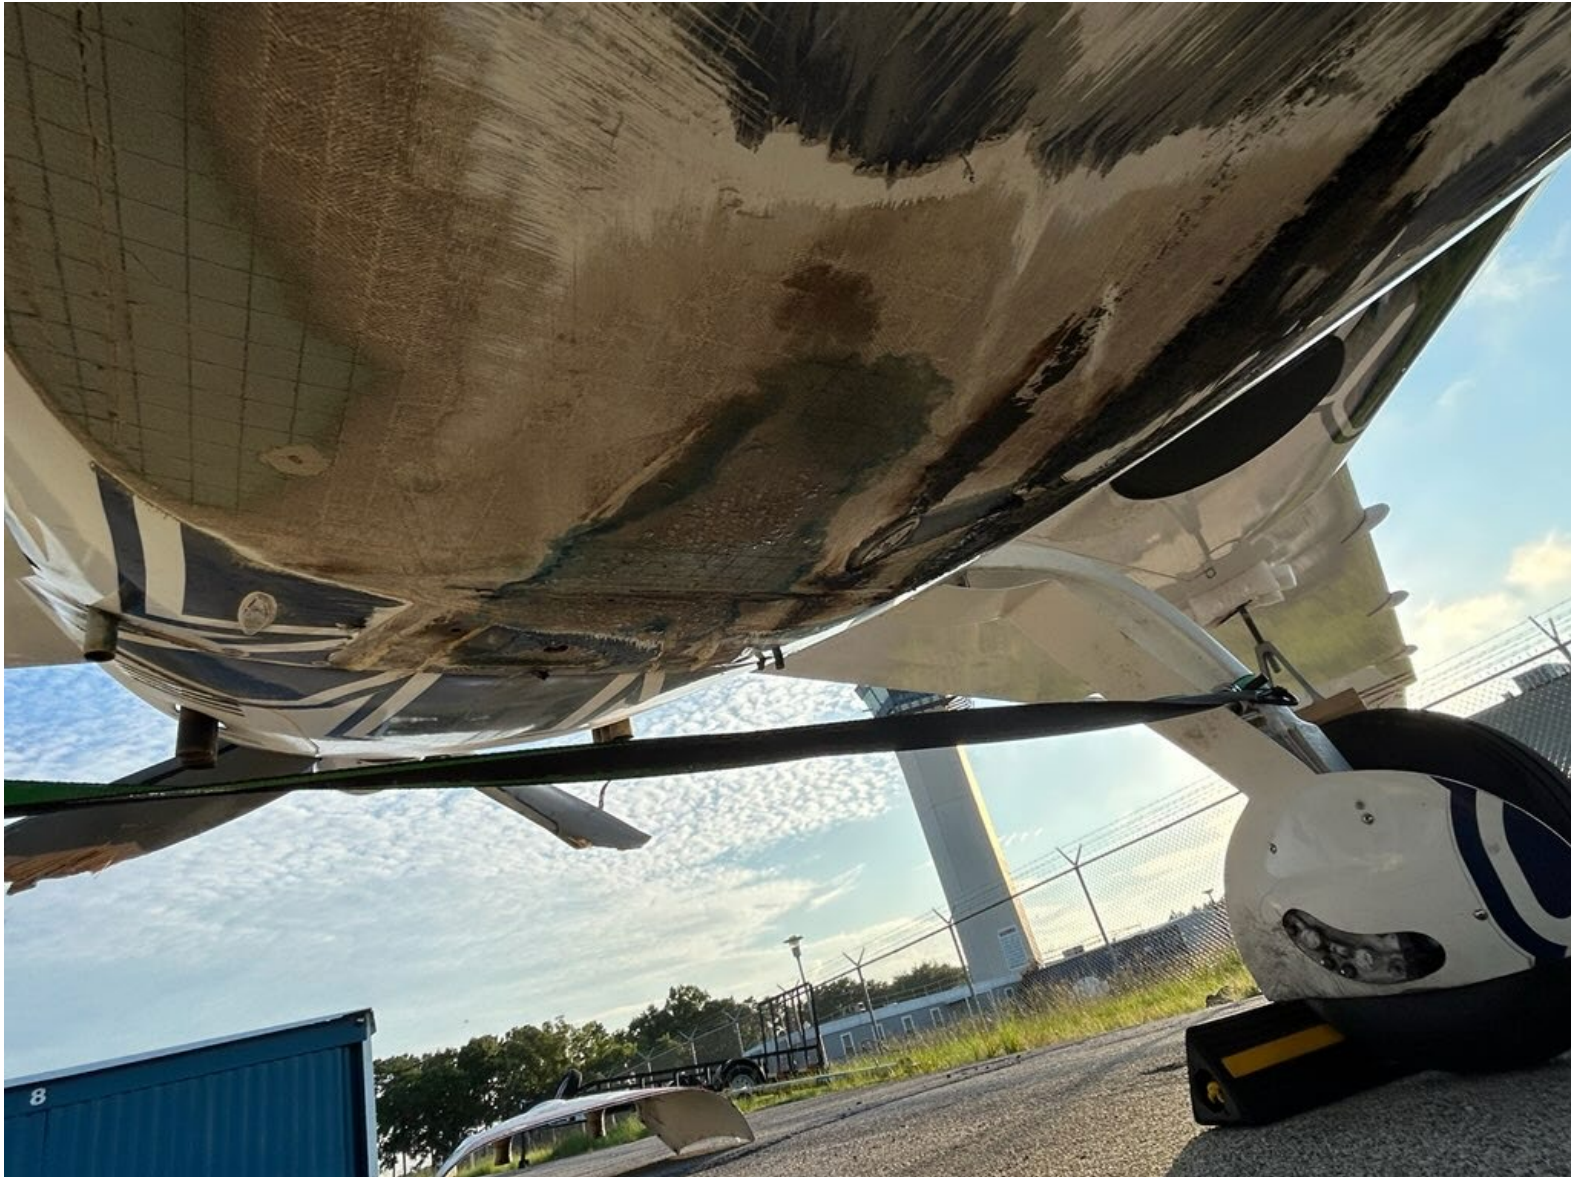
**Photograph 4 - Damage to underside of airplane (Courtesy of FAA)**

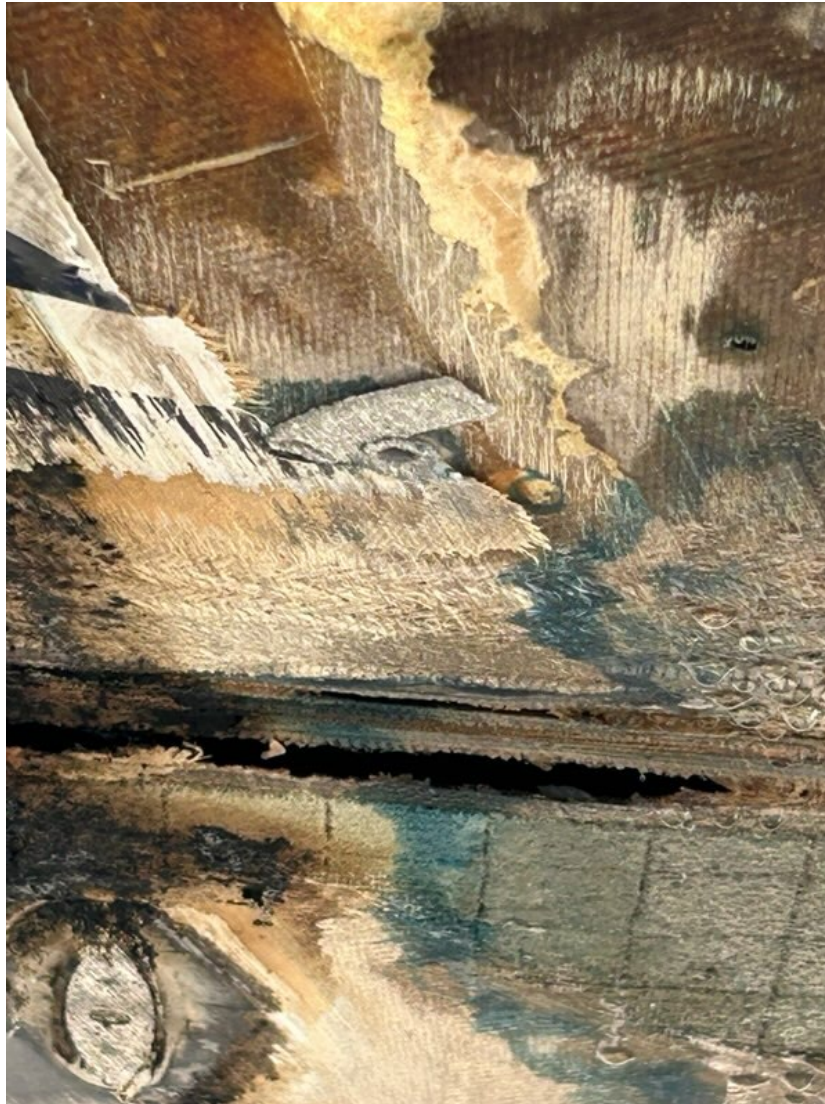
**Photograph 5 - Damage to underside of airplane (Courtesy of FAA)**
