Eric Alleyne  
Air Safety Investigator  
AS-Eastern Region Aviation

**Subject:** ERA25LA299, Accident Examination Discussion

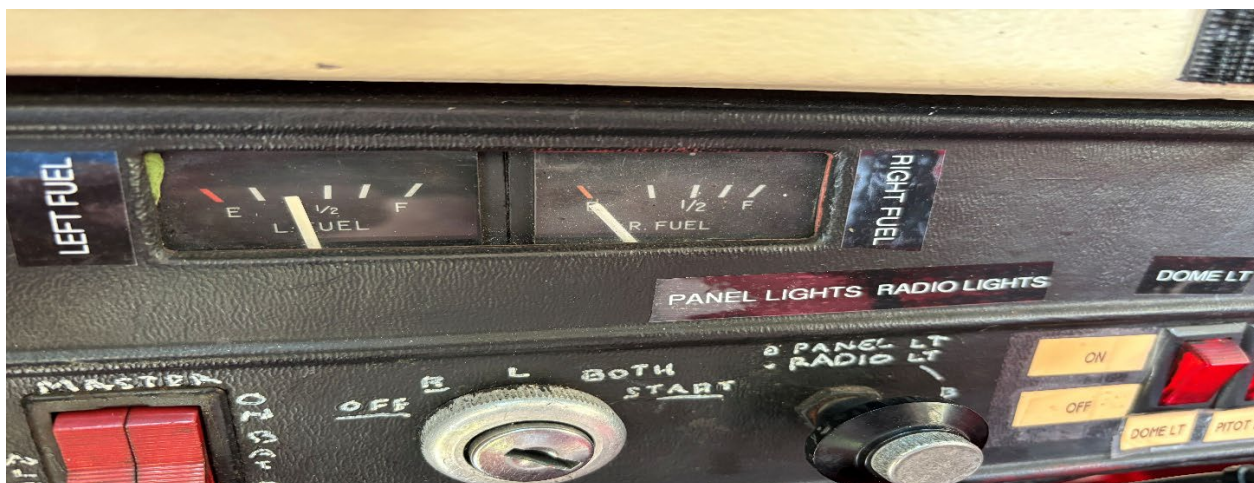
According to FAA Inspector Zehr, examination of the airplane at the wreckage site revealed substantial damage to the firewall and left-wing spar. Both main fuel tanks were intact, and the fuel caps were secure with no evidence of breach; however, less than one gallon of fuel was recovered from both tanks combined. Trace amounts of fuel were observed in the fuel lines, which were free of obstruction, and the gascolator was found empty. It was also noted on site that the left fuel gauge showed a reading of more than a  $\frac{1}{4}$  of a tank of fuel, although being void of fuel.

Left fuel tank reading over a  $\frac{1}{4}$  tank of fuel, but void of fuel. (FAA Photo)
