ERA25LA299

## INVESTIGATION PHOTOGRAPHS

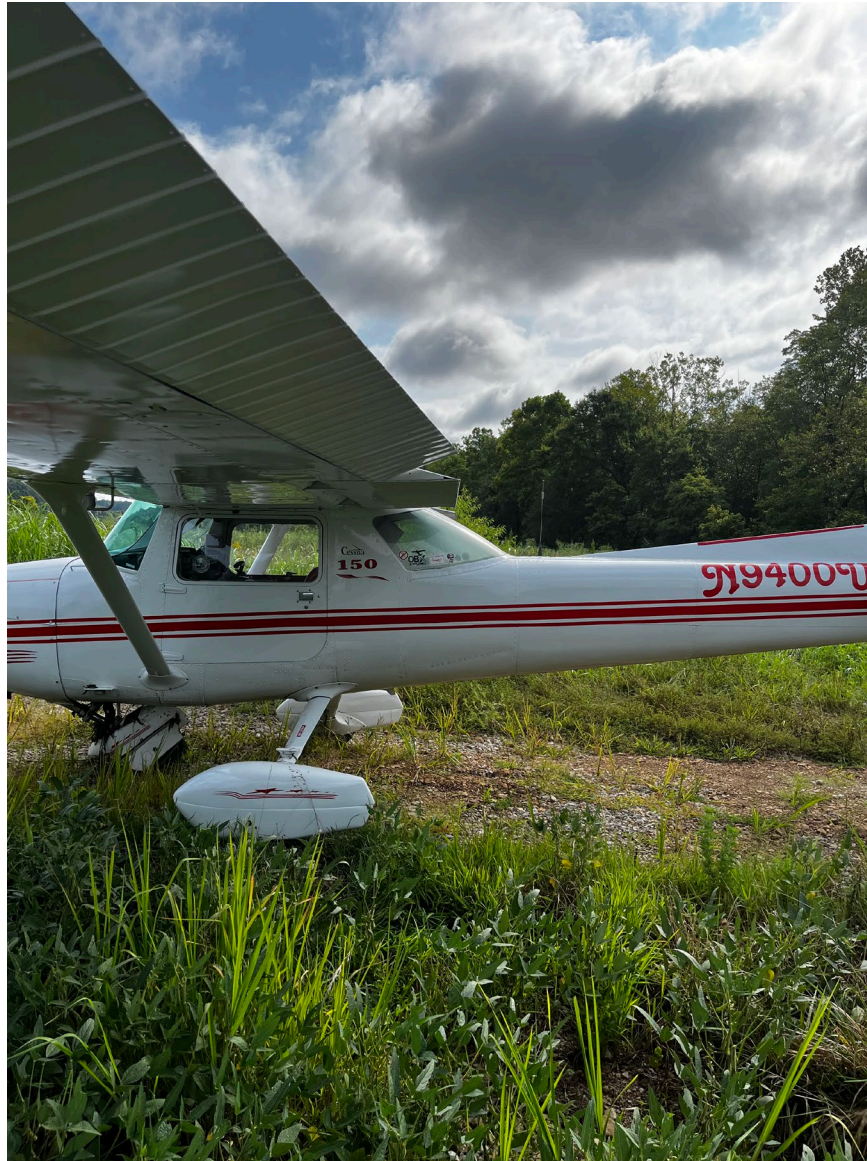
**Photograph 1 - Left side fuselage view (Courtesy of FAA)**

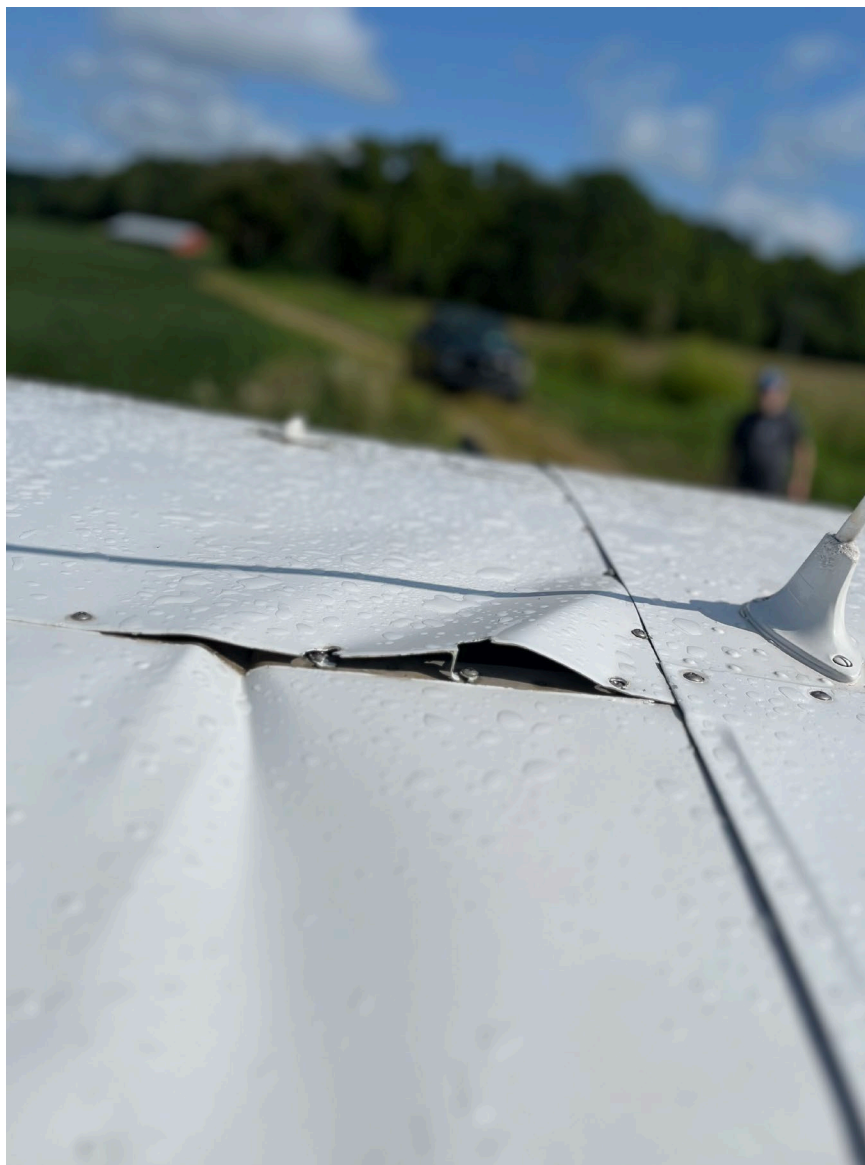
**Photograph 2 - Left upper wing root view (Courtesy of FAA)**

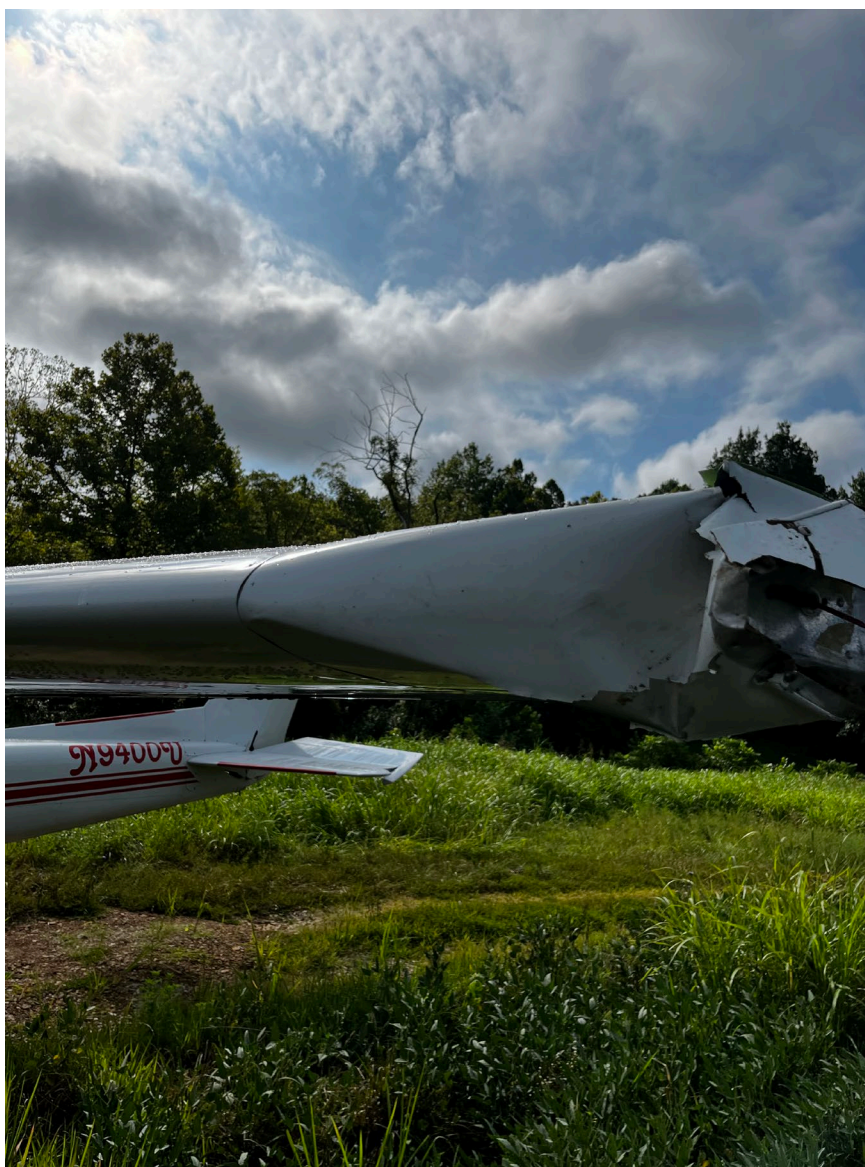
**Photograph 3 - left wing tip damage (Courtesy of FAA)**

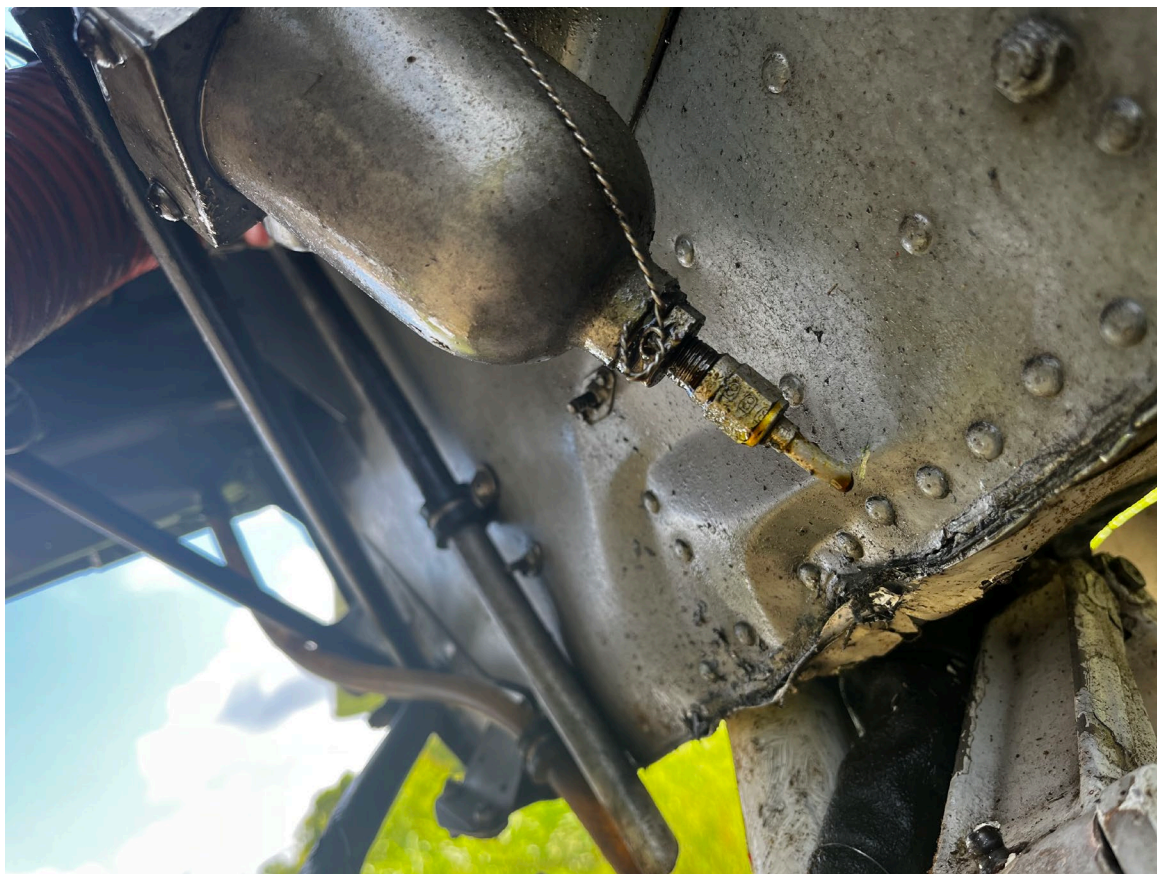
**Photograph 4 - Lower Firewall (Courtesy of FAA)**
