ERA25LA306

## INVESTIGATION PHOTOGRAPHS

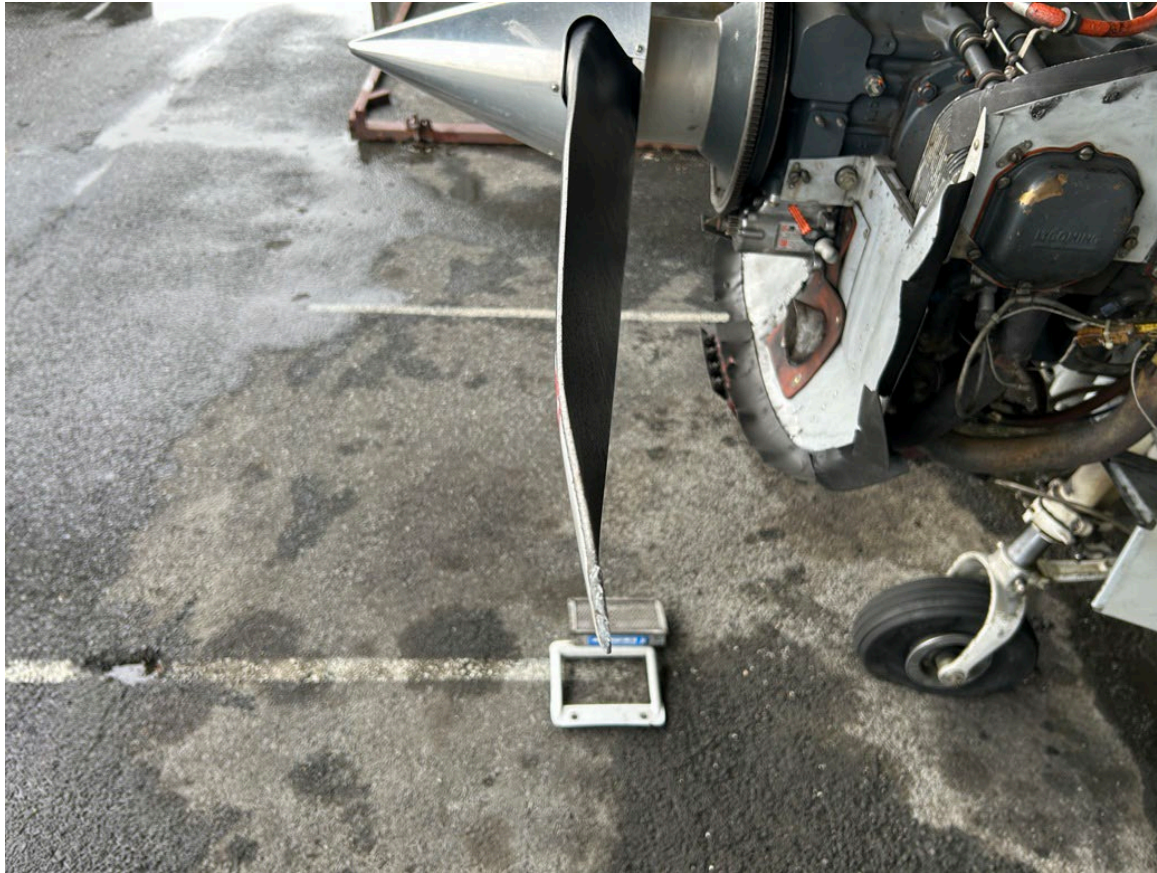
**Photograph 1 - Propeller And Nosewheel Tire Damage (Courtesy of FAA)**

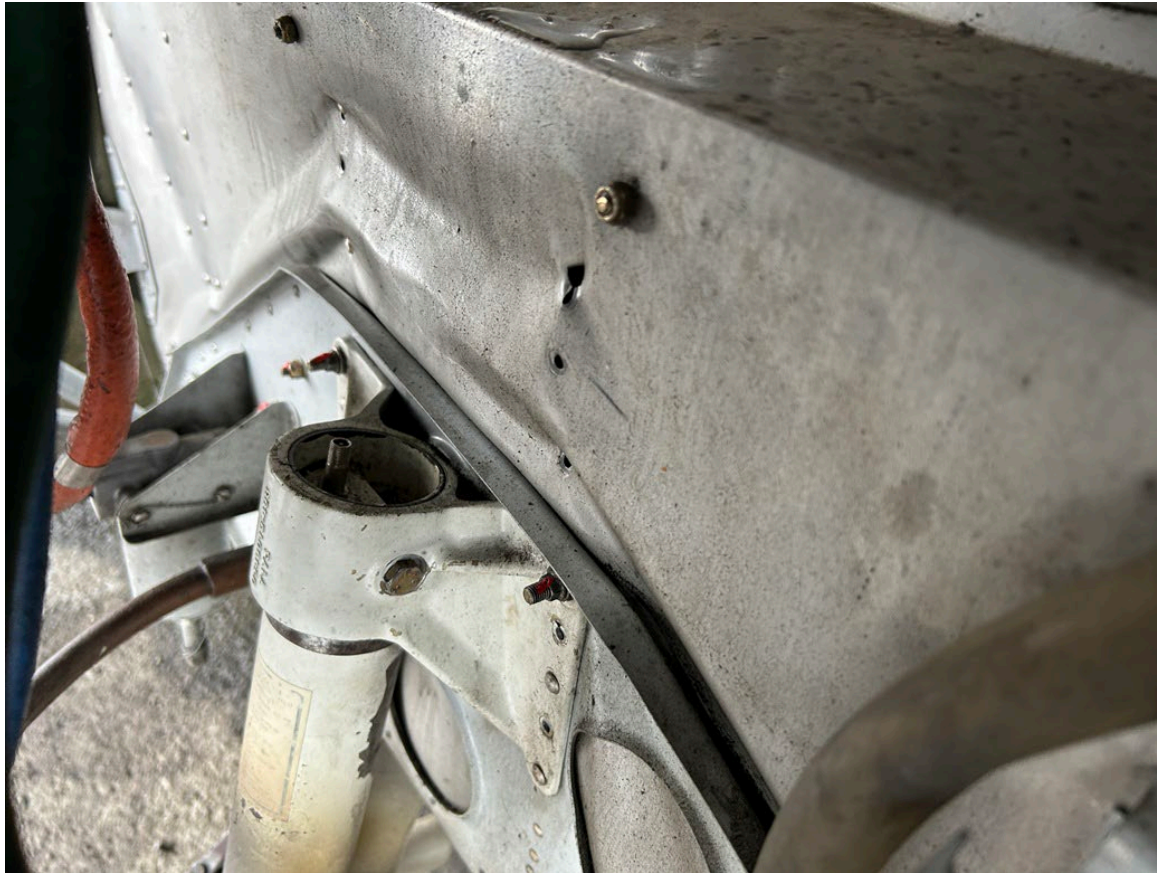
**Photograph 2 - Firewall Damage (Courtesy of FAA)**

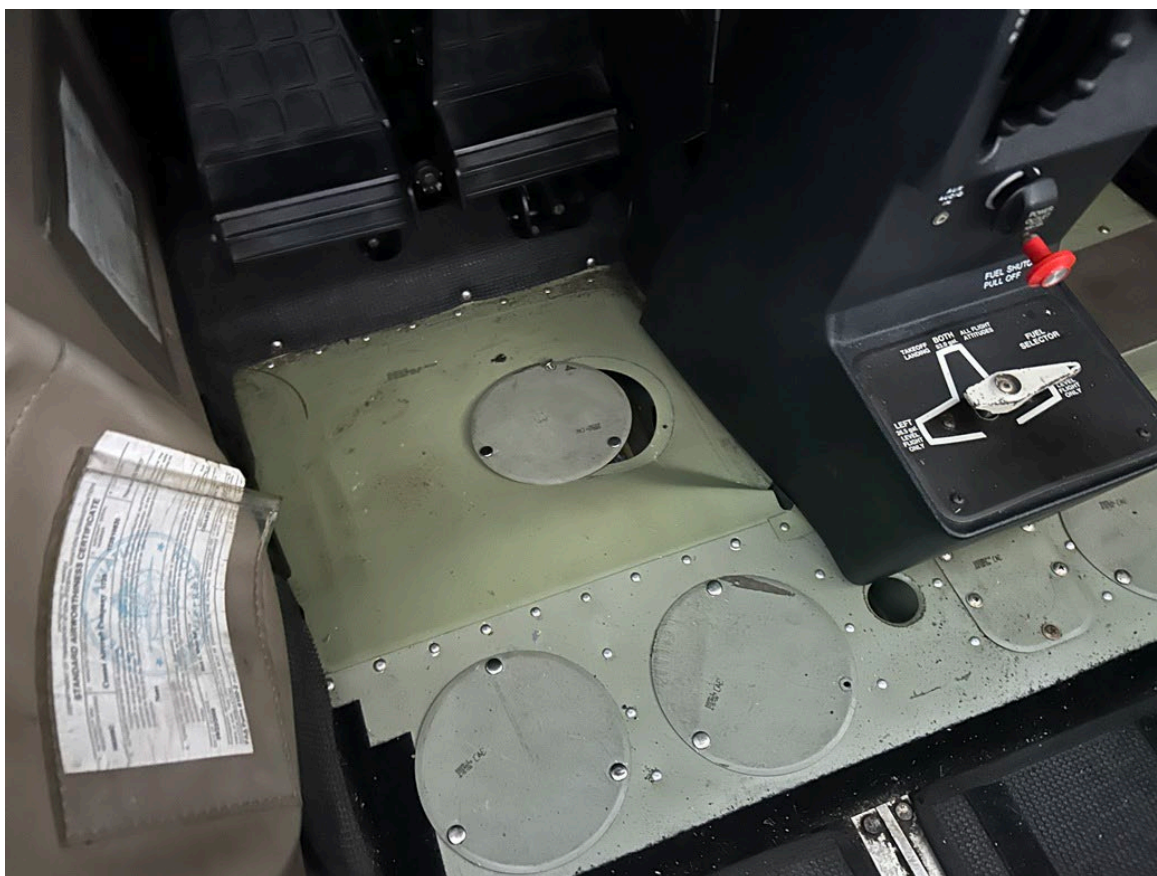
**Photograph 3 - Cockpit Floor Buckling Damage (Courtesy of FAA)**

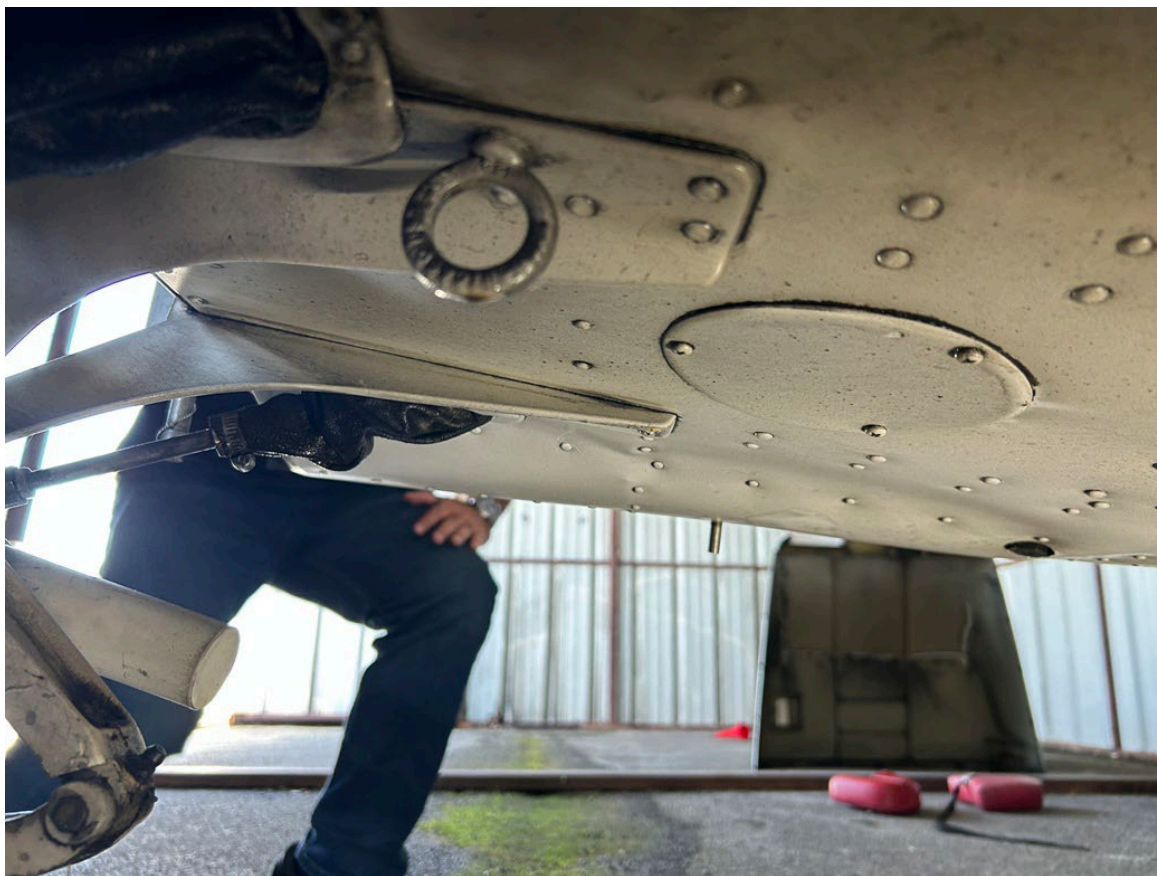
**Photograph 4 - Lower Fuselage Impact Damage (Courtesy of FAA)**

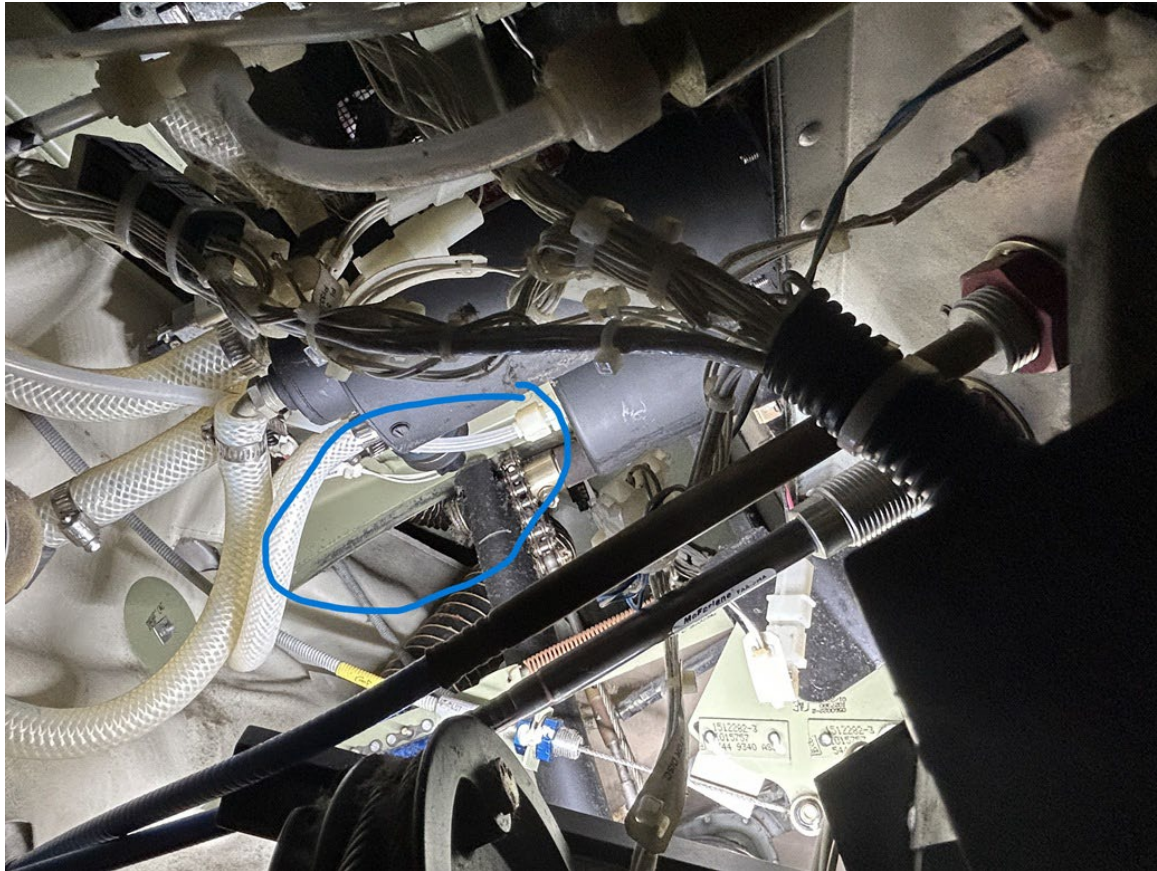
**Photograph 5 - Bending of Elevator Control Pivot Point (Courtesy of FAA)**

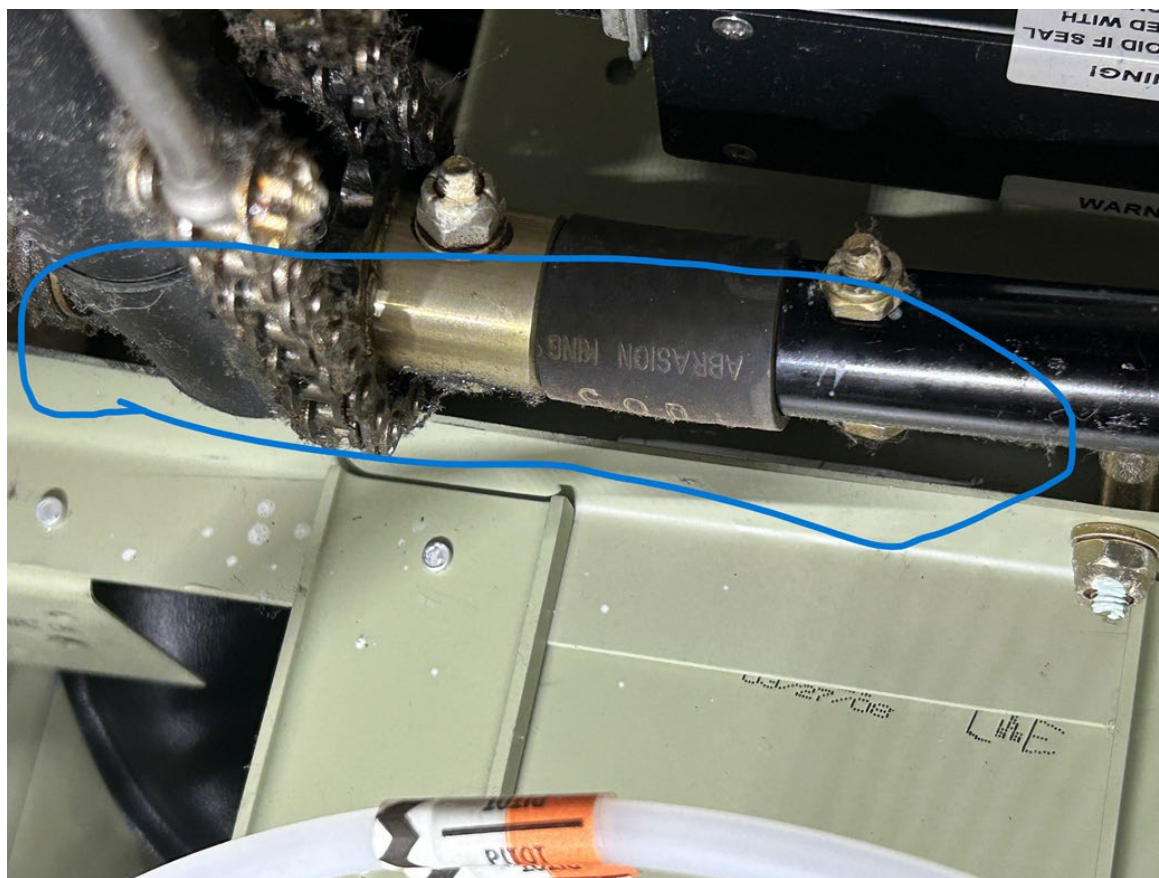
**Photograph 6 - Closeup View of Bending of Elevator Control Pivot Point (Courtesy of FAA)**
