ERA25LA312

## INVESTIGATION PHOTOGRAPHS

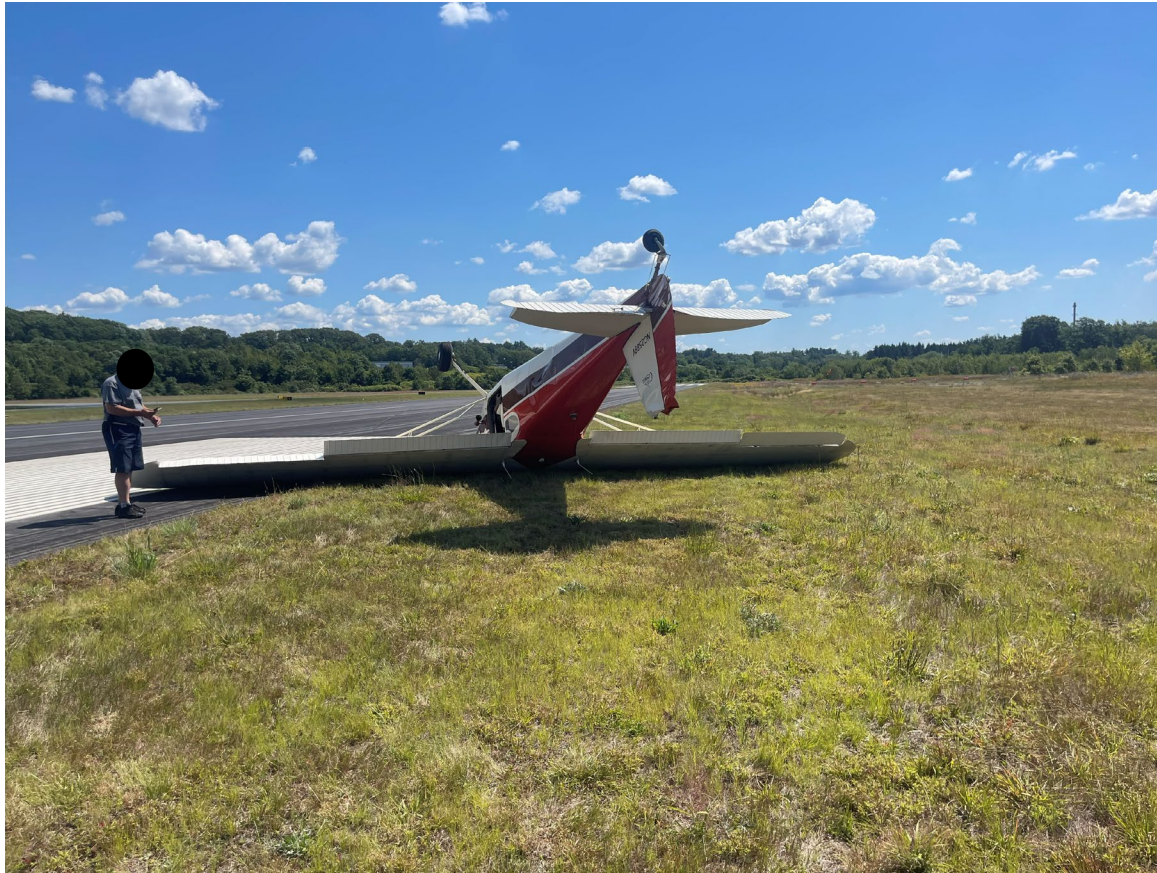
**Photograph 1 - Deformation noted to rudder and vertical stabilizer (Courtesy of FAA)**

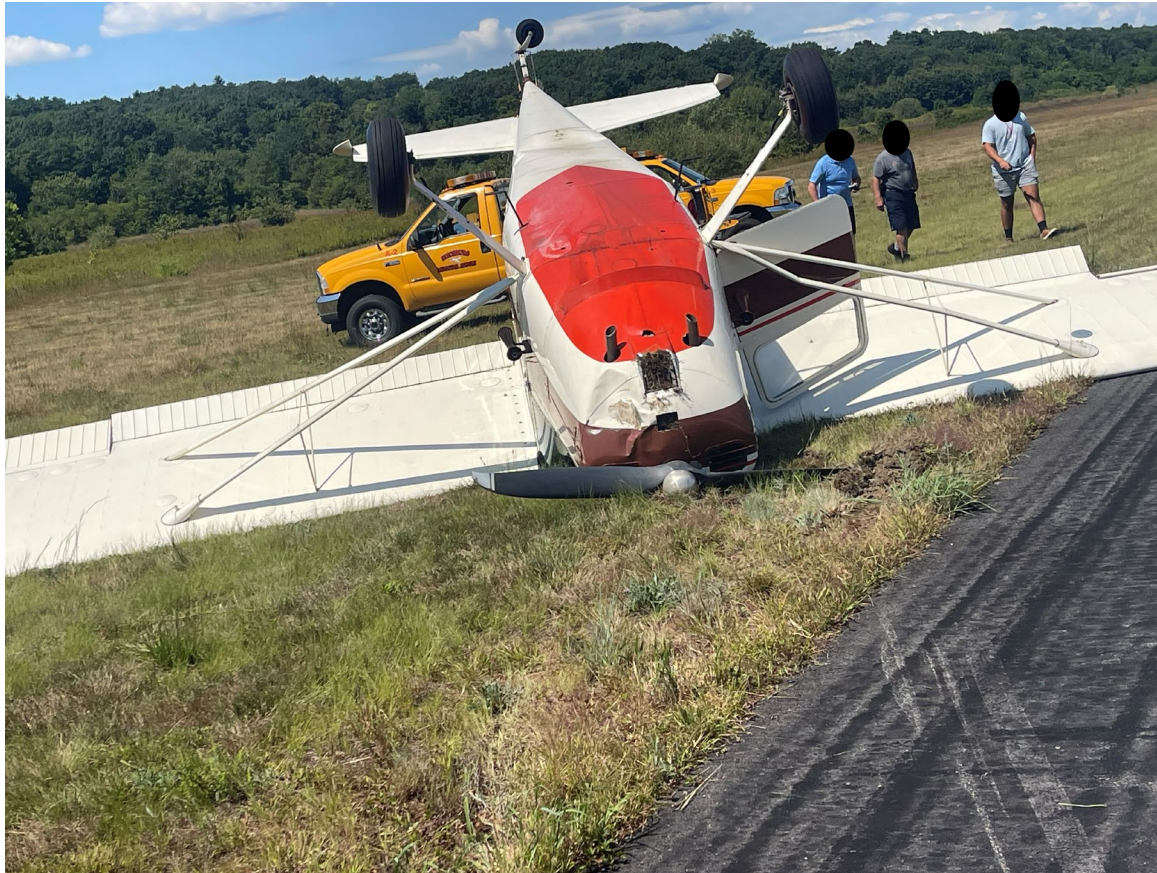
**Photograph 2 - Deformation noted to fuselage skin and right-wing lift strut (Courtesy of FAA)**
