ERA25LA319

## INVESTIGATION PHOTOGRAPHS

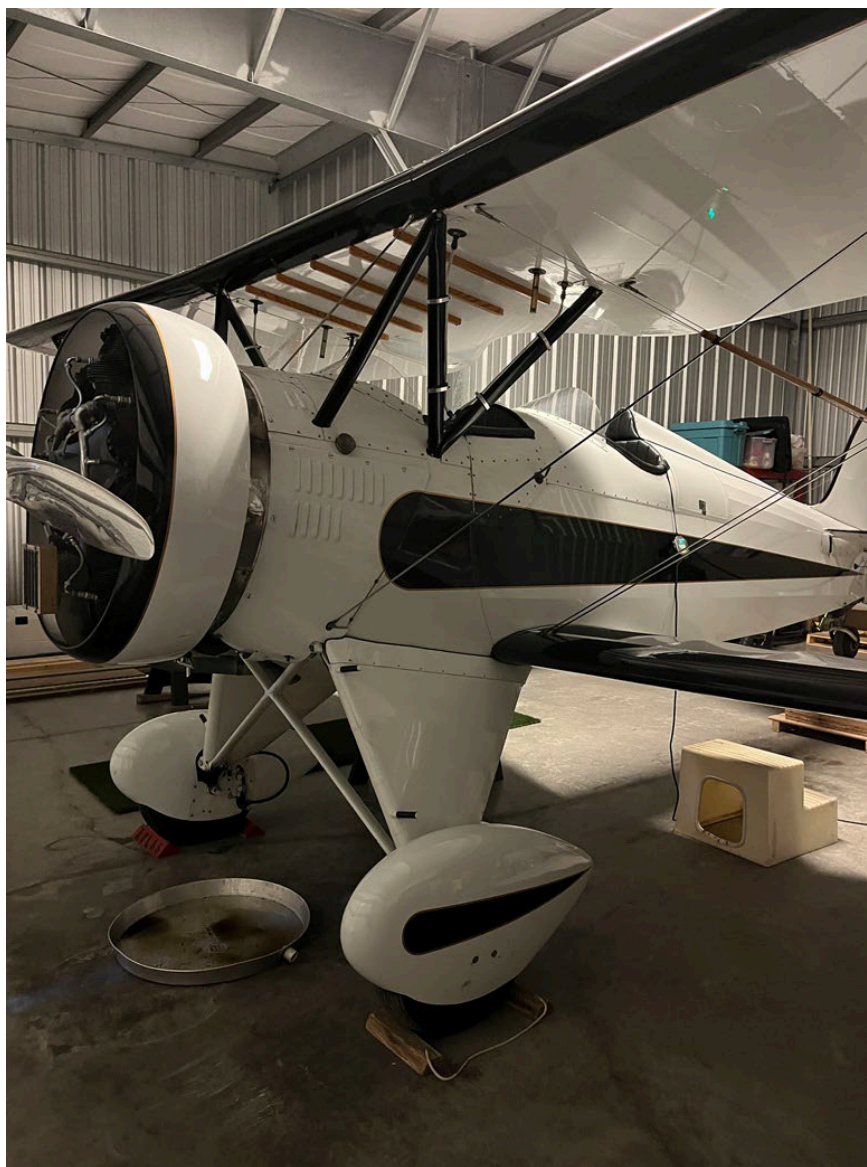
**Photograph 1 - Main Wreckage (Courtesy of FAA)**

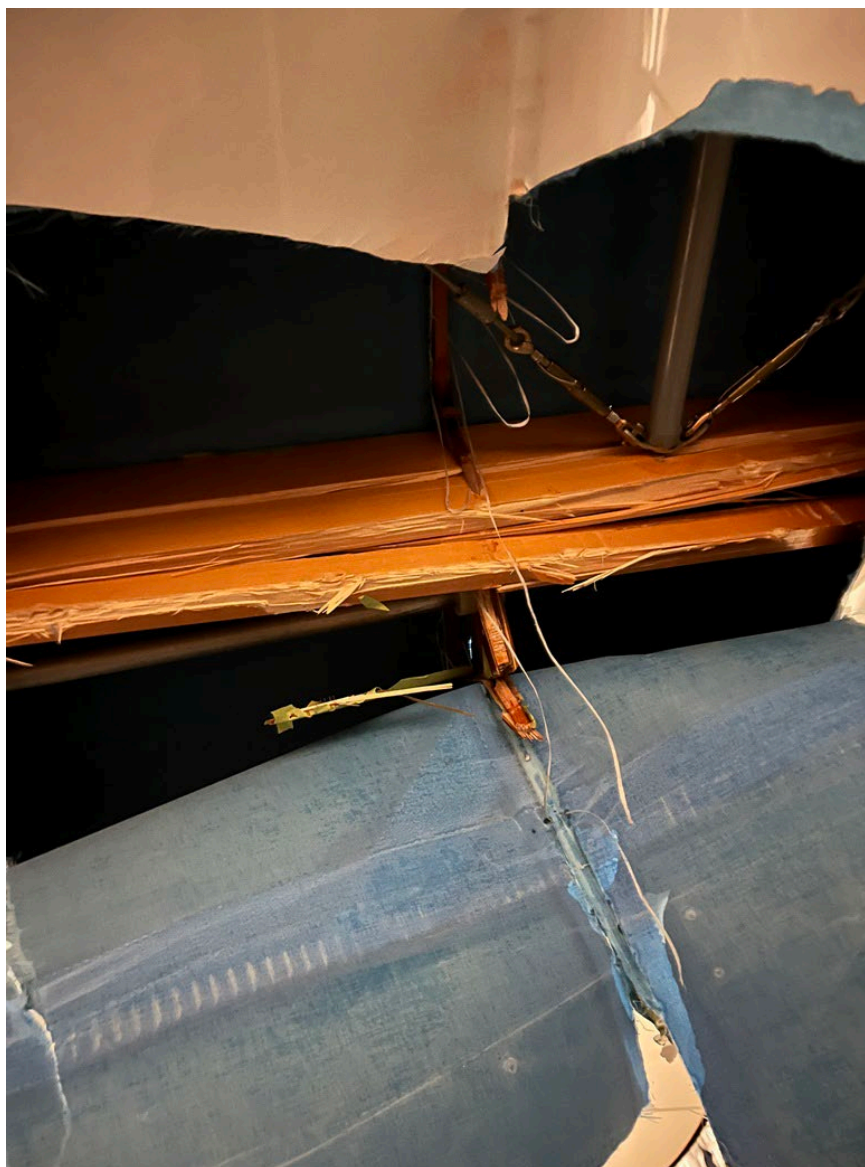
**Photograph 2 - Left Wing Spar Damage (Courtesy of FAA)**
