ERA25LA324

## INVESTIGATION PHOTOGRAPHS

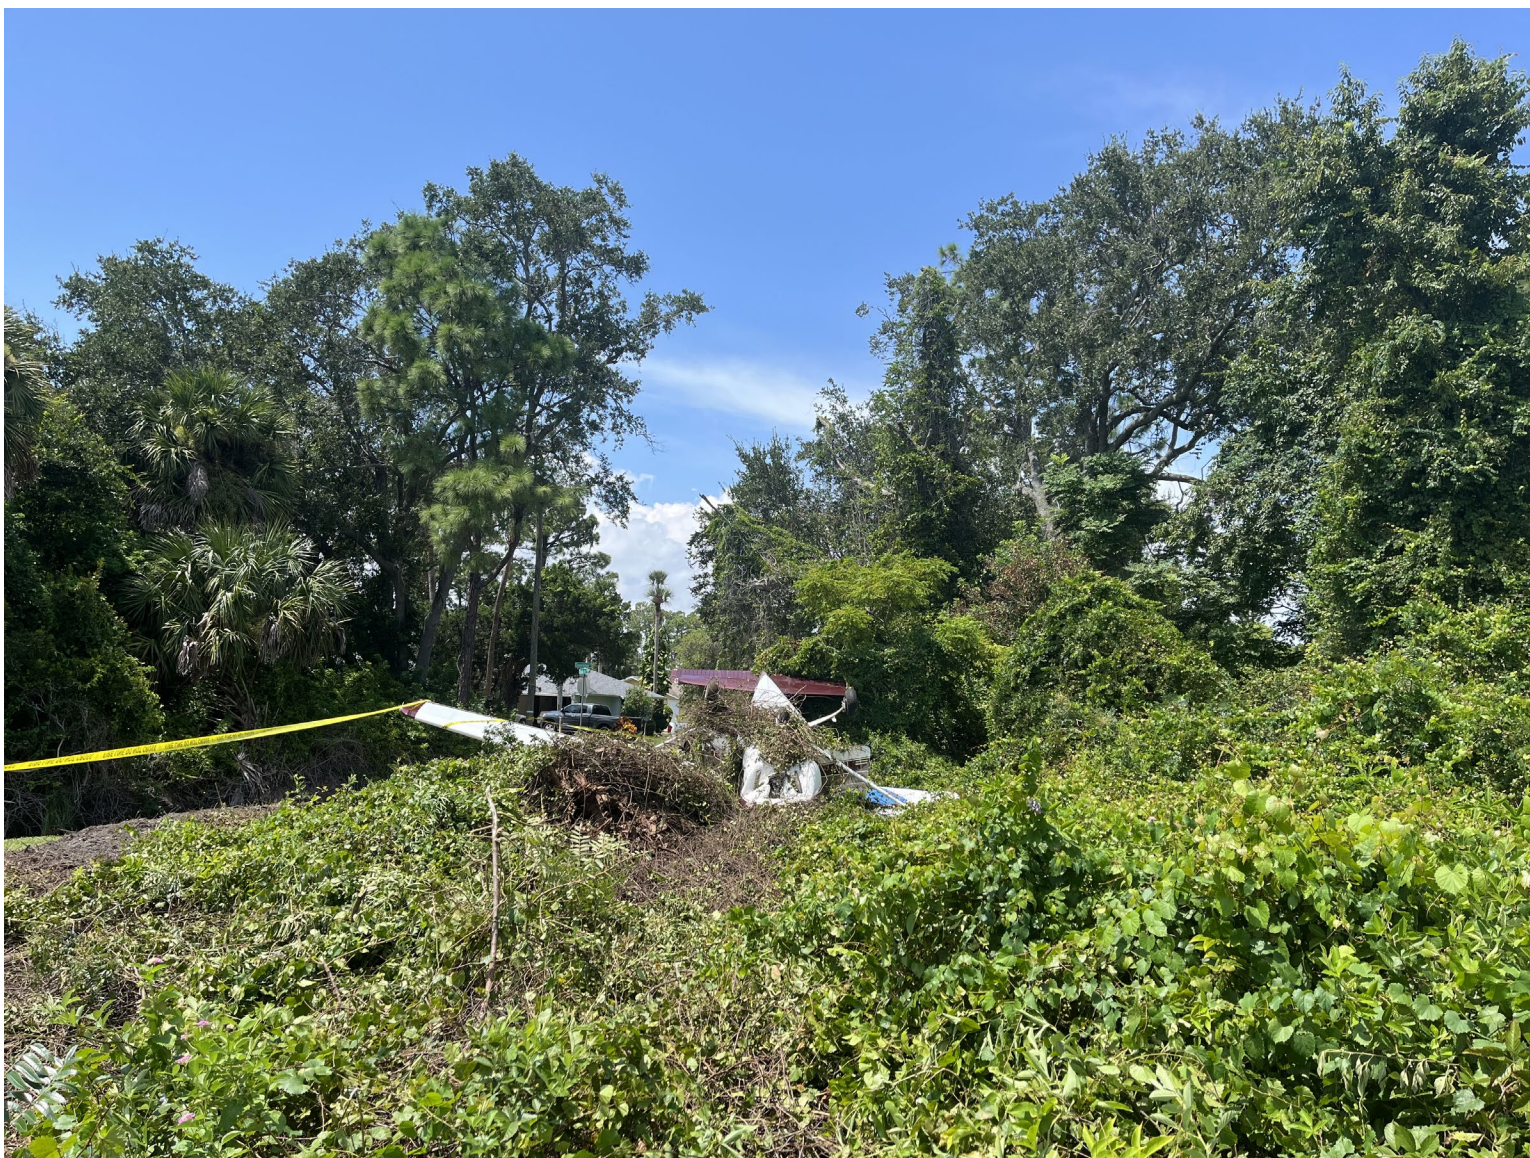
**Photograph 1 - Accident airplane at the accident site. (Courtesy of FAA)**

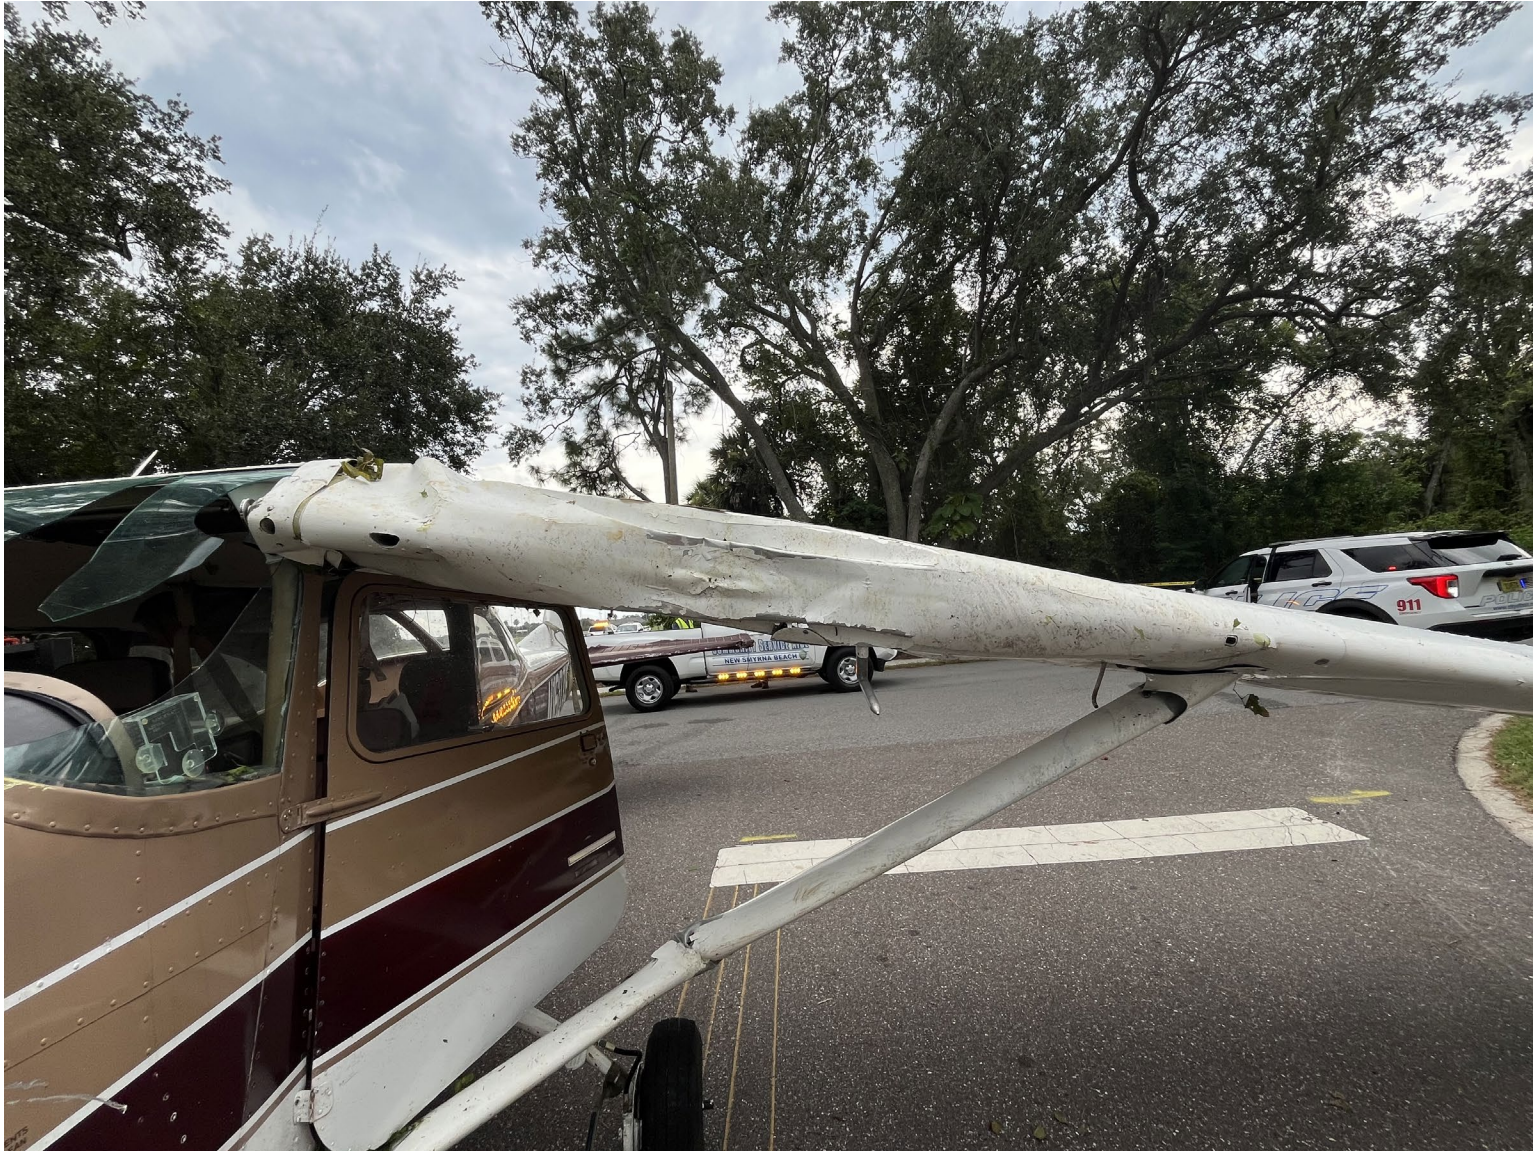
**Photograph 2 - View of damage to the left wing. (Courtesy of FAA)**

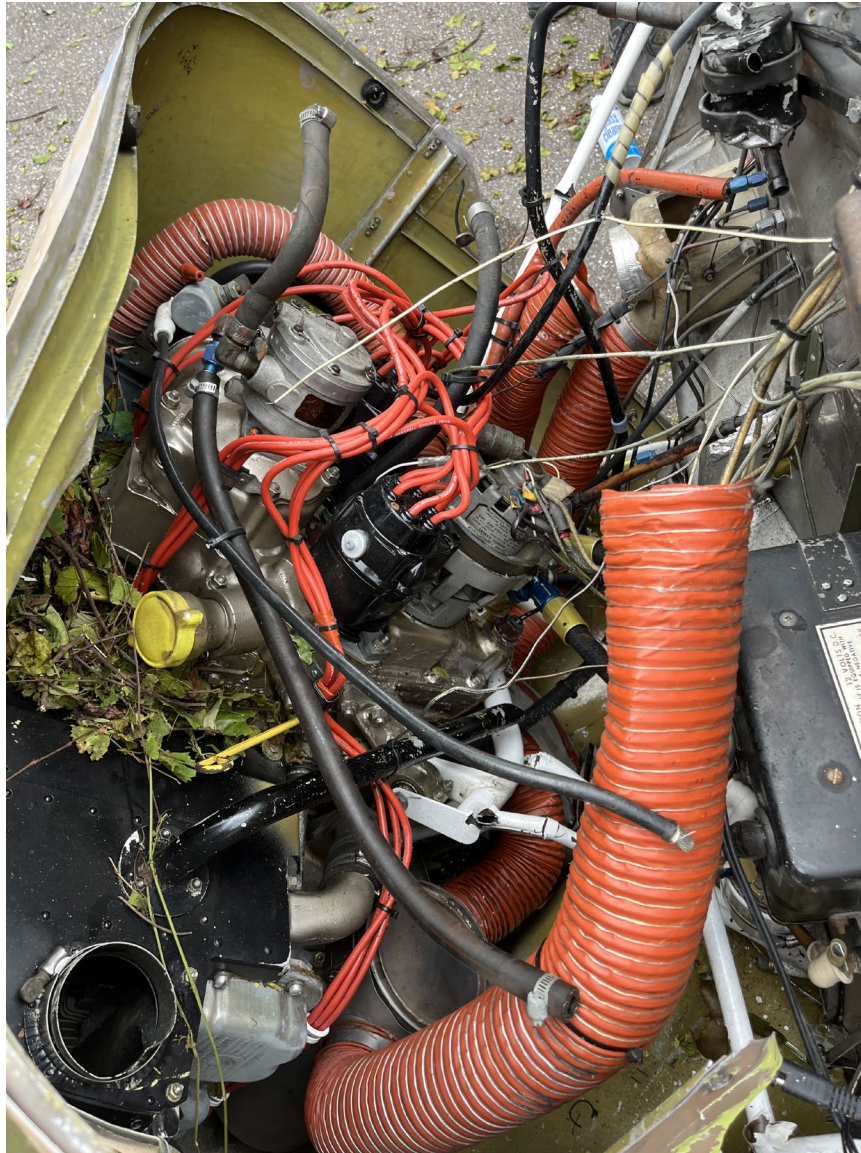
**Photograph 3 - View of engine mount damage. (Courtesy of FAA)**

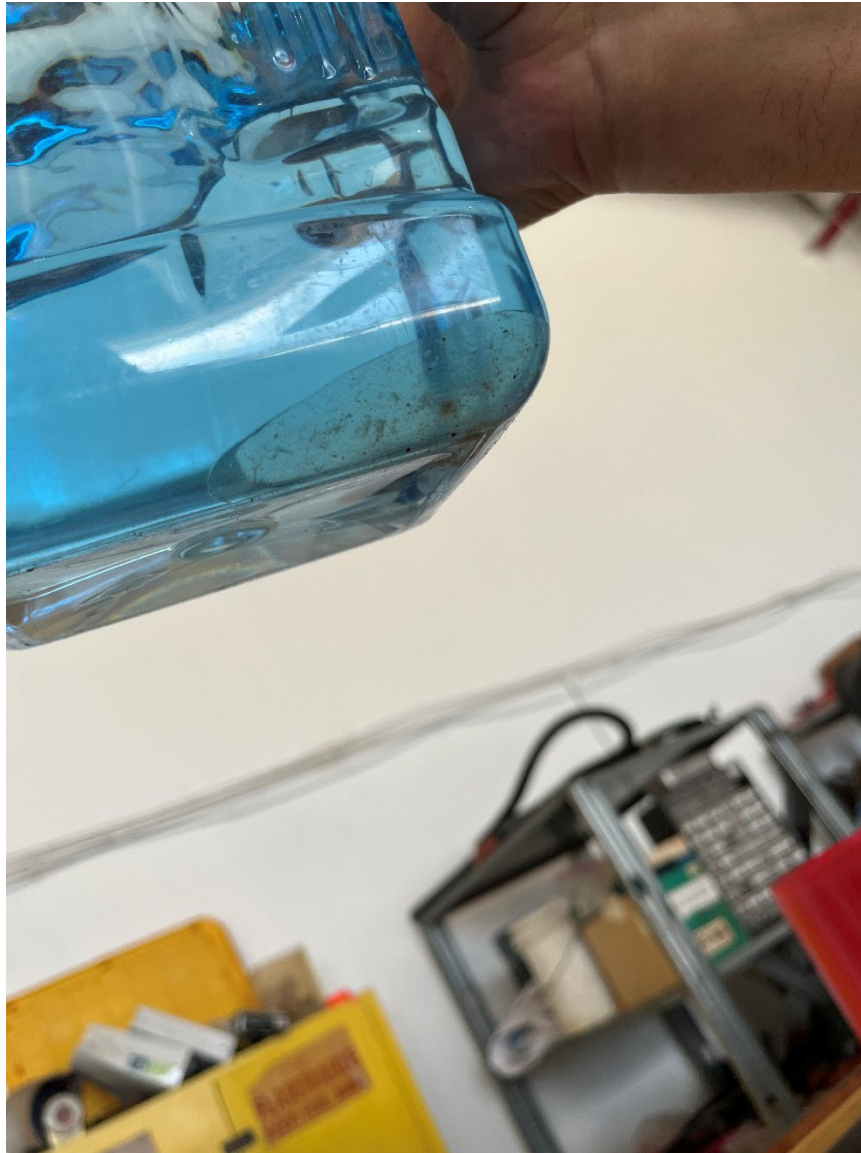
**Photograph 4 - View of fuel sample taken 2 days prior to the accident. (Courtesy of FAA)**
