# National Transportation Safety Board

ERA25LA324

## **WRECKAGE EXAMINATION**

Location: New Smyrna Beach, FL  
Date: August 29, 2025  
Time: 1027 EDT  
1427 UTC  
Airplane: Cessna 172H, N1607F

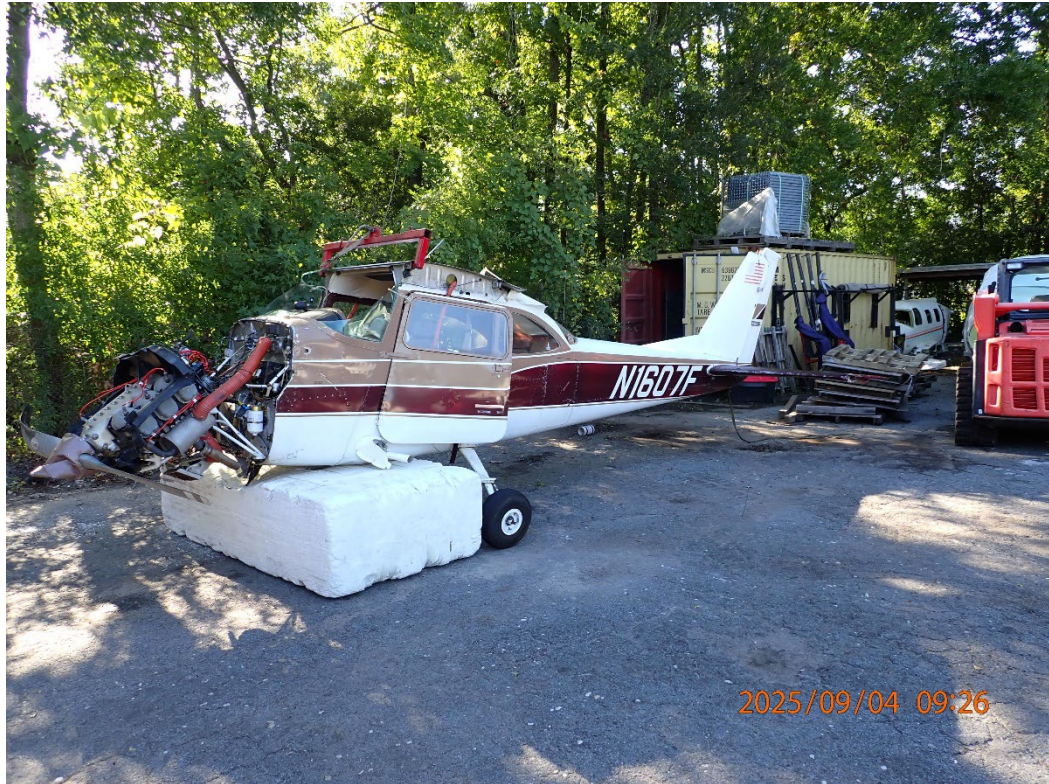
The fuselage remained intact with some scraping, dents and small holes.

**Photo 1: View of the fuselage.**

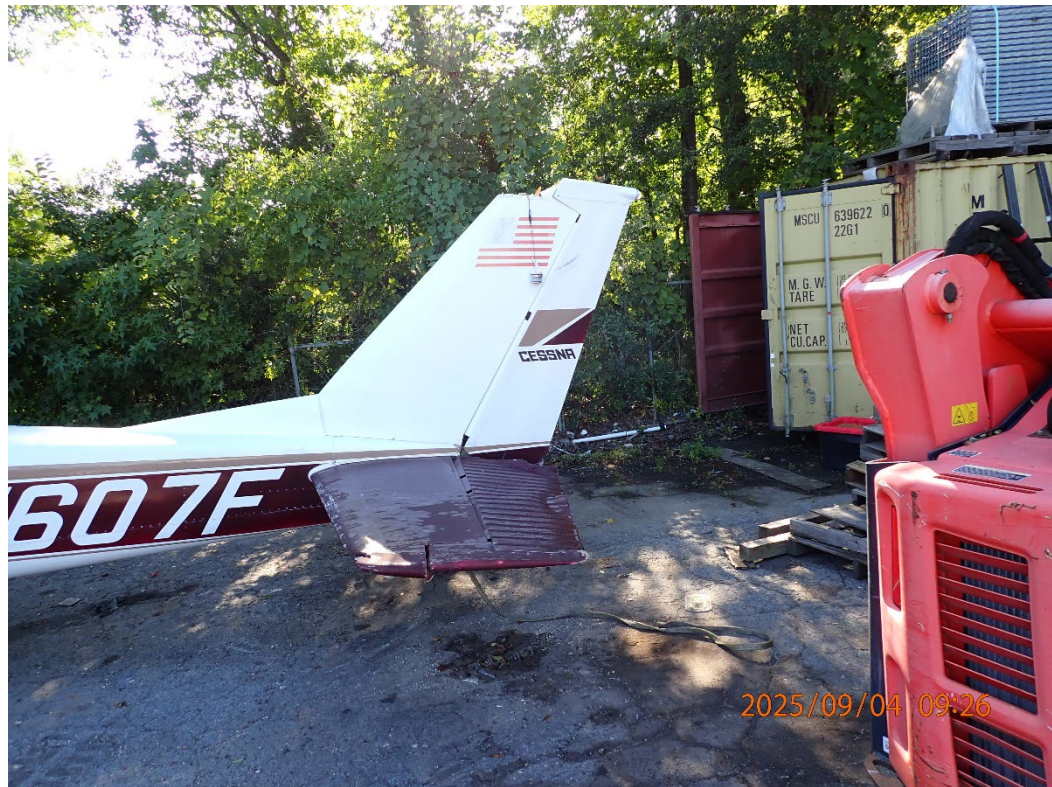
The empennage remained attached to the fuselage. The vertical stabilizer remained attached, and the top fairing was impact separated. The rudder remained attached at all attachment points. Flight control continuity was confirmed from the rudder flight control surface to the flight controls in the cockpit. The left horizontal stabilizer and elevator exhibited impact damage. The left elevator remained attached at all attachment points. The right horizontal stabilizer, elevator, and elevator trim tab were undamaged. Elevator control continuity was confirmed from the flight control surface to the flight controls in the cockpit.

**Photo 2: View of the left side of the empennage.**

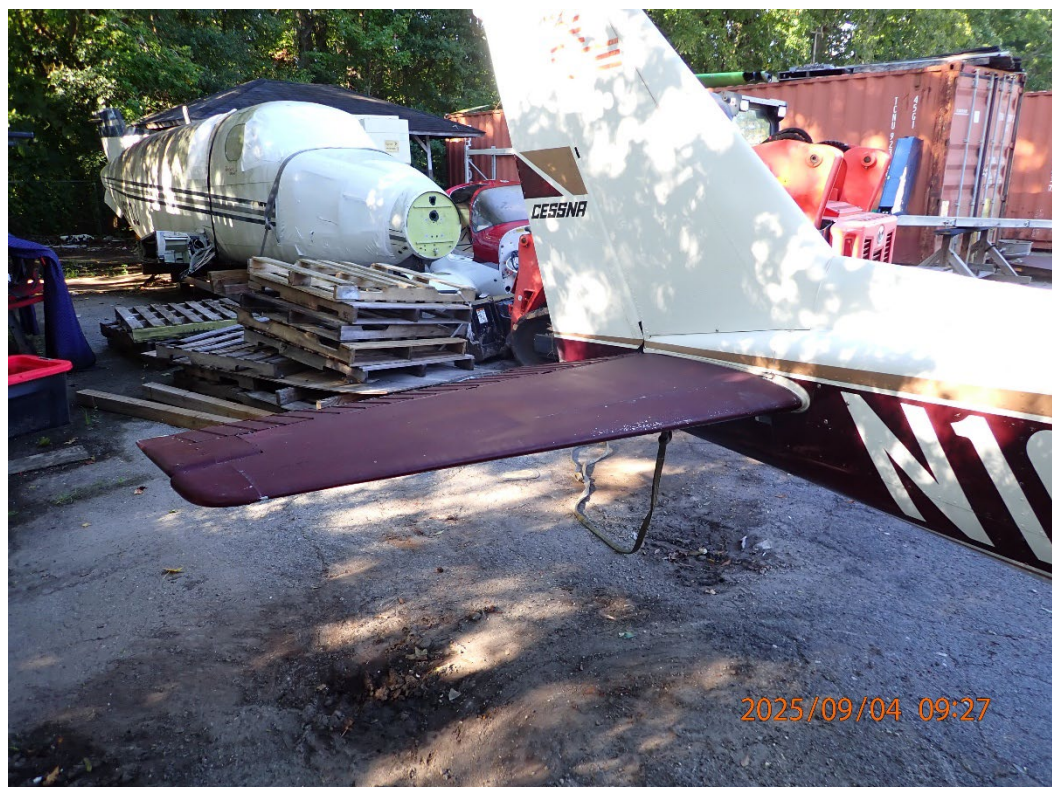
**Photo 3: View of the right side of the empennage.**

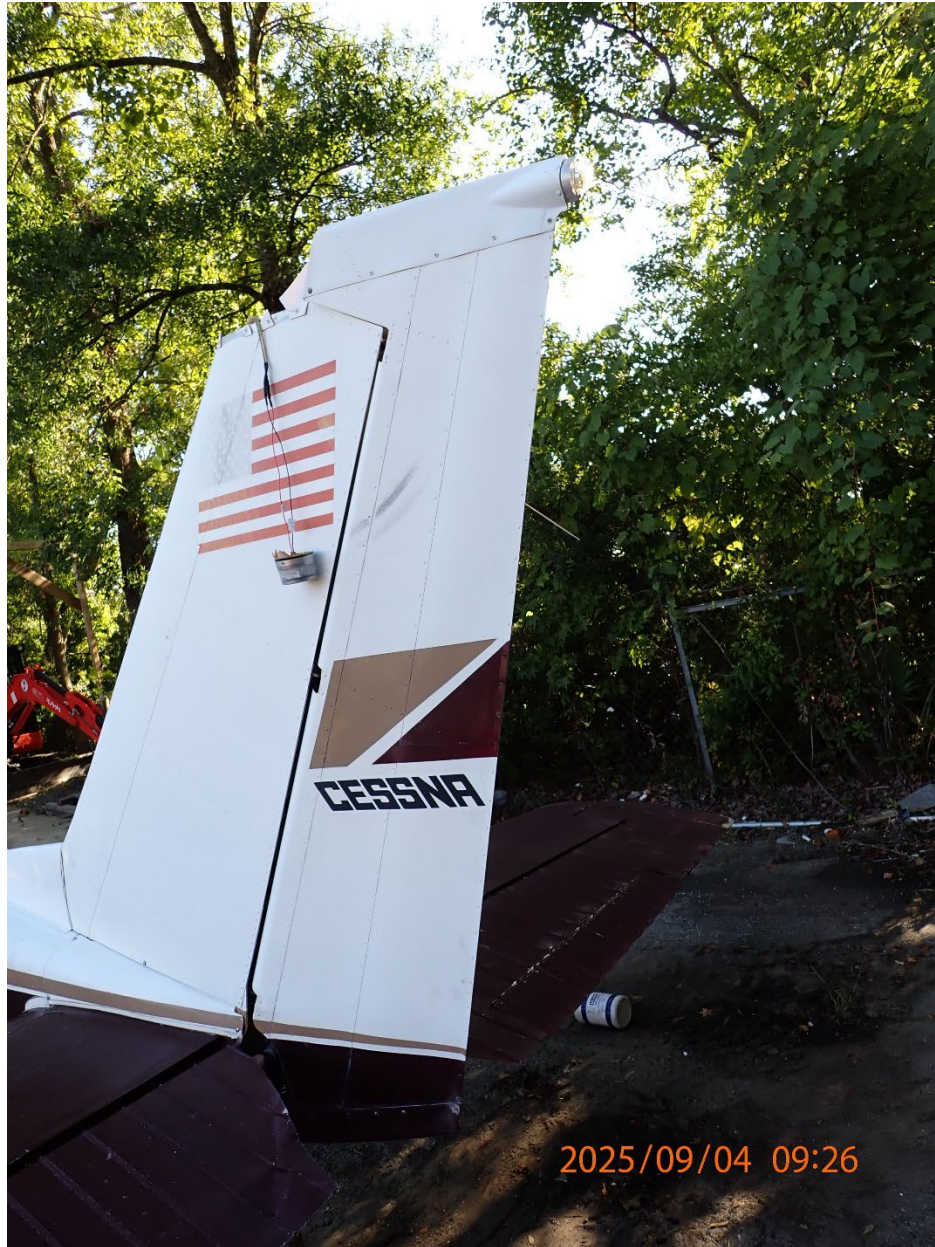
**Photo 4: View of the vertical stabilizer and rudder.**

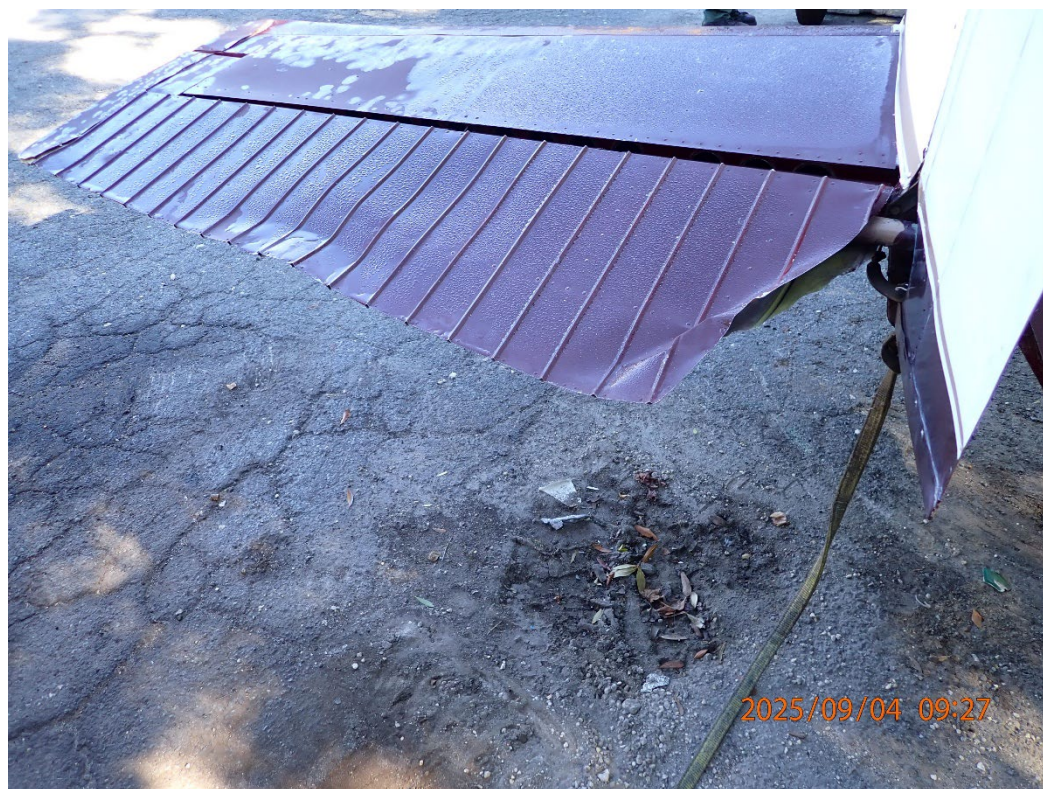
**Photo 5: View of damage to the left elevator.**

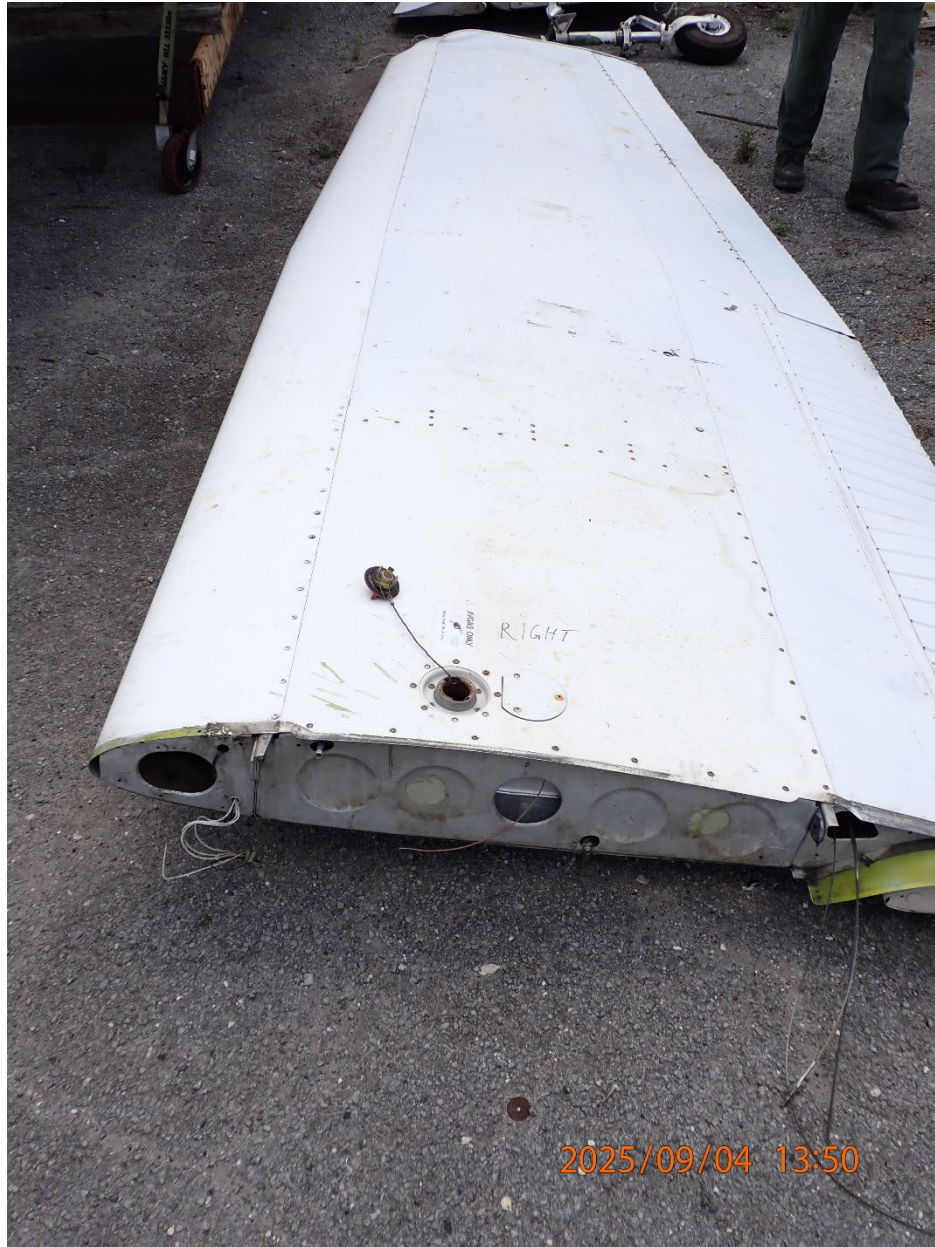
Both wings had been removed to facilitate recovery of the airplane. The right wing exhibited impact damage on the outboard leading edge. The right aileron and flap remained attached to the wing at all attachment points. The left wing exhibited leading edge impact damage. The left aileron and flap remained attached to the wing at all attachment points. Aileron continuity was established from the flight control surfaces to the flight controls in the cockpit through cuts made to facilitate recovery.

**Photo 6: View of the right wing.**

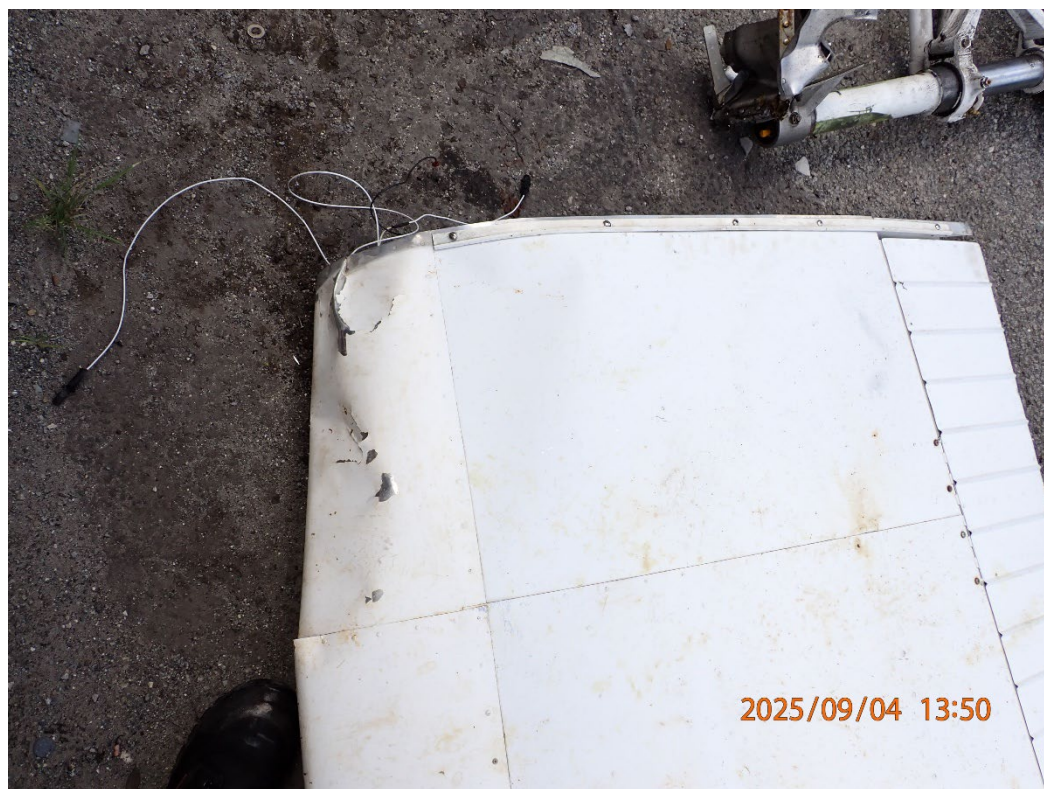
**Photo 7: View of damage to the right wingtip.**

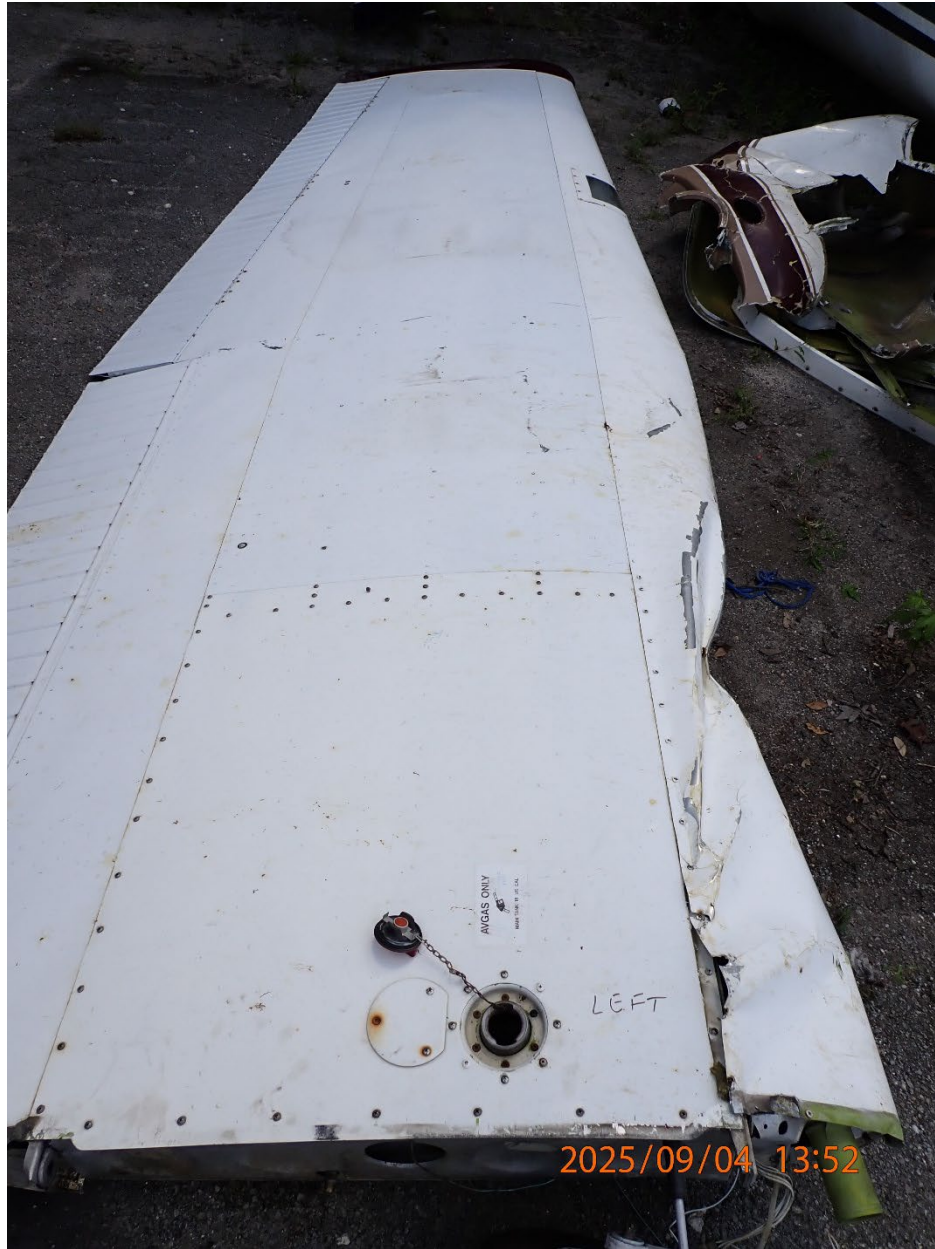
**Photo 8: View of the left wing.**

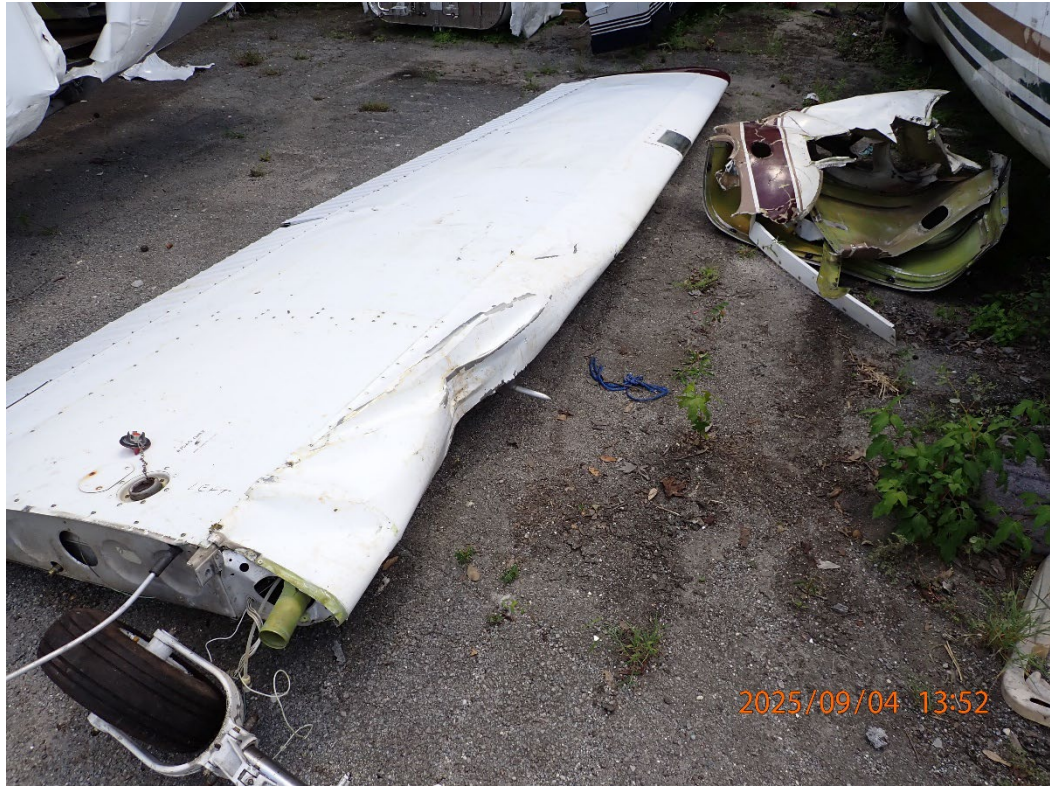
**Photo 9: View of damage to the leading edge of the left wing.**

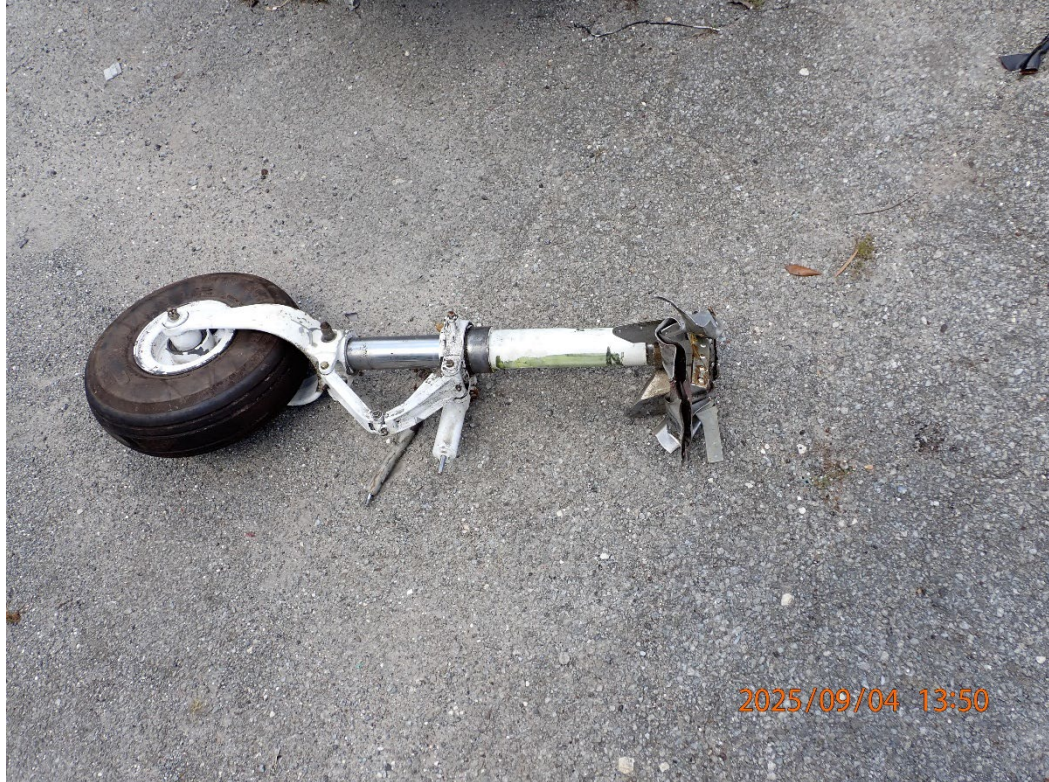
The main landing gear remained attached to the fuselage. The nose landing gear was impact separated.

**Photo 10: View of the impact separated nose landing gear.**

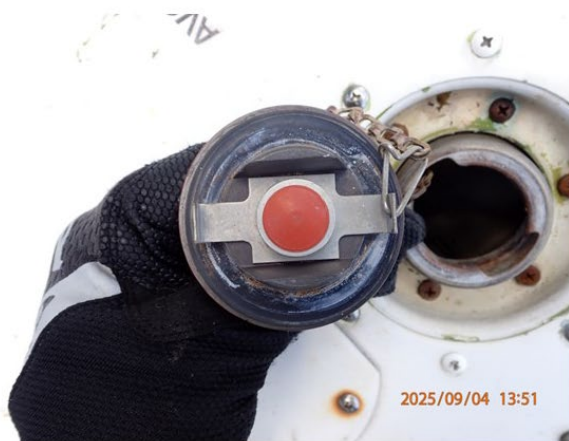
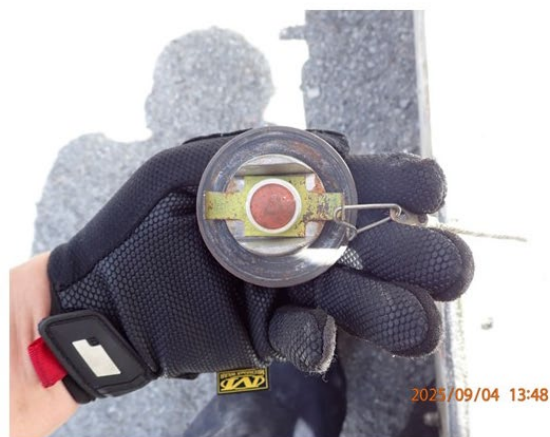
The fuel tank filler cap seals were replaced recently due to leaks. Both fuel tank filler openings exhibited rust and corrosion. An undetermined amount of fuel was drained from both wing tanks at the accident site. Both wing fuel tank outlet screens were clean when observed via lighted borescope. The fuel selector was on BOTH at the accident site according to postaccident photographs provided by the FAA. There was some play in the fuel selector linkage, but all detents were evident. The fuel selector operated correctly when tested with air through the fuel plumbing. The fuel strainer bowl and screen had a small amount of debris, and the bowl interior was corroded. The fuel strainer drain linkage from the cockpit would permit draining, but the travel was not enough to clear for disassembly. Fuel samples from the right wing fuel plumbing, and from the strainer had evidence of water through visual observation and use of water detecting paste. The left wing fuel plumbing did not show evidence of water.

**Photo 11: View of the left and right fuel tank caps.**

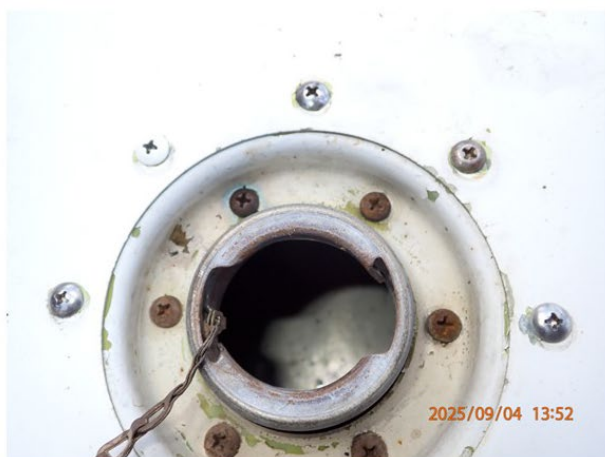
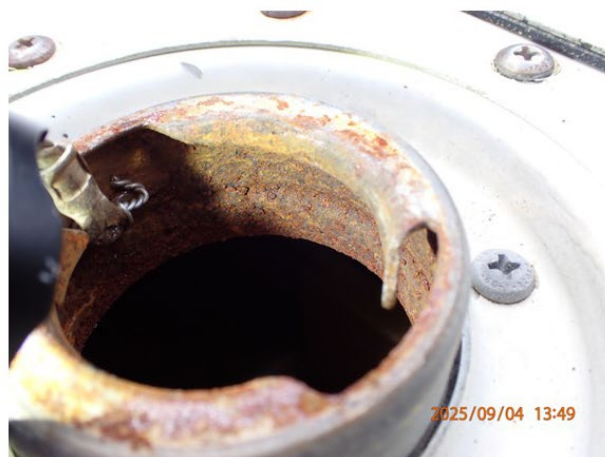
**Photo 12: View of the left and right fuel tank filler openings.**

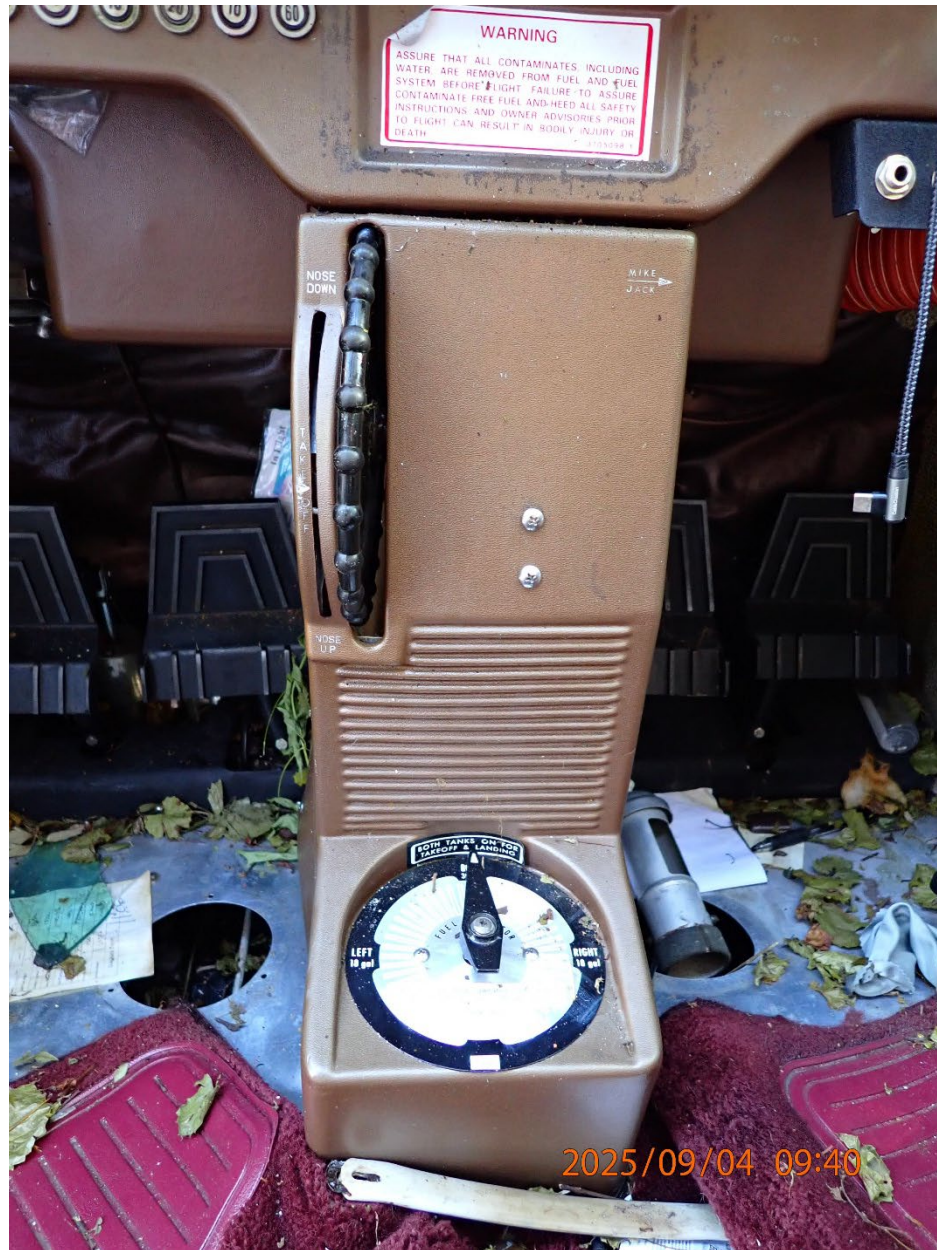
**Photo 13: View of the fuel selector.**

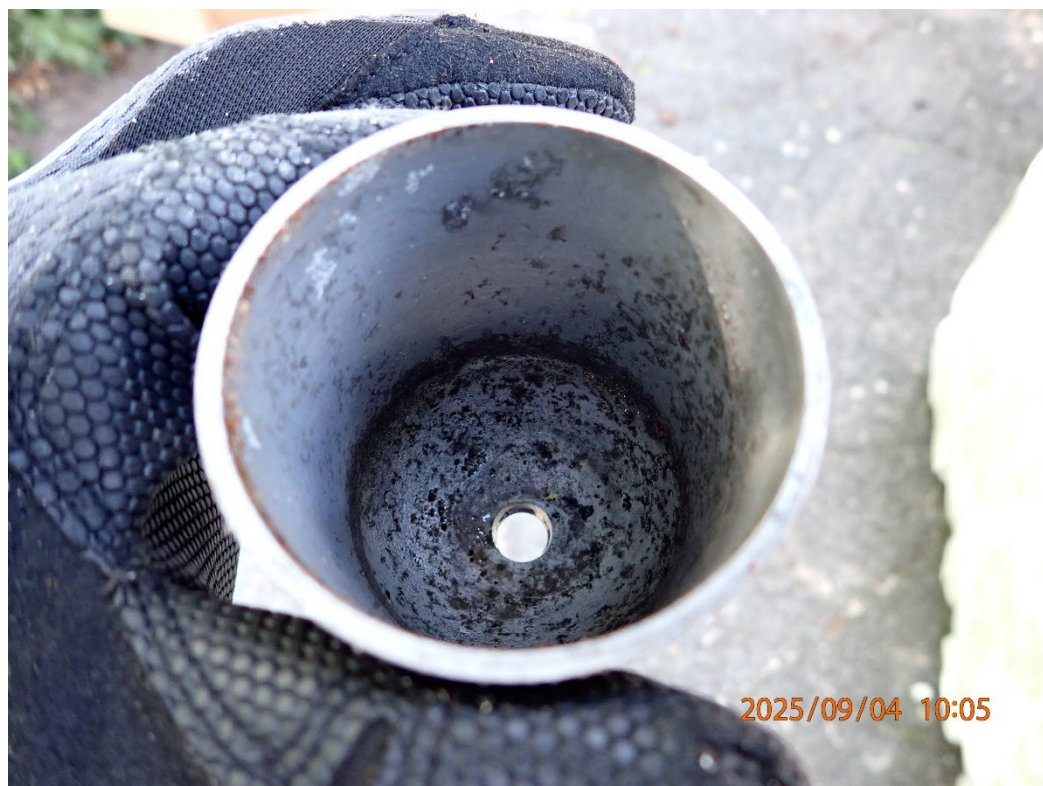
**Photo 14: View of the fuel strainer bowl.**

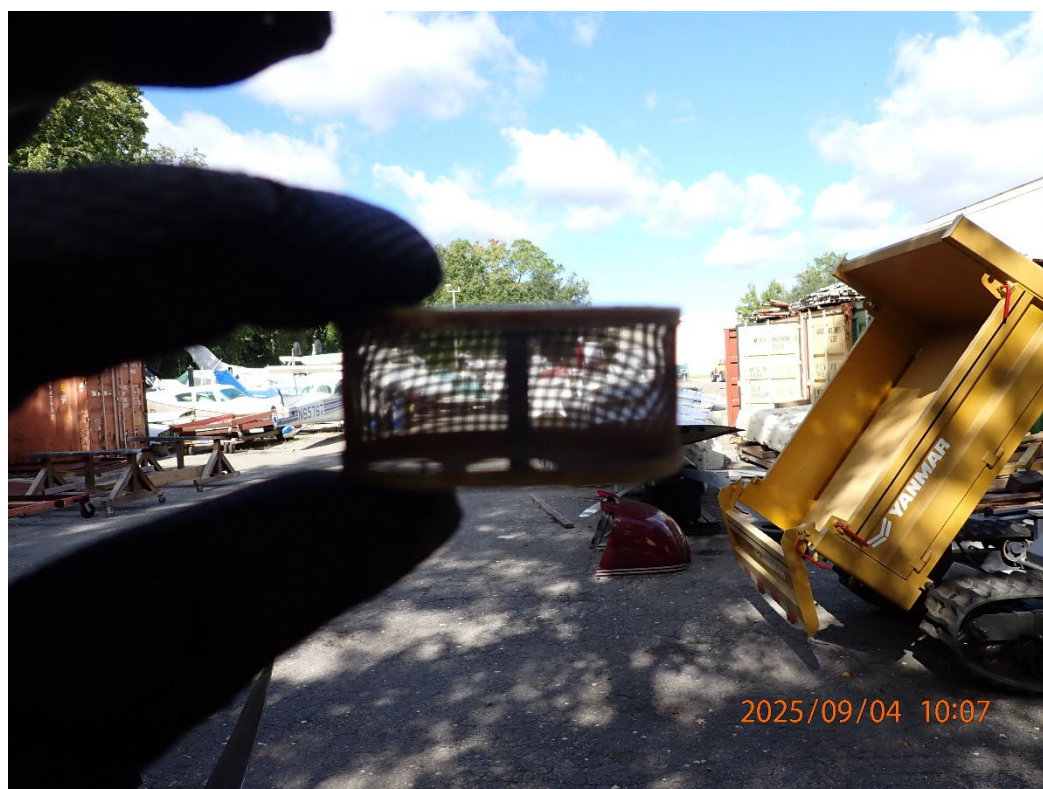
**Photo 15: View of the fuel strainer screen.**

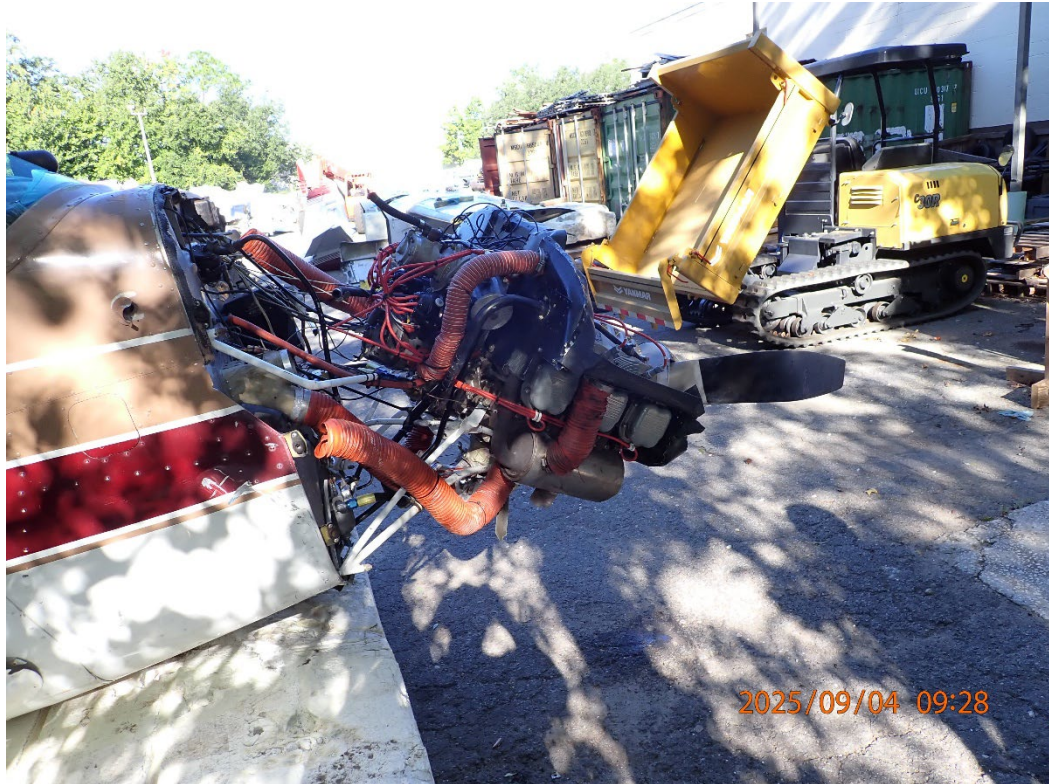
The engine remained attached to the engine mounts. Compression and suction were observed when the engine crankshaft was rotated through 720° of rotation by hand via the propeller. The rocker box covers were removed and valvetrain continuity was observed when the engine was rotated by hand using the propeller. Control continuity was confirmed from the cockpit to the engine controls for the throttle, mixture, and carburetor heat.

**Photo 16: Overview of the engine.**

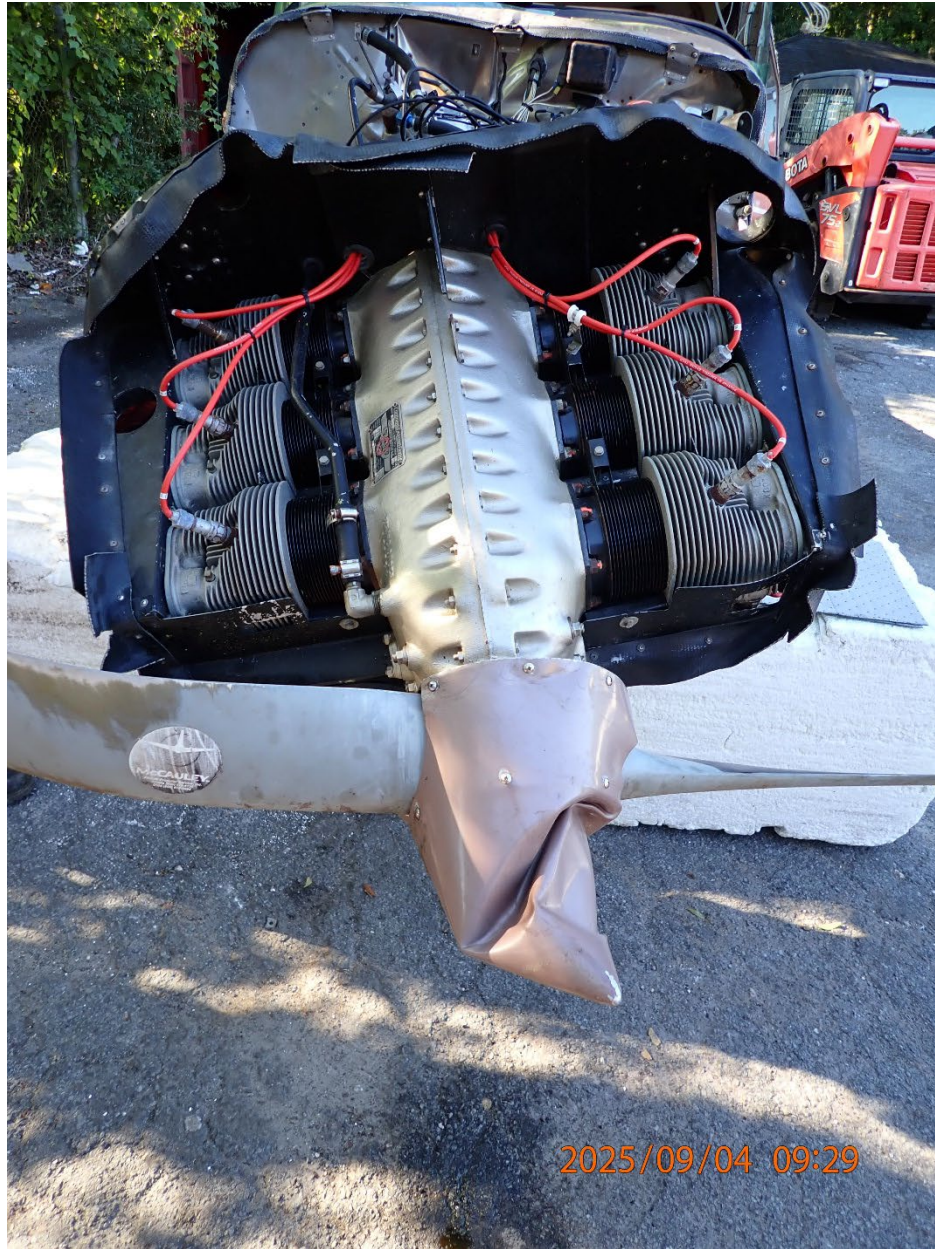
**Photo 17: View of the top of the engine.**

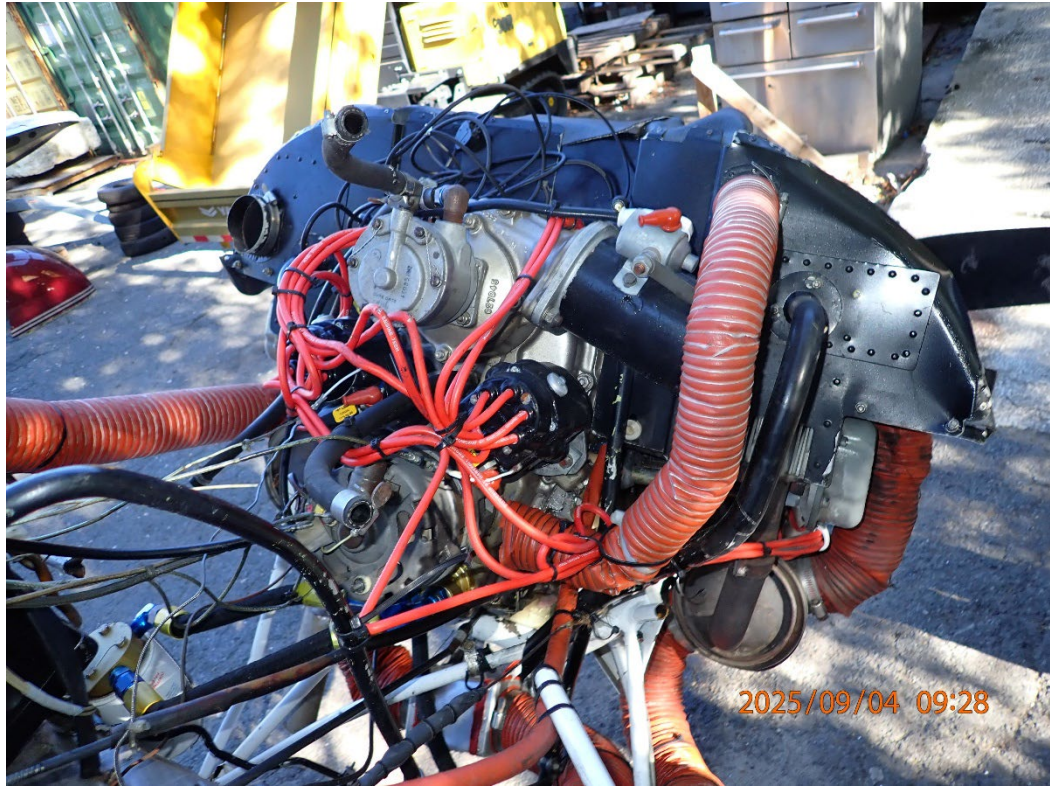
**Photo 18: View of the back of the engine.**

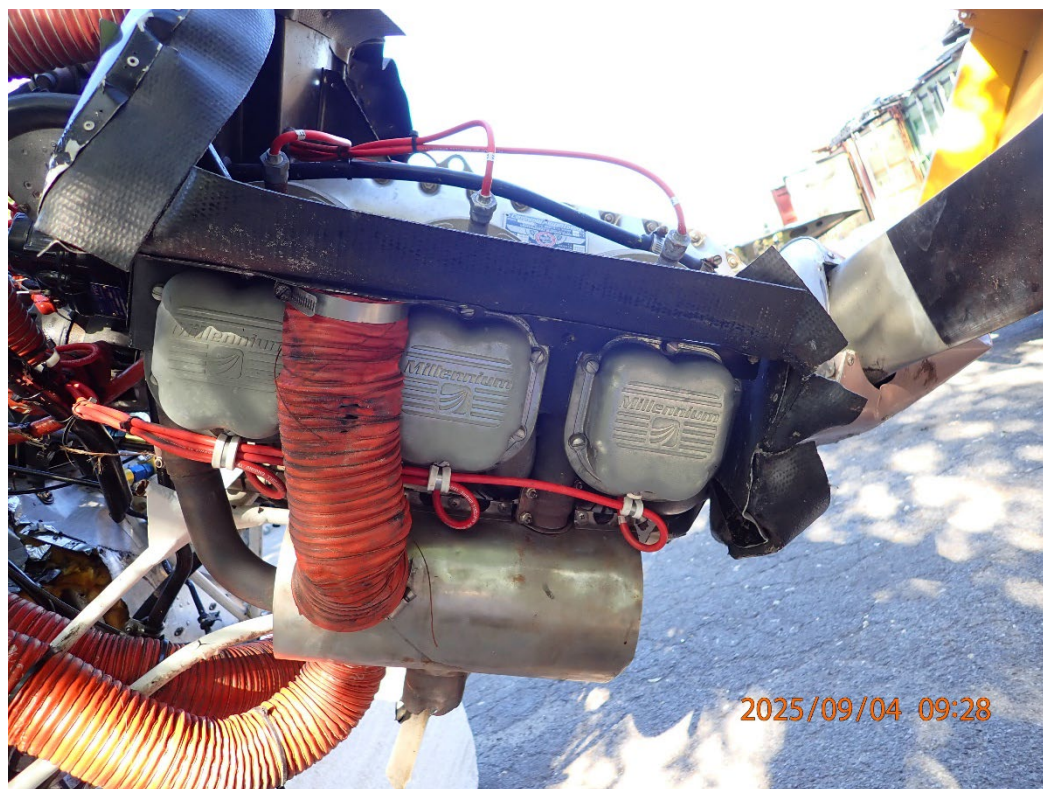
**Photo 19: View of the right side of the engine.**

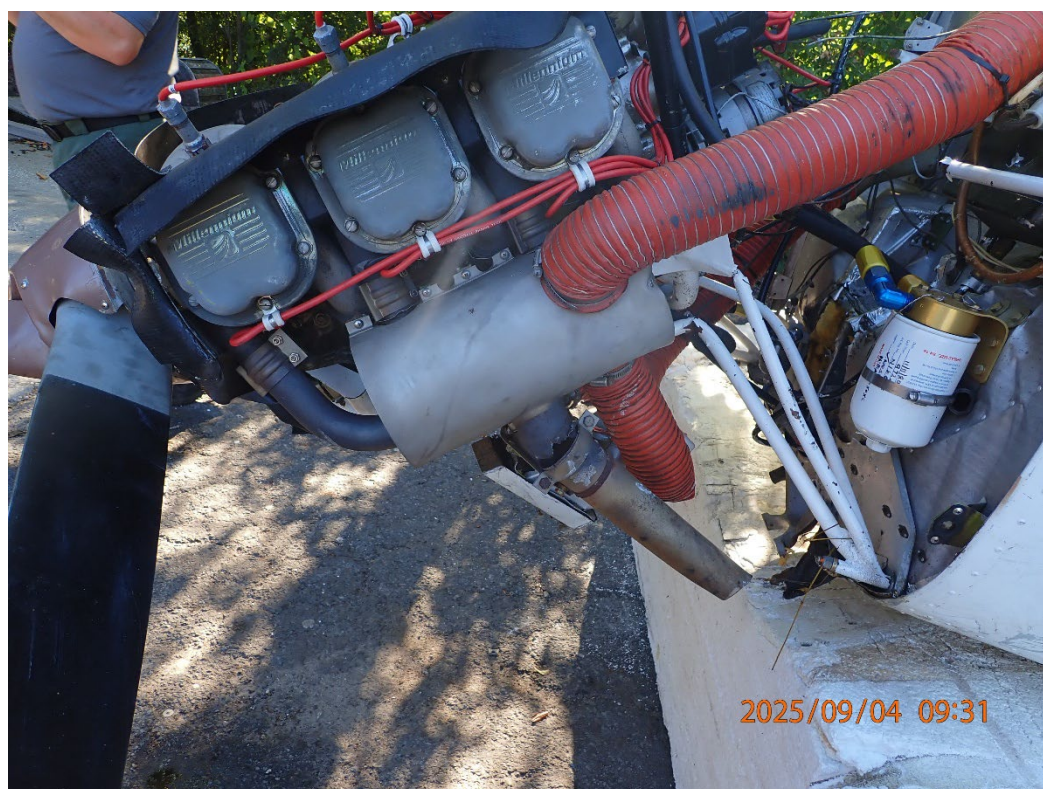
**Photo 20: View of the left side of the engine.**

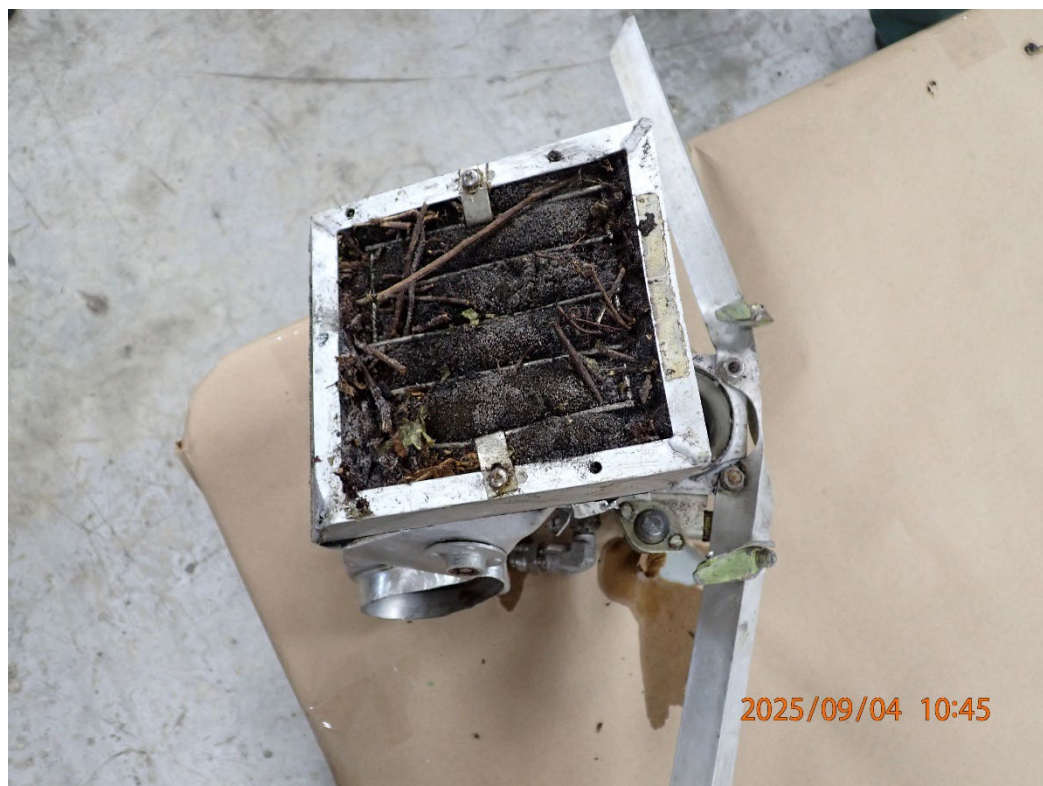
The induction air intake filter was packed with organic debris consistent with the airplane's impact into vegetation. The airbox remained attached to the carburetor by 3 of the 8 rivets. The exhaust system was undamaged.

**Photo 21: View of the air intake filter.**

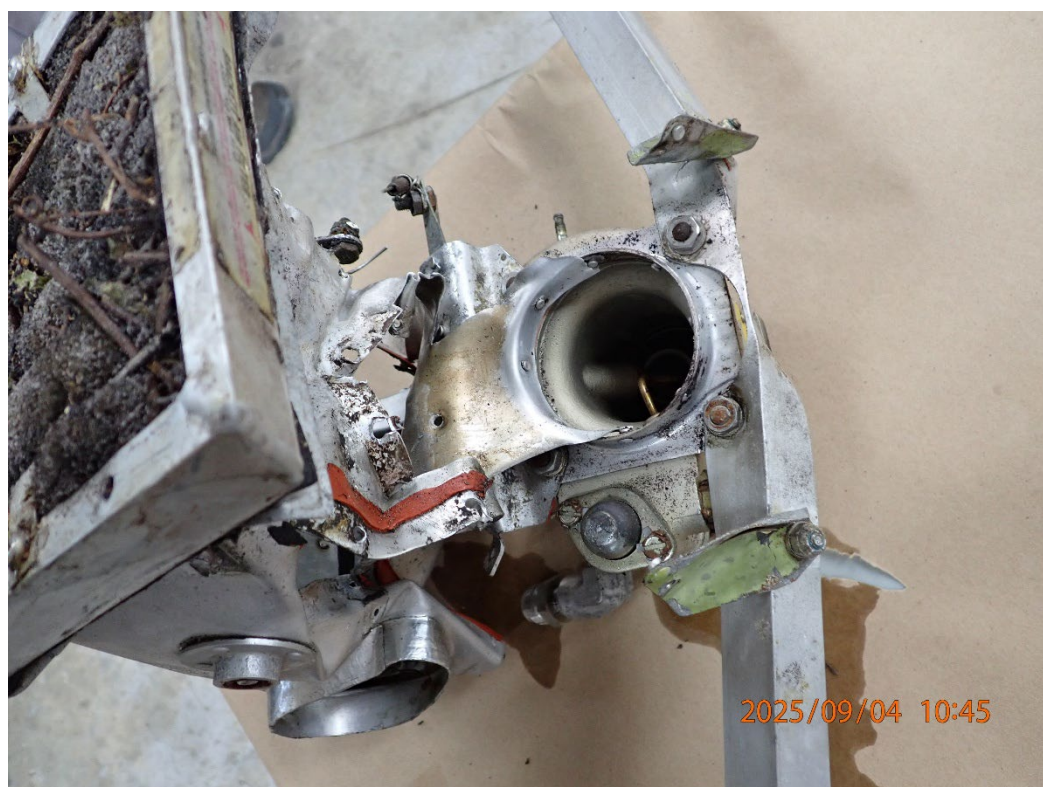
**Photo 22: View of the air intake carburetor attachment point.**

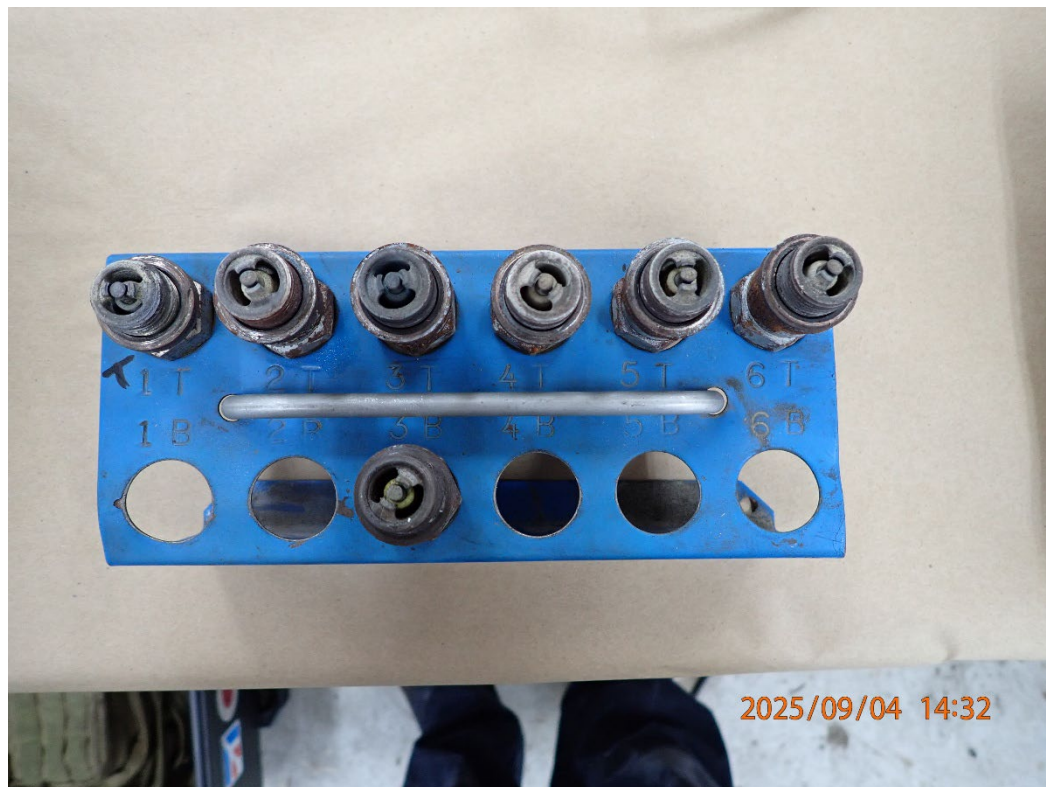
The top sparkplugs were removed and exhibited normal to worn out - normal appearance when compared to the champion aerospace aviation Check-A-Plug chart.

**Photo 23: View of the removed sparkplugs.**

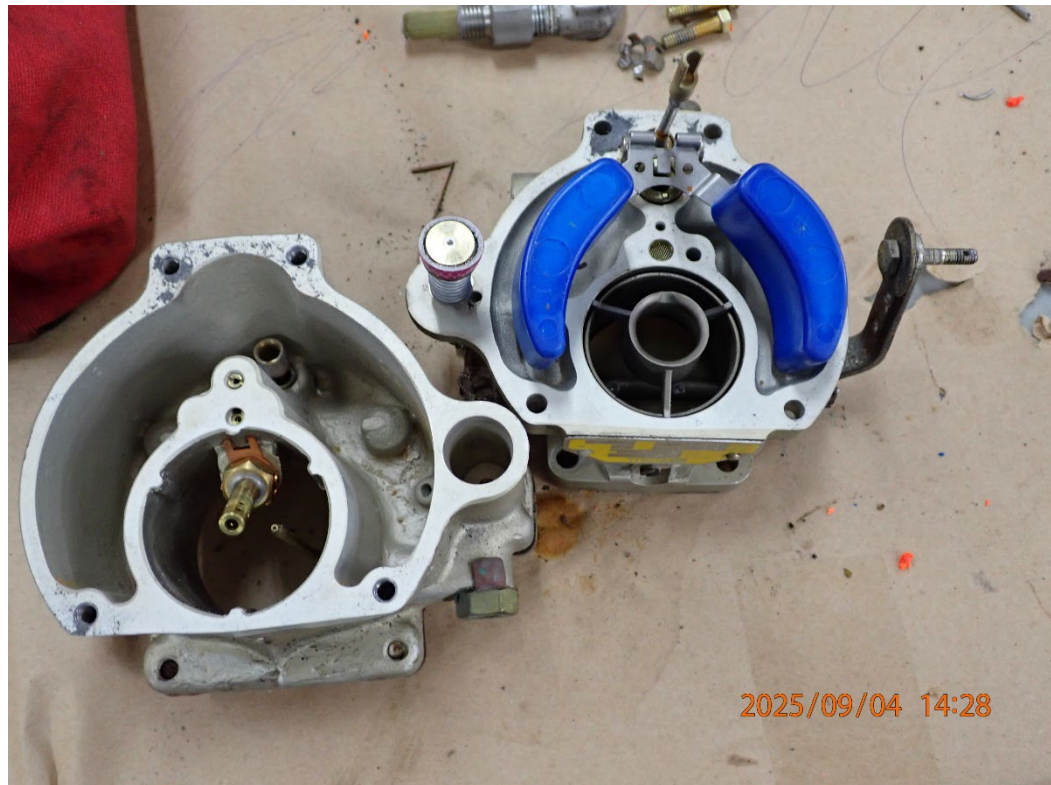
The carburetor remained attached to the engine. It was removed and partially disassembled. Water was found in the carburetor bowl, along with a small amount of fluid consistent with the color and smell of 100LL aviation fuel. A small amount of debris was observed on the inlet screen. The float was the newer style of closed cell material and floated when tested. The main carburetor jet was removed, and all ports were unobstructed.

**Photo 24: View of the partially disassembled carburetor.**

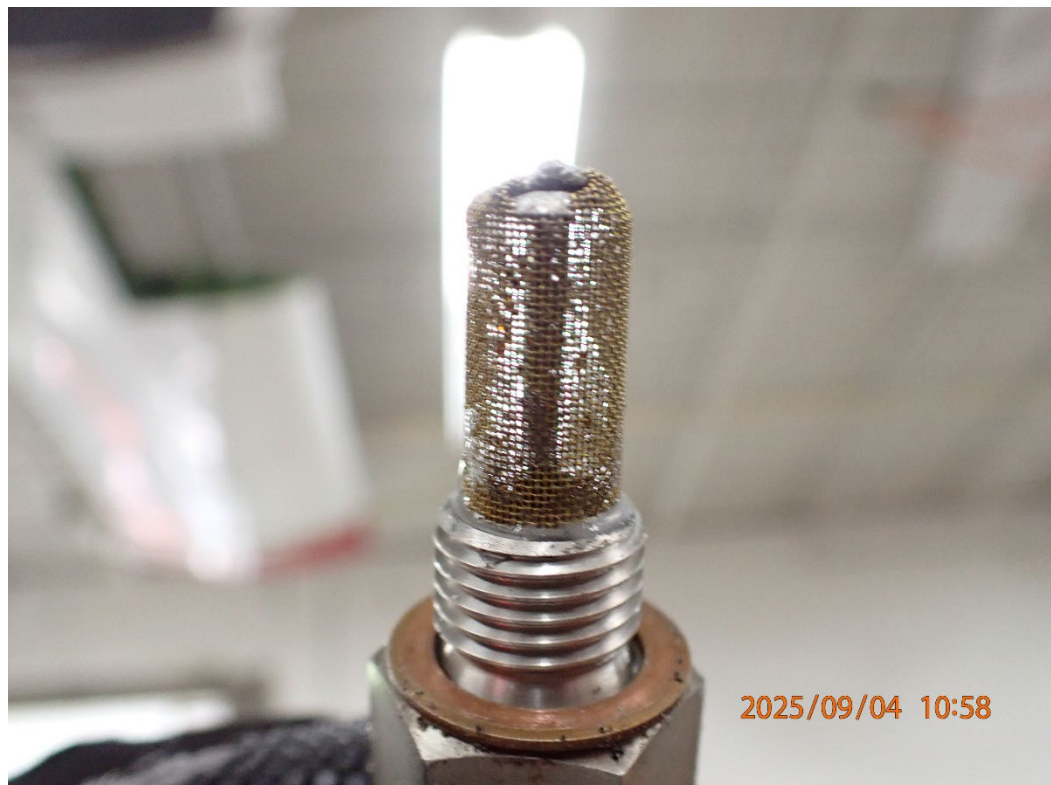
**Photo 25: View of the carburetor inlet screen.**
