# National Transportation Safety Board

ERA25LA324

## **WRECKAGE EXAMINATION**

Location: New Smyrna Beach, FL  
Date: August 29, 2025  
Time: 1027 EDT  
1427 UTC  
Airplane: Cessna 172H, N1607F

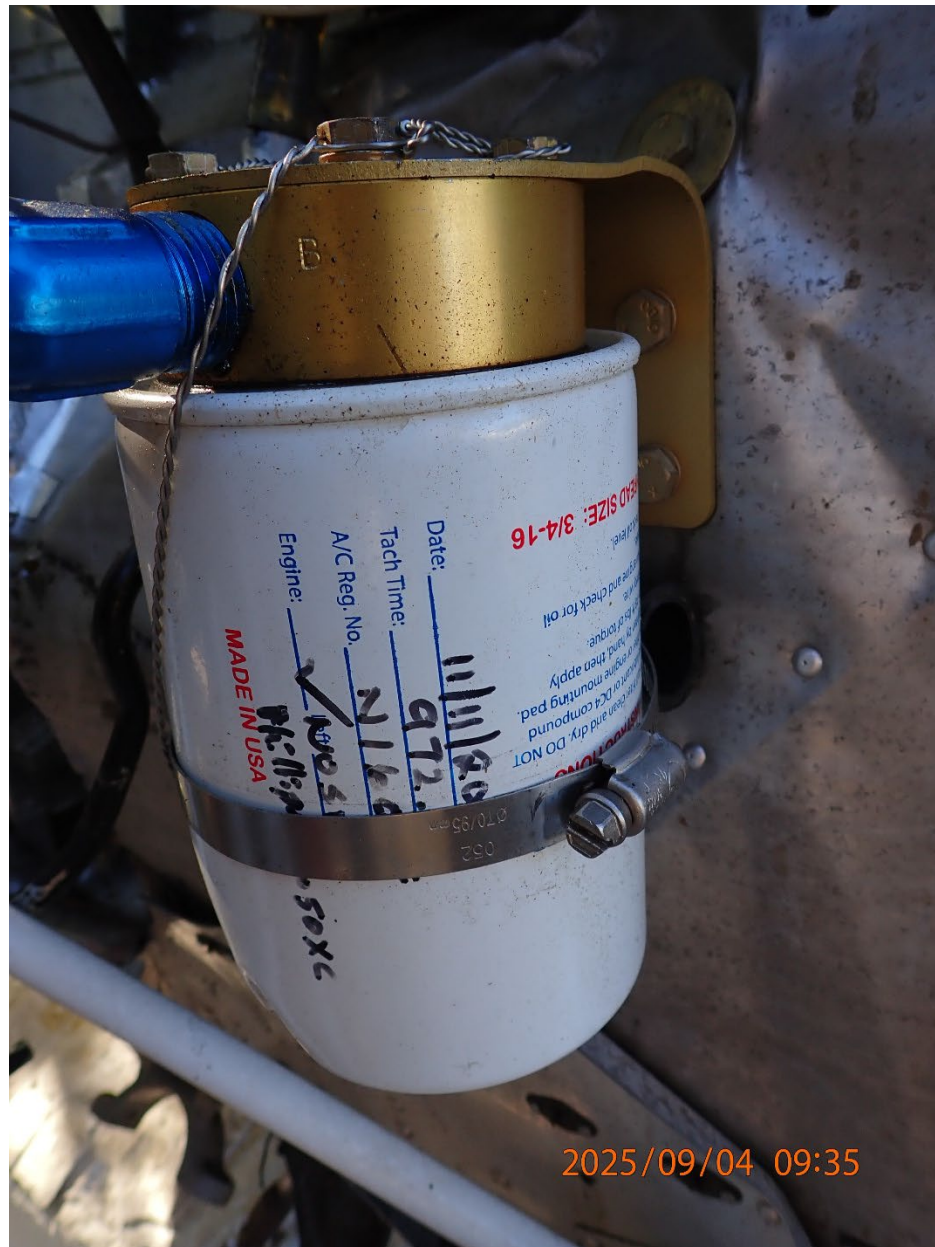
Photo 26: View of the oil filter attached to the oil filter adapter on the firewall.

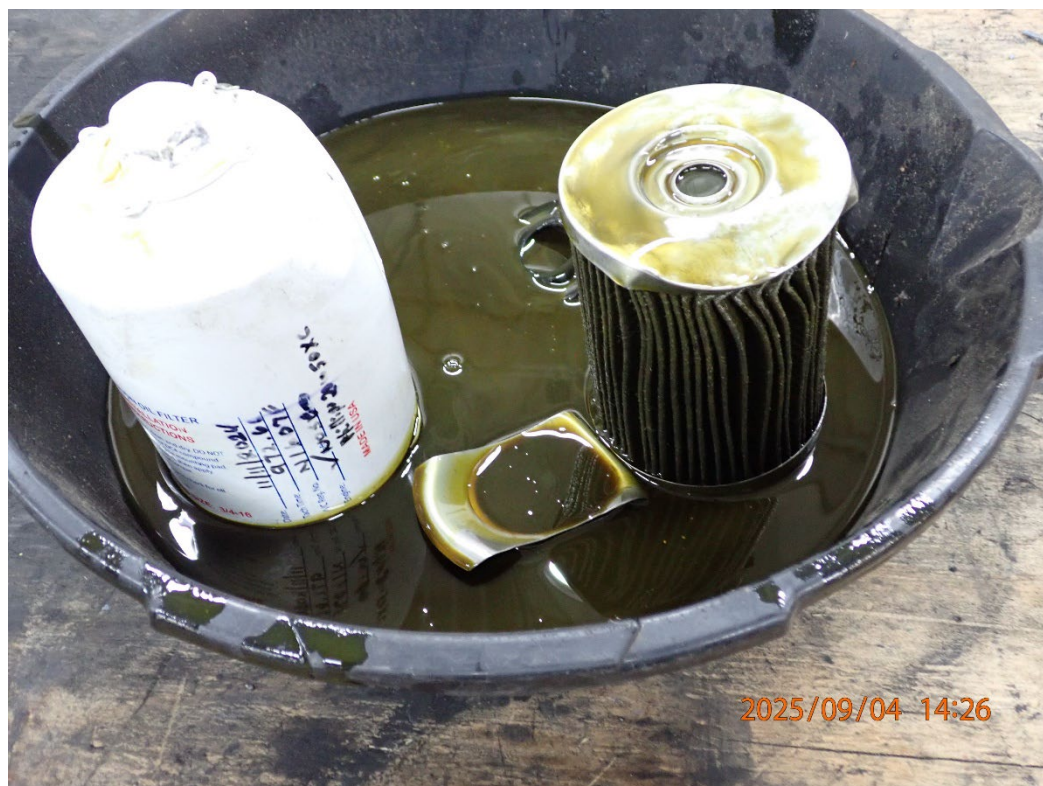
The oil filter remained attached to the oil filter adapter. It was removed, cut open, and the filter pleats were inspected. No debris was noted within the oil filter pleats.

**Photo 27: View of the cut open oil filter.**

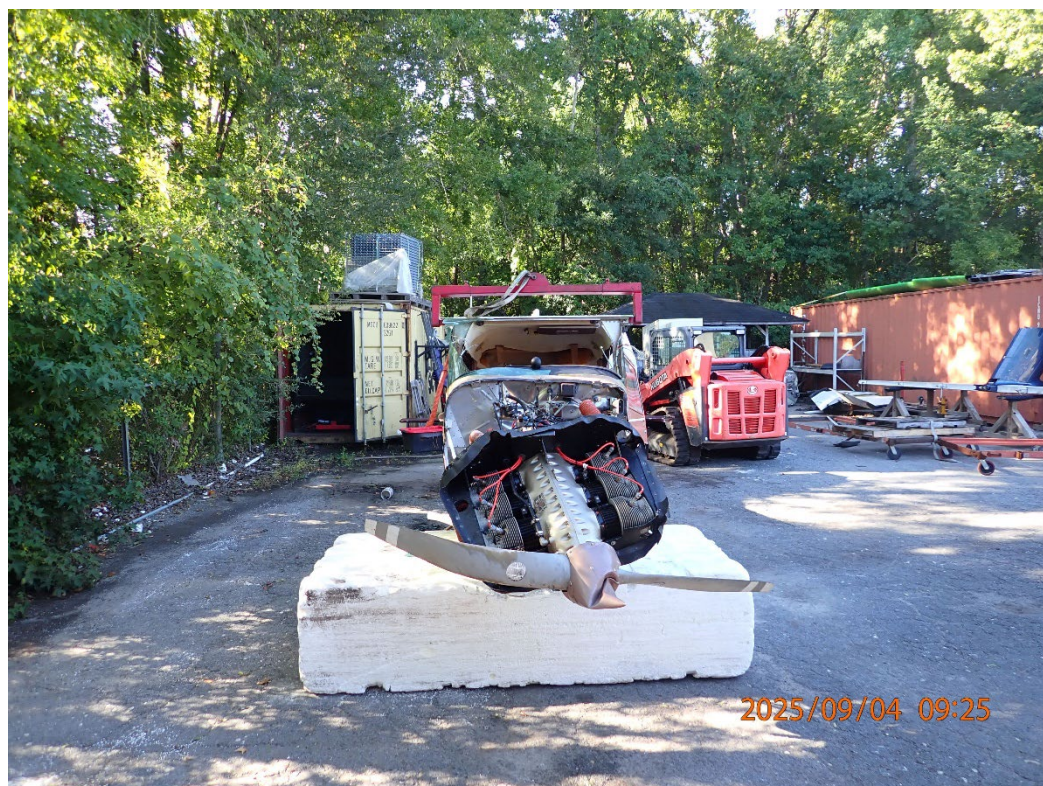
The propeller remained attached to the crankshaft flange. One propeller blade was undamaged, and the other was bent aft about 45° about midspan.

**Photo 28: Overview of the propeller.**

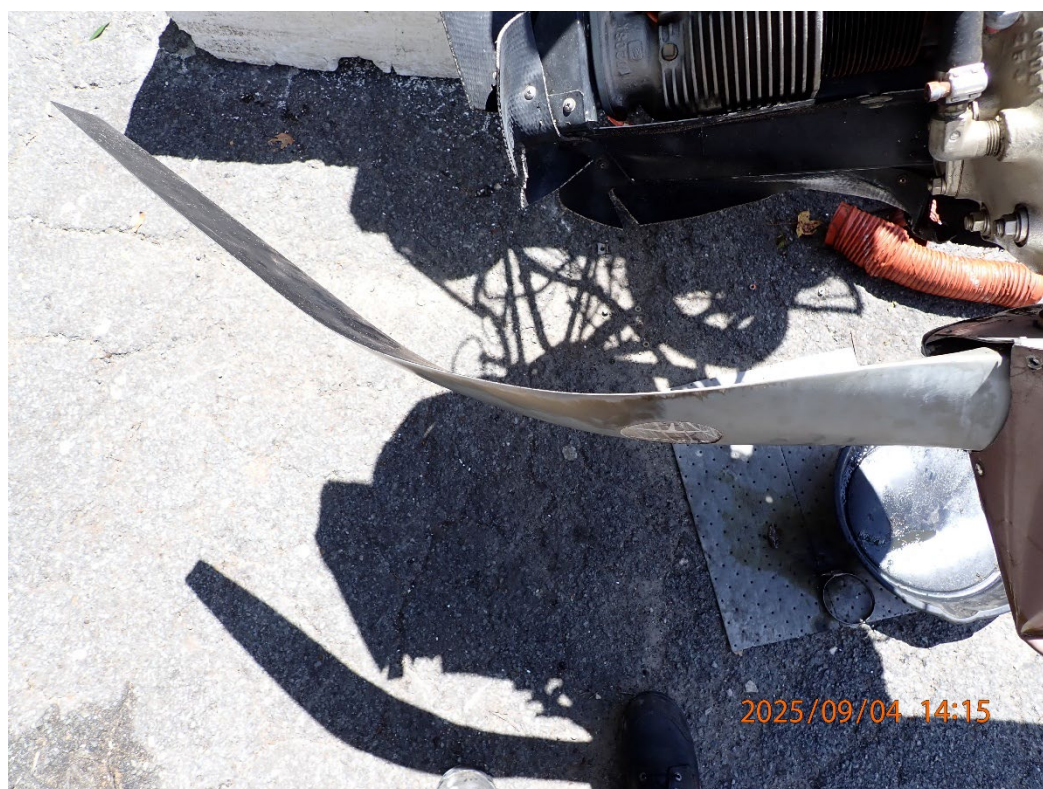
**Photo 29: View of the damaged propeller blade.**
