ERA25LA328

## INVESTIGATION PHOTOGRAPHS

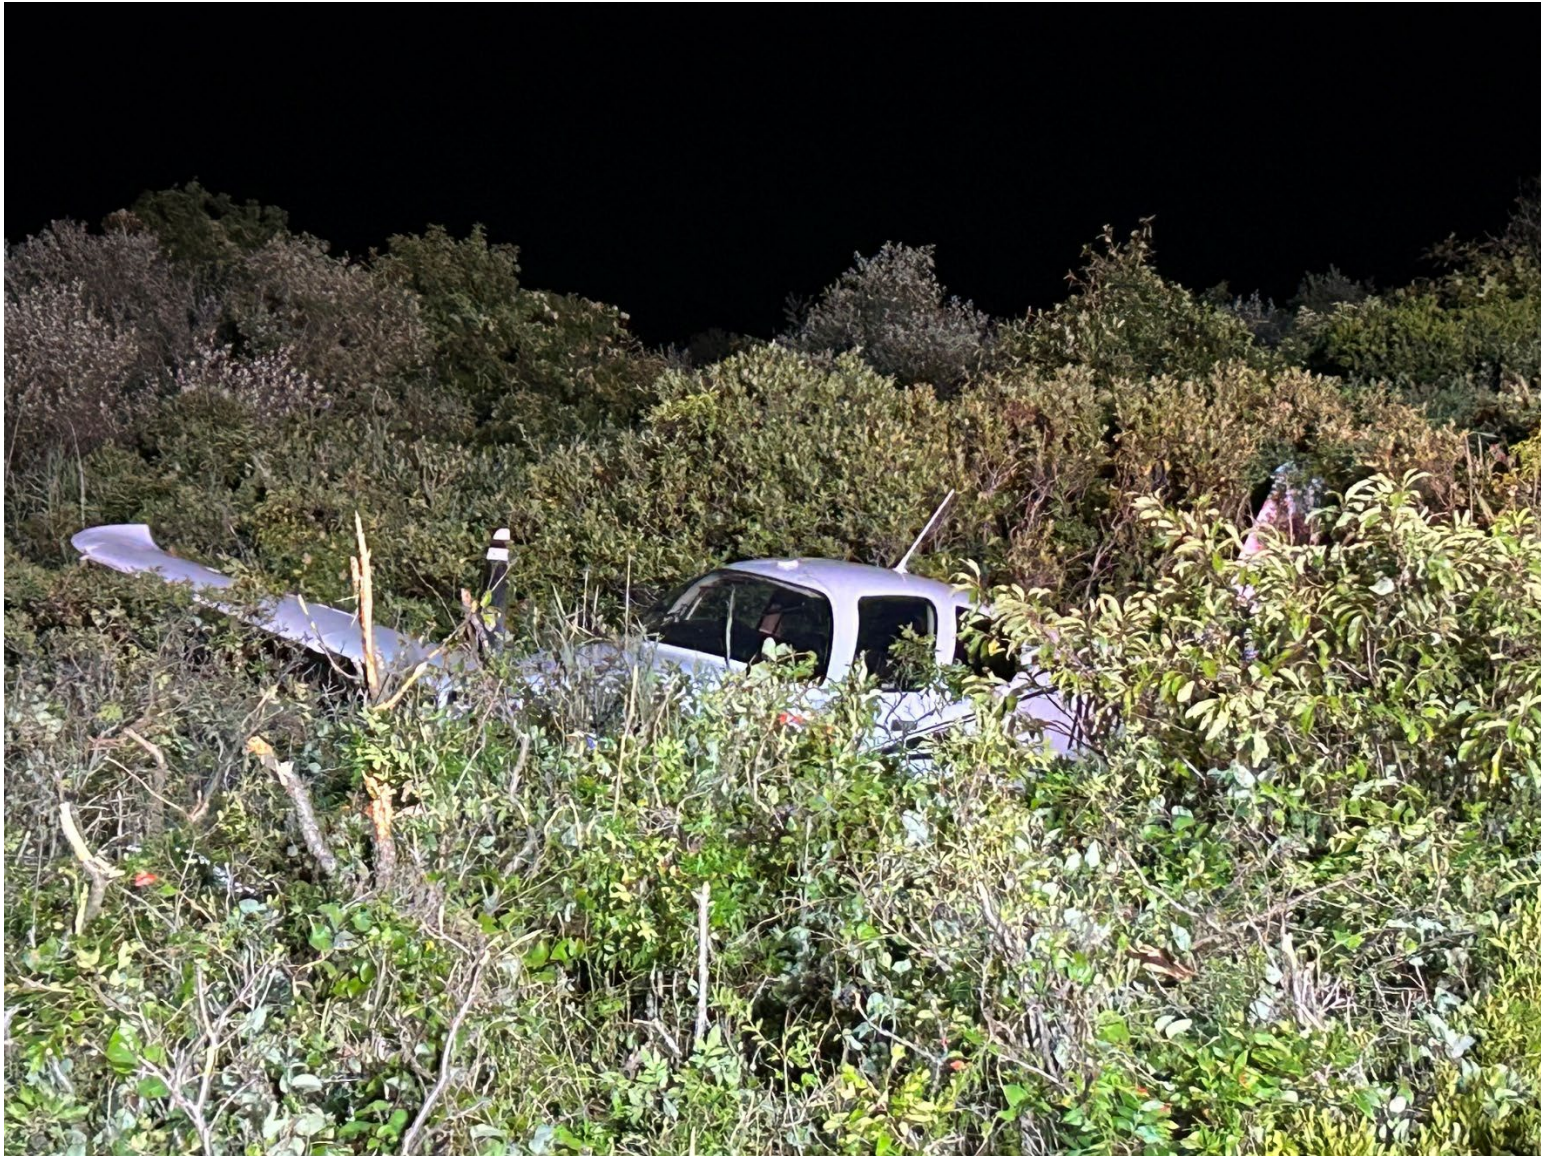
**Photograph 1 - Airplane On-Scene (Courtesy of FAA)**

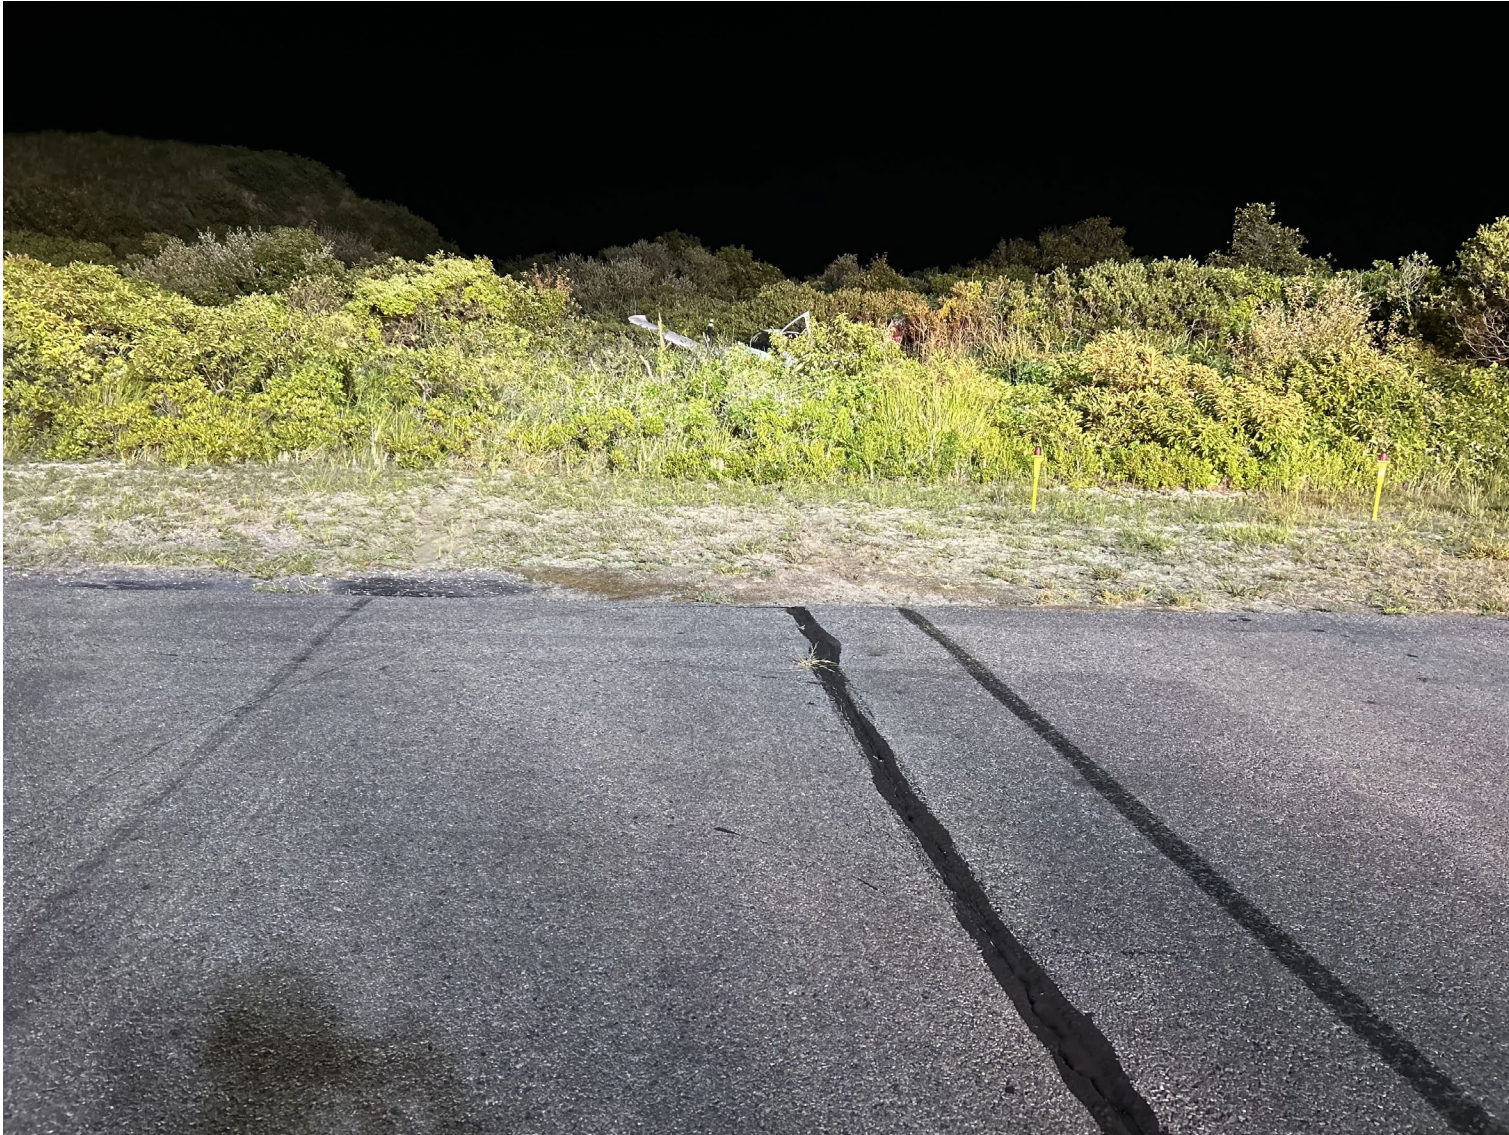
**Photograph 2 - Skid Marks from the Braking Application (Courtesy of FAA)**

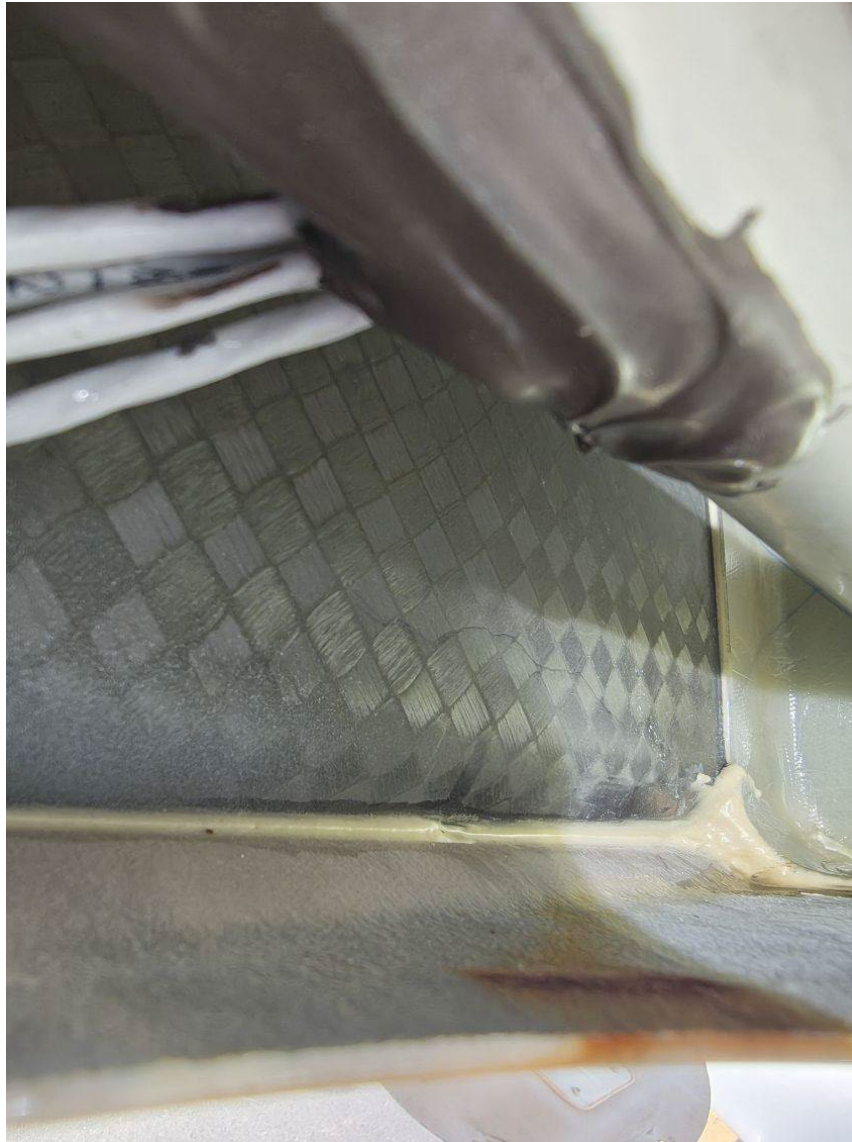
**Photograph 3 - Wing Spar Crack (Courtesy of FAA)**
