ERA25LA331

## INVESTIGATION PHOTOGRAPHS

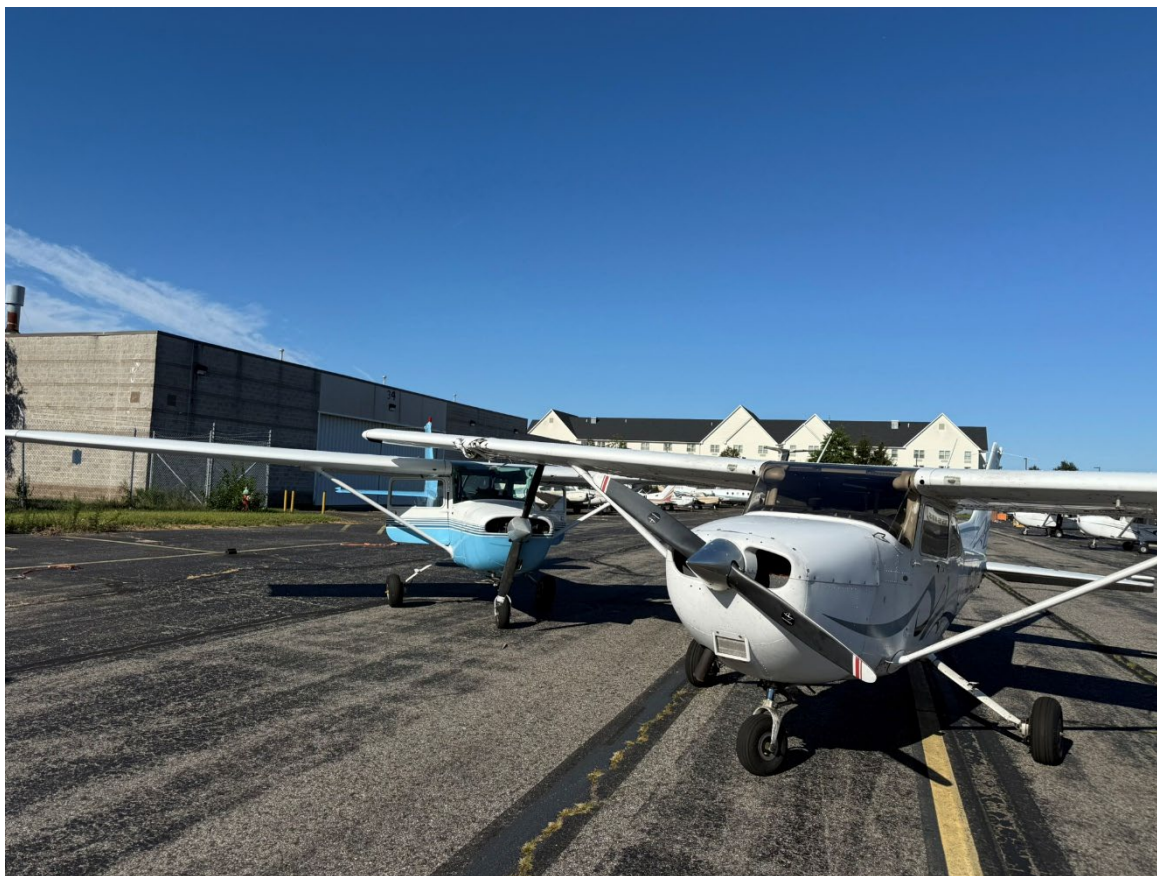
**Photograph 2 - View of Resting Position of Both Airplanes (Courtesy of FAA)**

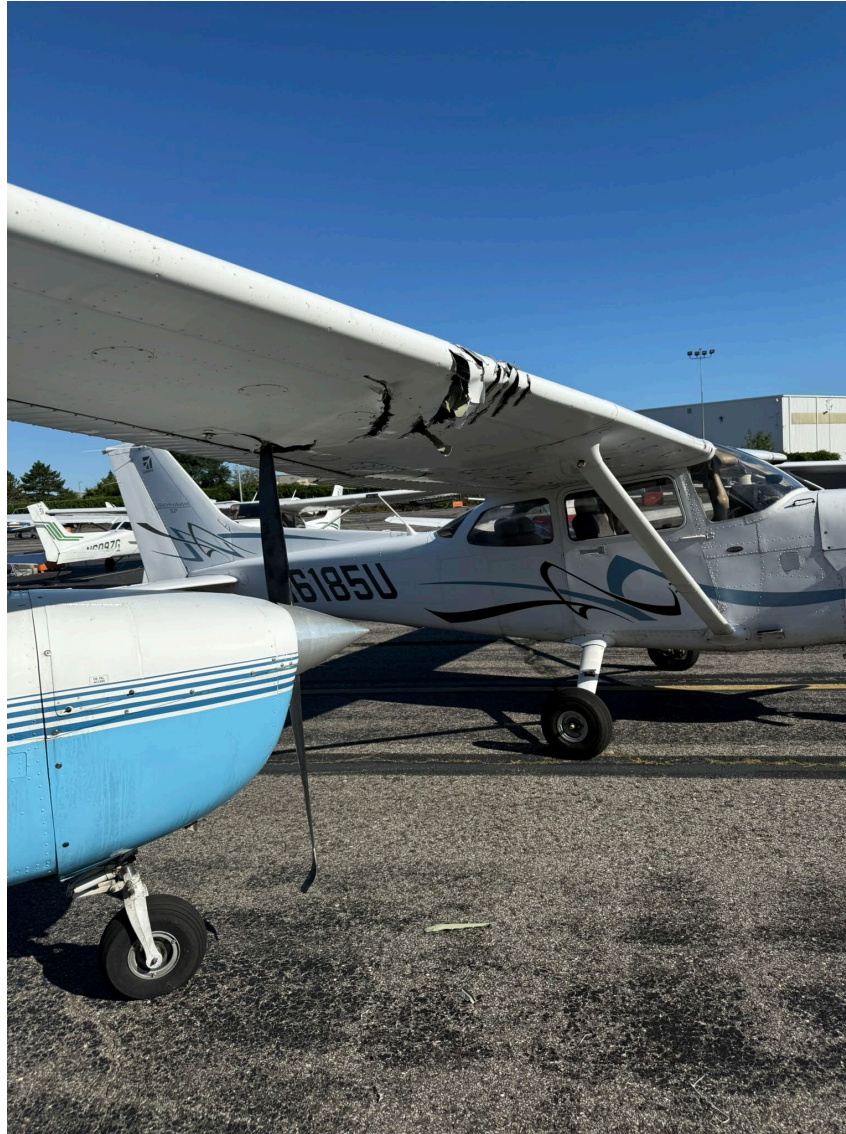
**Photograph 3 - View of Resting Position of Both Airplanes (Courtesy of FAA). Note the Damage to the Right Wing of N6185U**

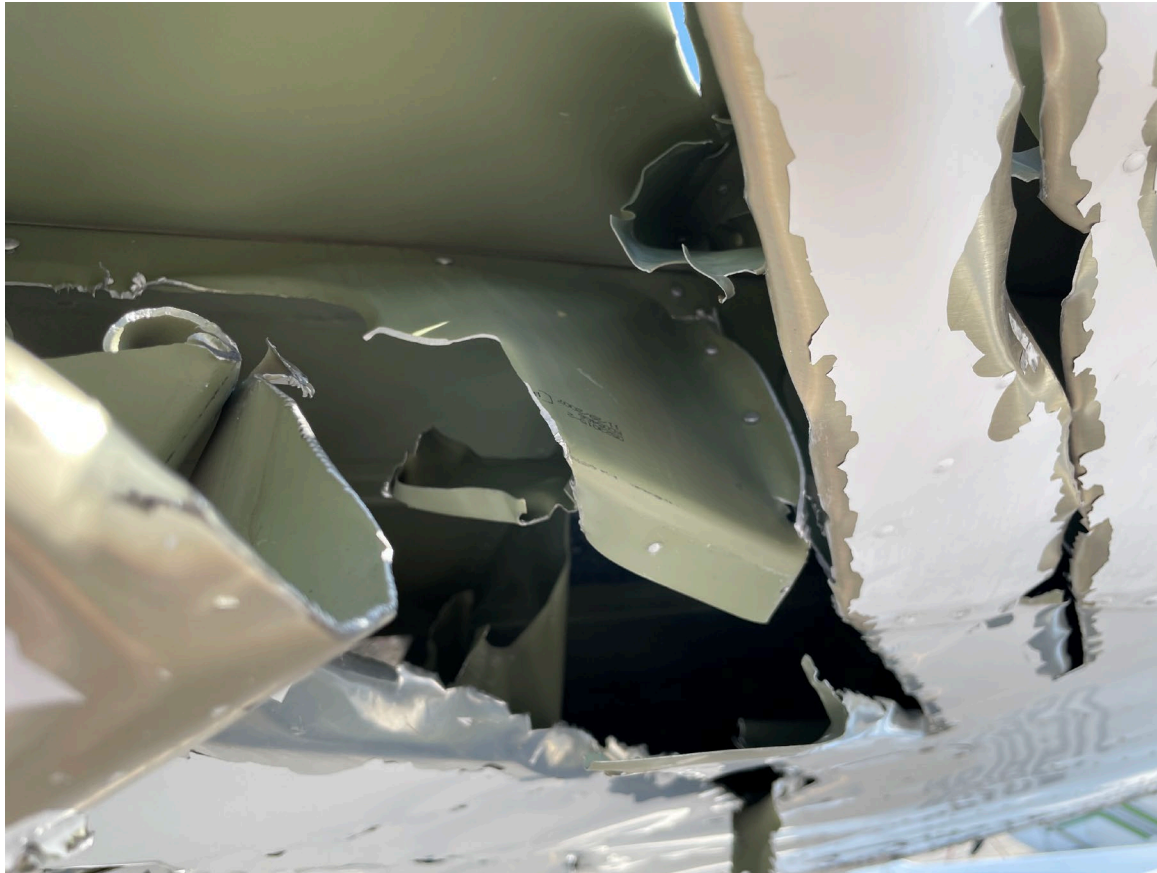
**Photograph 4 - Close up View Showing Right Wing Spar Damage to N6185U (Courtesy of FAA)**

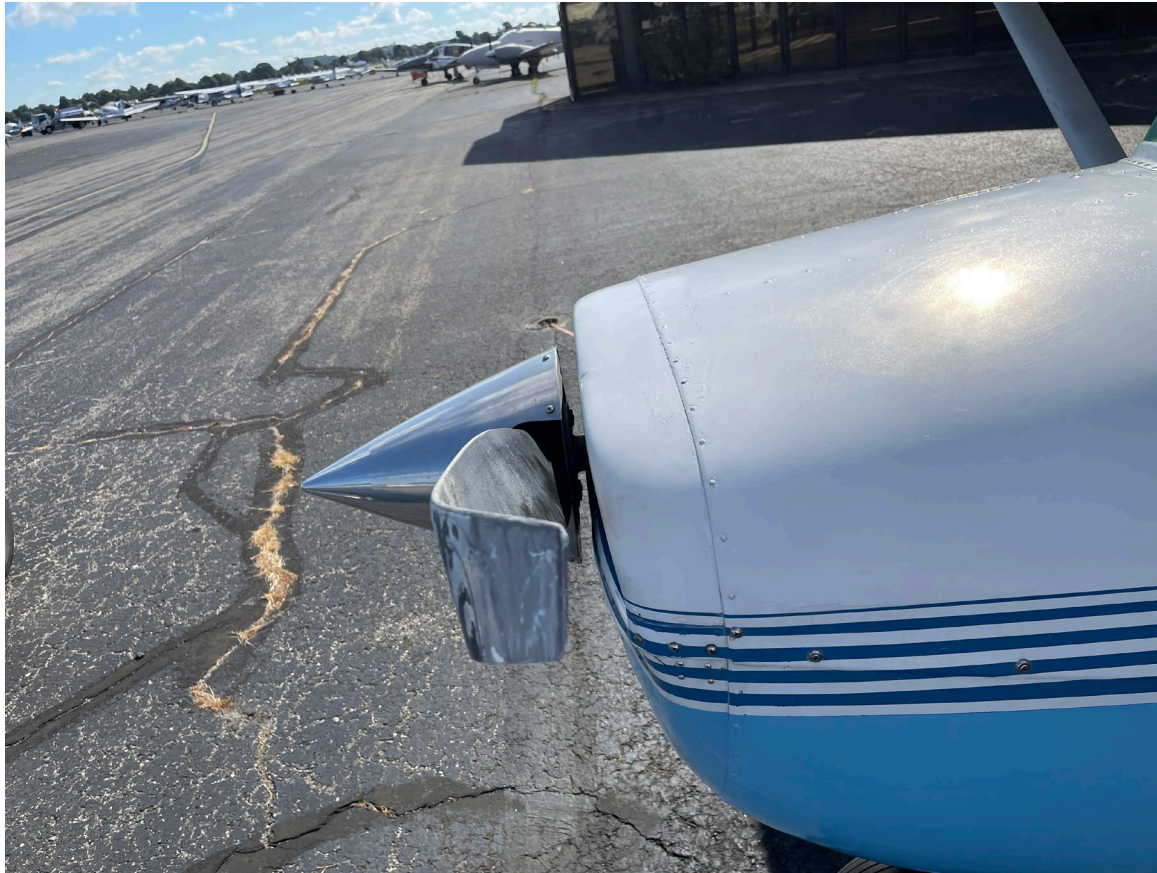
**Photograph 5 - View of Damage to One Propeller Blade of N22998 (Courtesy of FAA)**
