ERA25LA334

## INVESTIGATION PHOTOGRAPHS

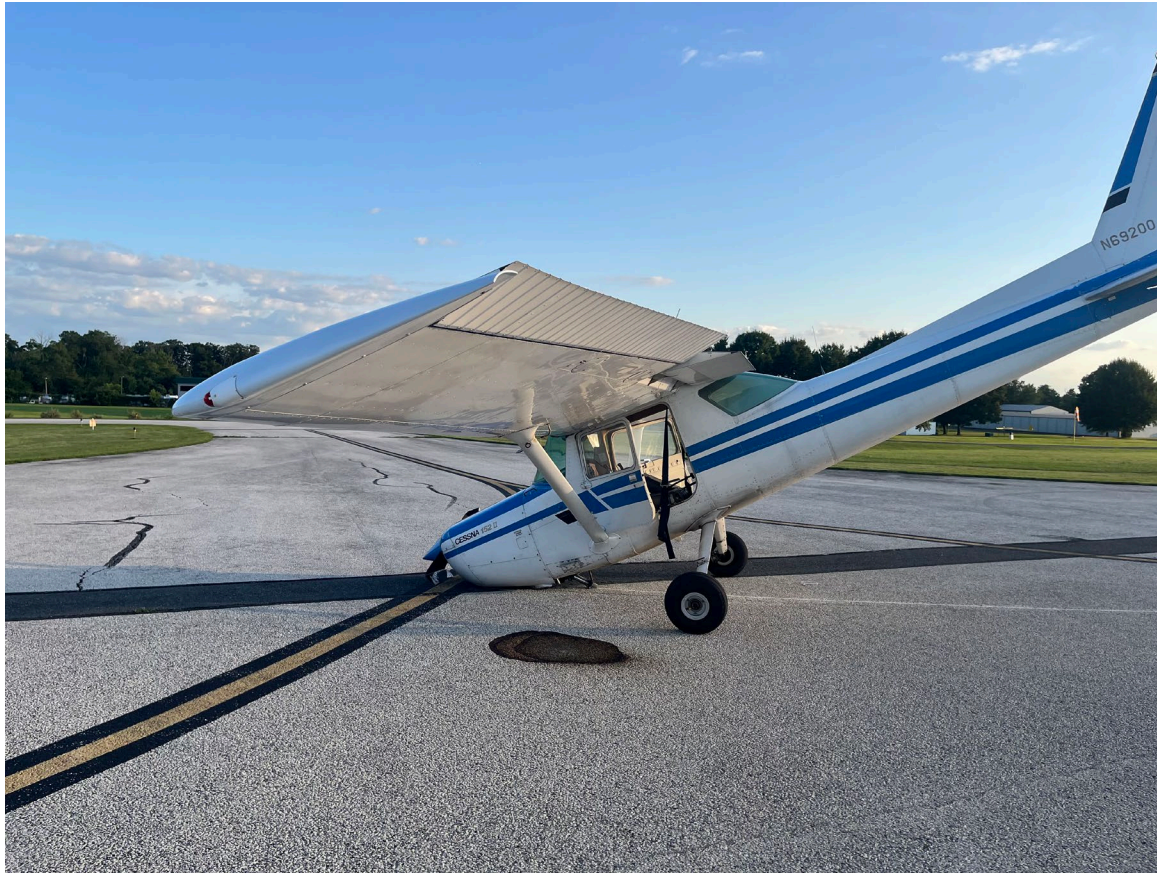
**Photograph 1 - Left side of airplane with nose wheel collapse at accident site (Courtesy of FAA)**

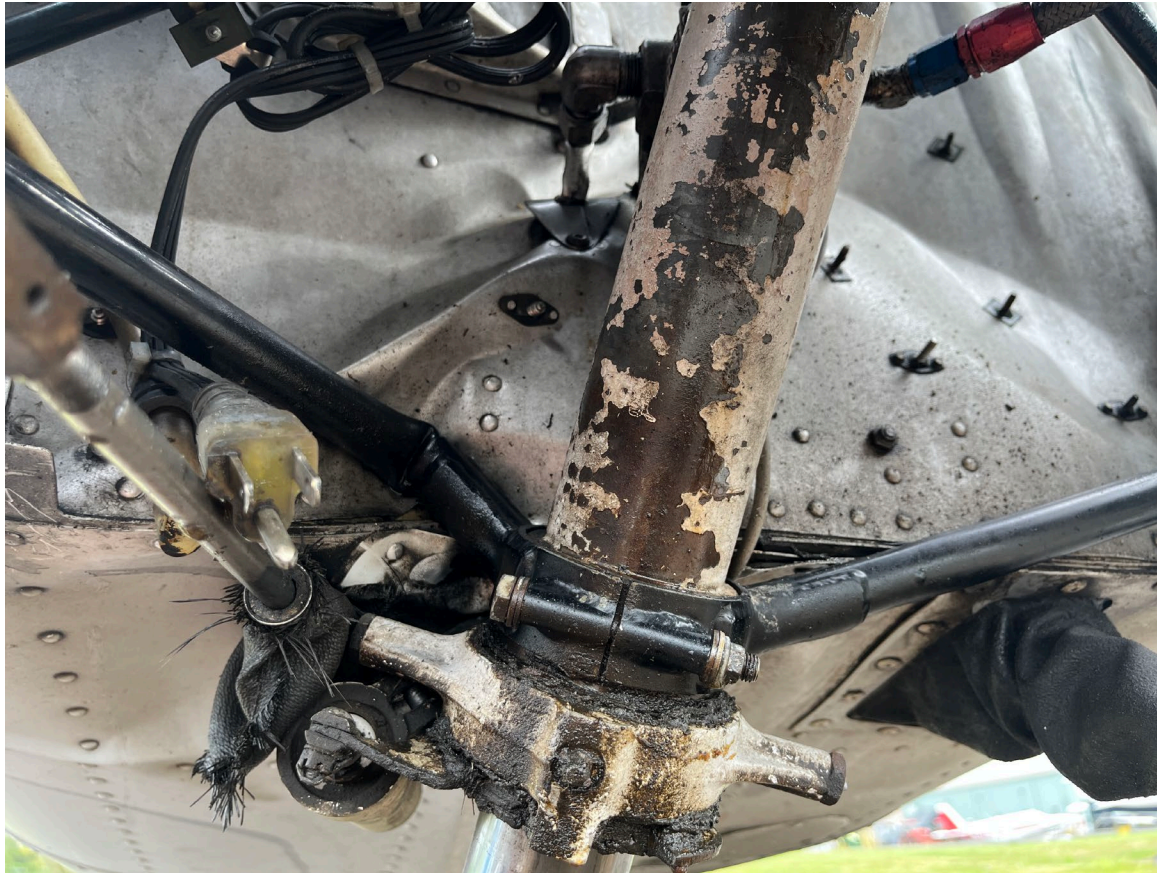
**Photograph 2 - Damaged engine mount and collapsed nose wheel strut (Courtesy of FAA)**
