ERA25LA337

## INVESTIGATION PHOTOGRAPHS

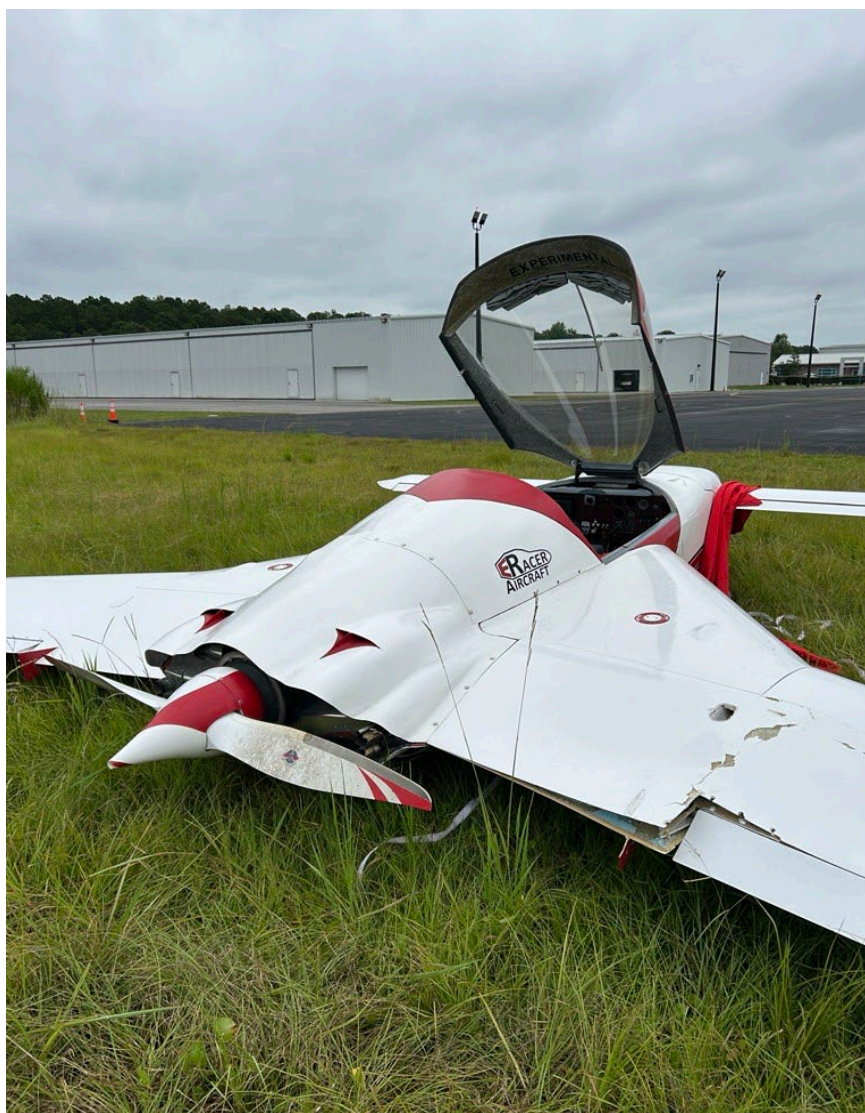
**Photograph 1 - View of damage right wing.  
(Courtesy of FAA)**

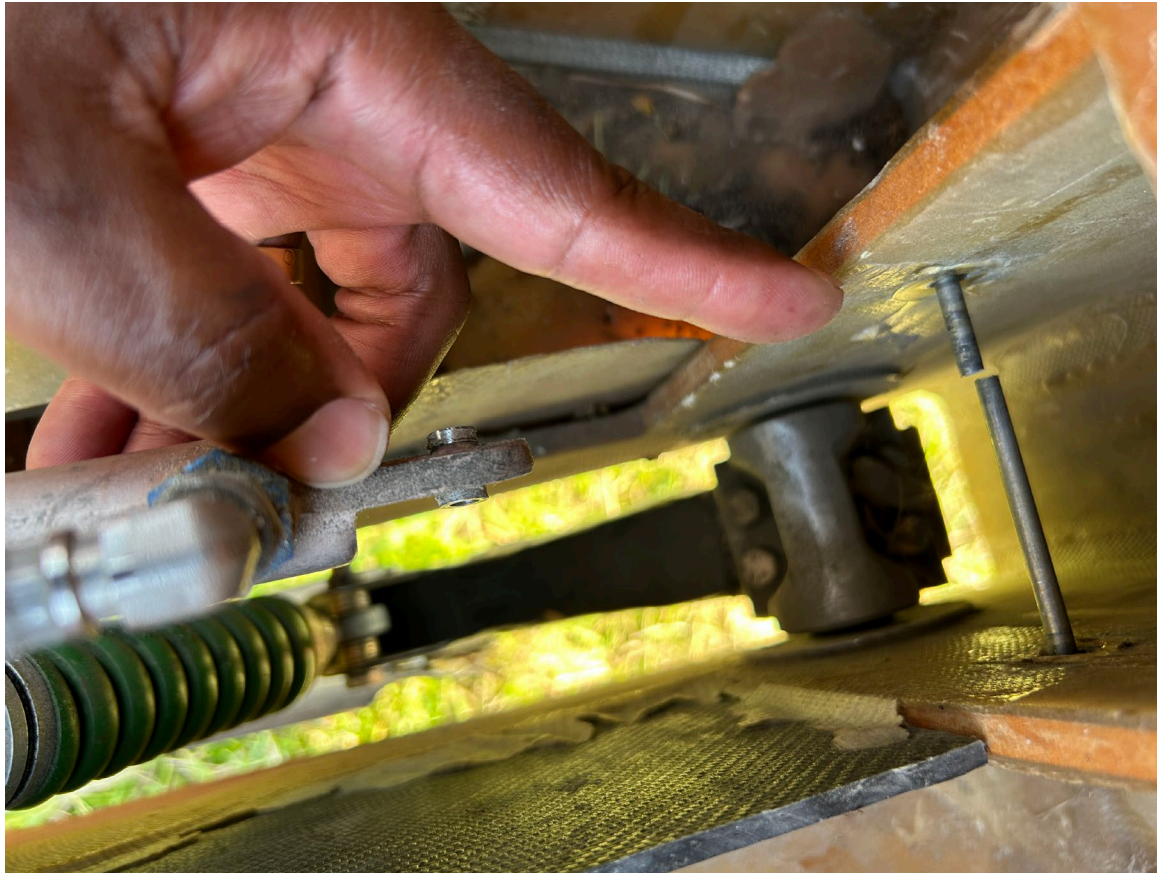
**Photograph 2 - View of broken actuator bolt.  
(Courtesy of FAA)**
