ERA25LA355

## INVESTIGATION PHOTOGRAPHS

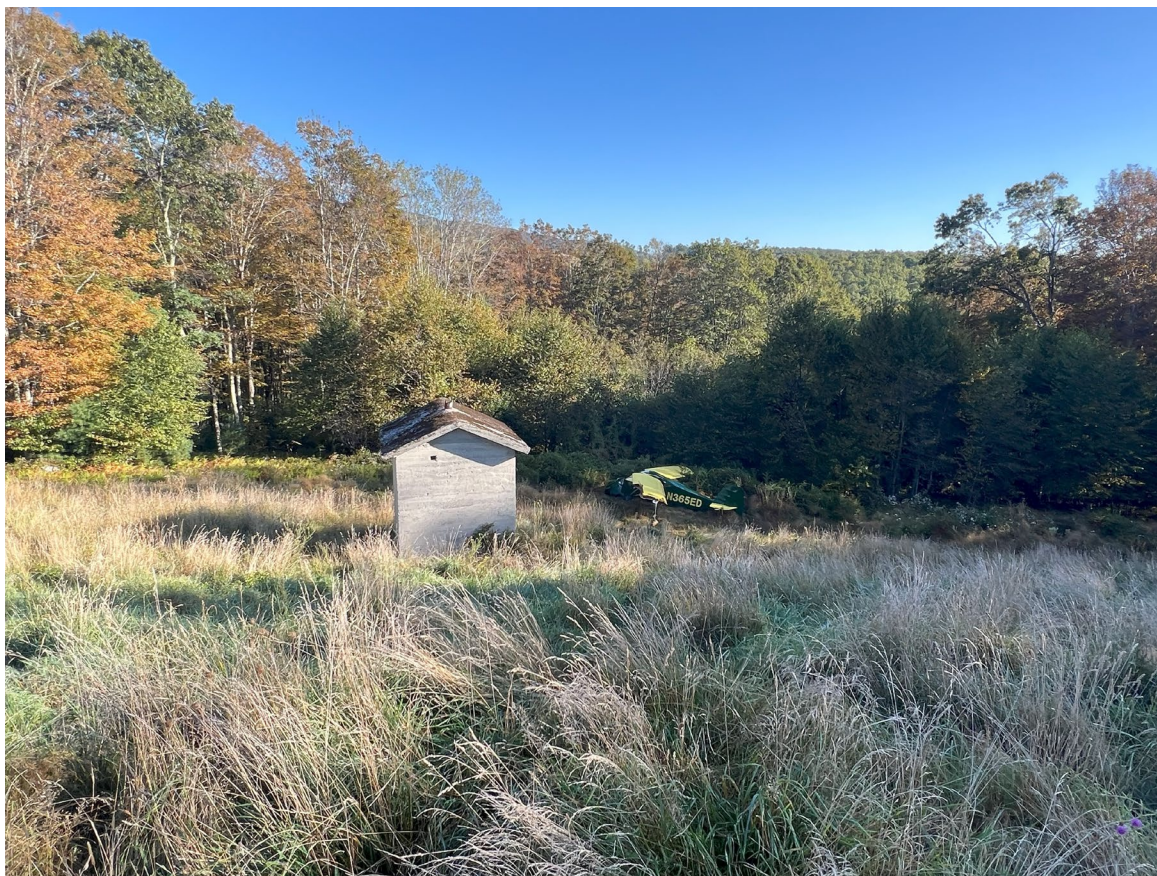
**Photograph 1 - Ground structure impacted by airplane (Courtesy of FAA)**

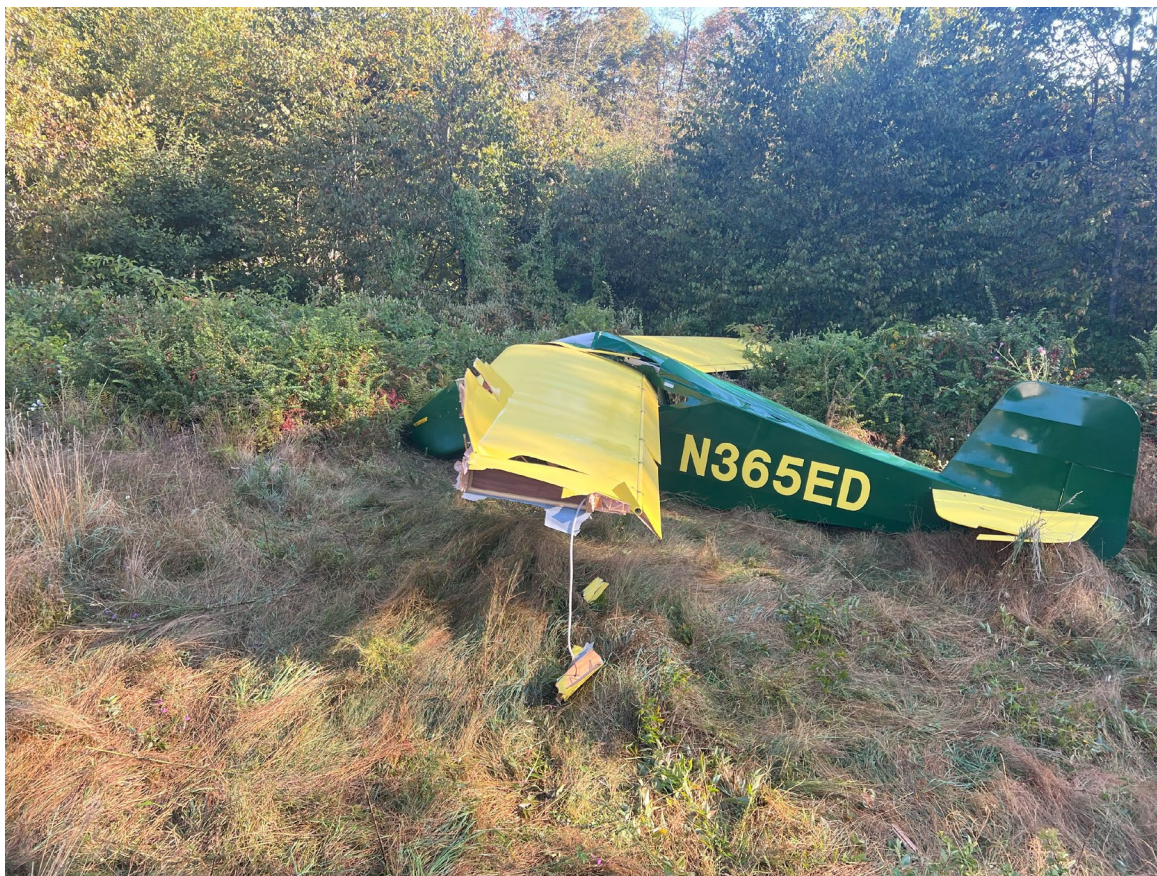
**Photograph 2 - Skin separations and spar fractures noted to left wing (Courtesy of FAA)**
