ERA25LA358

## INVESTIGATION PHOTOGRAPHS

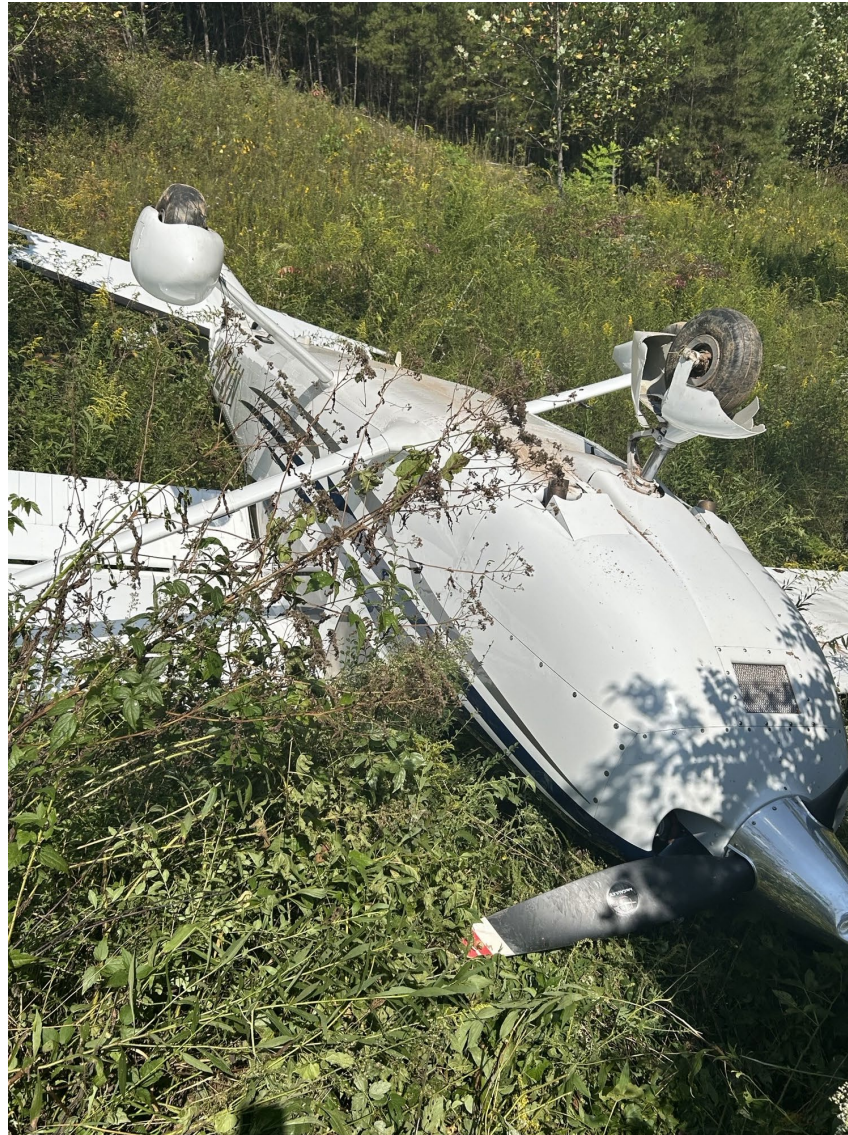
**Photograph 1 - Main wreckage, inverted (Courtesy of fire department)**

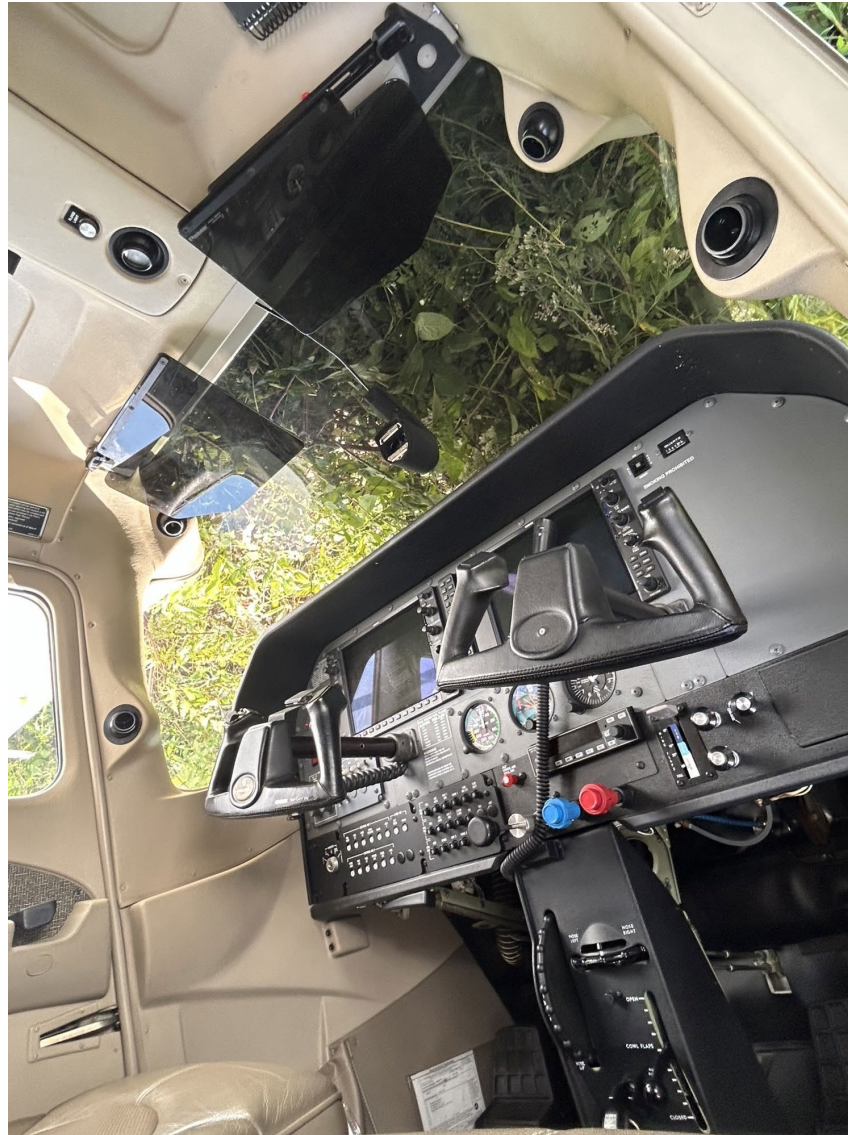
**Photograph 2 - View of cockpit (Courtesy of Fire department)**

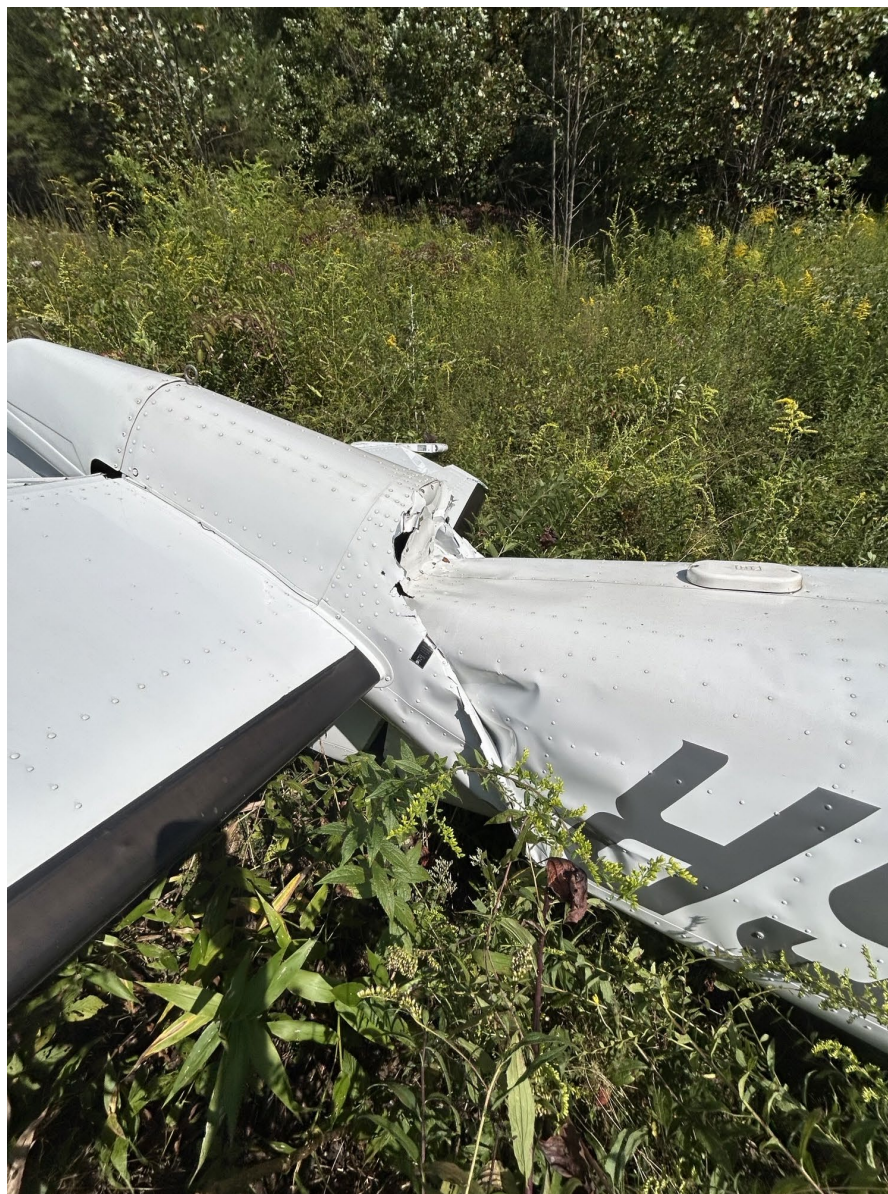
**Photograph 3 - damaged tail section (Courtesy of Fire Department)**
