ERA25LA376

## INVESTIGATION PHOTOGRAPHS

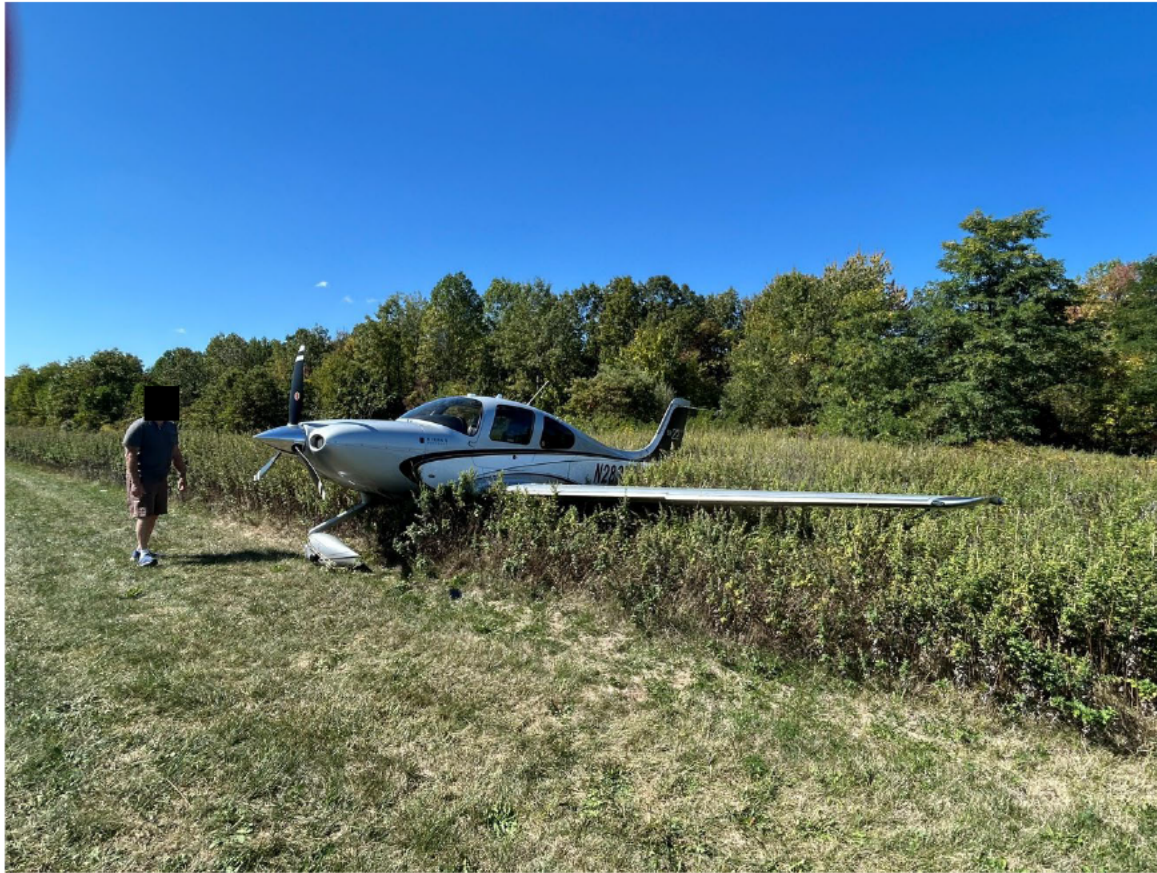
**Photograph 1 - Accident Site (Courtesy of FAA)**

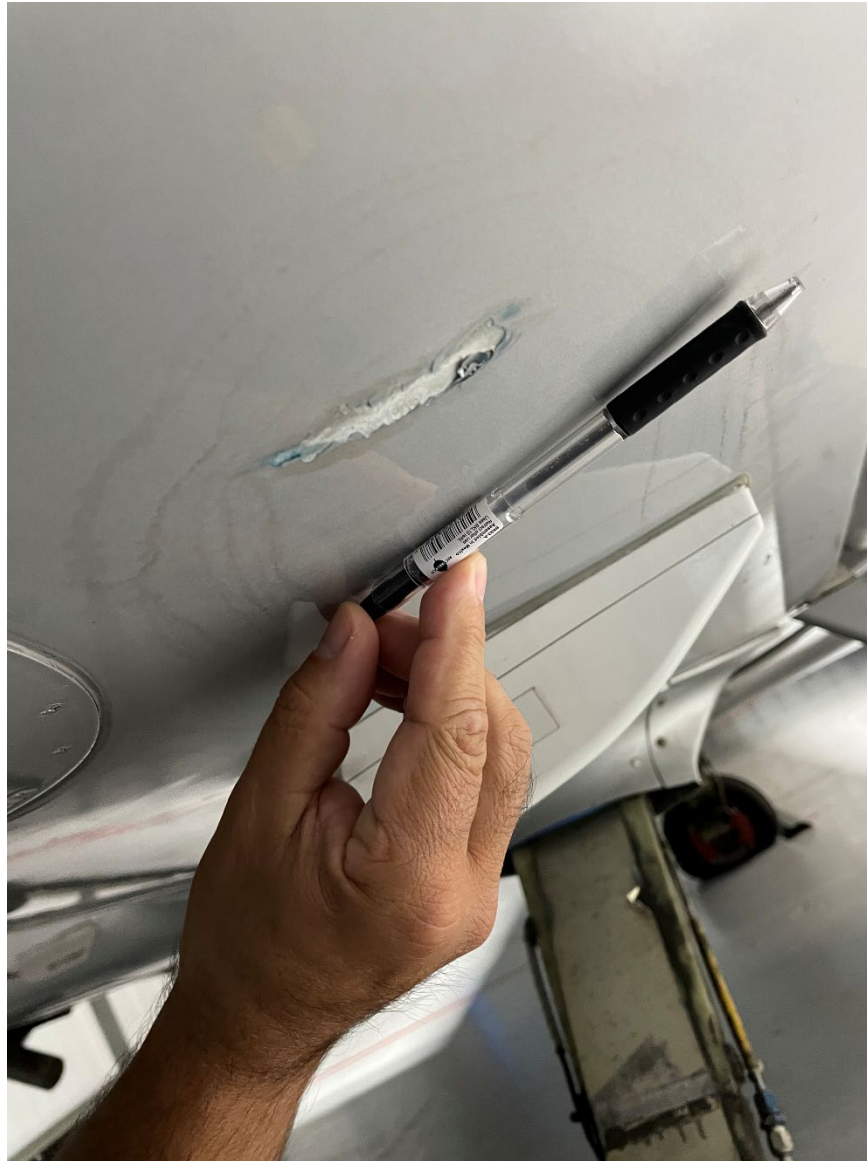
**Photograph 2 - Left Fuel Cell Breach (Courtesy of FAA)**

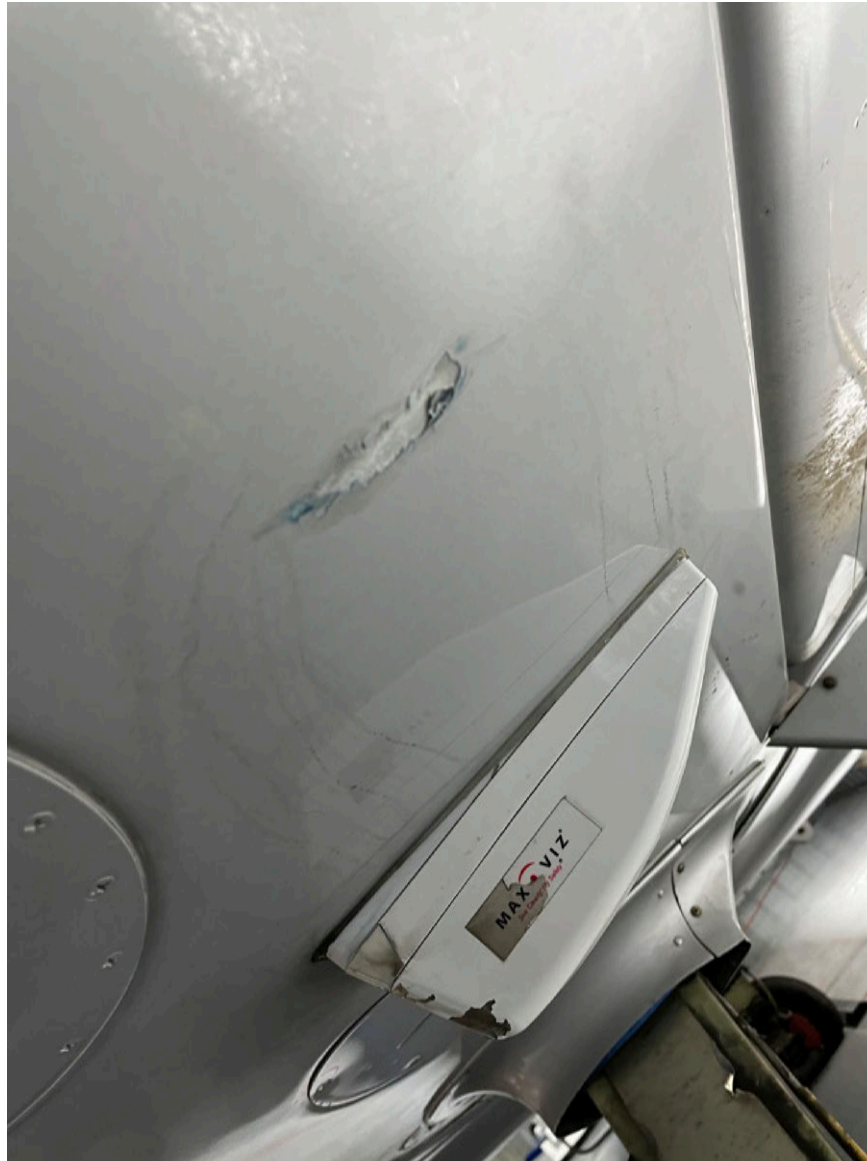
**Photograph 3 - Left Fuel Cell Breach (Courtesy of FAA)**
