ERA25LA379

## INVESTIGATION PHOTOGRAPHS

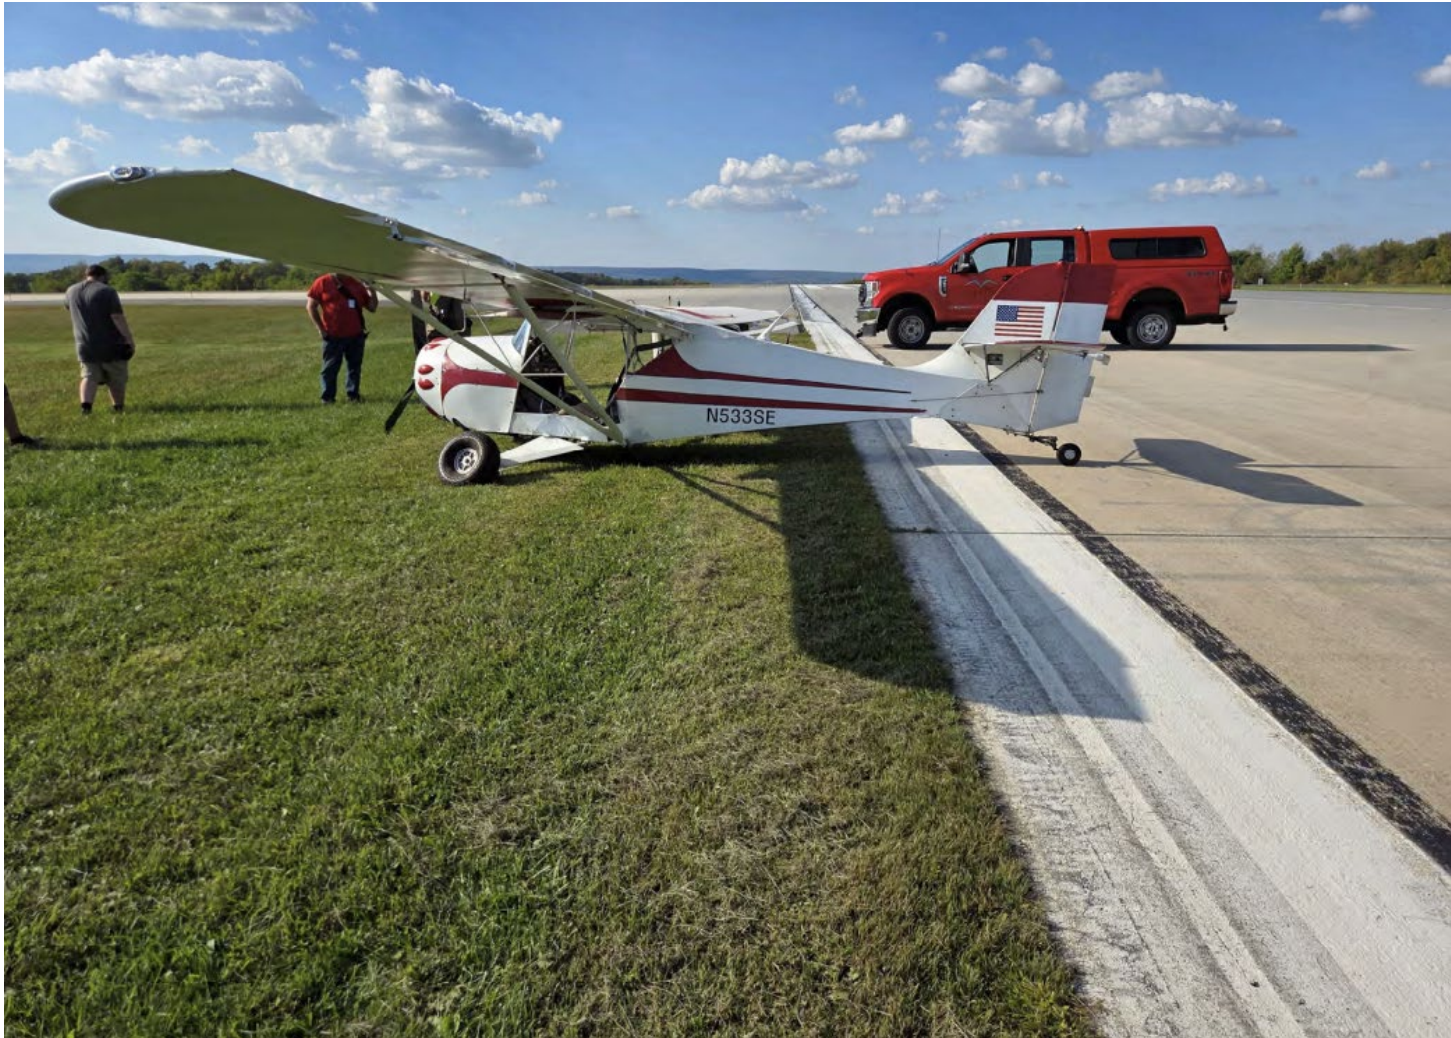
**Photograph 1 - N533SE Accident Prior to Recovery (Courtesy of Johnstown Airport)**

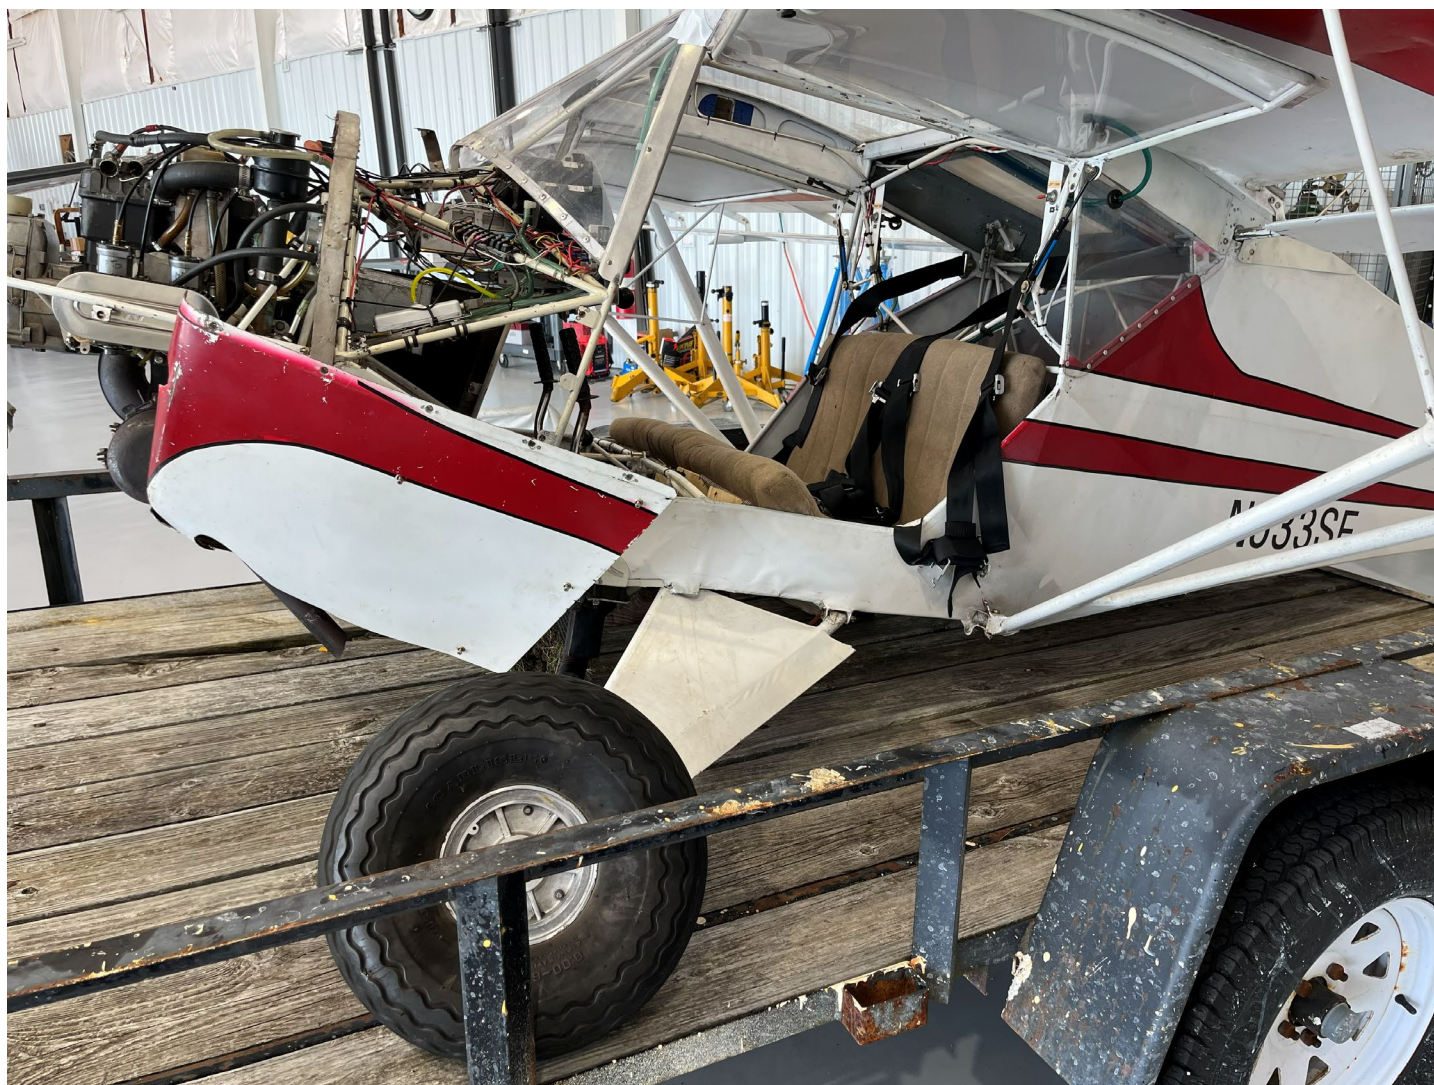
**Photograph 2 - Left Forward Landing Gear Bracket Torn from Frame (Courtesy of FAA)**

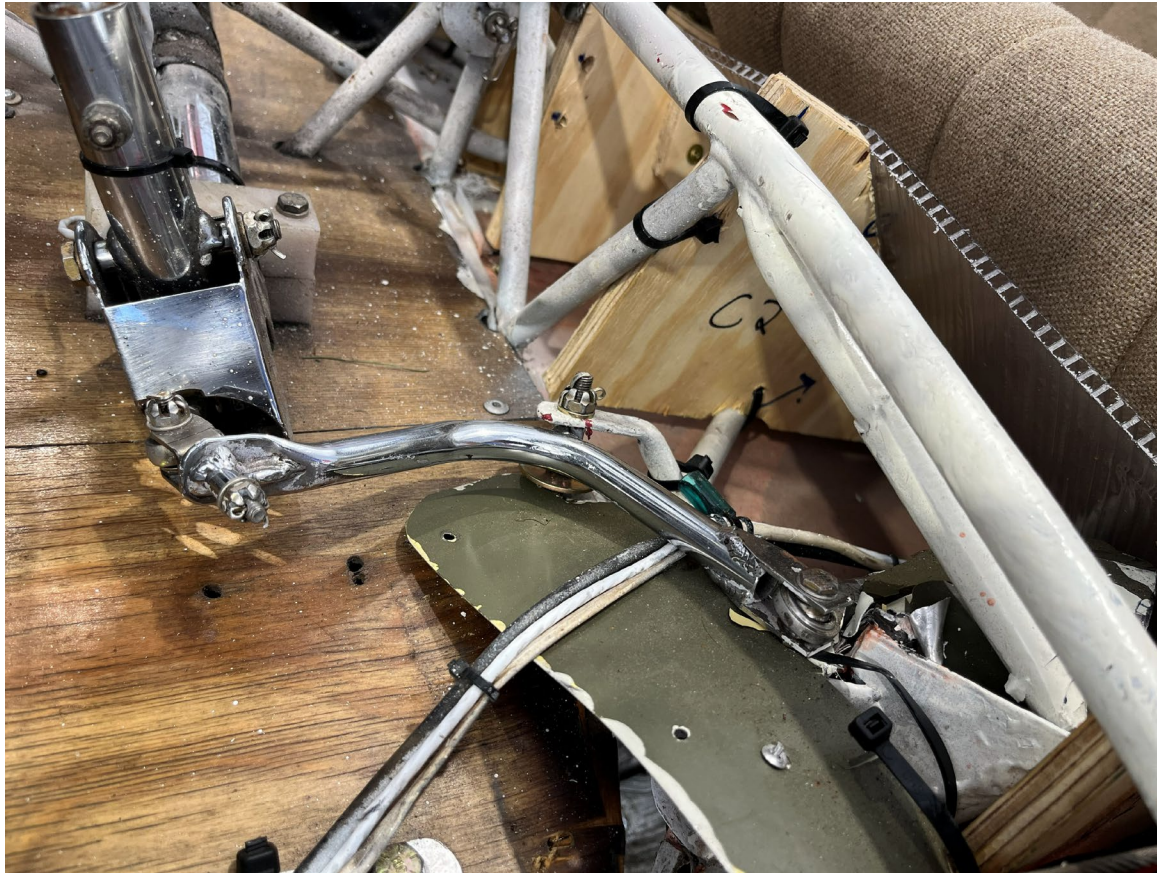
**Photograph 3 - Left Forward Landing Gear Strut Punched Through Cockpit Floor (Courtesy of FAA)**

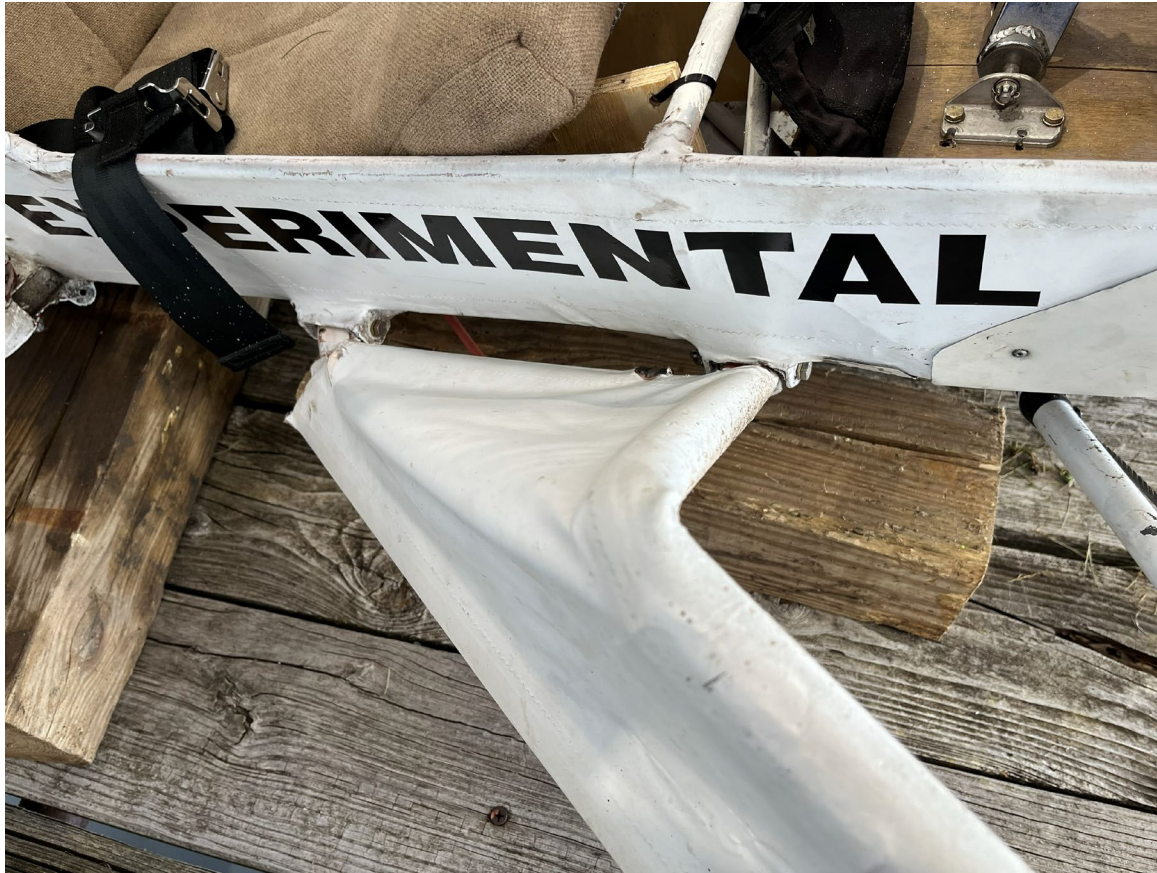
**Photograph 4 - Right Landing Gear Collapse, Brackets Still Attached (Courtesy of FAA)**

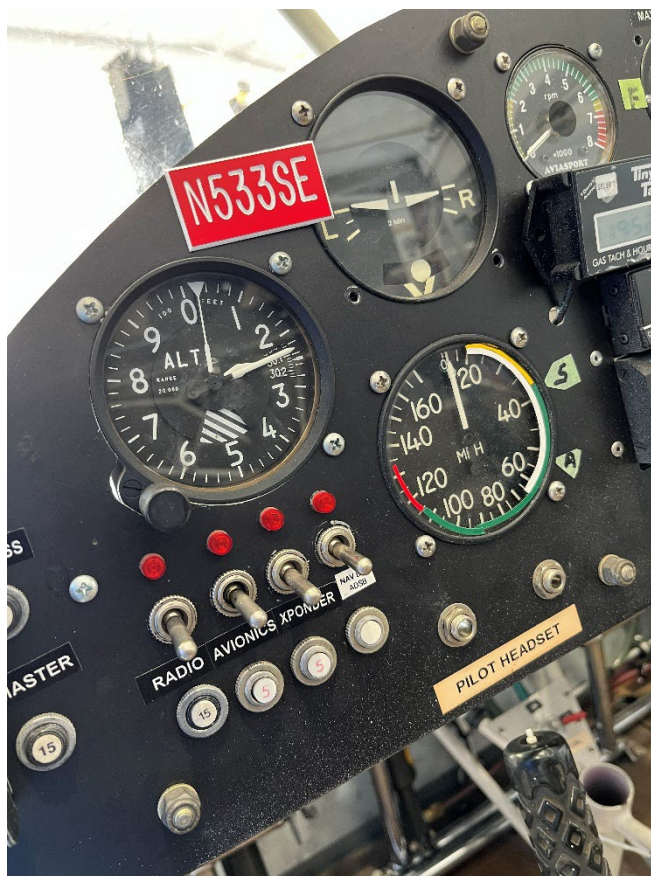
**Photograph 5 - N533SE Interior Showing ADS-B and Airspeed Markings (Courtesy of FAA)**
