ERA25LA380

## INVESTIGATION PHOTOGRAPHS

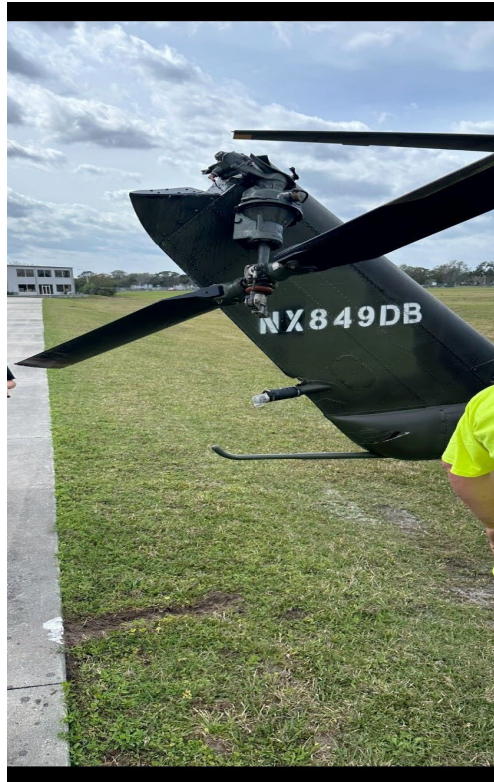
**Photograph 1 - View of damaged tail rotor.  
(Courtesy of FAA)**
