# National Transportation Safety Board

ERA25MA106

## **ENHANCED GROUND PROXIMITY WARNING DEVICE**

Specialist's Factual Report

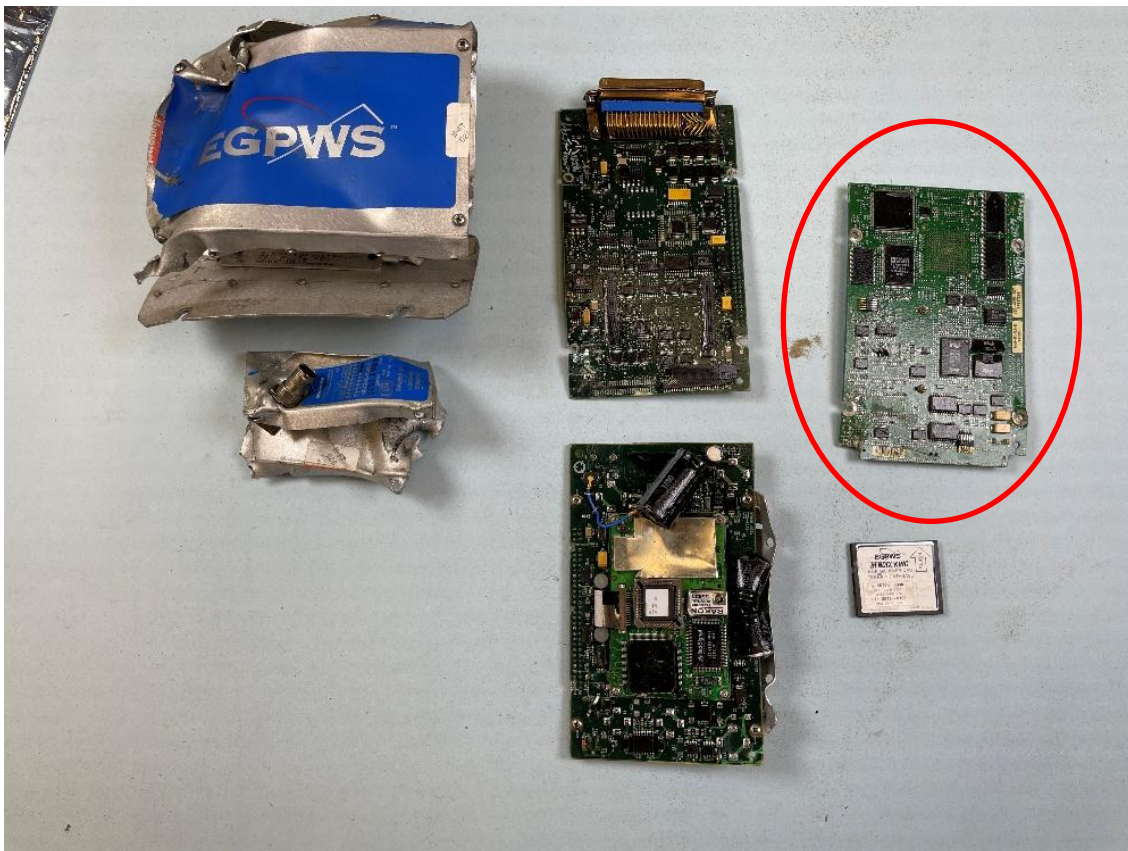
Upon arrival at the Vehicle Recorder Laboratory, an exterior examination revealed the unit had sustained heavy impact damage. The unit was disassembled. The relevant circuit card containing the NVM chips that would have recorded data is annotated with a red circle (Figure 1).

**Figure 1.** Photo of Honeywell EGPWS after being disassembled. The circuit card containing the NVM chips that would hold data has been circled in red.

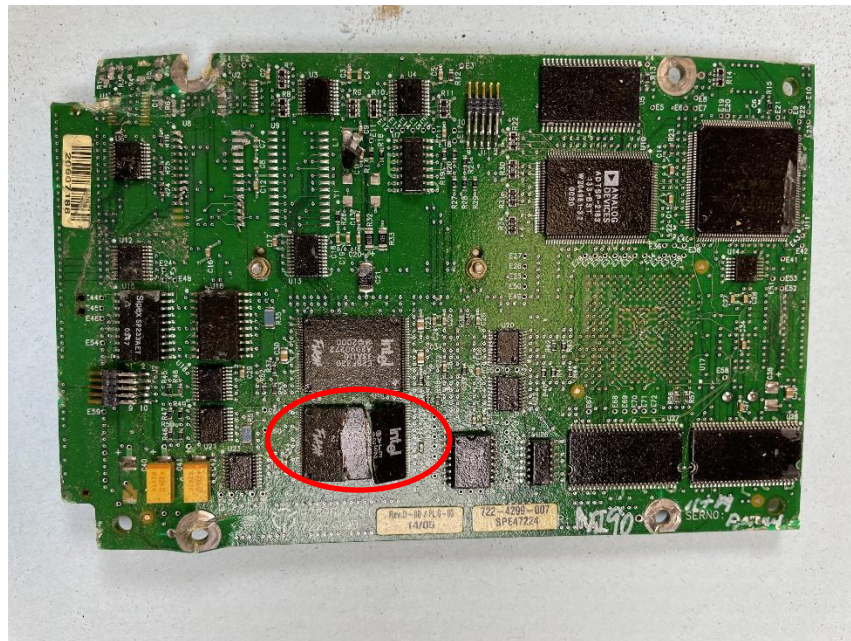
**Figure 2.** Photo of the circuit card containing data. Chip U24 is circled in red. This chip contains the device's recording logs.

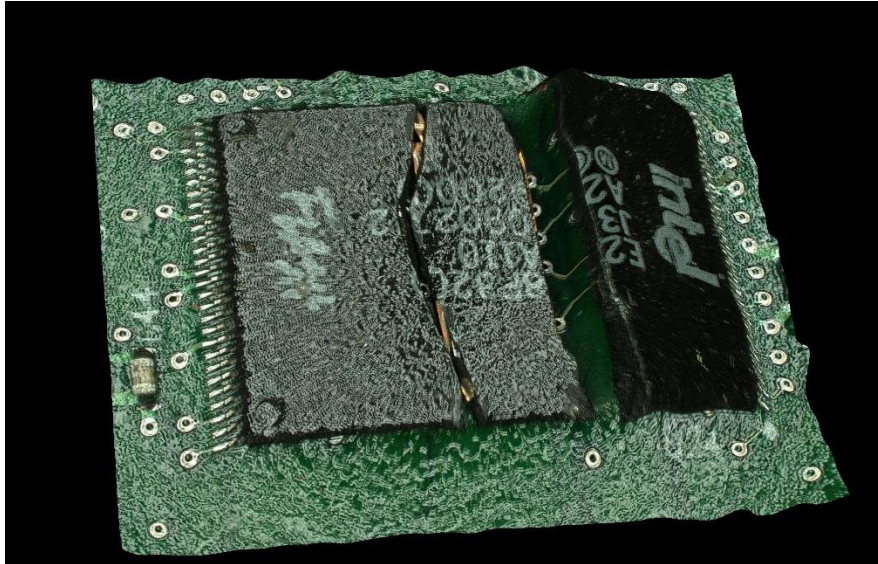
The U24 chip was cracked in two locations, and the three parts of the cracked chip were disjointed. Figure 3 is a virtual reconstruction of the chip's topography using a stacked microscopy imaging to illustrate the chip's disjointed condition. Figure 4 is a top-down image taken at 10X magnification of chip U24. A location circled in yellow is illustrated in imagery in Figure 5. A location circled in blue is illustrated in imagery in Figure 6. The descriptions for figures 5 and 6 are given below.

**Figure 3.** A virtual reconstruction of the chip U24's topography using stacked microscopy imaging.

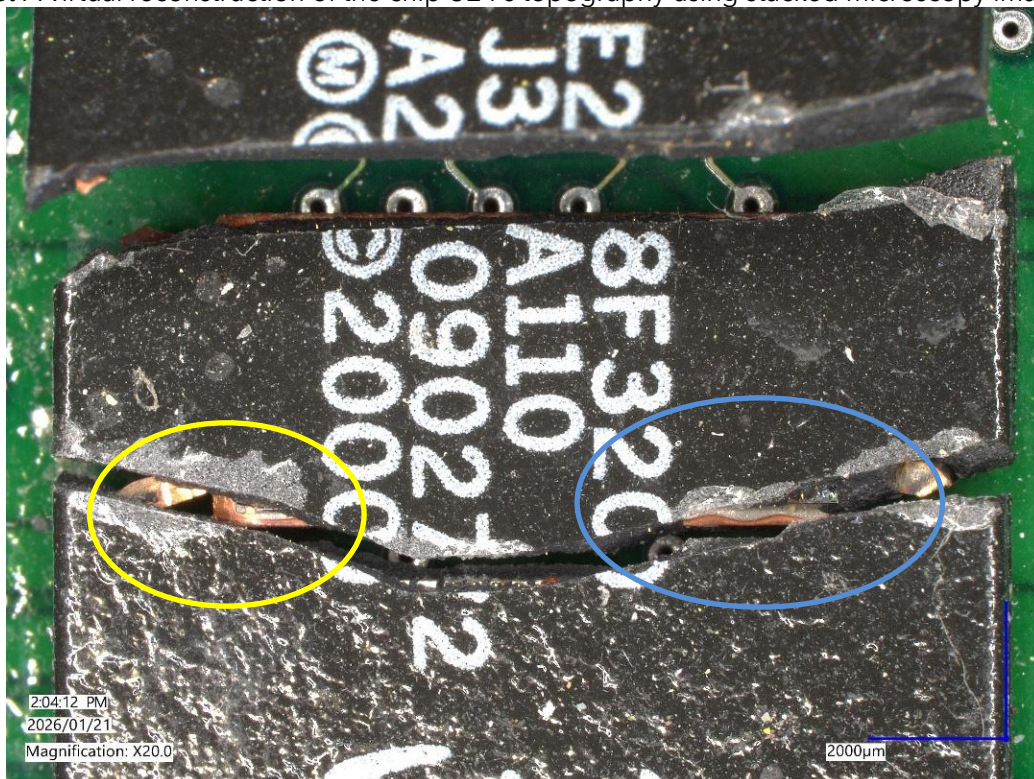
**Figure 4.** A top down 10x magnification image of chip U24. The area circled in yellow is annotated in Figure 5. The area circled in blue is annotated in Figure 6.

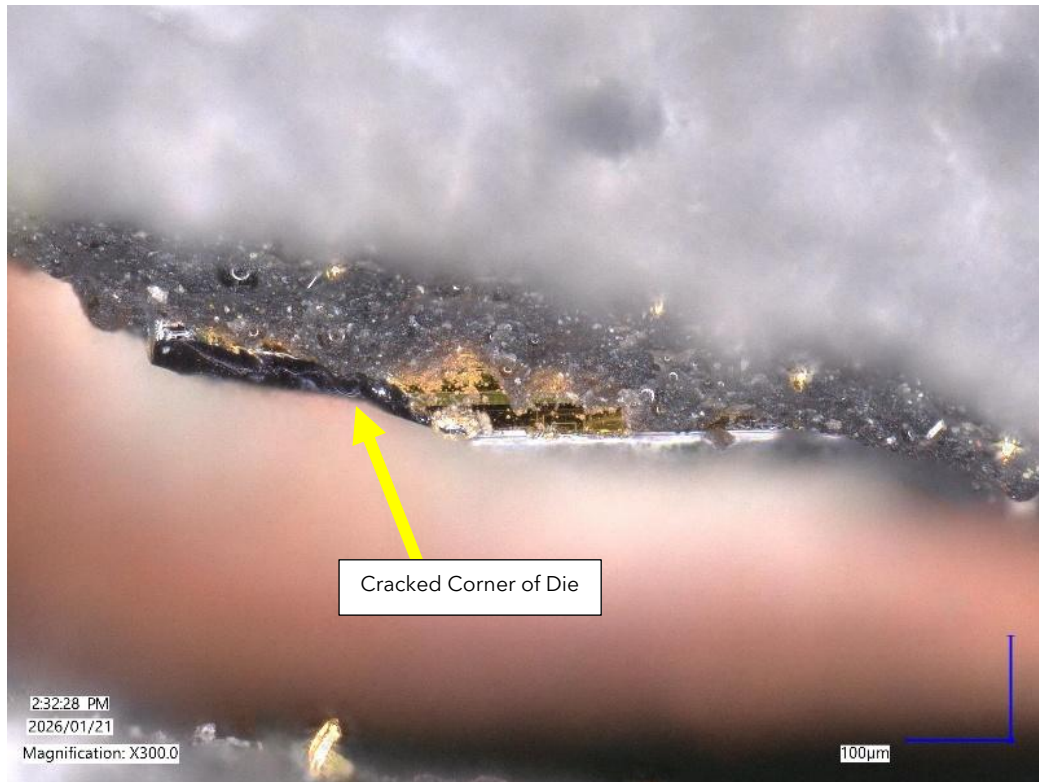
**Figure 5.** A 300x magnification image of the area circled in yellow in Figure 4. The yellow arrow annotates a cracked corner of the chip's die.

The yellow arrow in Figure 5 shows that the corner of the chip's internal silicon die is cracked and missing. The blue arrow in Figure 6 shows that the die surface has been exposed.

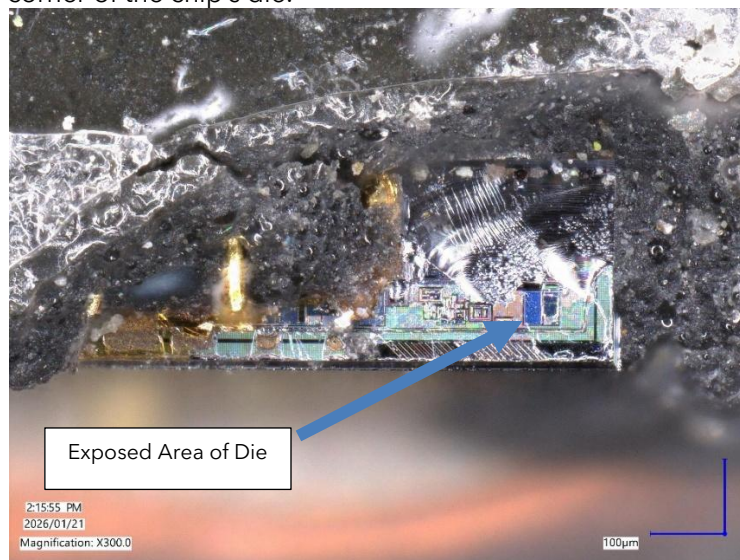
**Figure 6.** A 300x magnification image of the area circled in blue in figure 4. A blue arrow indicates an exposed area of the die.

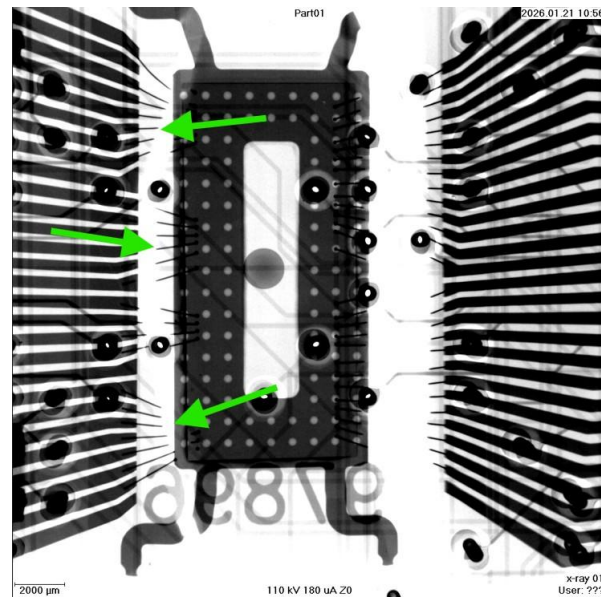
X-ray imagery was conducted using the NTSB's x-ray imaging device. Figure 7 is an x-ray image of chip U24. The x-ray image shows numerous broken wire bonds

between the chip's pin interface and the chip's internal die. These areas of damage are annotated with a green arrow. Note that x-ray imaging is not fully effective at imaging the silicon die and is ineffective at illustrating all additional areas of die cracking.

**Figure 7.** An x-ray image of the center area of chip U24. Areas of damaged wire bonds are annotated with green arrows.

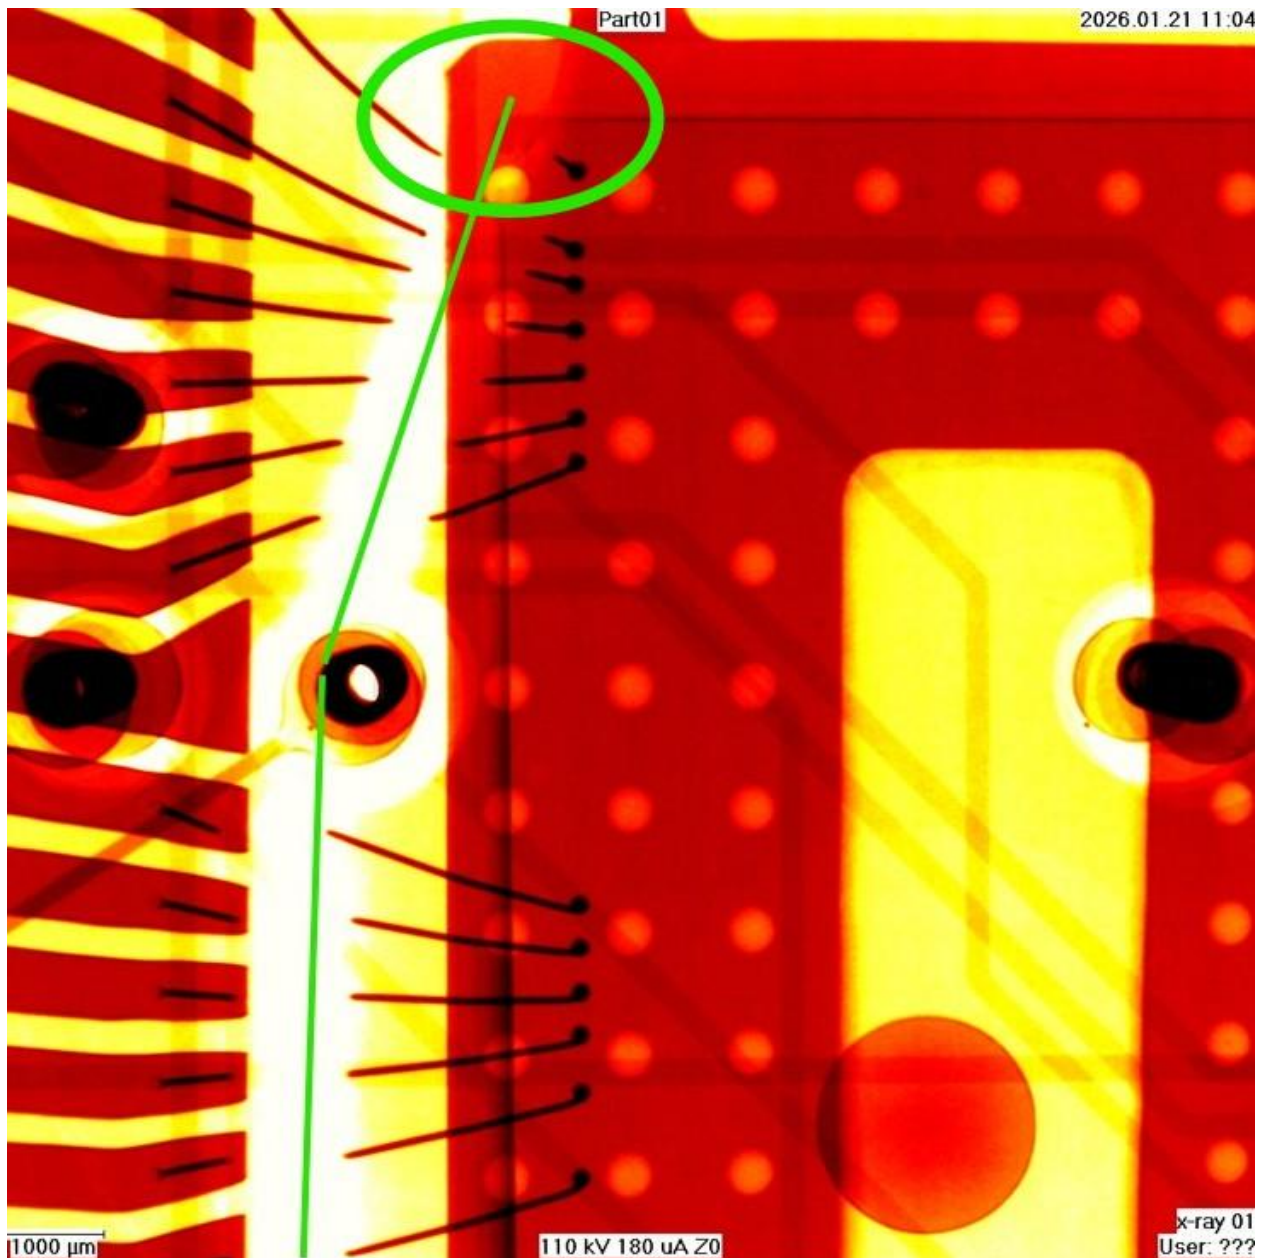
Figure 8 shows a detail area of the upper left portion of chip U24. The x-ray image has been post processed with the x-ray machine's software processing tools to provide additional contrast. A light area near the left of the x-ray image shows an area of cracking. This light area has been highlighted with a green line annotation. This area of cracking extends along the length of the entire chip. An additional area annotated with a green circle suggests that the crack extends across the corner of the chip's silicon die.

**Figure 8.** An x-ray image of the upper left portion of chip U24. The center of a crack is annotated with a green line. A green circle annotates an area of the chip where the crack extends across the region of the chip's internal silicon die.
