# National Transportation Safety Board

ERA25MA106

## COCKPIT VOICE RECORDER

Specialist's Factual Report

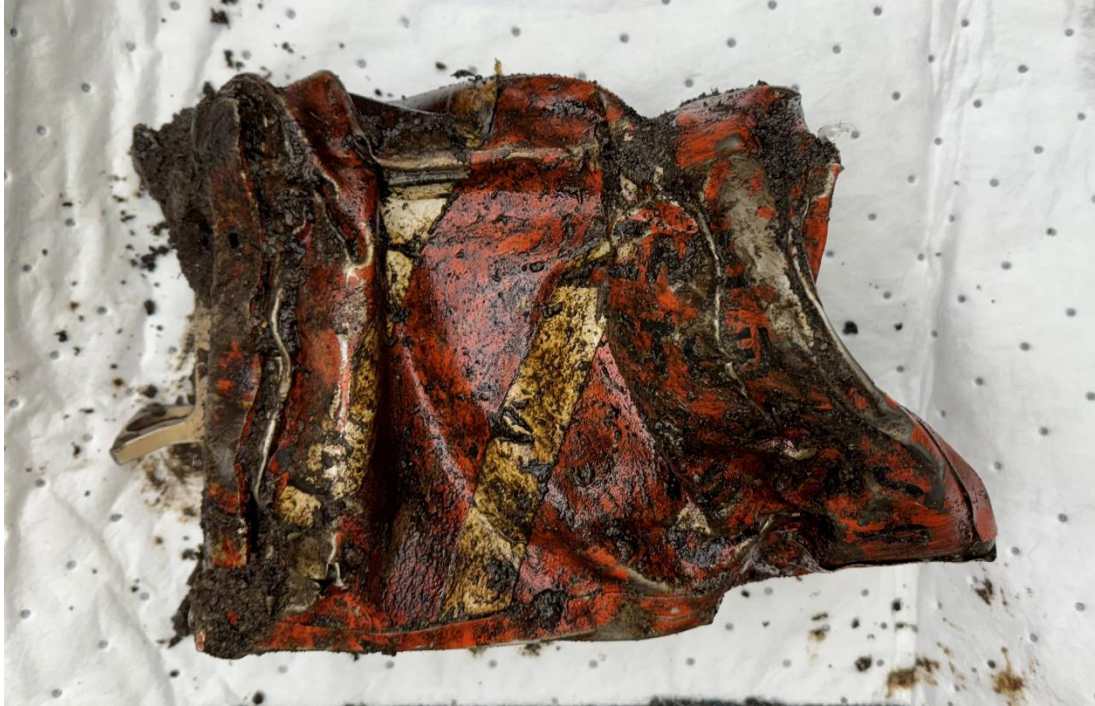
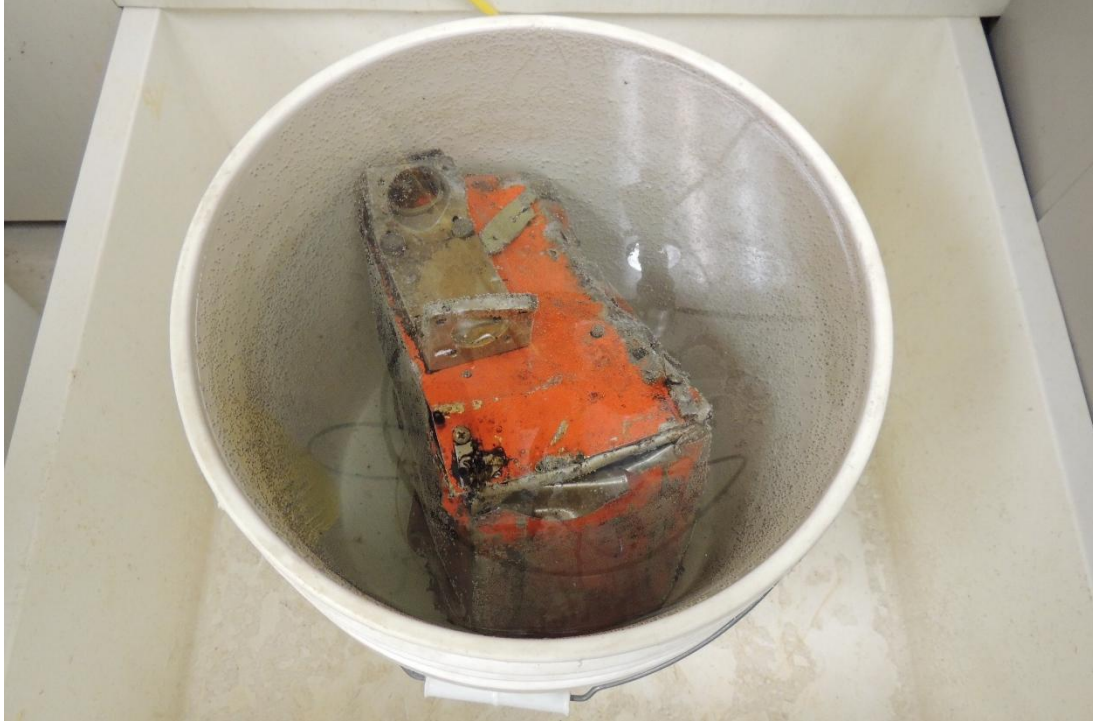
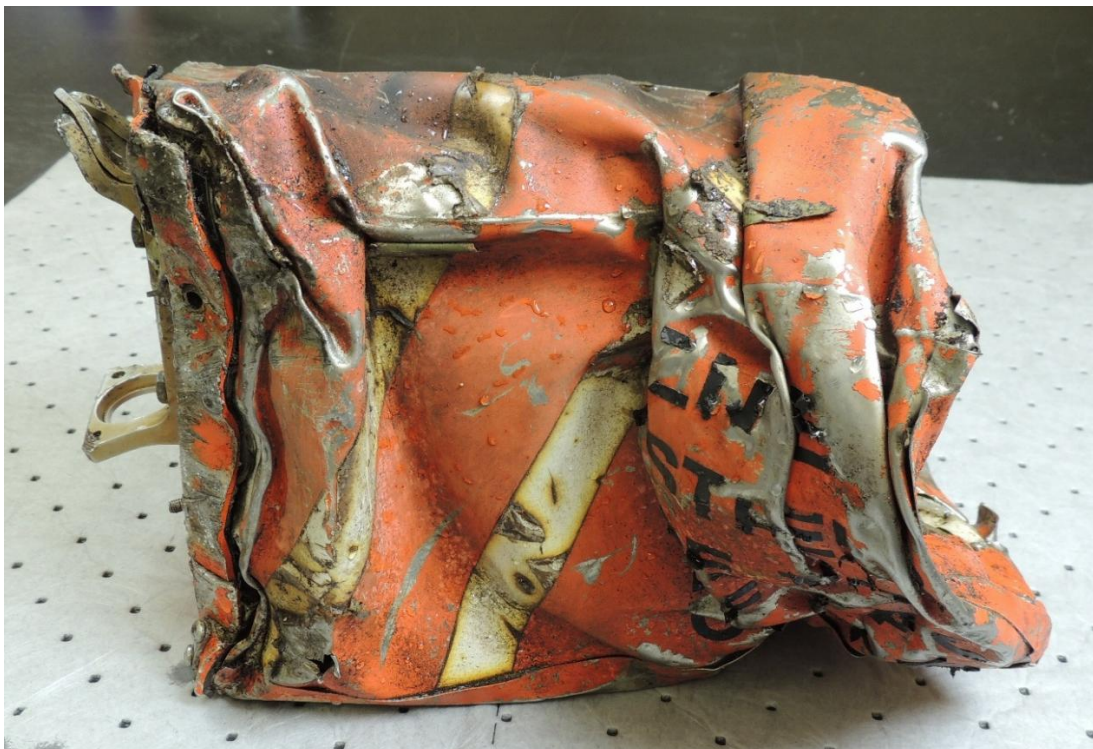
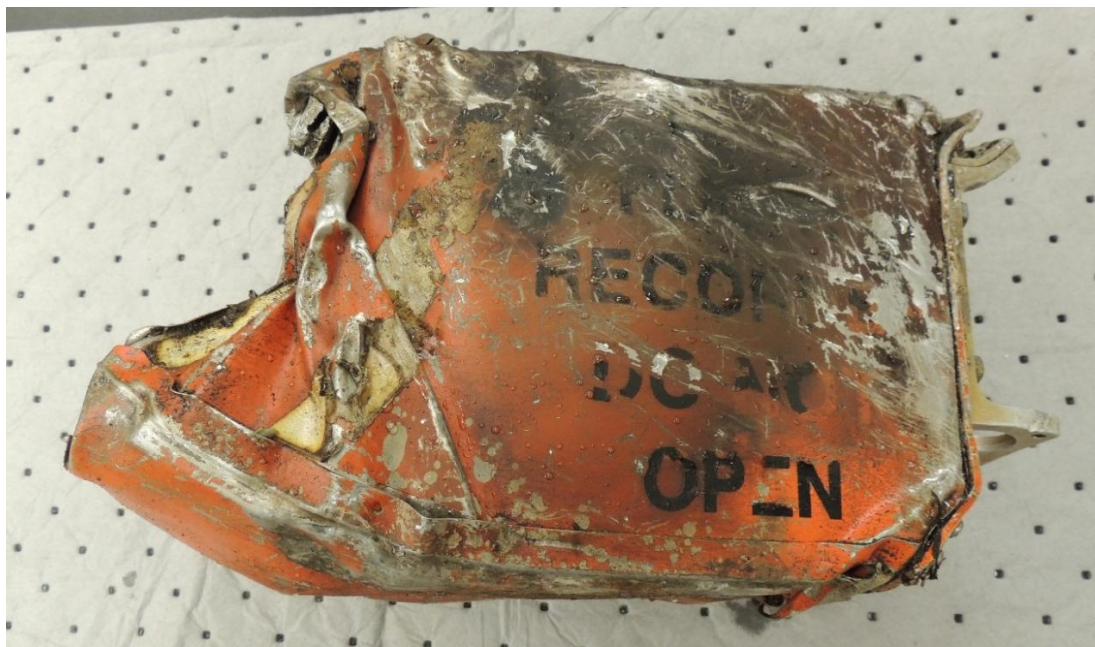
Upon arrival at the laboratory, it was evident that the CVR had sustained severe structural damage as shown in figures 1 - 4. The CVR had also sustained extreme fluids exposure including water, fuel, and biohazard as it sat for multiple days at the 6-foot level of an impact crater after firefighting and recovery efforts were completed. The CVR was first soaked in fresh RO/DI<sup>1</sup> water in multiple stages to slowly reduce the initial contamination while mitigating any further degradation of the recording medium (figure 2). Due to extreme deformation to the recorder, the outer case was removed using a variety of cutting tools, chisels, and other mechanical means to expose the internal crash case (figure 5).

**Figure 1.** Damaged exterior view of CVR prior to initial soaking.

**Figure 2.** Damaged exterior of CVR during initial soaking.

**Figure 3.** Damaged exterior view of CVR after initial soaking.

**Figure 4.** Damaged exterior of CVR after initial soaking.

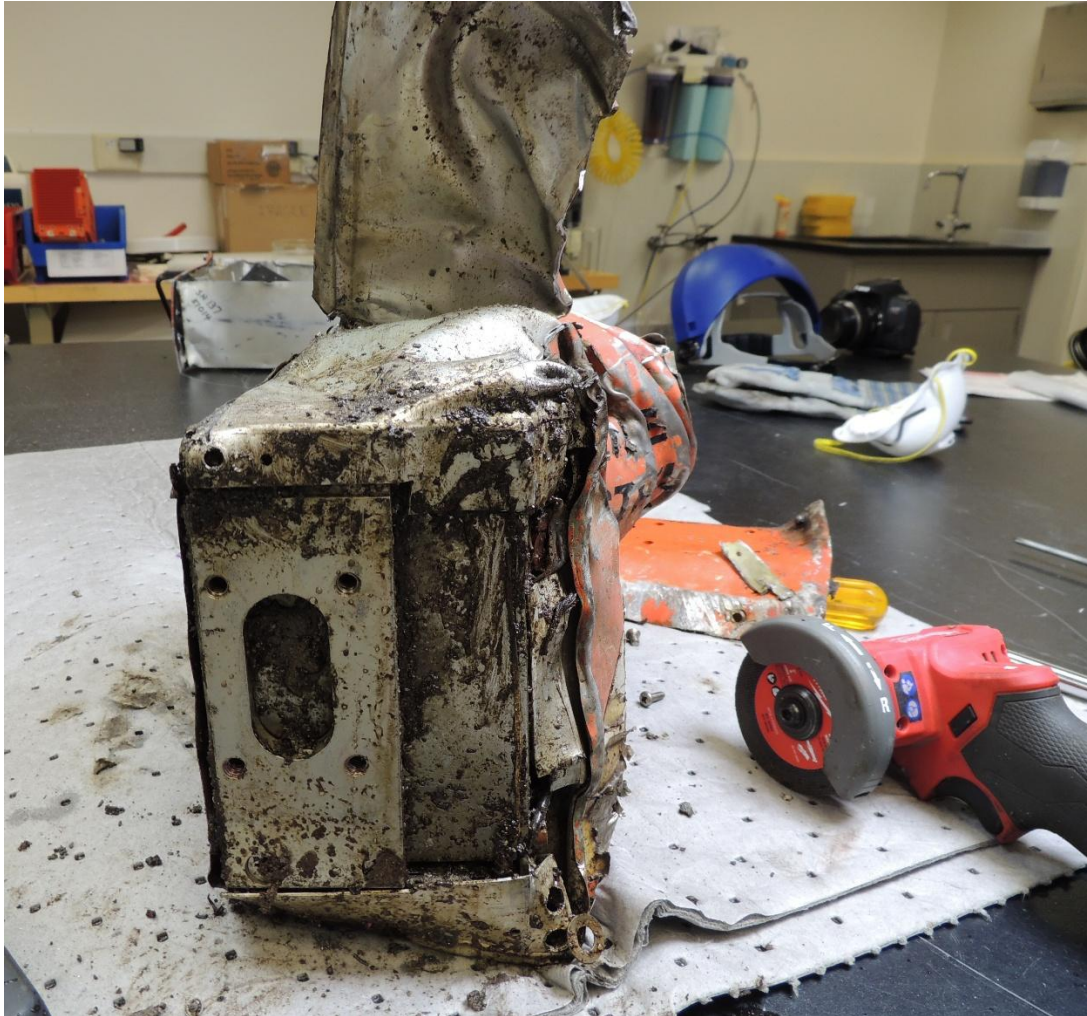
**Figure 5.** Damaged exterior of CVR being removed using cutting tools.

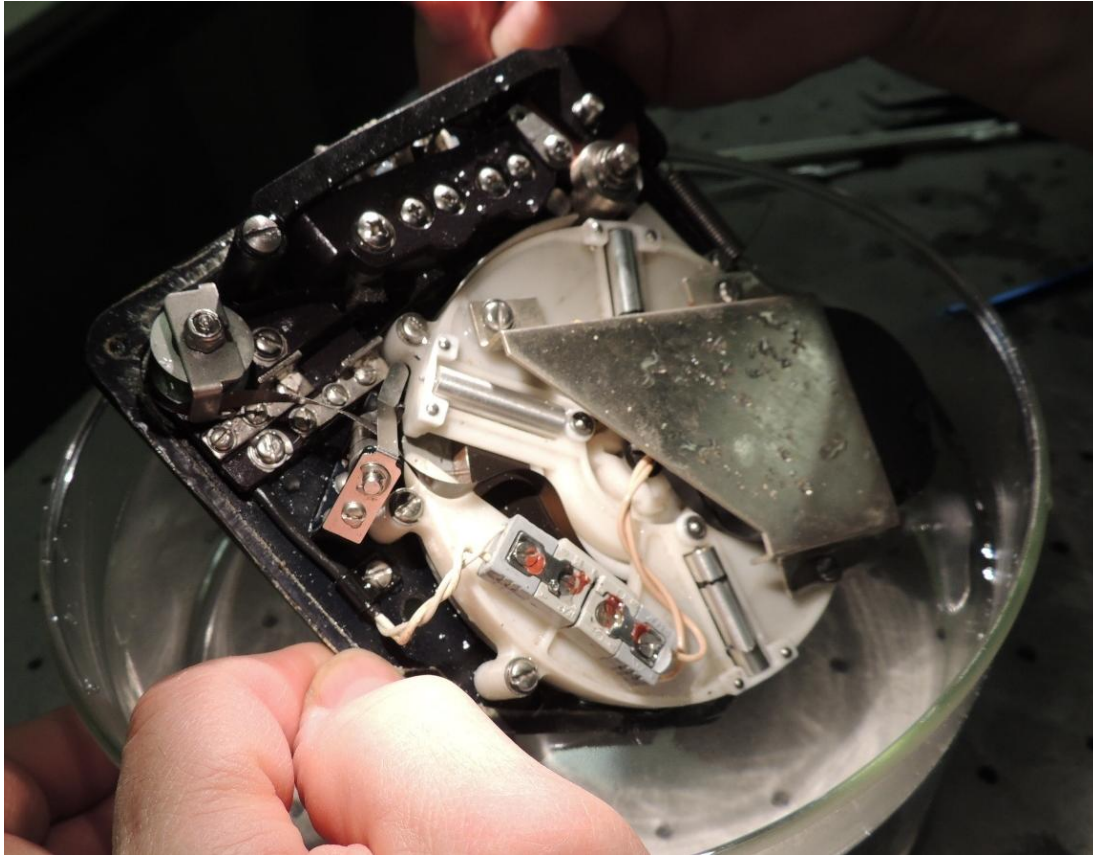
**Figure 6.** Transport mechanism removed from the damaged A-100A (s/n 25033).

the Drive Unit Assembly including the Reel Cover Assembly<sup>8</sup> and Bridge Assembly<sup>9</sup> were removed as a unit from the deformed and broken crash case. These three Assemblies will be collectively referred to as the *transport mechanism* in the narrative that follows (figure 6).

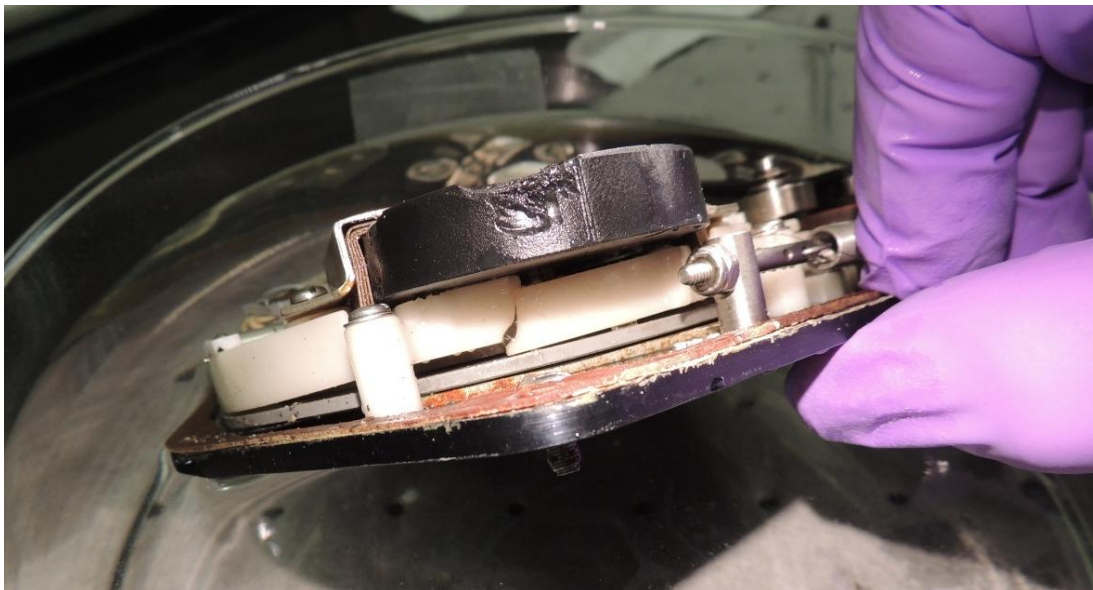
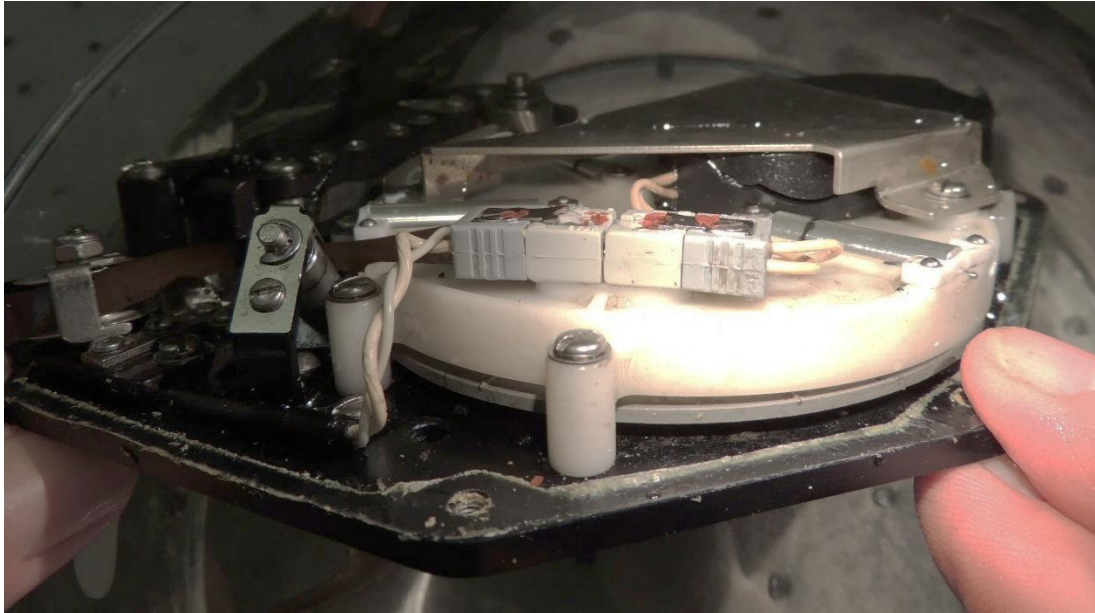
Impact damage was observed to both the Reel Cover Sub-Assembly<sup>10</sup> and the Erase Coil Assembly (figures 7 - 8). One splice<sup>11</sup> in the magnetic tape material was immediately observable on the data side of the tape in the area of the pinch roller near the Playback Head Assembly (figures 9, 18, 19). A second splice was also observed approximately 2 inches from the first, but on the opposite (non-data) side of the tape (figures 10, 20-22). The magnetic tape was found to be otherwise contiguous and unbroken before removal from the recorder.

**Figure 7.** Transport mechanism showing internal damage due to impact forces.

**Figure 8.** Transport mechanism showing internal damage due to impact forces.

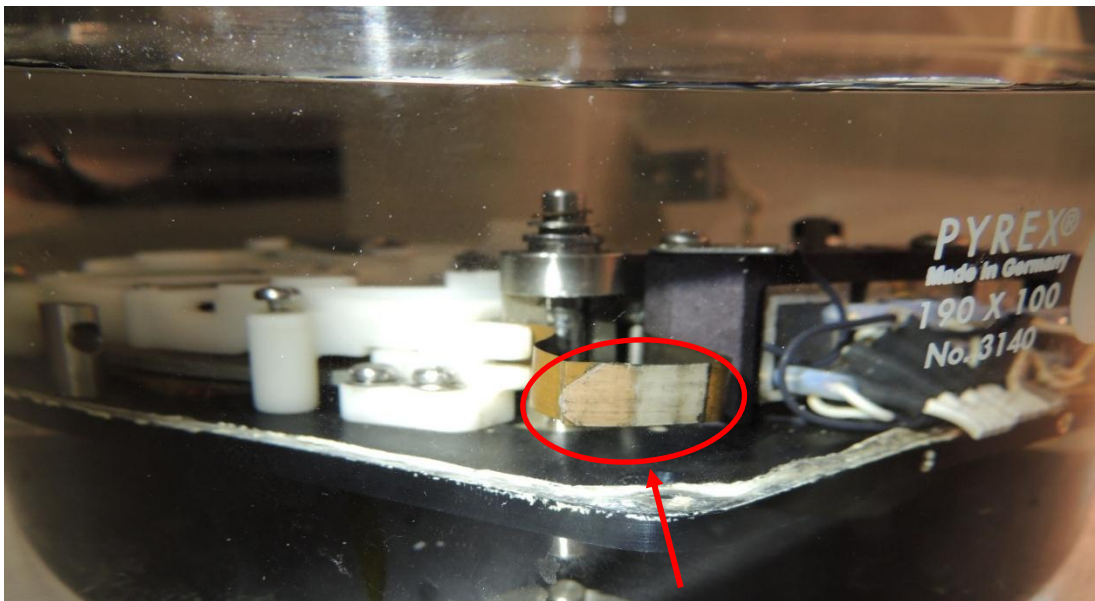
**Figure 9.** Transport mechanism showing an existing splice to data side of magnetic tape.

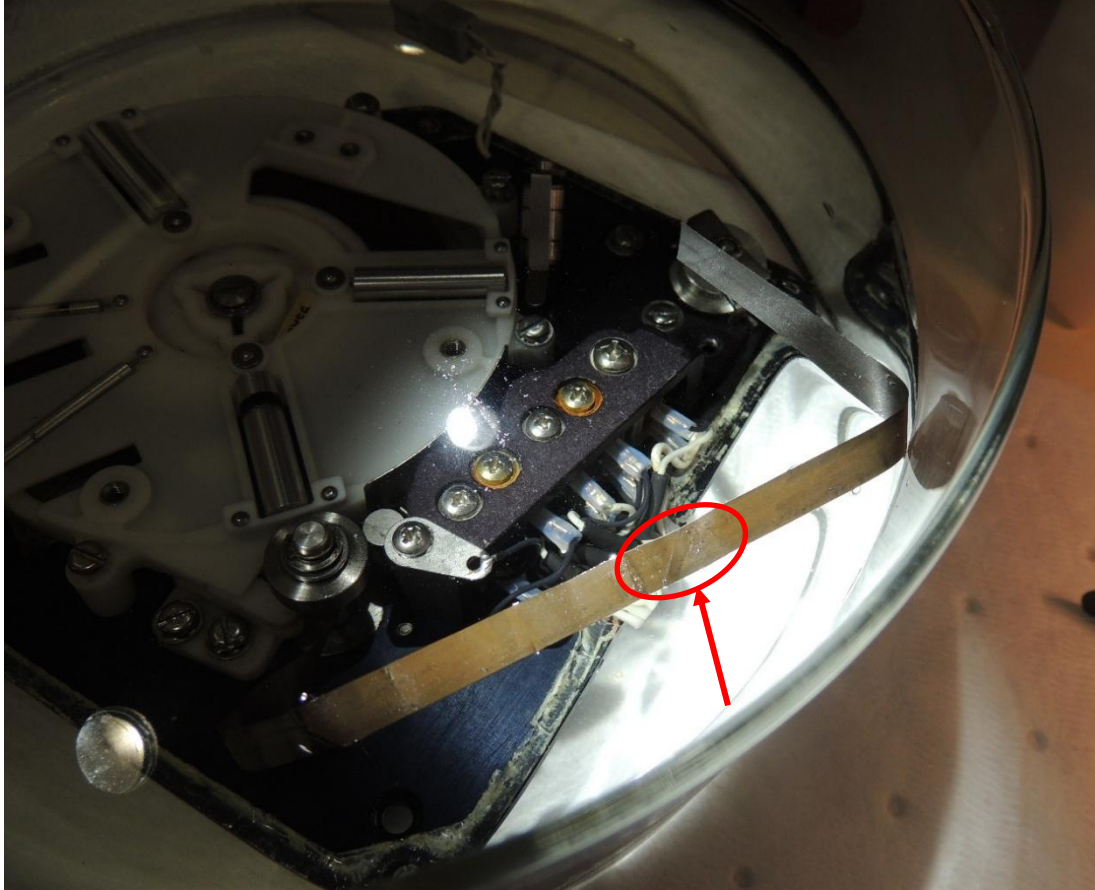
**Figure 10.** Transport mechanism showing an existing splice to non-data side of magnetic tape.

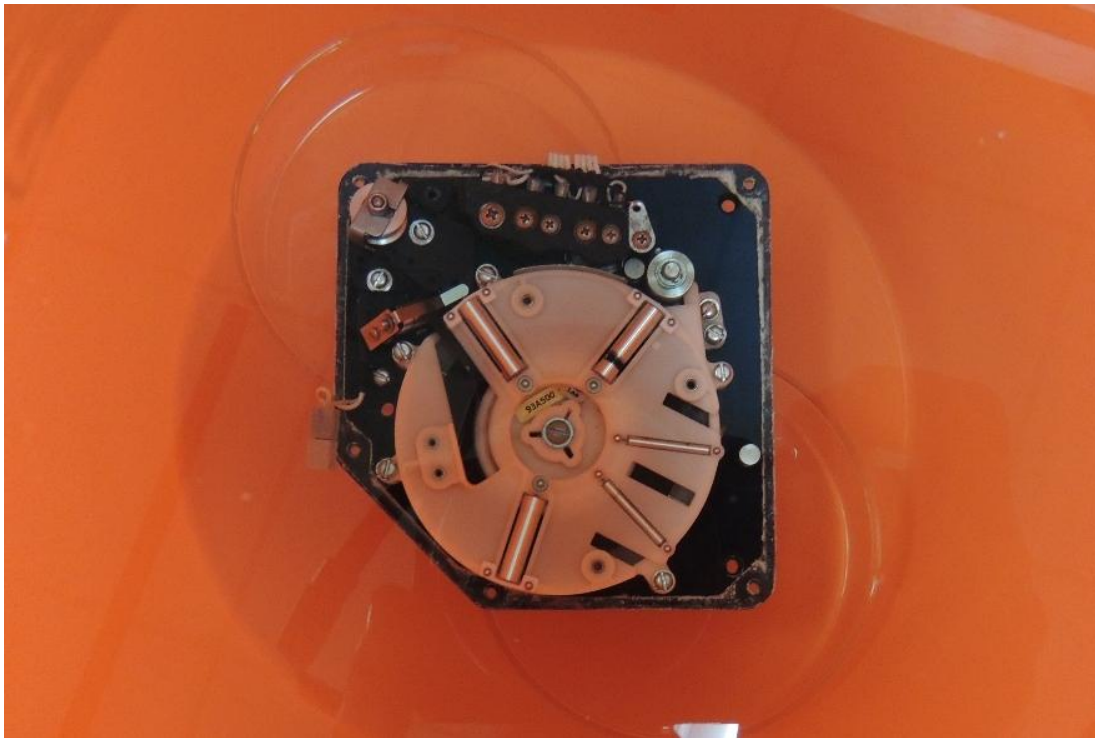
**Figure 11.** Transport mechanism in process of staged soaking and cleaning.

After removal from the recorder, the transport mechanism containing the magnetic tape was soaked for several more days in 7-gallon buckets of RO/DI water occasionally agitated and changed daily until evidence of fuel sheen on the surface of the water was reduced to a minimum (figure 11). Portions of the transport mechanism were slowly removed during this soaking process to aid in cleaning and contaminant diffusion while maintaining support and protection for the magnetic tape medium. This included the removal and replacement of the damaged Reel Cover Assembly with a structurally sound Reel Cover Sub-Assembly.

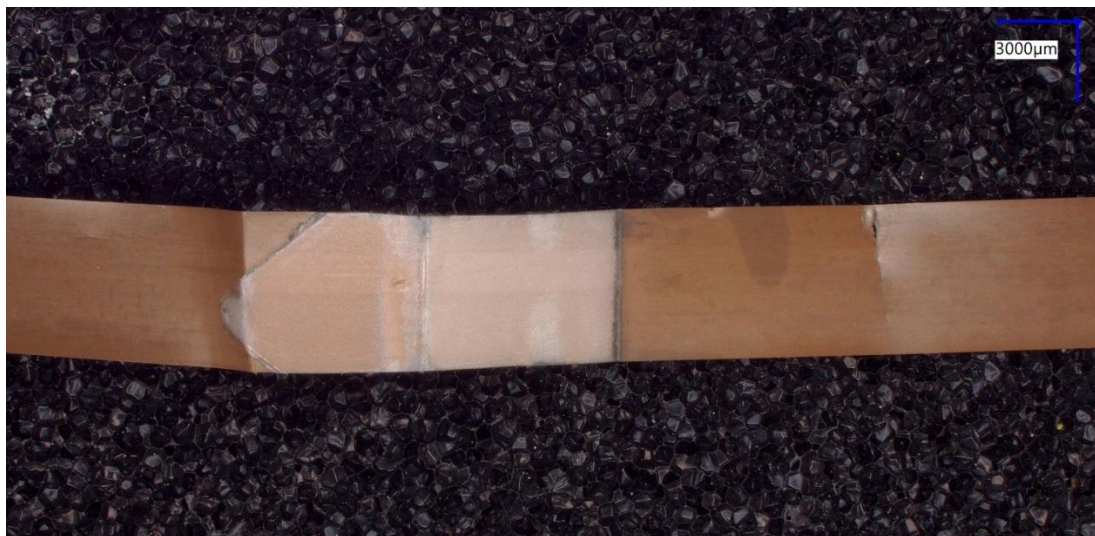
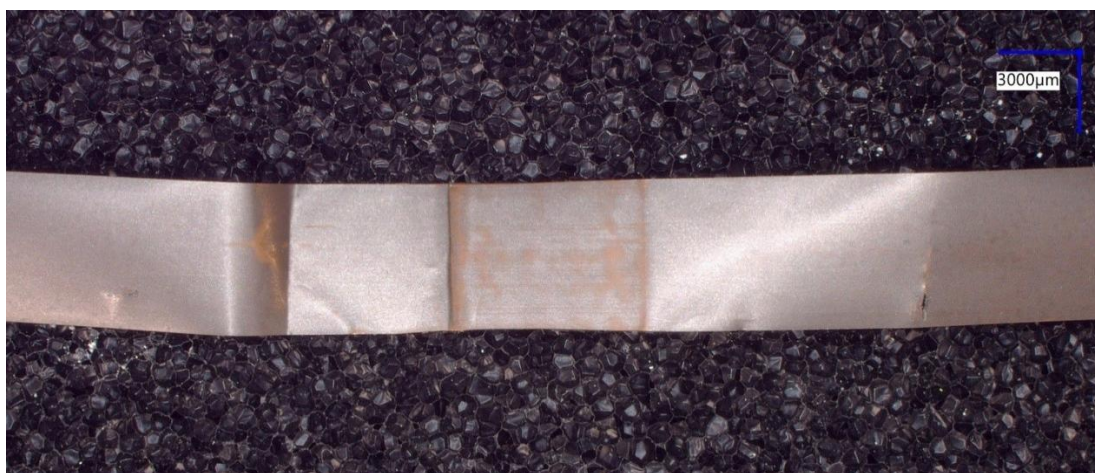
**Figure 18.** First pre-existing splice viewed from the data side of the tape.

**Figure 19.** First pre-existing splice viewed from the non-data side of the tape.

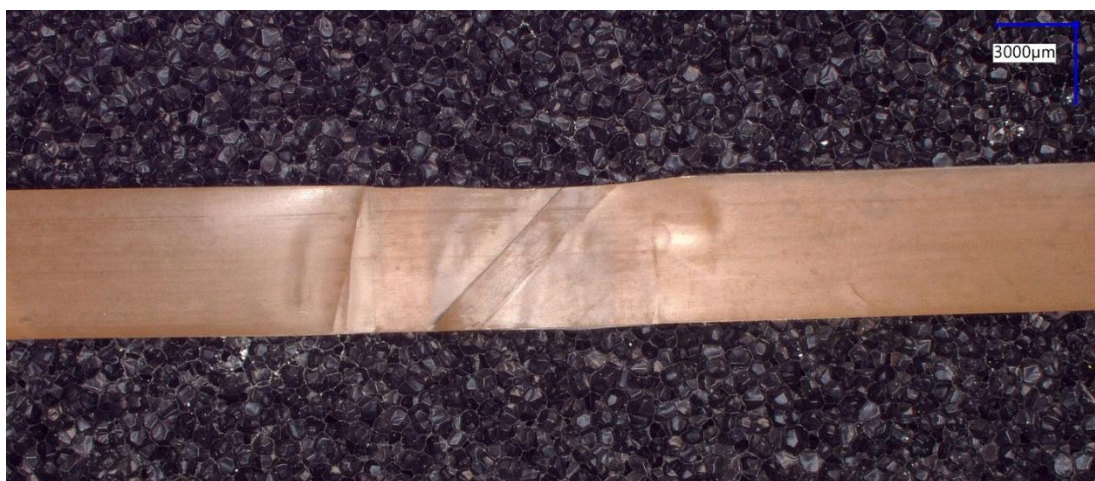
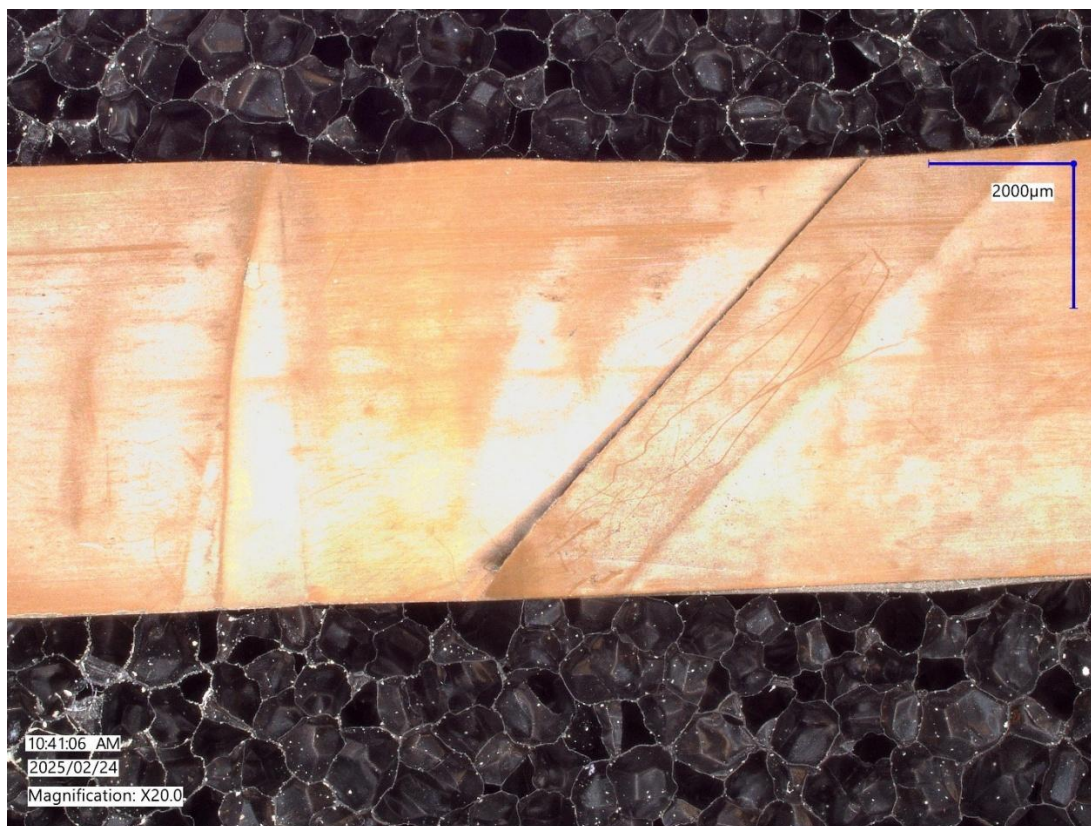
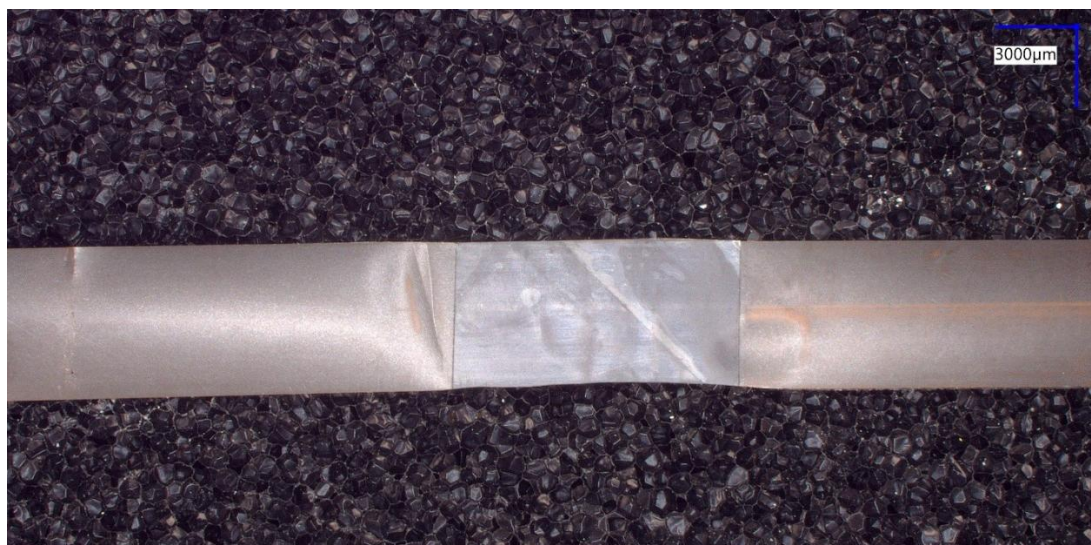
**Figure 20.** Second pre-existing splice viewed from the data side of the tape.

**Figure 21.** Second pre-existing splice viewed from the data side of the tape (closeup).

**Figure 22.** Second pre-existing splice viewed from the non-data side of the tape.
