# National Transportation Safety Board

ERA25MA106 (KEYS# 199630)

## COMPUTED TOMOGRAPHY

Specialist's Factual Report

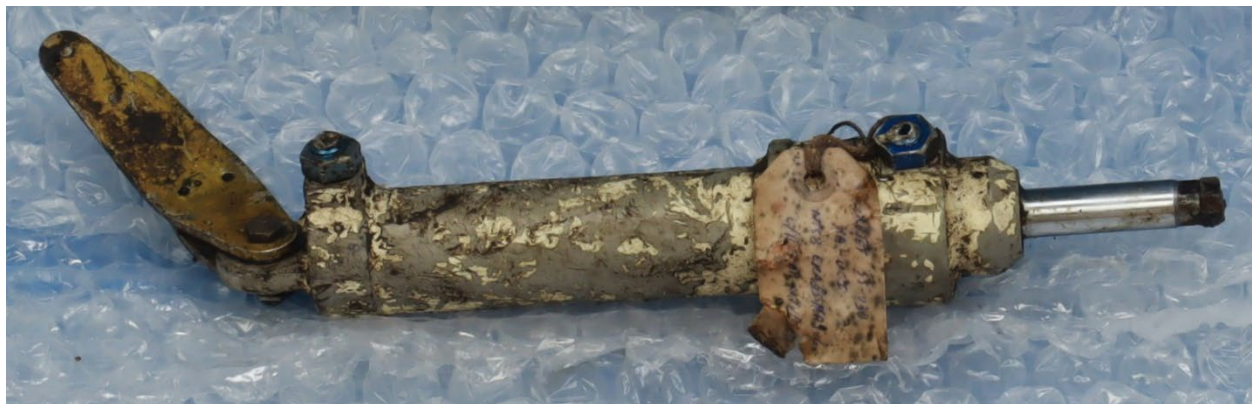
According to the Airworthiness Group Chairman, the LH flap actuator was measured to be about 13-¼ inches long, which corresponds to about 2° of flap (retracted). The piston appeared to be jammed and could not be moved by hand.

**Figure 1.** LH flap actuator as received at the NTSB Materials Laboratory.

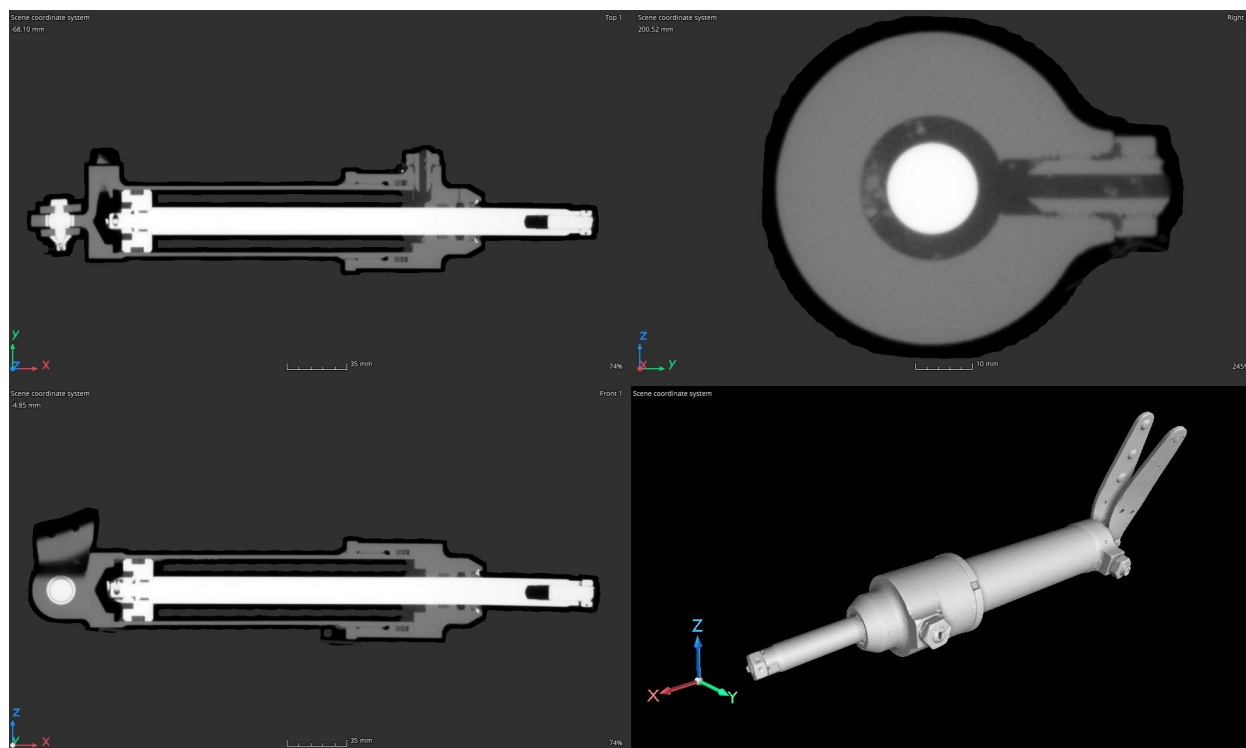
All components were present and in their correct locations besides the extension and retraction elbow fittings, which were broken off and partially missing, and the rod end, which was broken off.

**Figure 2.** Views of the whole LH flap actuator.

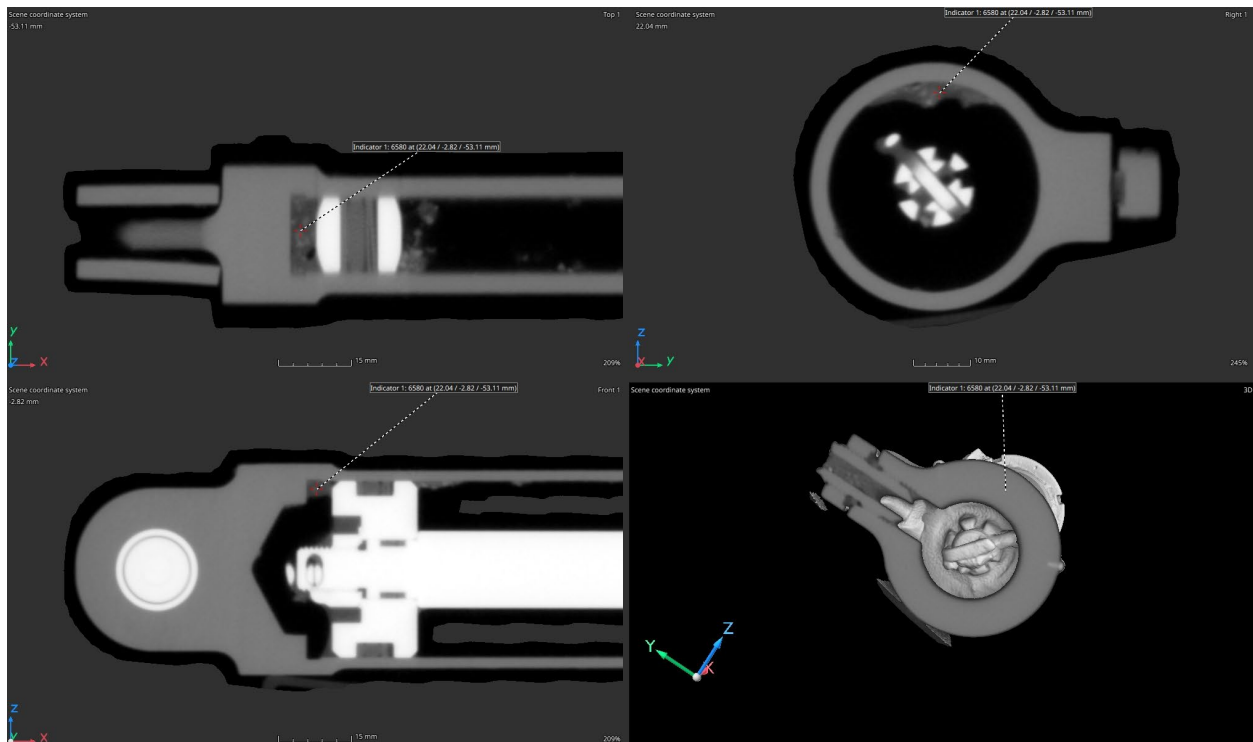
Debris was identified throughout the LH flap actuator. During the scan, the debris was found on both sides of the LH piston (Figure 3 and Figure 4). The voxel values of the debris ranged from about 5,500 to about 7,500.

**Figure 3.** Debris on the inner walls of the cylinder body and the extension side of the piston head. The voxel value at the indicator is 6,580.

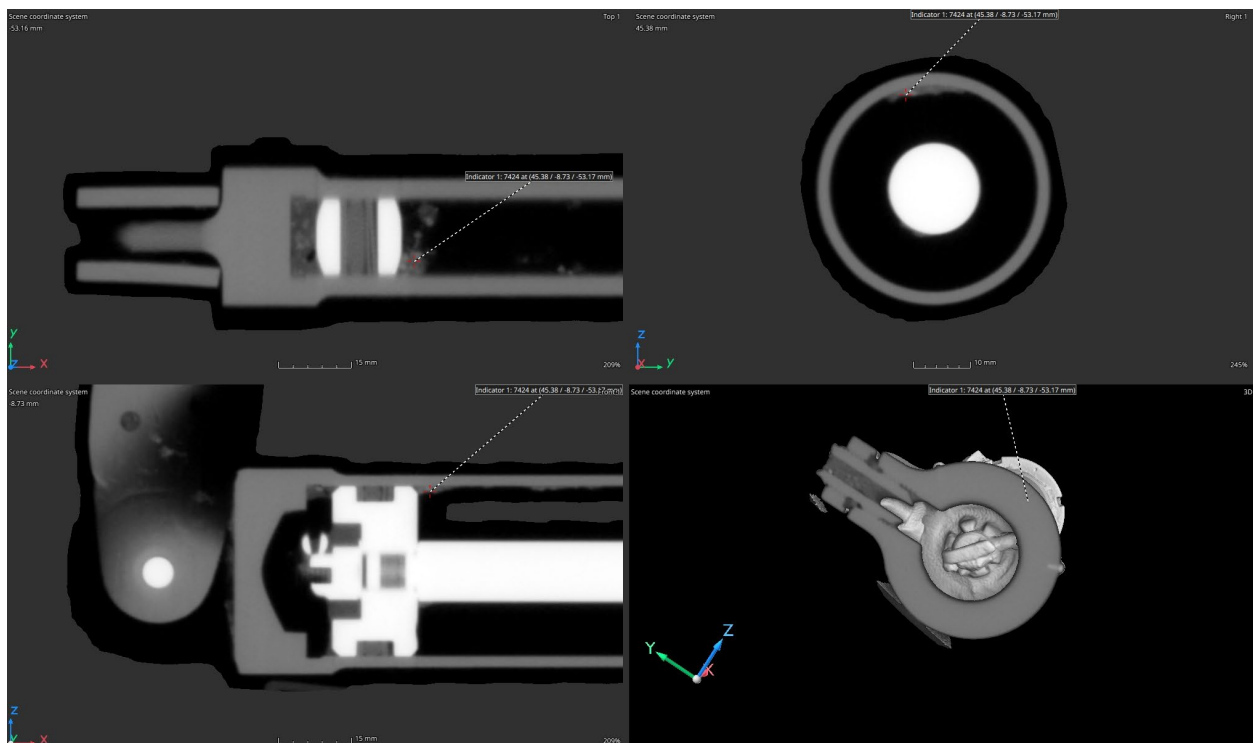
**Figure 4.** Debris on the inner walls of the cylinder body near the retraction side of the piston head. The voxel value at the indicator is 7,424.

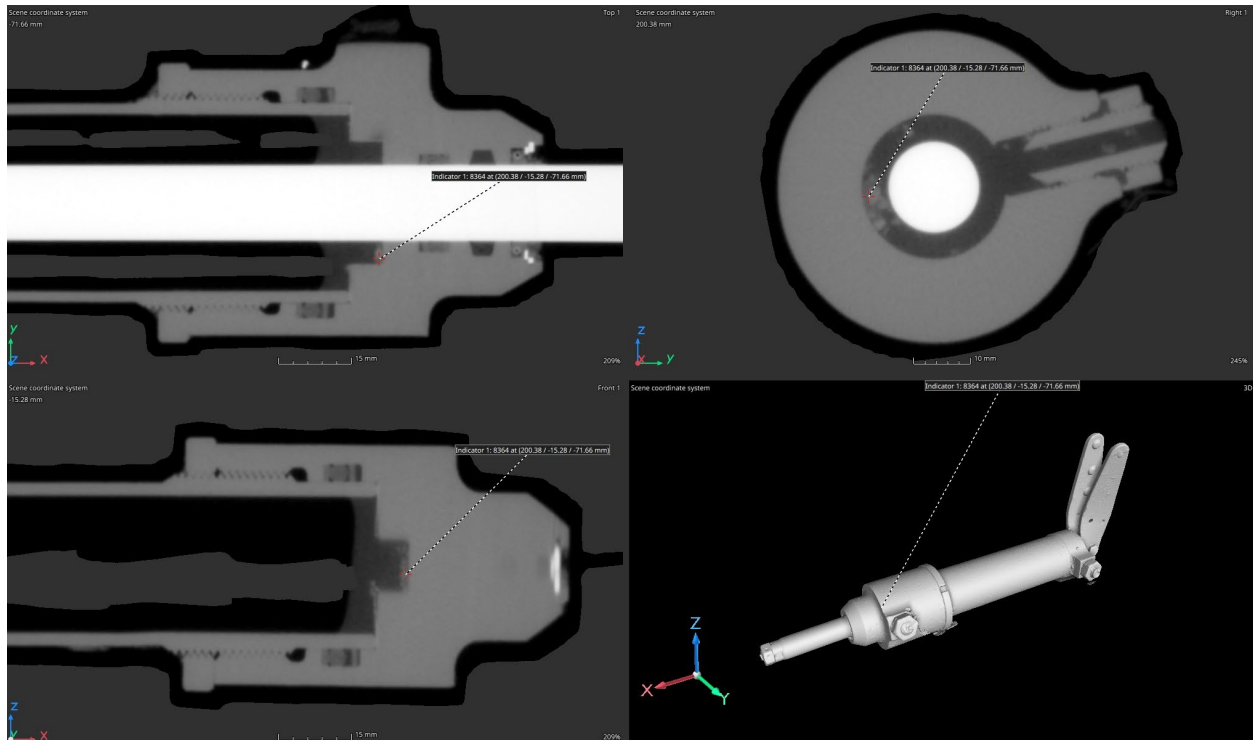
Debris was also found near or within both the extension and retraction fittings (Figure 5) with voxel values ranging from about 6,500 to about 9,000. All of the debris was less dense than the cylinder body or piston rod indicating that it is unlikely to be aluminum or steel. For reference the cylinder body had a voxel value of about 9,700 to about 10,300 (Figure 6).

**Figure 5.** Debris between the inner walls of the cylinder body and the piston rod on the extension end of the actuator. The voxel value at the indicator is 8,364.

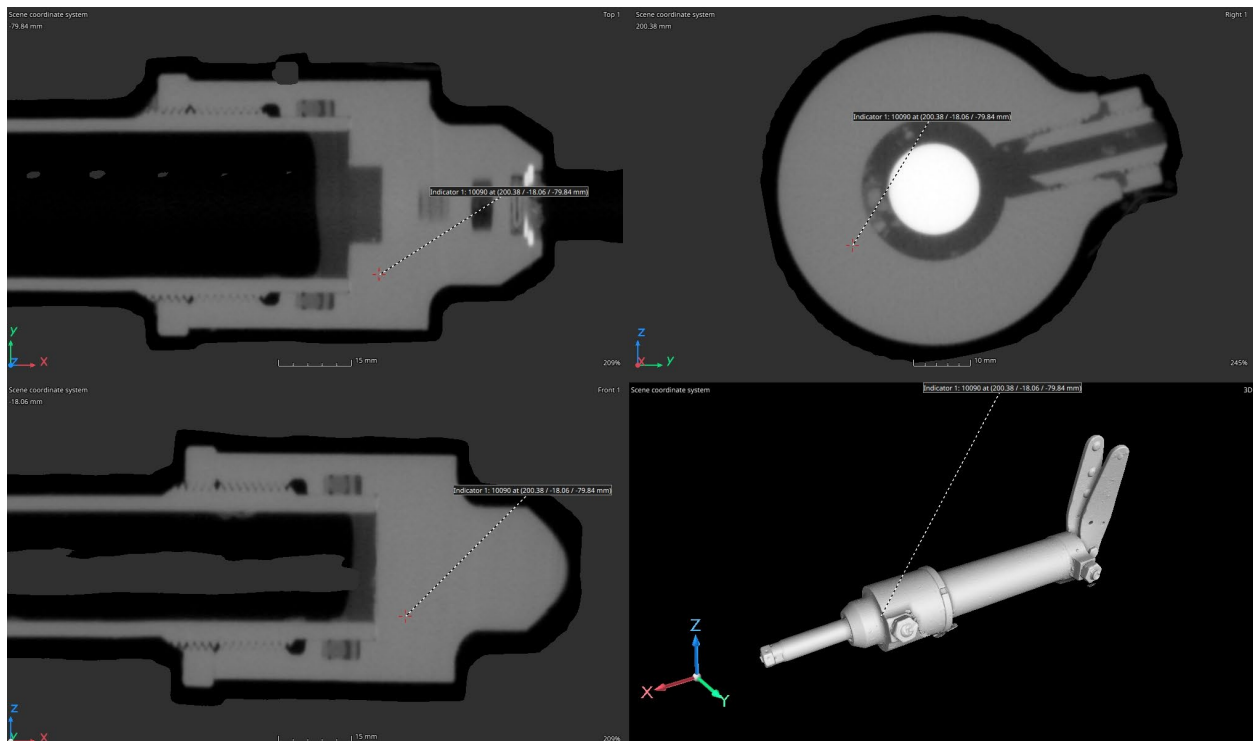
**Figure 6.** The density of cylinder body was taken for reference. The voxel value at the indicator is 10,090.

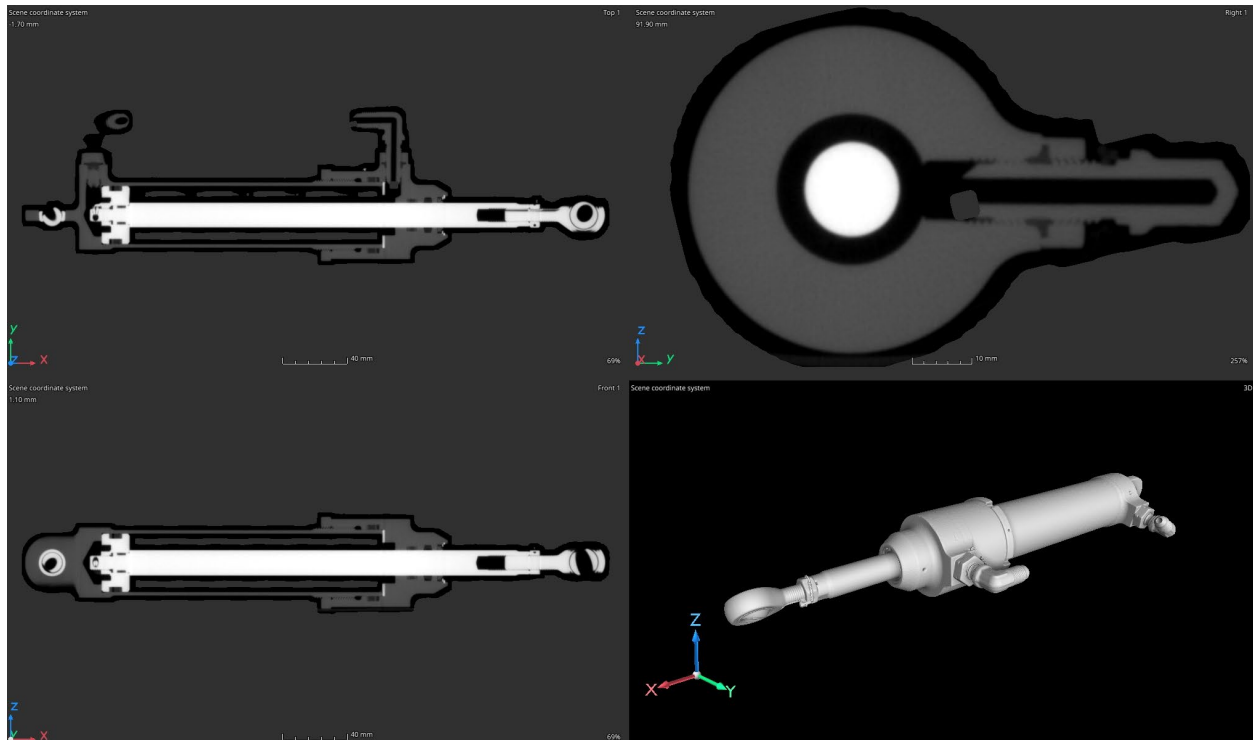
All components were present and in their correct locations. No debris was identified within the actuator. The internal components appear to move as expected. No anomalies were identified.

**Figure 8.** RH flap actuator in the retracted position.

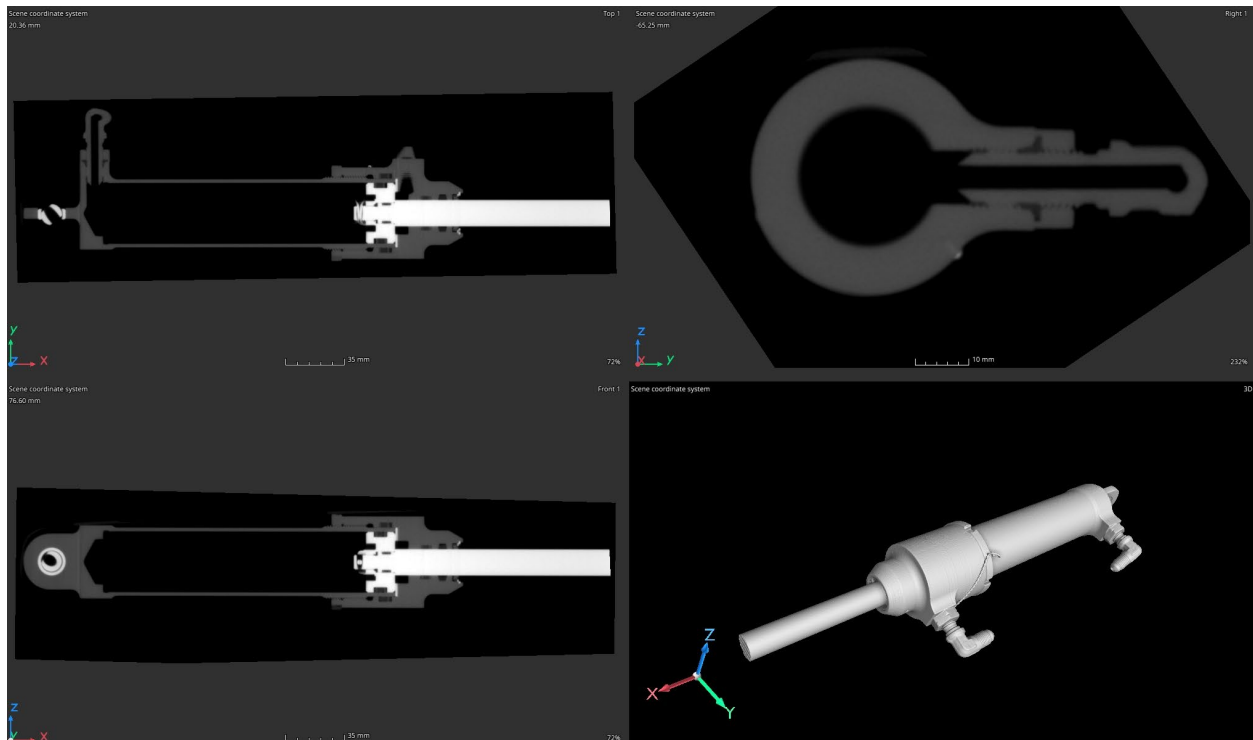
**Figure 9.** RH flap actuator in the extended position.

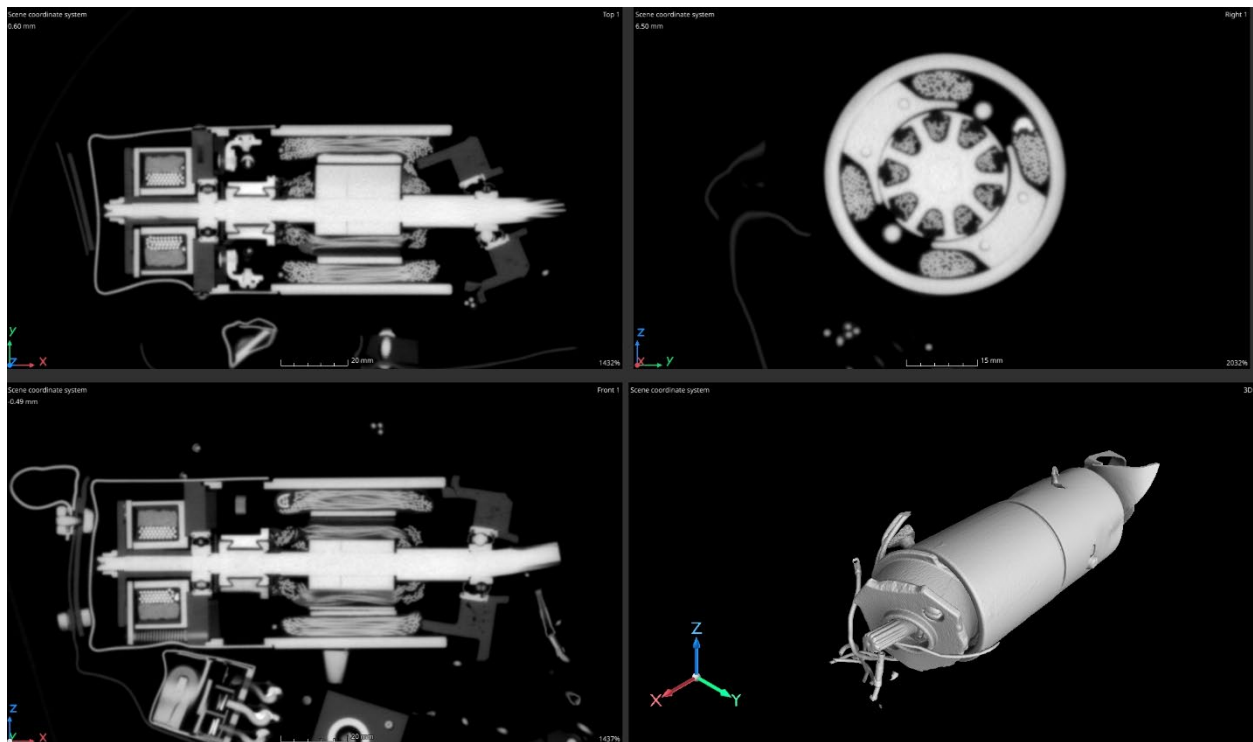
The drive shaft was permanently deformed. The end cap was dislodged and rotated. The outer bearing race remained with the end cap, but the ball bearings and inner race remained on the drive shaft. The housing beyond the commutator and rotor bearings was deformed radially inwards. The commutator and brushes appeared in good condition. No other anomalies were identified.

**Figure 12.** Views showing rotor and stator windings.

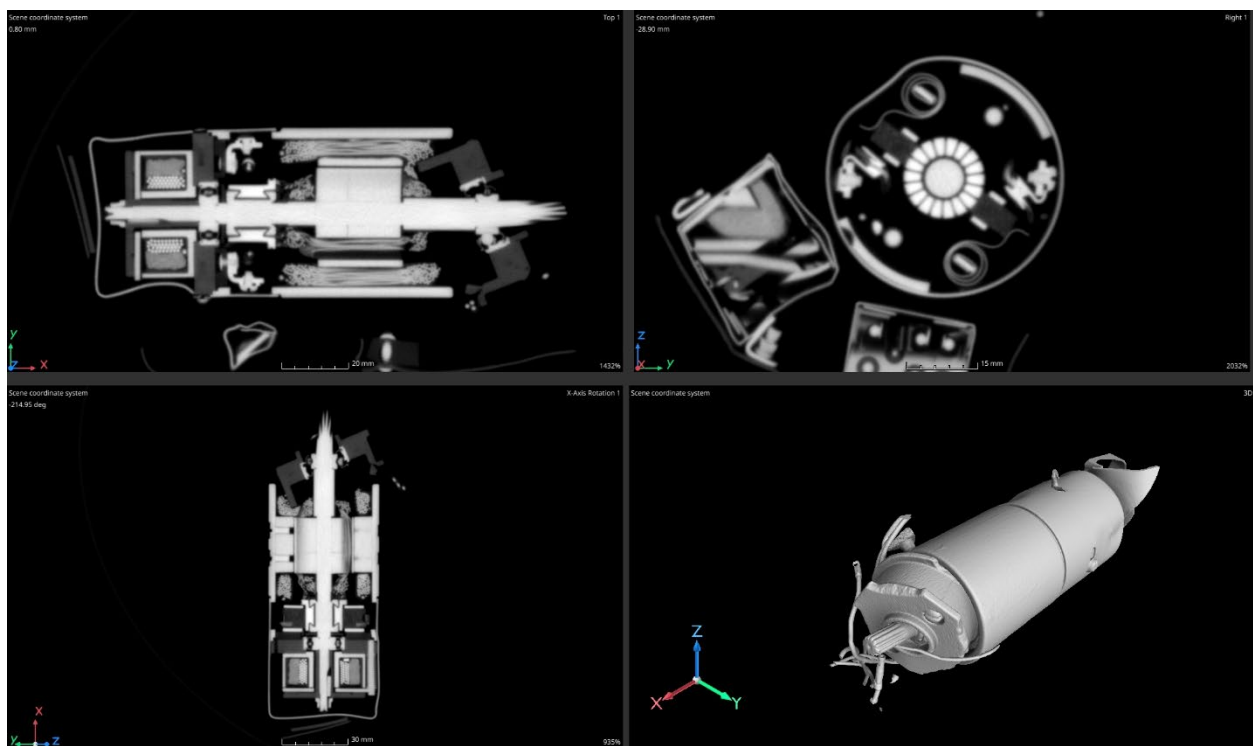
**Figure 13.** Views showing the commutator and brushes.

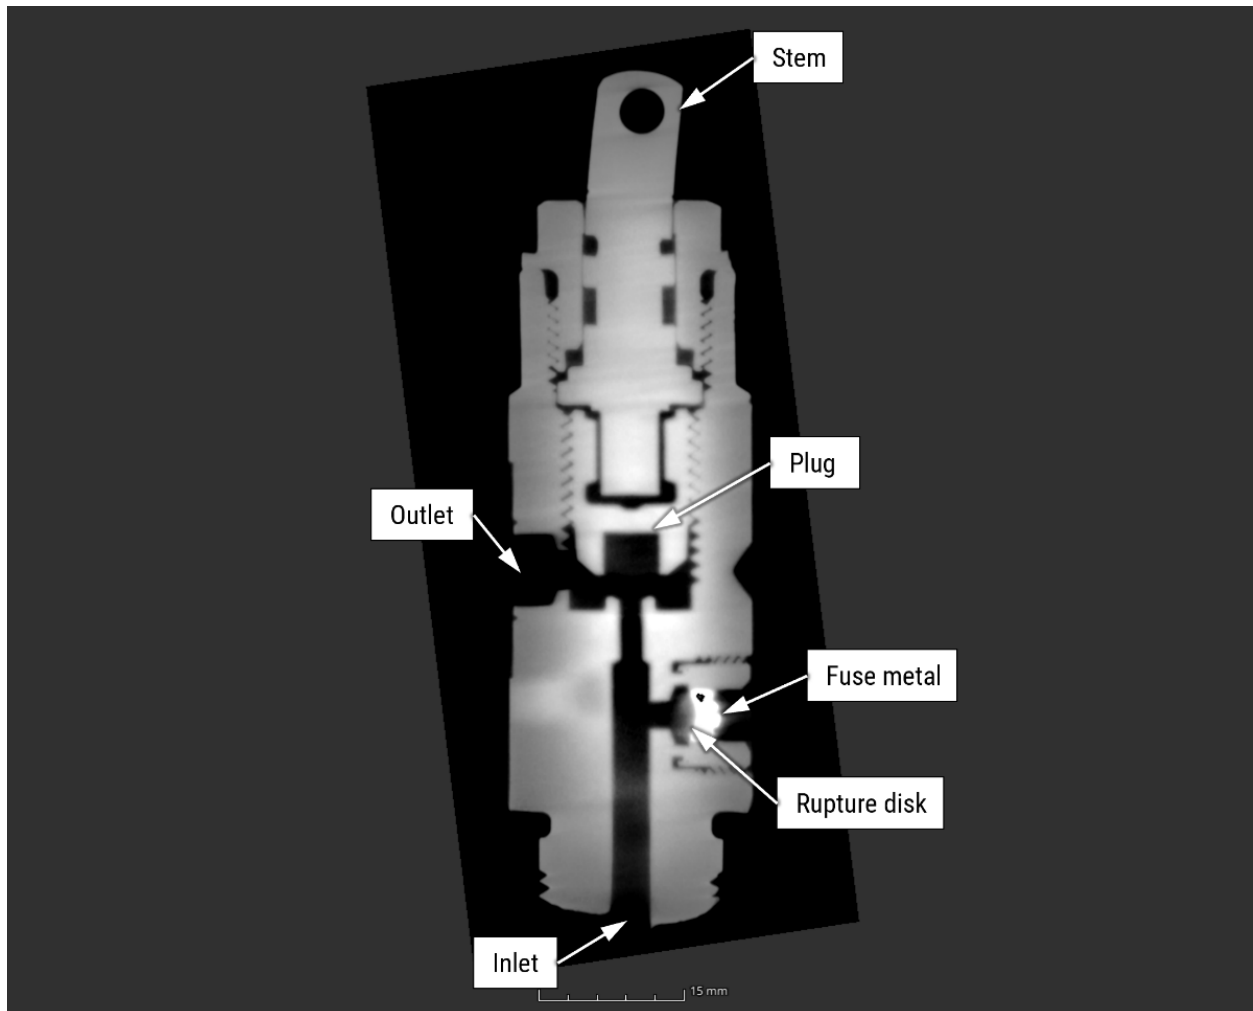
**Figure 15.** Oxygen valve parts labeled in CT slice.

The inlet threads were broken. The stem exhibited permanent deformation.

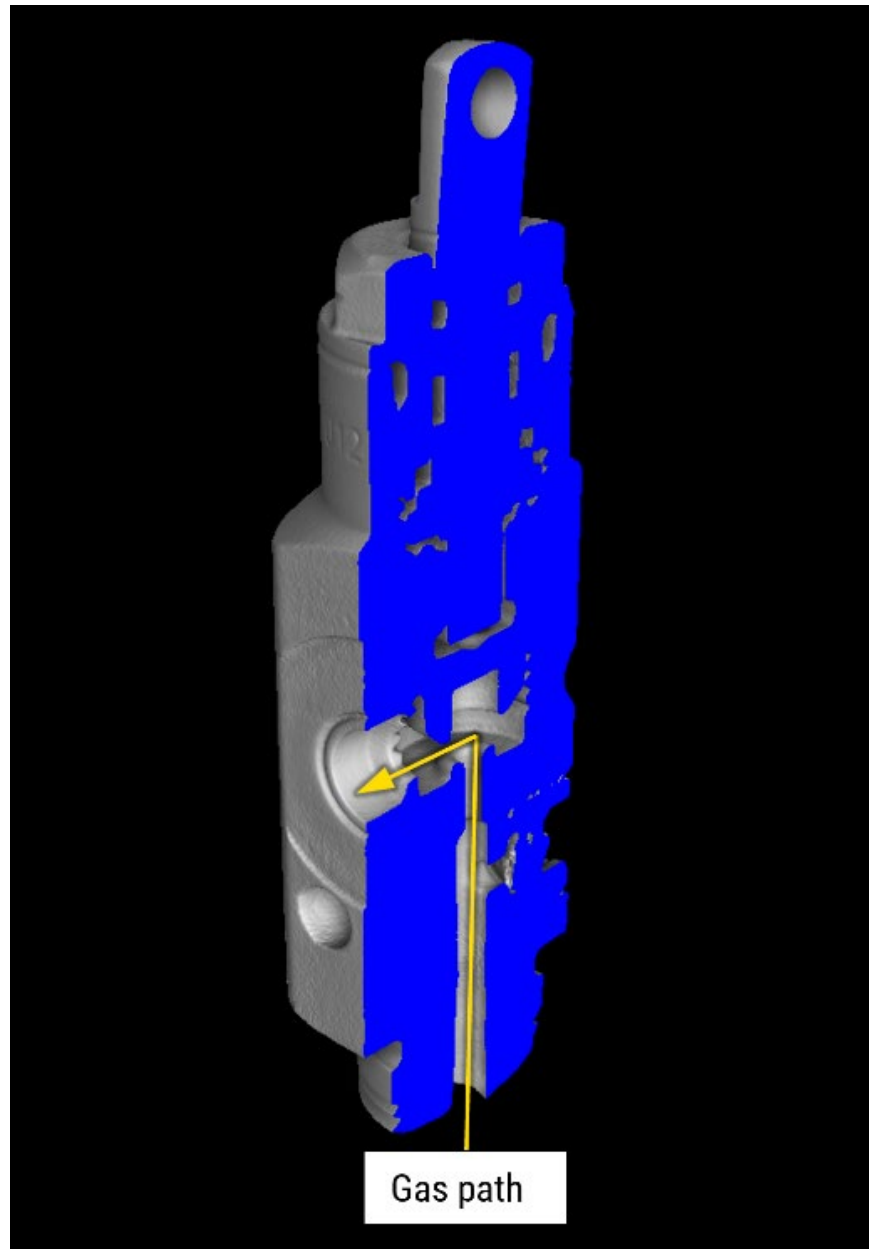
The position of the internal components show the plug is up; therefore, the valve is in an opened position with a clear gas path from inlet to outlet (Figure 16).

**Figure 16.** Gas path (yellow arrow) shown from cross-section of isosurface.

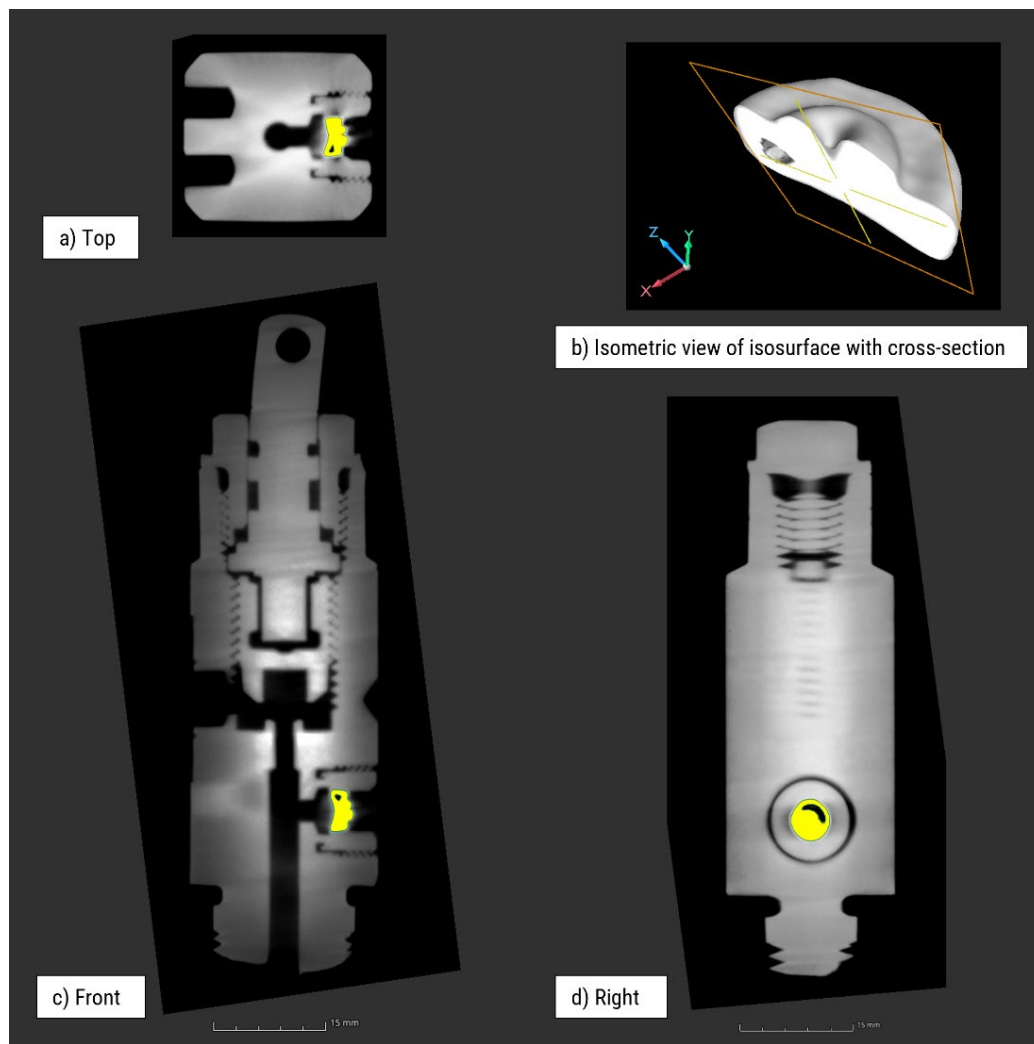
The fusible alloy was not symmetrical and showed a bulge on the exterior with a small crater extending inwards. There was also void within the solder, but this did not appear to create a path from the interior to the exterior. Nevertheless, it does not appear that the conditions existed to activate the safety device, since the fusible alloy was still in place. See Figure 17.

**Figure 17.** Three-view slices of the oxygen valve with the fusible alloy highlighted in yellow. An isometric view of the isolated fusible alloy is also shown in subfigure b).

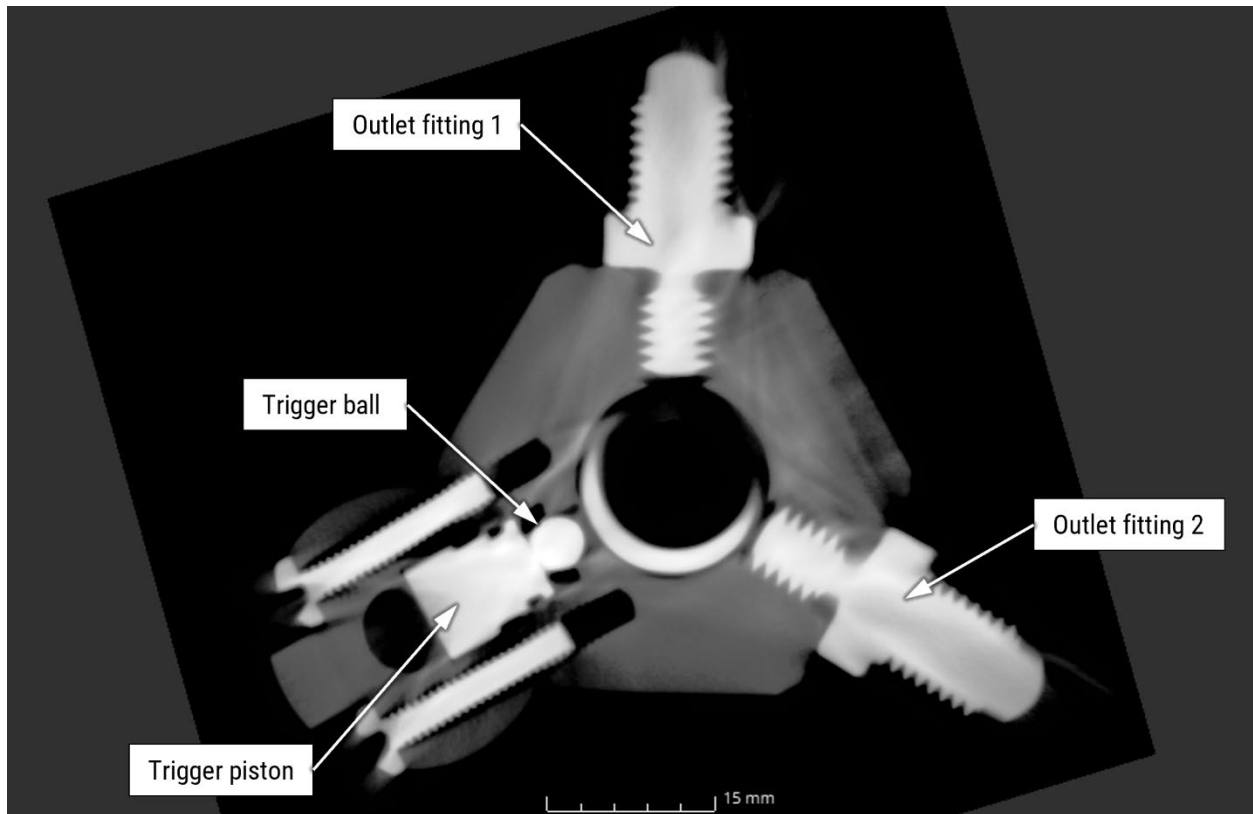
Figure 21 shows a CT slice through the trigger mechanism of the inflation valve from the accident. The pull cable was missing. The breakaway pin (item 180) was not visible in the CT scan. Also, the trigger piston and ball have been shuttled outwards.

**Figure 21.** Components of the inflation valve assembly; top view.

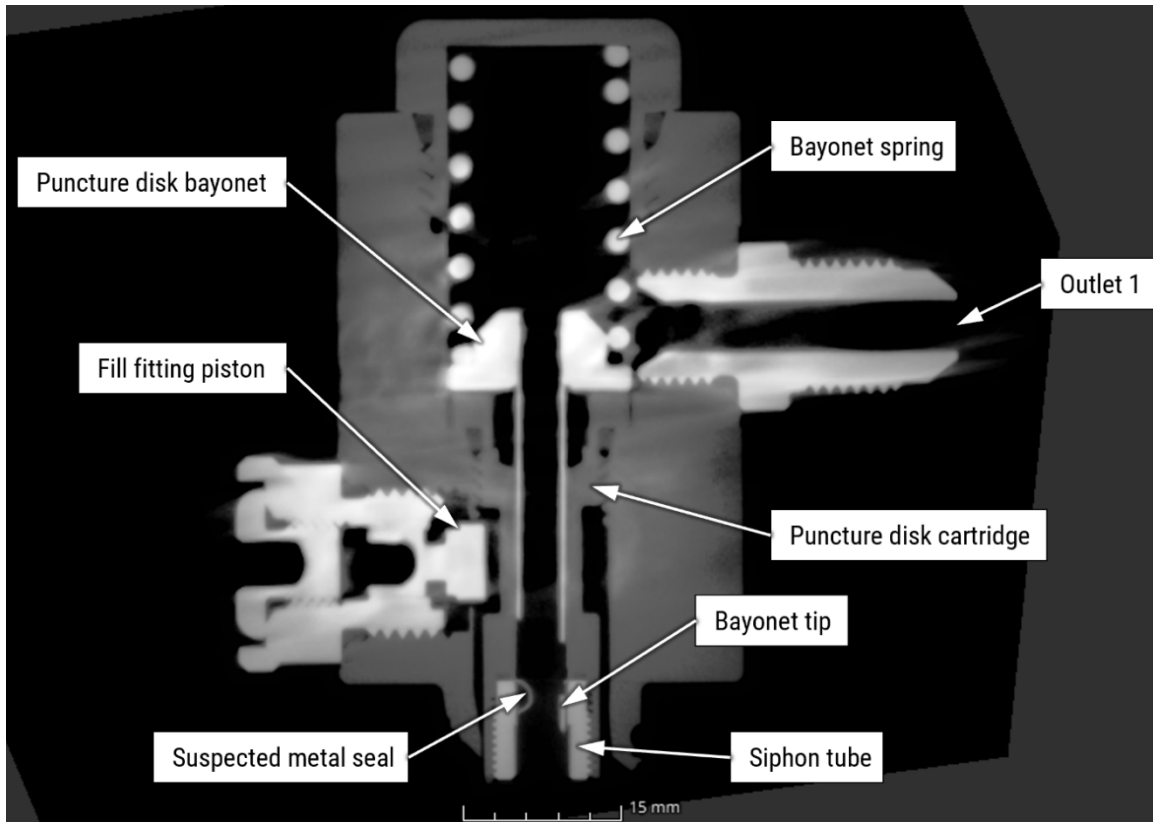
Figure 22 shows a CT slice of the inflation valve from the accident. Given that the bayonet spring (Figure 20, item 230) is in its most uncompressed state without disassembling and that the puncture disk bayonet (item 20) has stroked towards the inflation port, the inflation valve appears to have been activated. Furthermore, a metal seal appears to be broken and curled underneath the puncture disk bayonet.

The following additional observations were made. The inlet area appears to have sustained damage including a broken siphon tube (Figure 19, item 20) and broken threads where the valve body (Figure 20, item 10) mates with the carbon dioxide cylinder. The green safety disk (item 80) appears to be intact (see Figure 23). No other anomalies were identified.

It could not be determined whether the inflation valve activated before or after the airplane impacted the ground.

**Figure 22.** Components of the inflation valve assembly; front view.

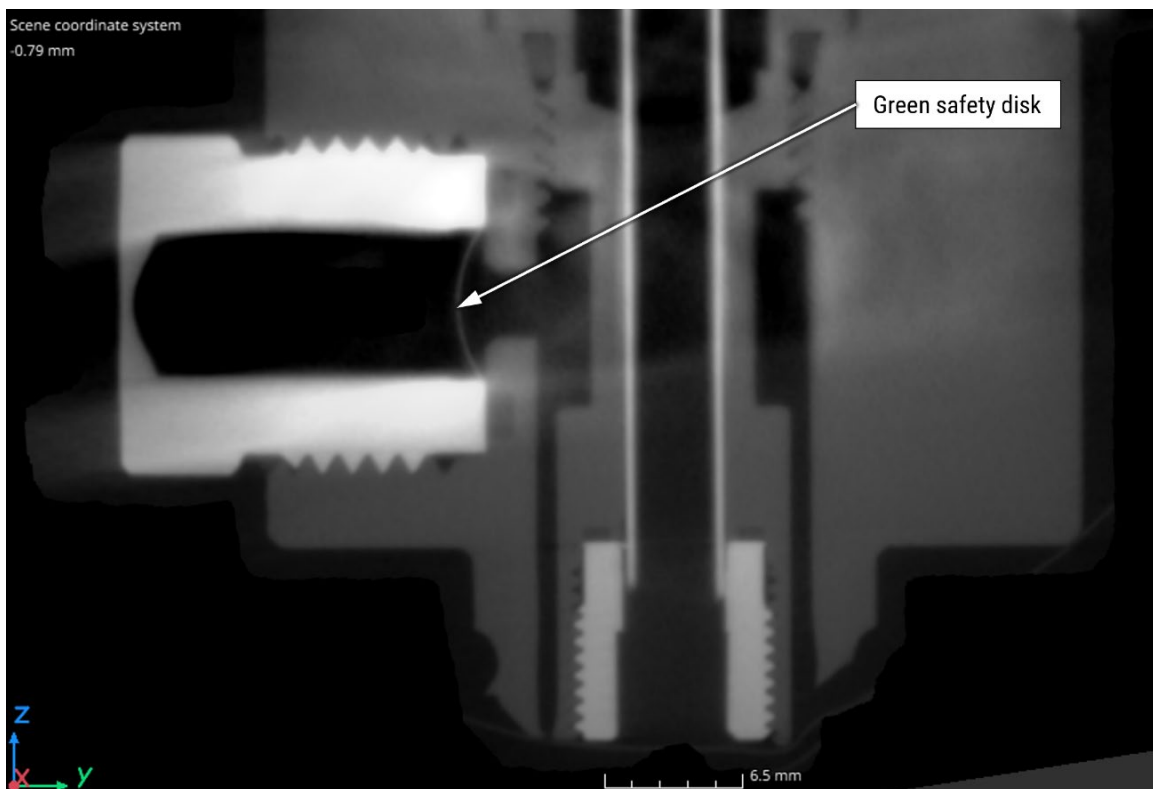
**Figure 23.** Green safety disk as seen in CT slice.
