# National Transportation Safety Board

ERA25MA106

## **AIRWORTHINESS FACTUAL REPORT- WRECKAGE LAYOUT**

Location: Philadelphia, Pennsylvania  
Date: January 31, 2025  
Time: 1807 eastern standard time  
Airplane: Learjet 55, registration XA-CUI

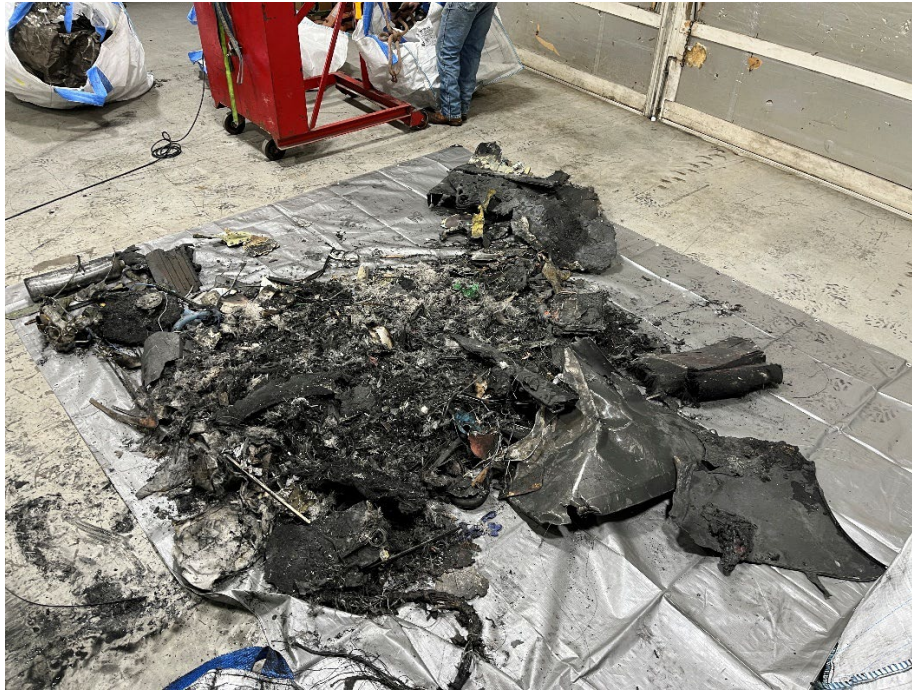
**Figure 3: Bag 10**

Bag 10: Contained various automobile parts and fiberglass. Remnants of an HP laptop computer were identified. An O2 bottle and CO2 medical bottle were identified.

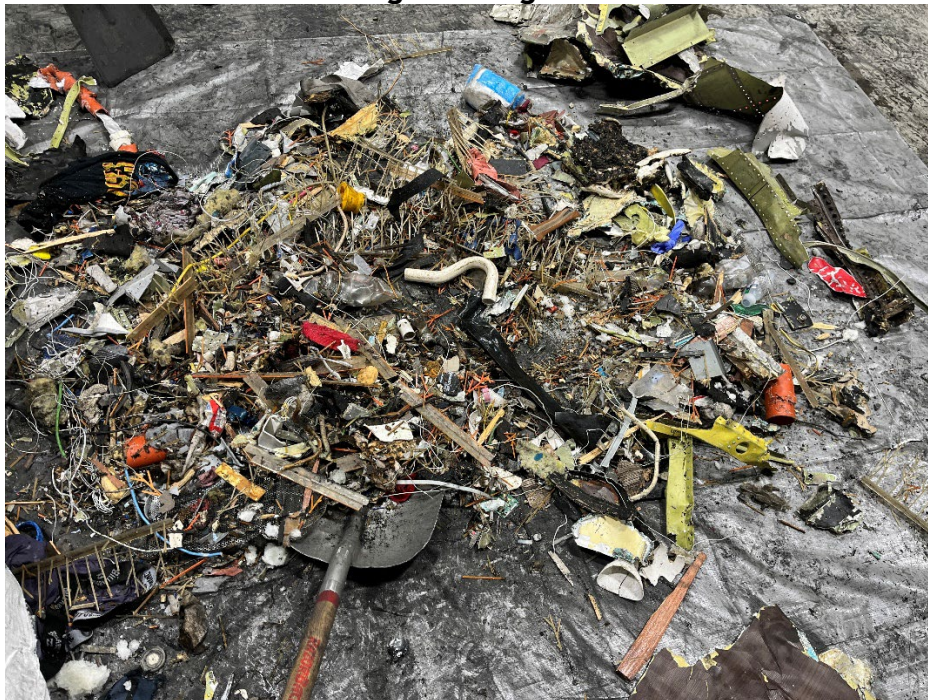
**Figure 4: Bag 21**

Bag 21: Contained airframe structural components and control surface components.

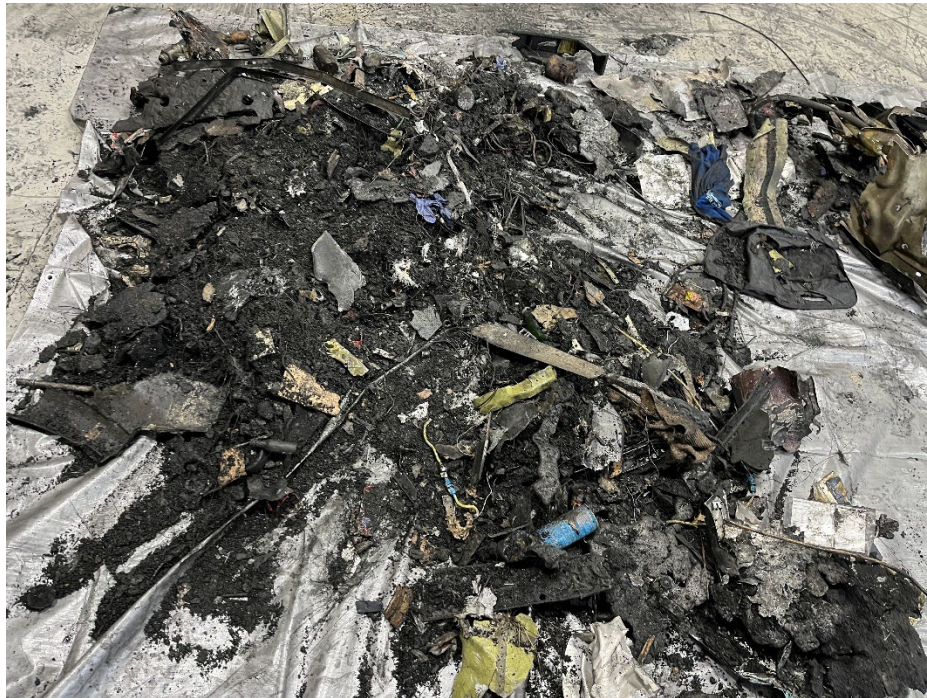
**Figure 5: Bag 9**

Bag 9: Contained a small portion of circuit breaker paneling. A piece of flap track was identified. The bag also contained an anti-ice system valve, aileron control pulley, and external power receptacle.

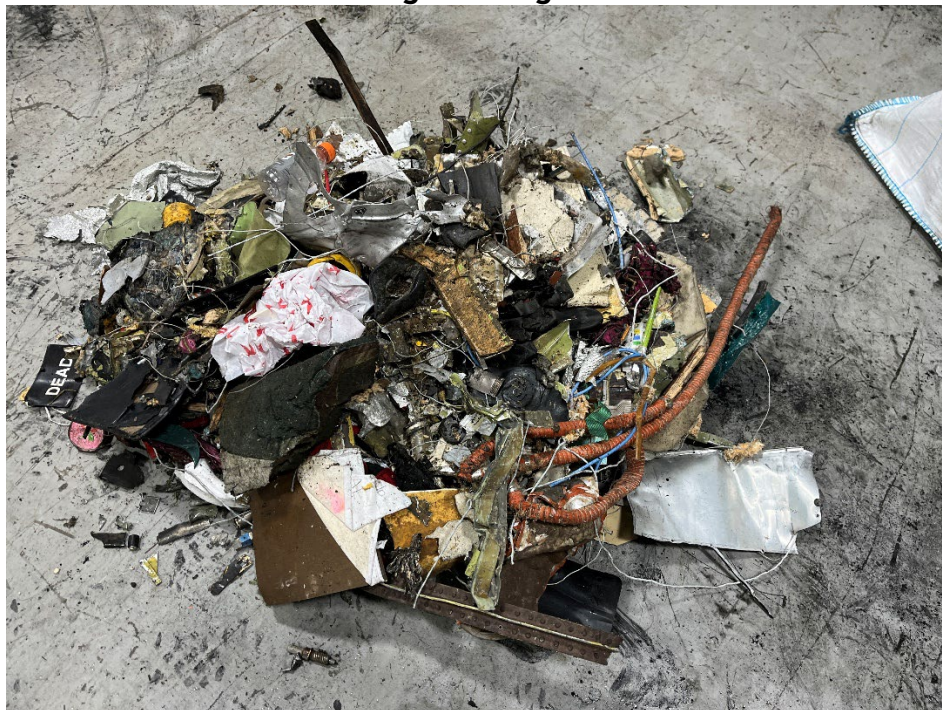
**Figure 6: Bag 1**

Bag 1: Contained the main door components, flap actuator valve, spoiler actuator, and cabin temperature control.

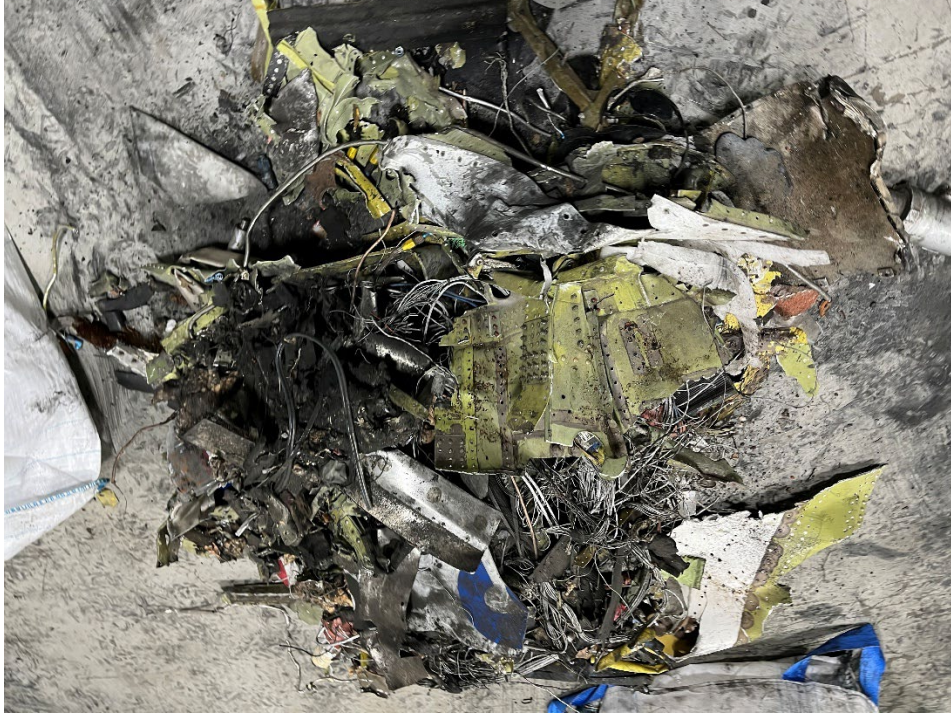
**Figure 7: Bag 28**

Bag 28: Contained a destroyed iPad, several damaged circuit boards, several control cables, the nose gear trunnion, airplane oxygen bottle, and an airframe fuel filter housing. A portion of the fuselage fuel tank with bladder pieces was located. A piece of seat track and air condition lines were within the bag.

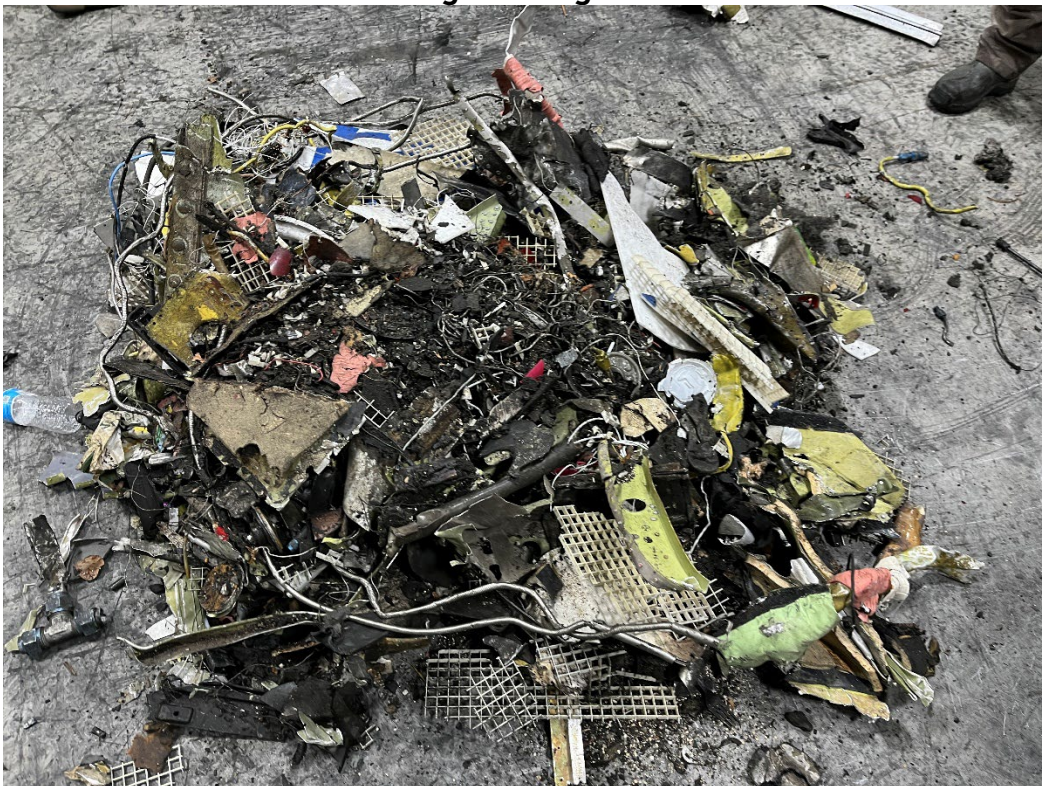
**Figure 8: Bag 13**

Bag 13: Several control cables were in the bag. The avionics junction box, wing spar piece where the landing light attaches, fuel transfer hose, and a portion of a nose gear door.

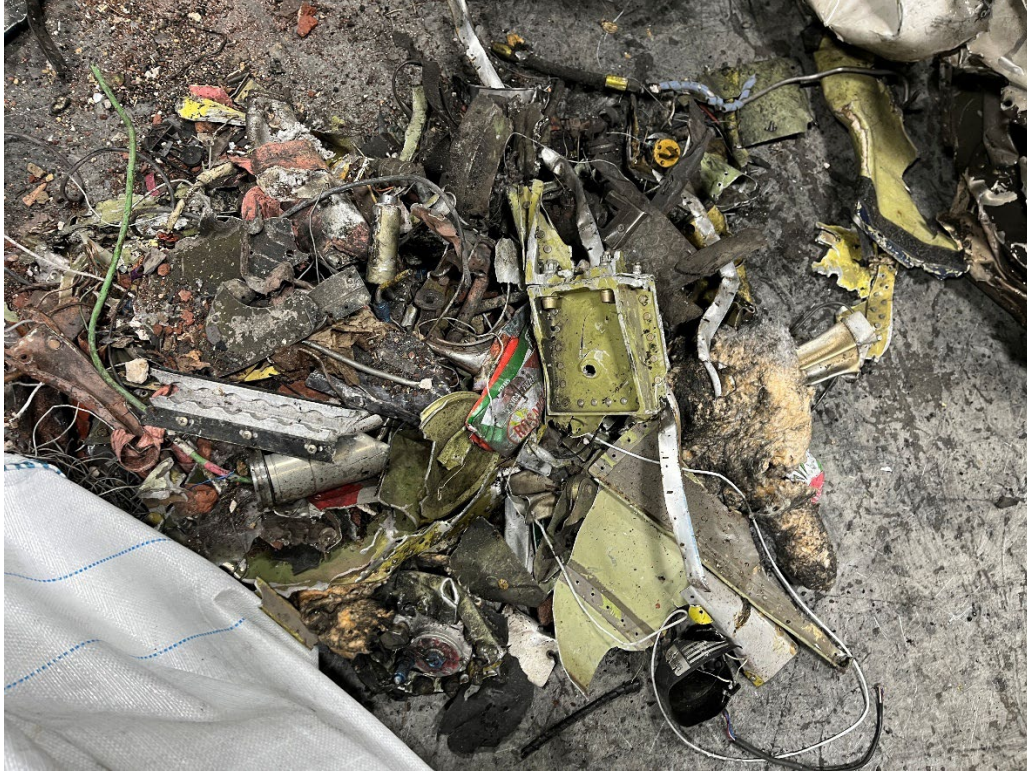
**Figure 9: Bag 29**

Bag 29: Contained the left engine cowling, braking anti-skid control valve, warning light control box, a piece of seat track, a portion of the left spar, and miscellaneous control pulleys.

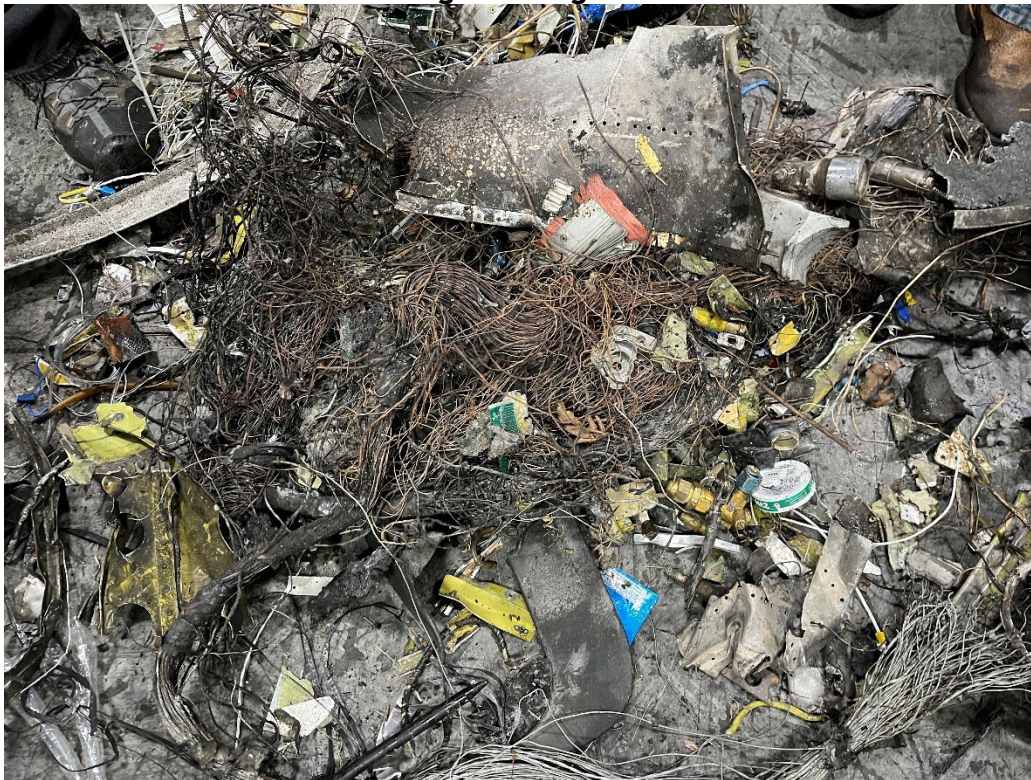
**Figure 10: Bag 31**

Bag 31: Contained a large section of the vertical stabilizer. The bag contained a large portion of a wiring bundle, a flap track, a blowdown bottle, dorsal inlet duct, left winglet, and a copilot rudder pedal fitting.

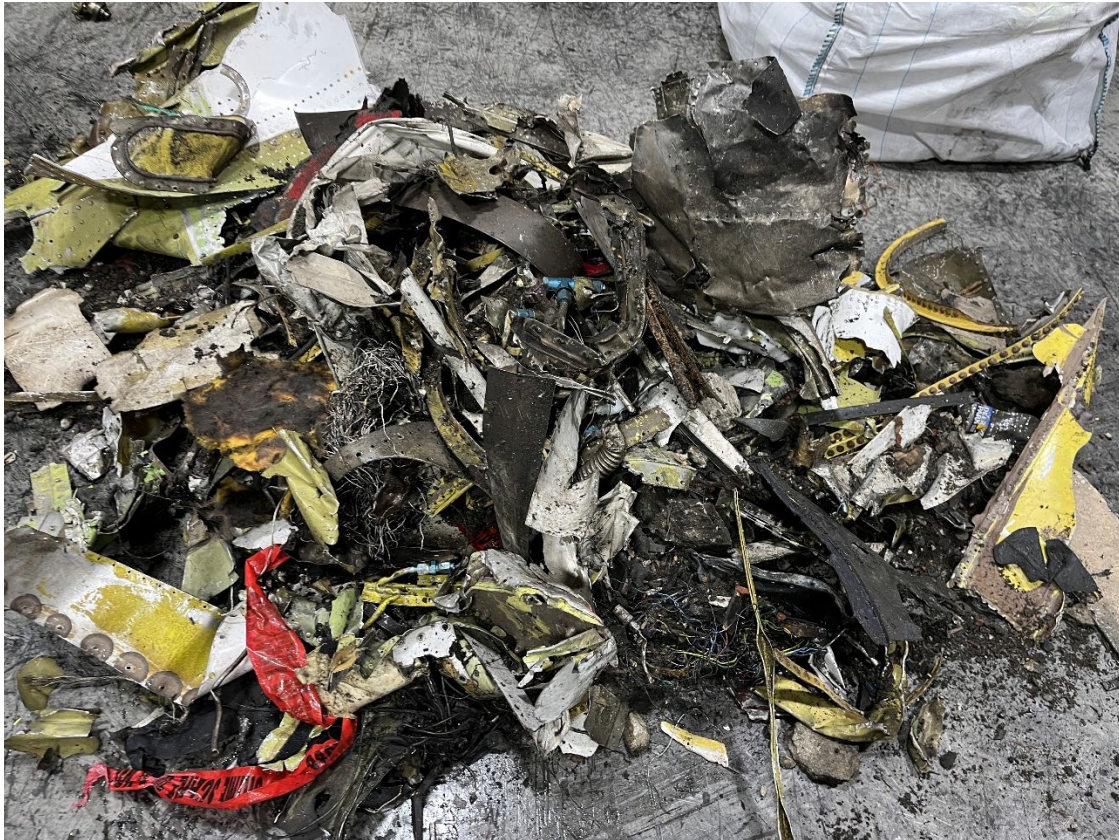
**Figure 11: Bag 14**

Bag 14: Contained the rotating beacon, a flap track, large portions of lower fuselage, and an engine fuel control unit.

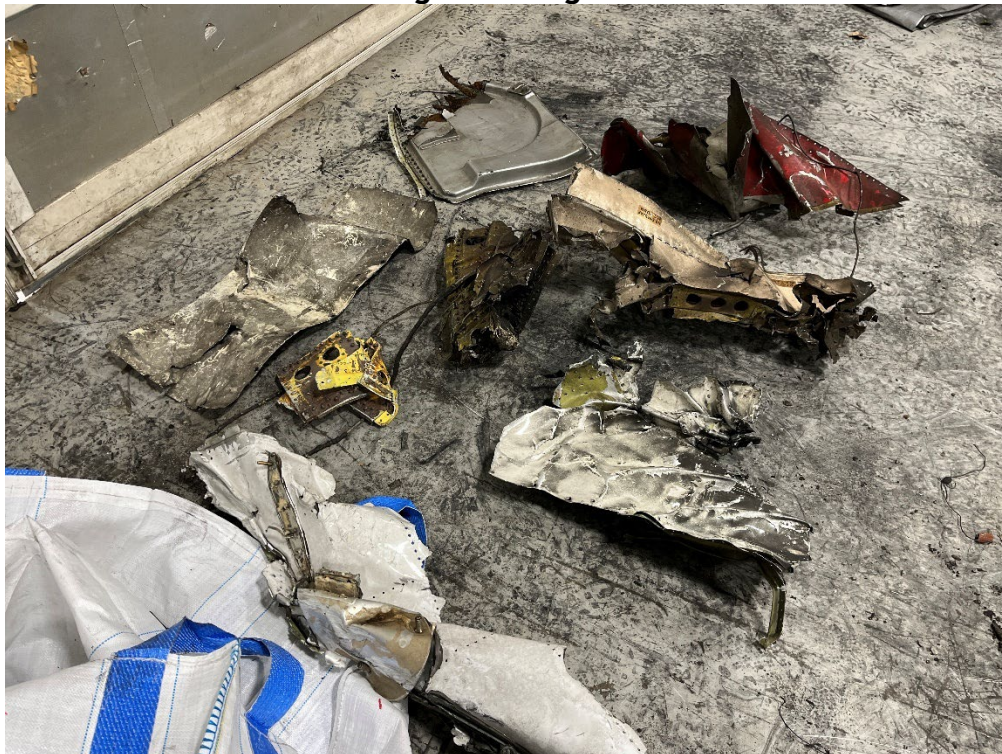
**Figure 12: Bag 35**

Bag 35: Contained portions of the left wing, general wing pieces, and the center gear door.

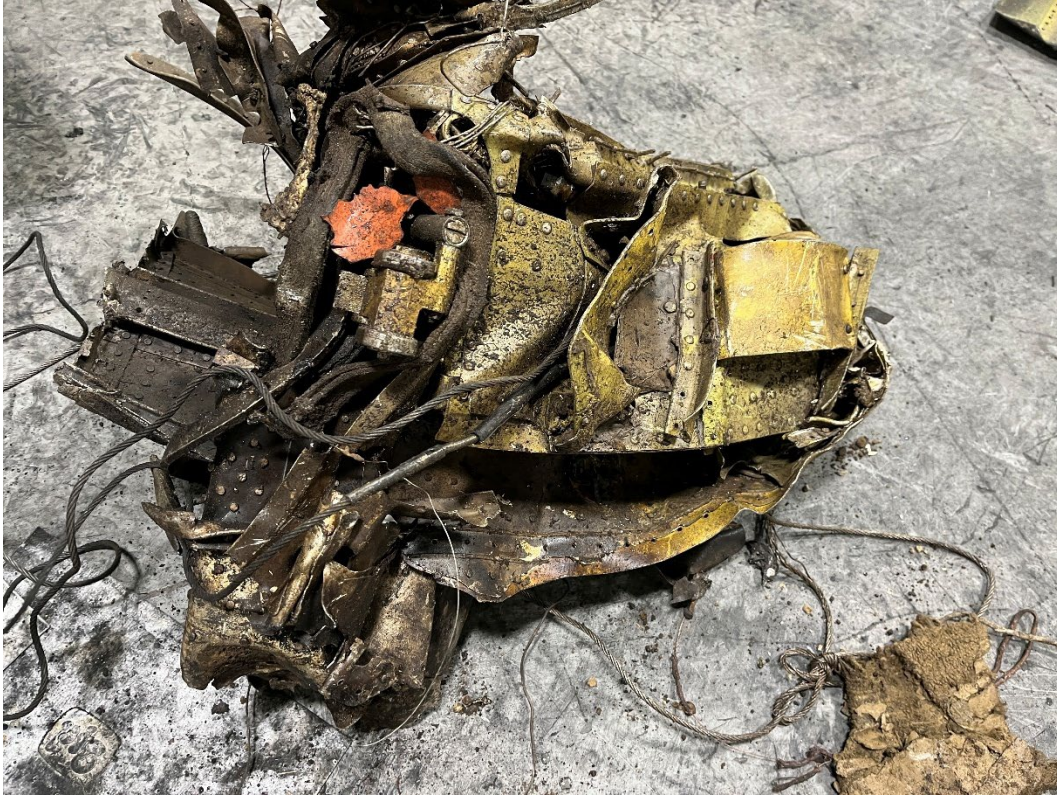
**Figure 13: Bag 25**

Bag 25: Had the large portion of the bottom of the tail structure with control cables attached. The bag contained an engine starter, portion of vertical tail skin, and a portion of an engine fuel control unit.

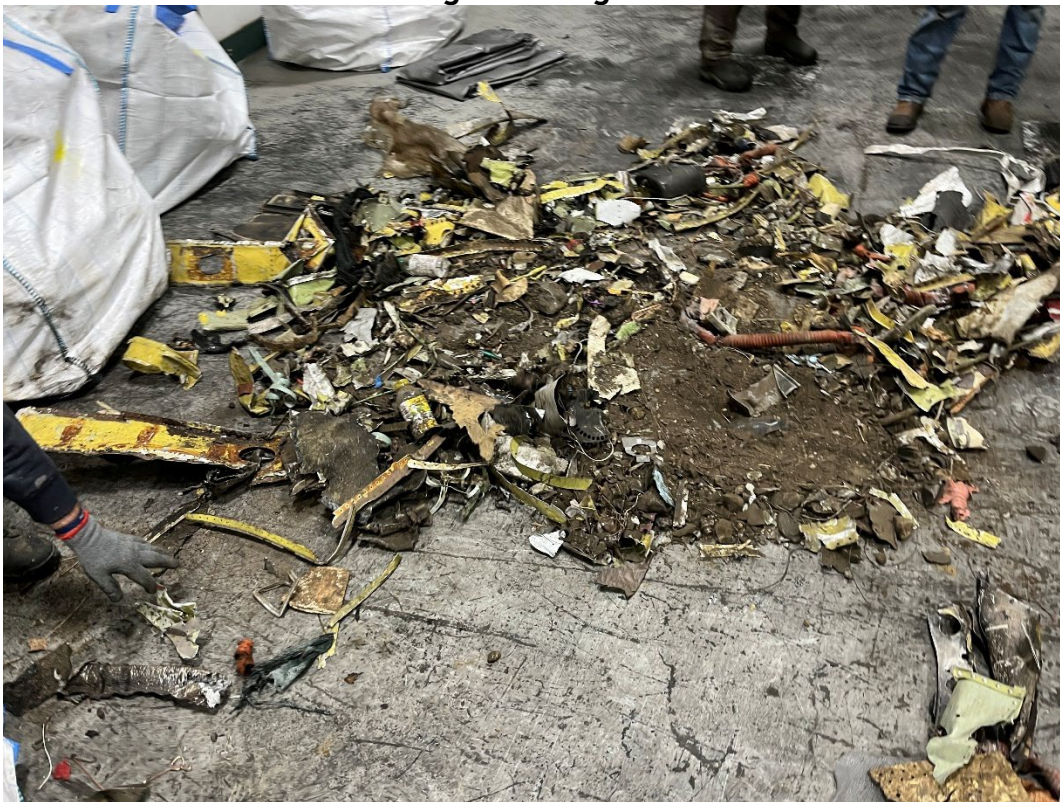
**Figure 14: Bag 36**

Bag 36: Contained windshield structure, windshield, a compressor blade, and the pilot control yoke.

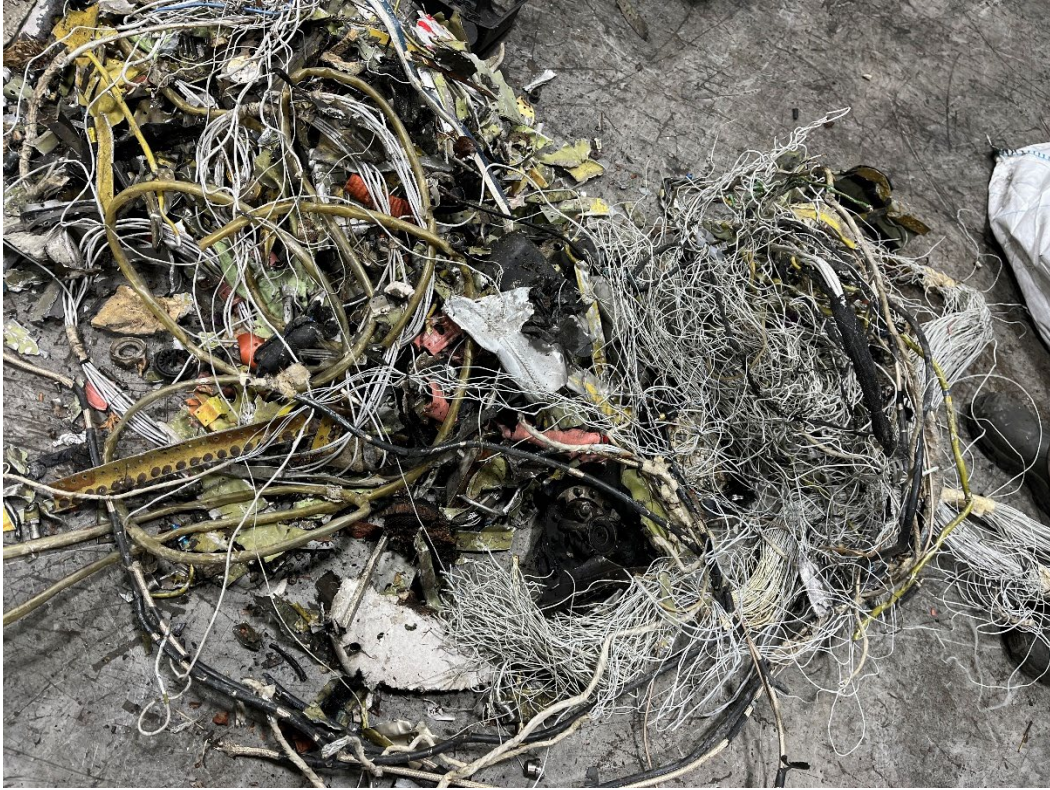
**Figure 15: Bag 27**

Bag 27: Contained a main landing gear door, fuselage fuel tank structure, large wire bundles, left inboard flap, and wing structure pieces.

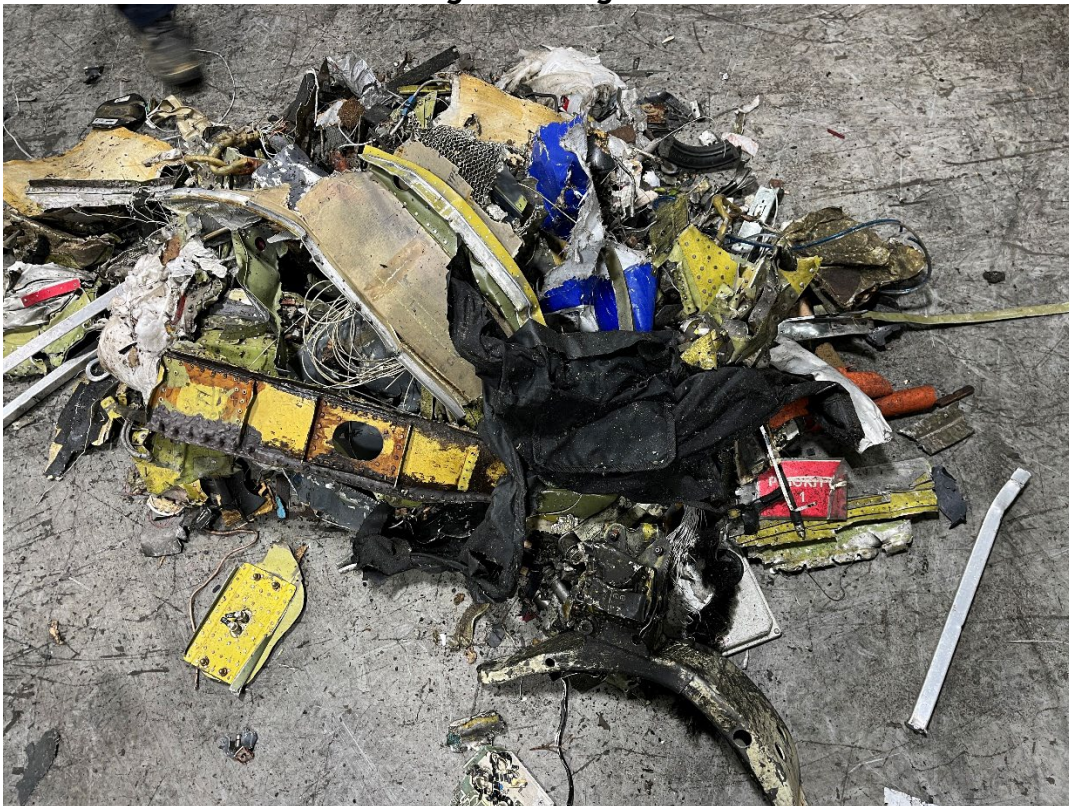
**Figure 16: Bag 5**

Bag 5: Contained the forward and aft left engine mounts, a large wire bundle, various cockpit instrumentation, various avionics equipment, and the internal door handle of the main entry door.

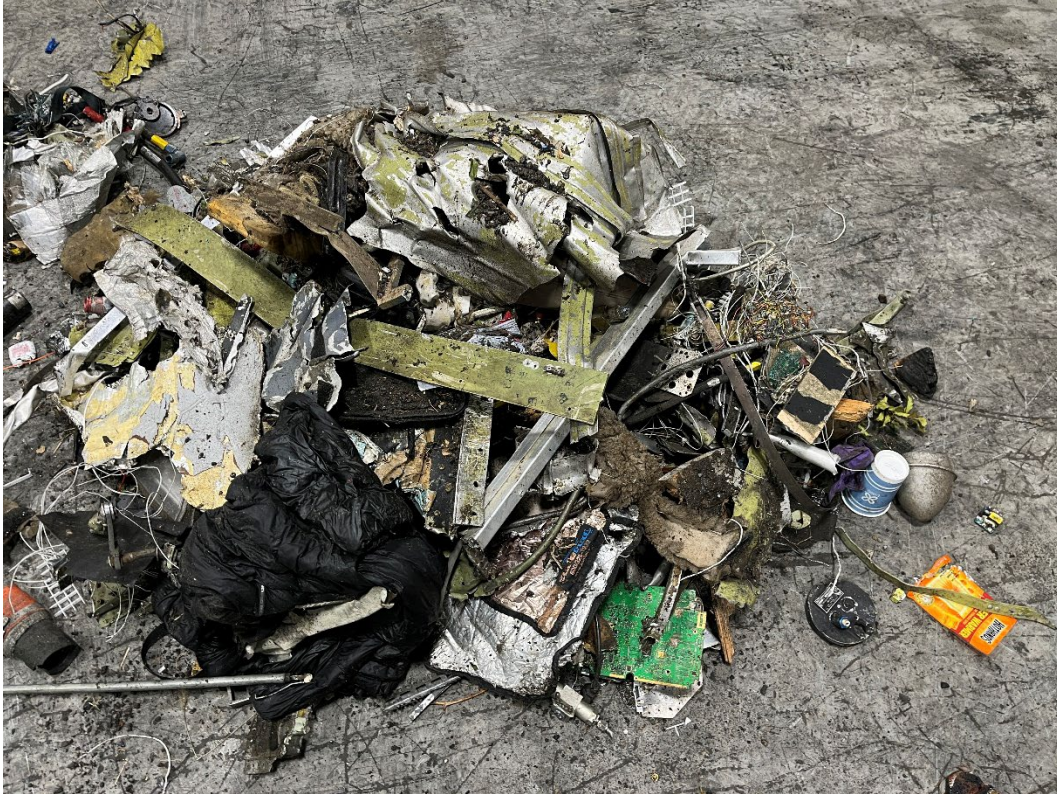
**Figure 17: Bag 3**

Bag 3: Contained the bottom structure of a crew seat, various engine accessories, an engine mount, brake discs, the copilot control yoke, and an aileron control cable with a cut.

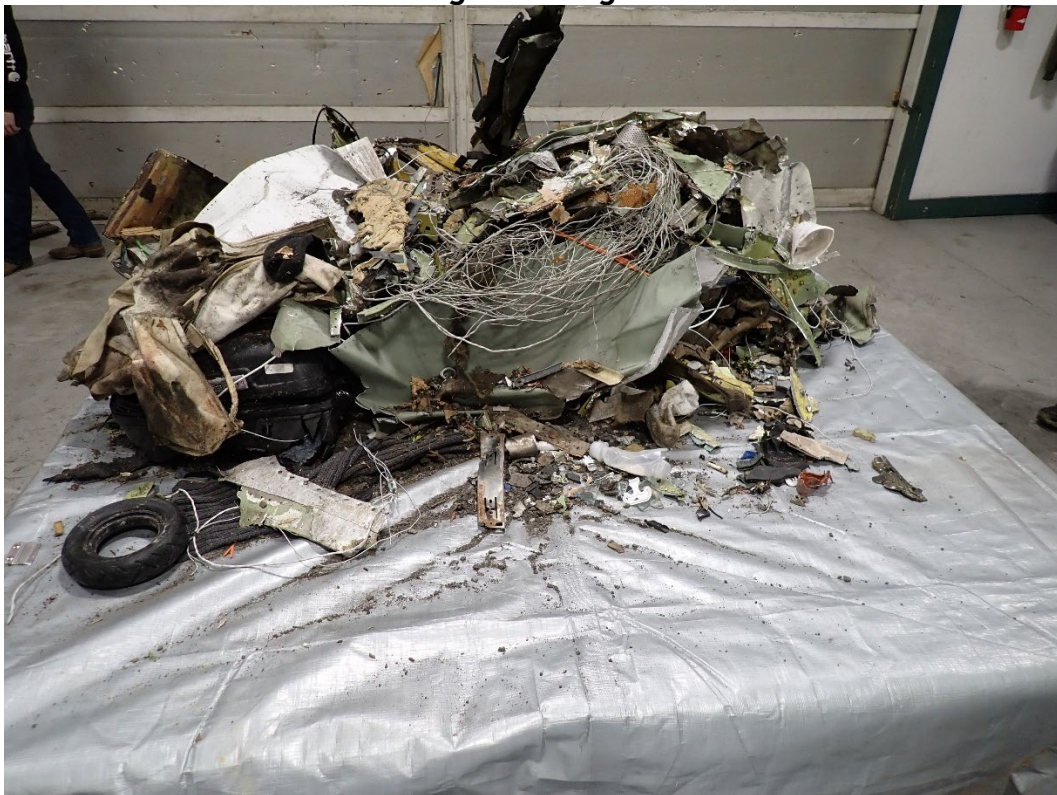
**Figure 18: Bag 37**

Bag 37: Large structural debris. Large portion of wire bundle. Small computer chips. Small pieces of interior panel. Personal clothing and miscellaneous medical supplies. A fragment of a fan or compressor blade.

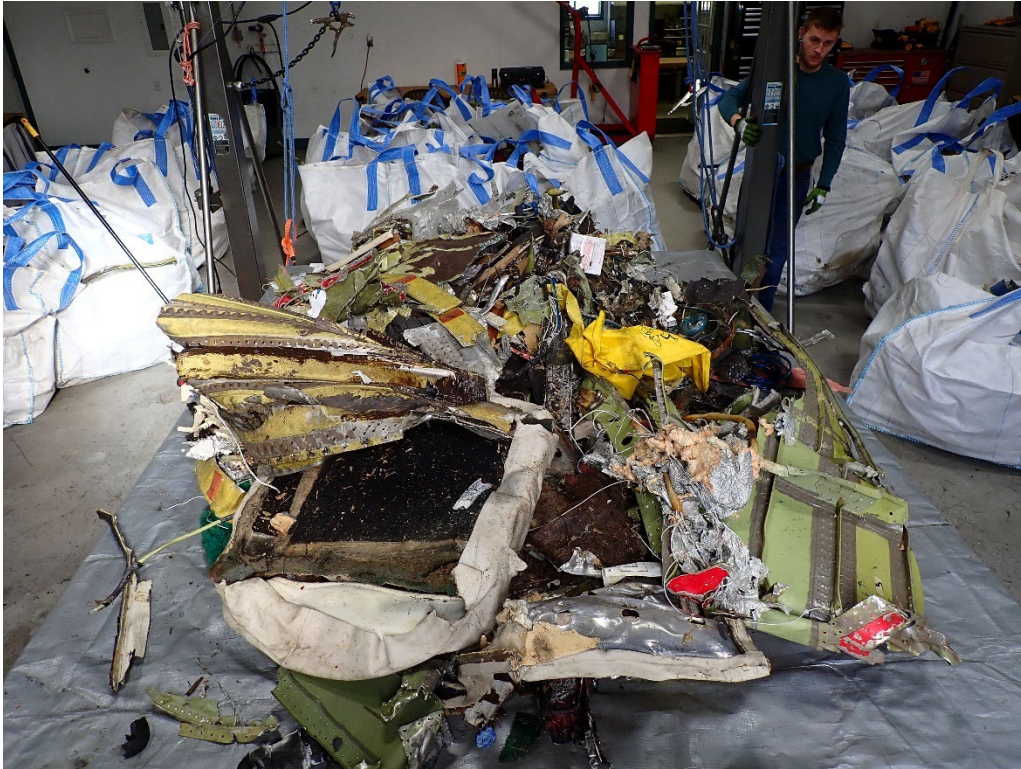
**Figure 19: Bag 38**

Bag 38: Life jacket CO2 cartridge. Window frame. Miscellaneous POH pages. Small computer chip pieces. iPad and Honor phone (destroyed). Miscellaneous medical equipment. Wing spar structure. Aileron balance weight. Three fan stator vanes, fragments of stators, a fragment of a fan blade, and duct flange were identified.

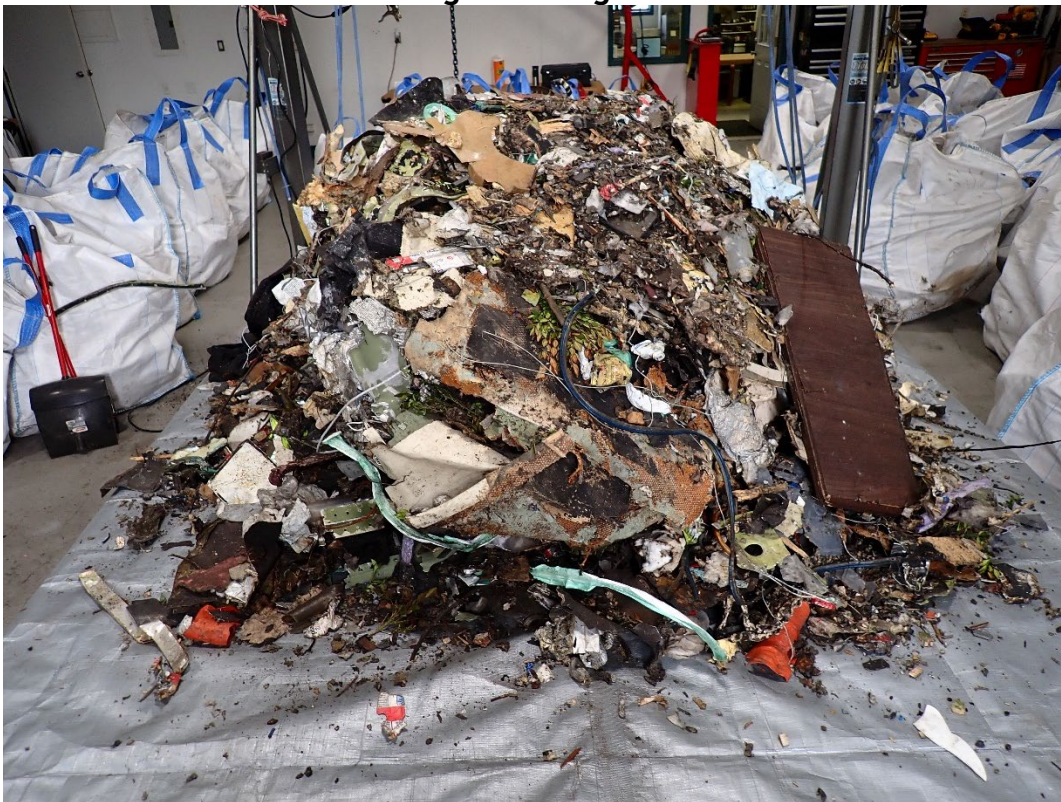
**Figure 20: Bag 39**

Bag 39: Large piece of wing skins. Fuselage skin and strainers. Fuselage fuel cell pieces. 1 wing rib. 1 apple watch, intact, likely from the patient's mother (based on the clothing it was tangled in). Hydraulic filter assembly. A portion of a fan blade and 2 fan stator vanes.

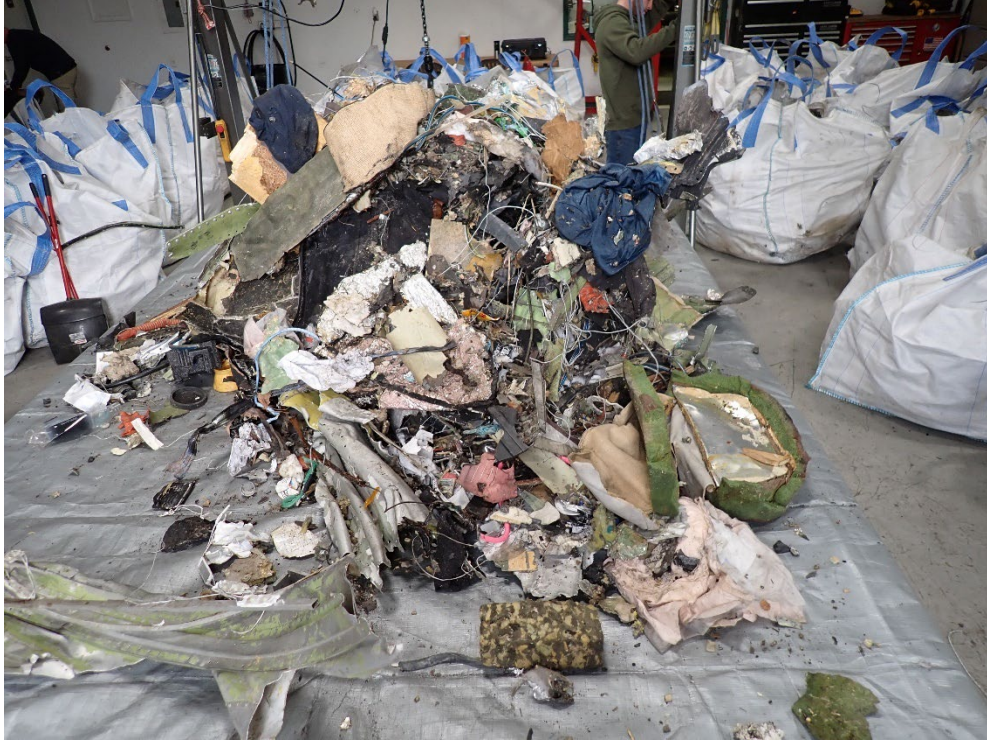
**Figure 21: Bag 40**

Bag 40: Cabin interior components. Piece of engine cowling. Medical equipment. Miscellaneous airplane wiring. Manual pressurization control valve. Frame 25 structure. Fan blade root and fan stator vane.

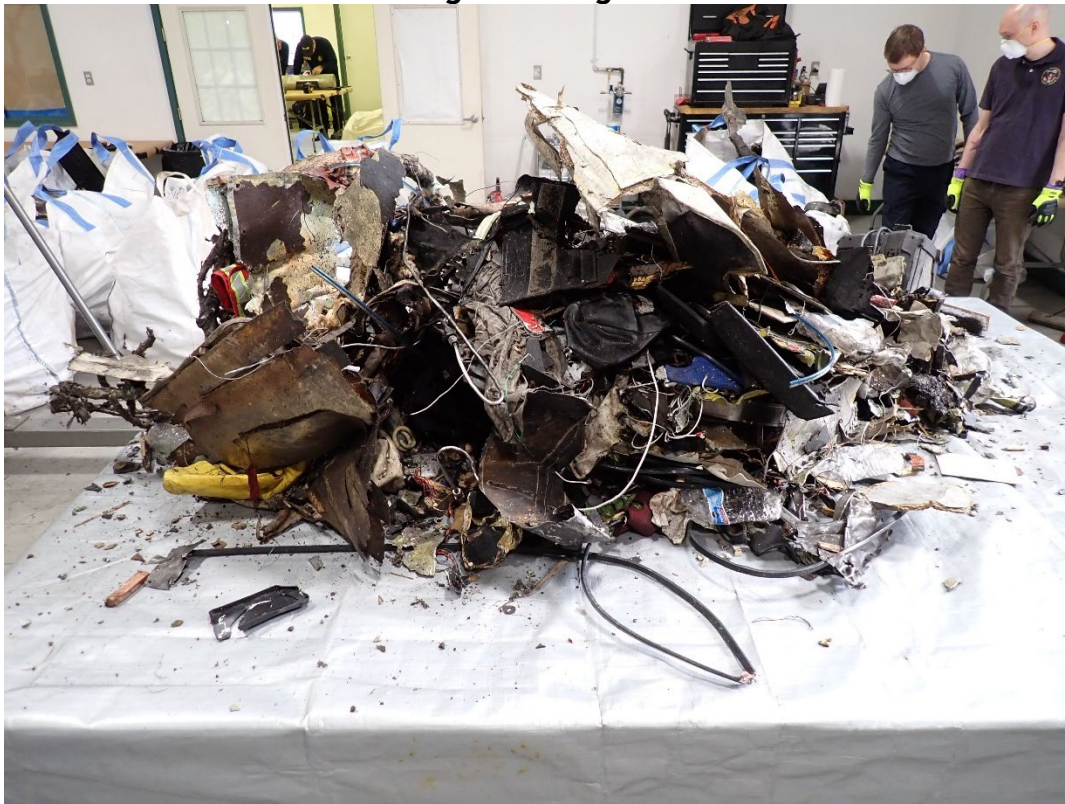
**Figure 22: Bag 8**

Bag 8: Medical equipment. Misc car parts. Flap rotary switch arm. A few airplane ribs and structure. Spar 8 piece. Portion of seat with a portion of seat belt. Fragment of pressure limiter valve (fuel control), fragment of starter pad, a portion of a fan blade, fragment of LPC axial blade (including root), 6 fan stators, and 5 LPC axial stator vanes from two different stages.

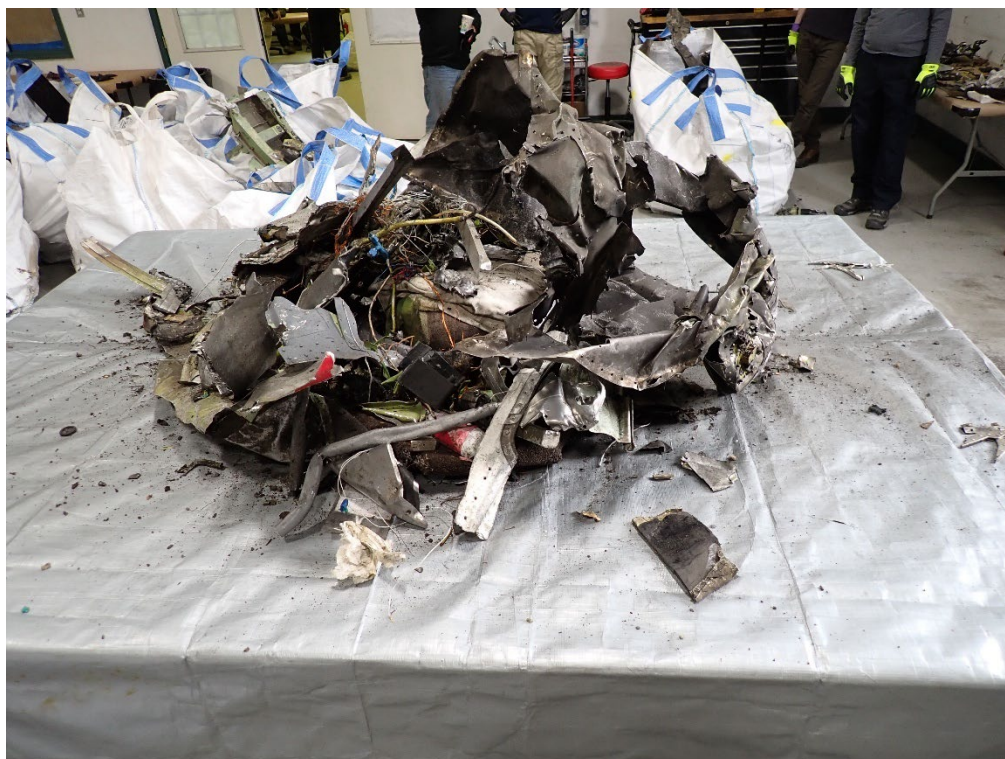
**Figure 23: Bag 6**

Bag 6: Crew seat and seat tracks. Wing skin. Thrust reverser portion. Avionics rack housing. 2 fan blades, 2 fan stators, and 3 LPC axial stator vanes.

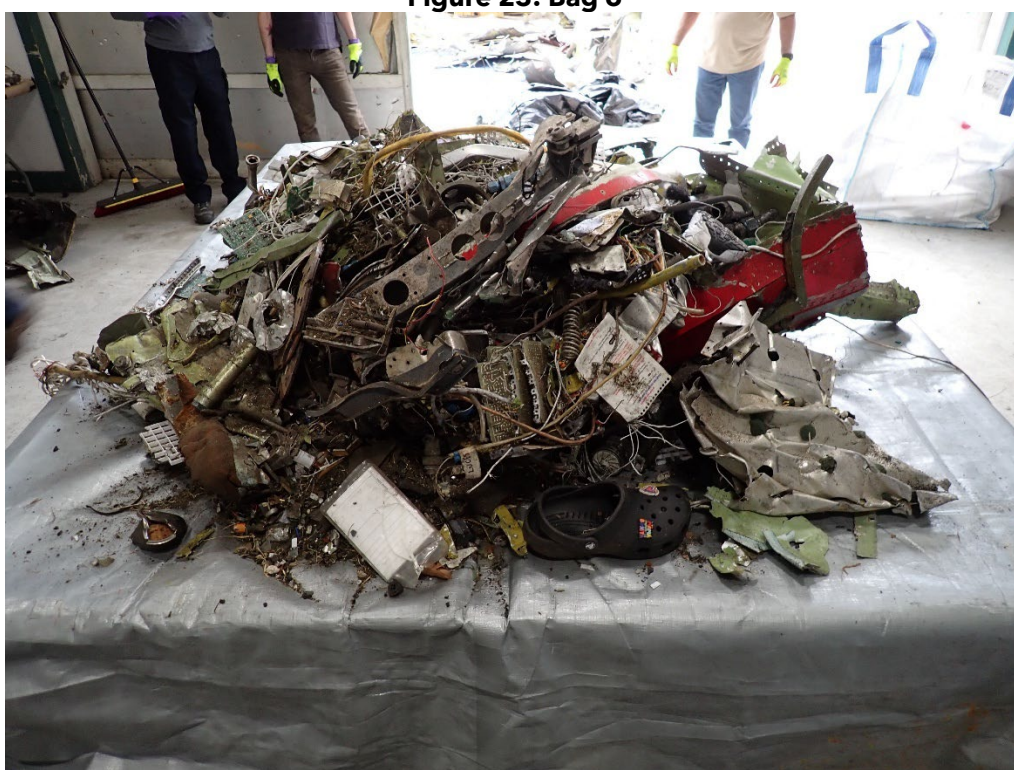
**Figure 24: Bag 4**

Bag 4: Engine fire bottle. Engine thrust reverser chunk. Wheel well parts/brake components. Door and door hinge. Secondary trim actuator motor. Manual pressurization valve. Seat components and tracks. Fragments of intermediate case and bearing housing assembly (inner part of front frame). Bearing from an engine, fragments of FCU, duct fragment, fragments of LPT vane assembly, and a portion of fan blade.

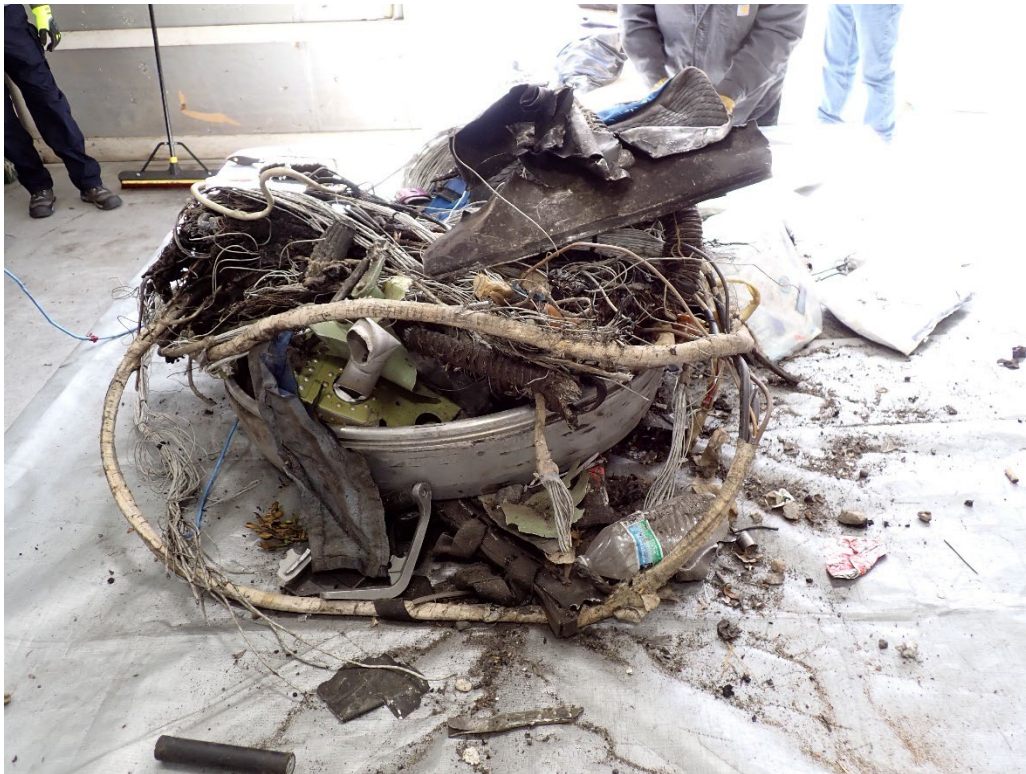
**Figure 25: Bag 41**

Bag 41: Large wire bundle. Medical equipment bags. Fan housing fragment and fragment of LPT vane assembly.

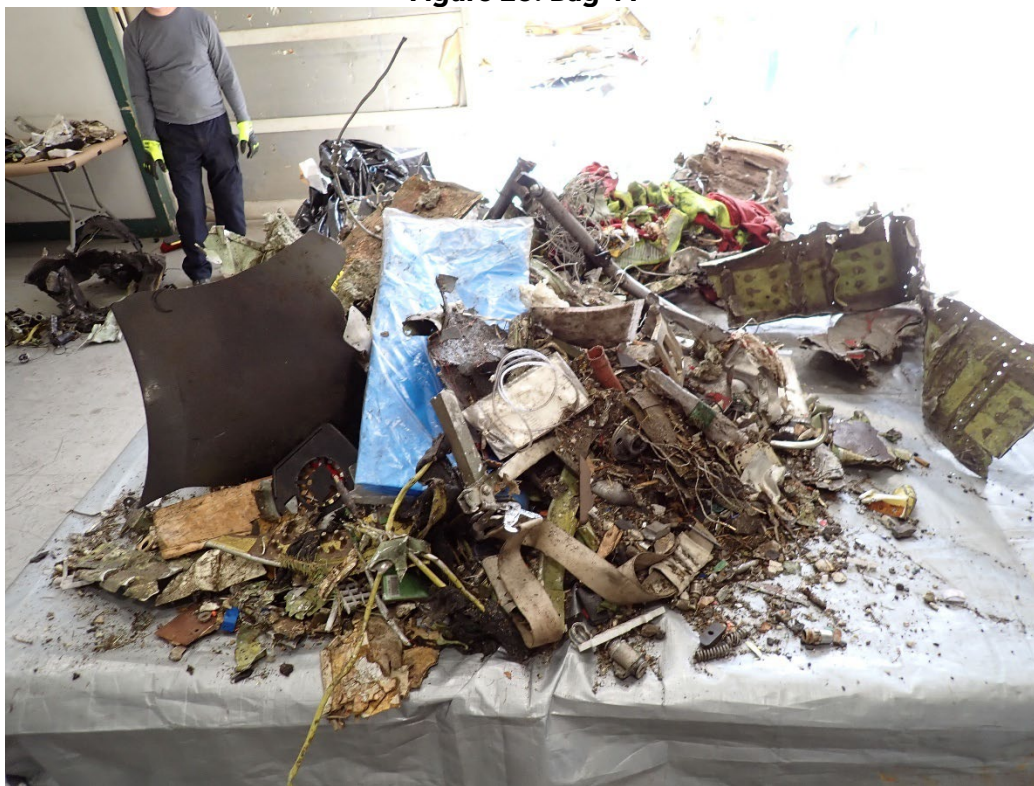
**Figure 26: Bag 42**

Bag 42: Left hand fuselage front entry door, door pulley cables, and handle. Seat tracks, seat belt, fuselage skin, pitot tube. Engine cowl or bypass duct. 2 fan blades. Fan stator, fuel heater, and a fragment of bypass duct with some LRUs attached.

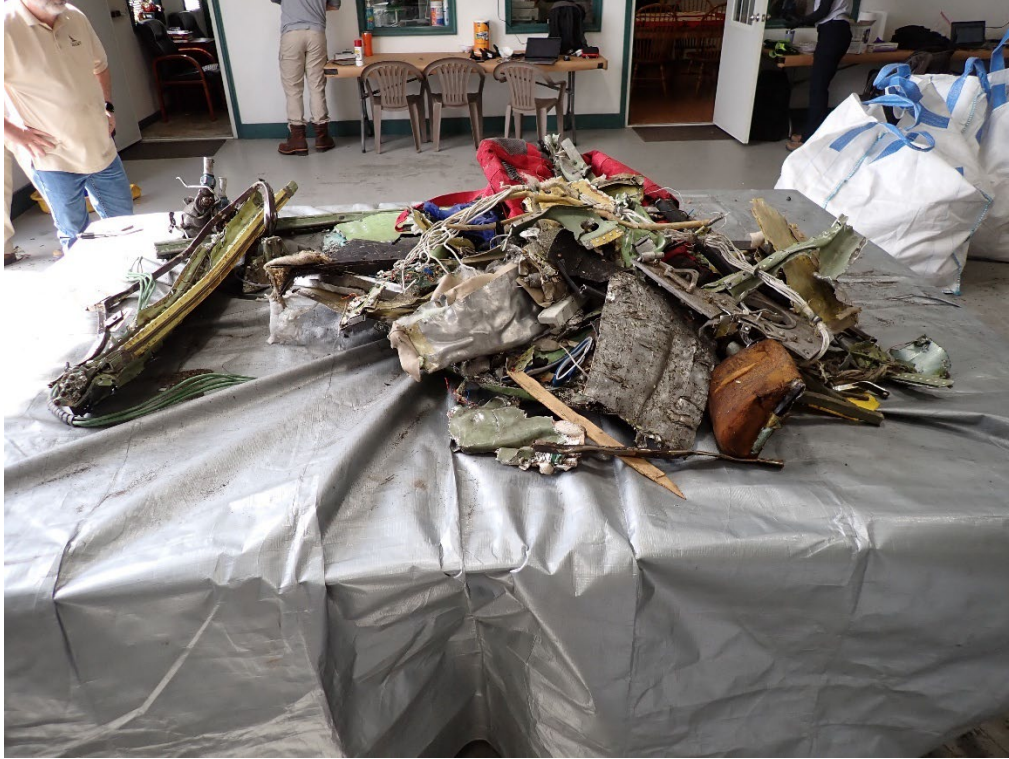
**Figure 27: Bag 43**

Bag 43: Engine fire bottle. Aft cabin baggage compartment floor structure. Medical bag and medical equipment. 3 large engine fan blades. Flight computer and steering guide.

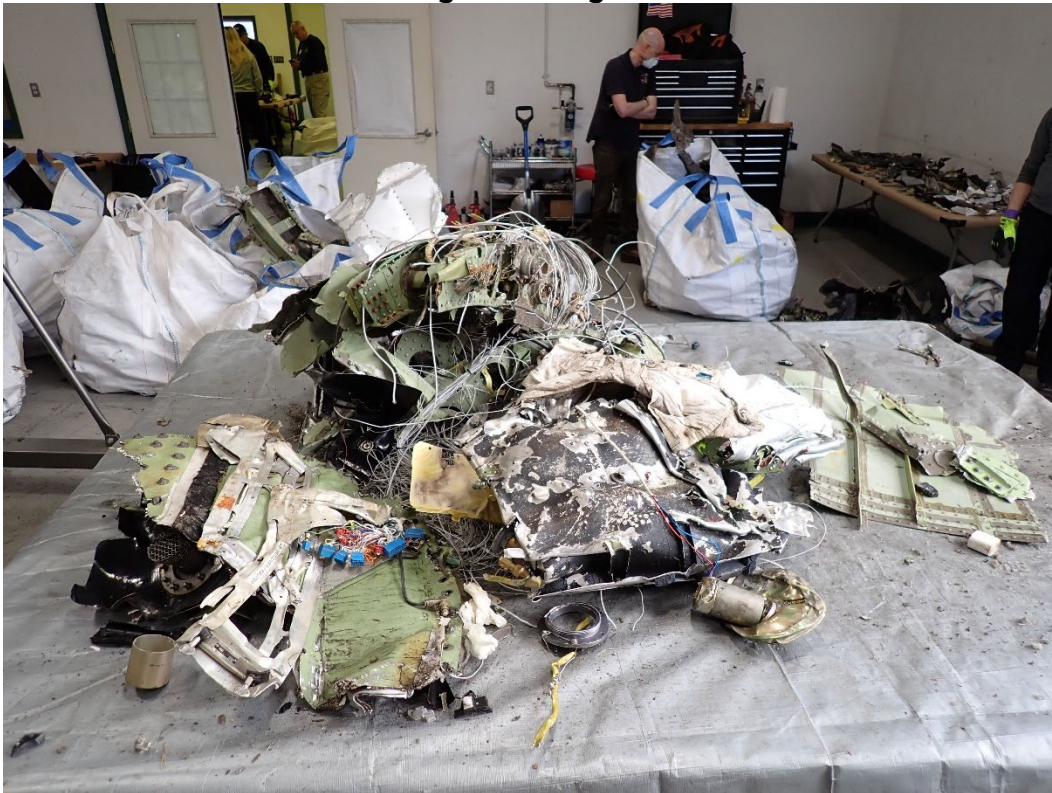
**Figure 28: Bag 44**

Bag 44: (initially mislabeled as 43). Large wiring bundles. Fuselage structure. Cockpit structure with expansion valve. Avionics computer. Fuel cap attached to structure. Aft pressure bulkhead. Aft pressure feed through frame and wiring. Piece of seat track. Fan blade.

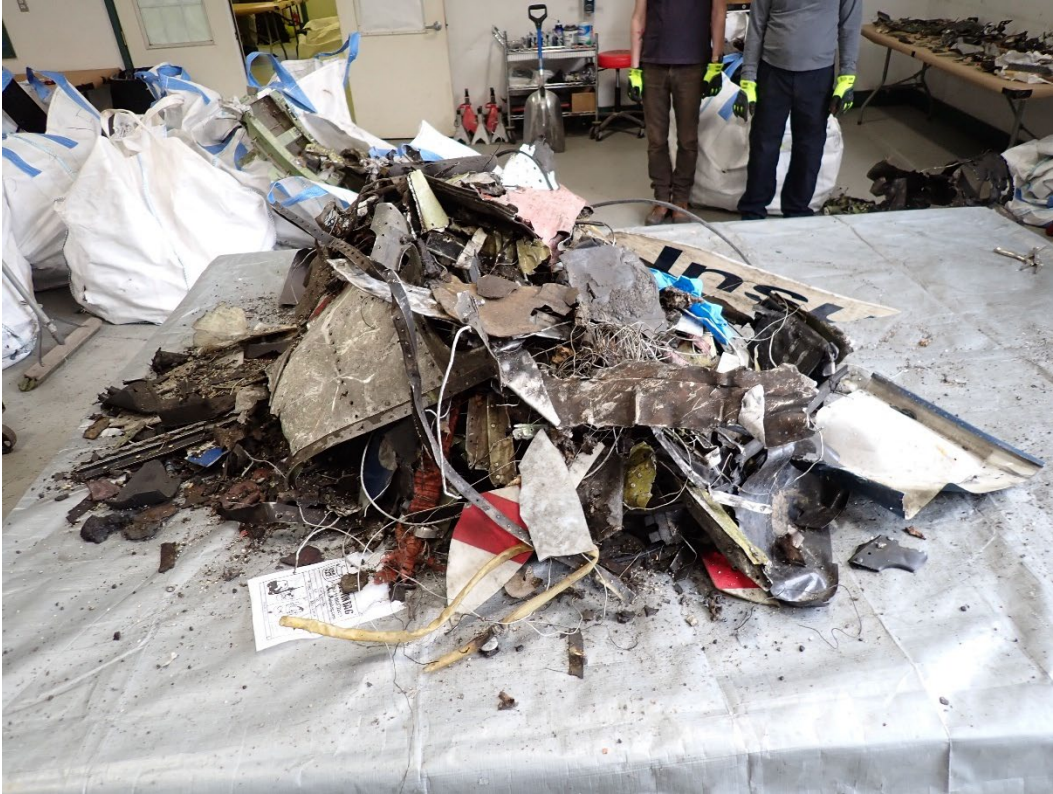
**Figure 29: Bag 12**

Bag 12: Nose wheel steering gearbox. Fan stator shroud.
