# National Transportation Safety Board

ERA25MA106

## **AIRWORTHINESS FACTUAL REPORT- WRECKAGE LAYOUT**

Location: Philadelphia, Pennsylvania  
Date: January 31, 2025  
Time: 1807 eastern standard time  
Airplane: Learjet 55, registration XA-CUI

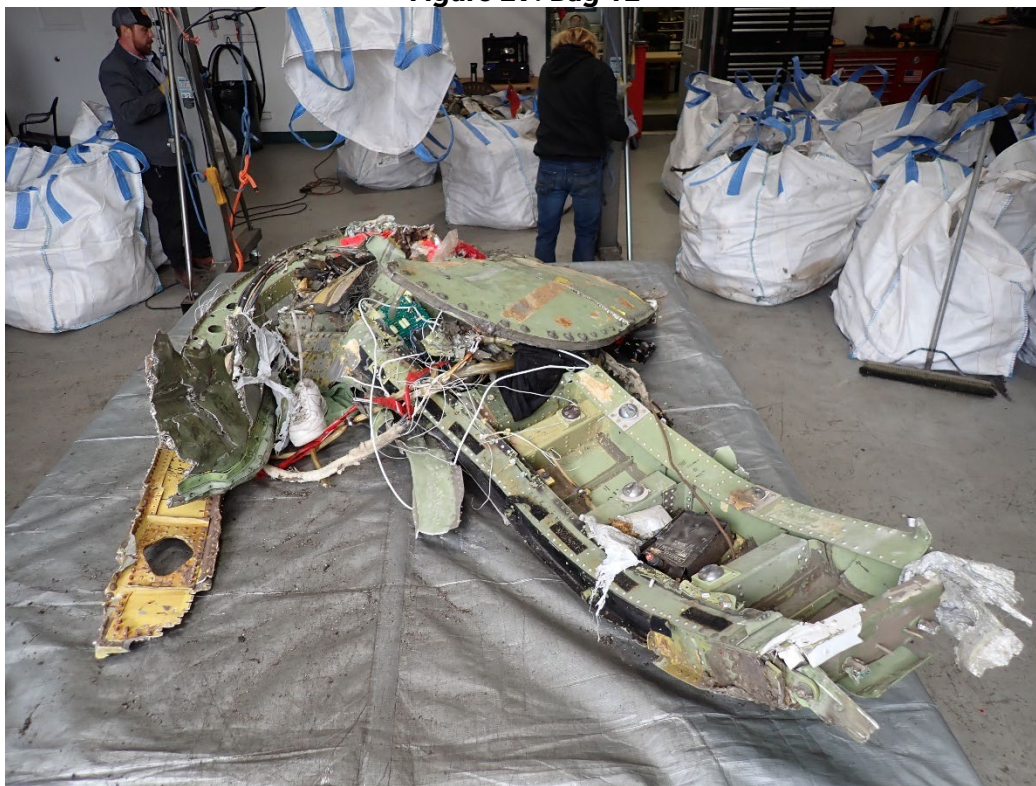
**Figure 30: Bag 45**

Bag 45: Fuselage frame aft of the emergency exit. Aft pressure bulkhead parts. Raft ELT/additional survival equipment. Wing structure. Large wiring bundles. Windshield structure and glass.

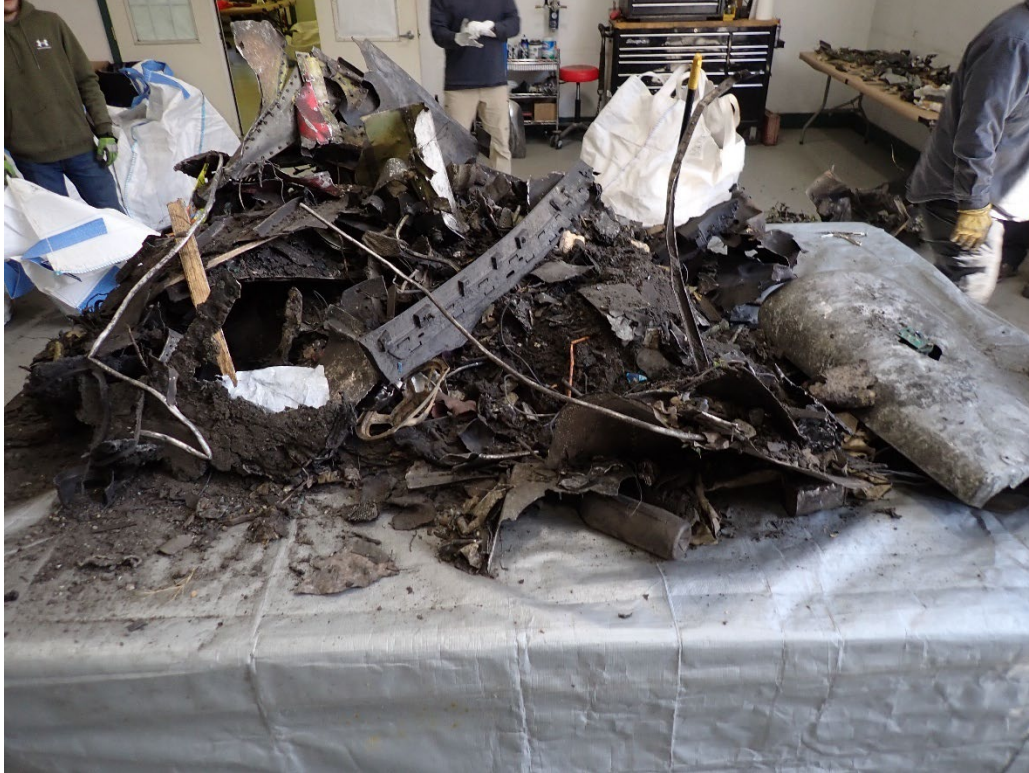
**Figure 31: Bag 17**

Bag 17: Significant amount of soil. 4 fan stators blades and portion of shroud. Small pieces of structure. Portion of landing gear trunnion pin. Fragment of a fan blade tip.

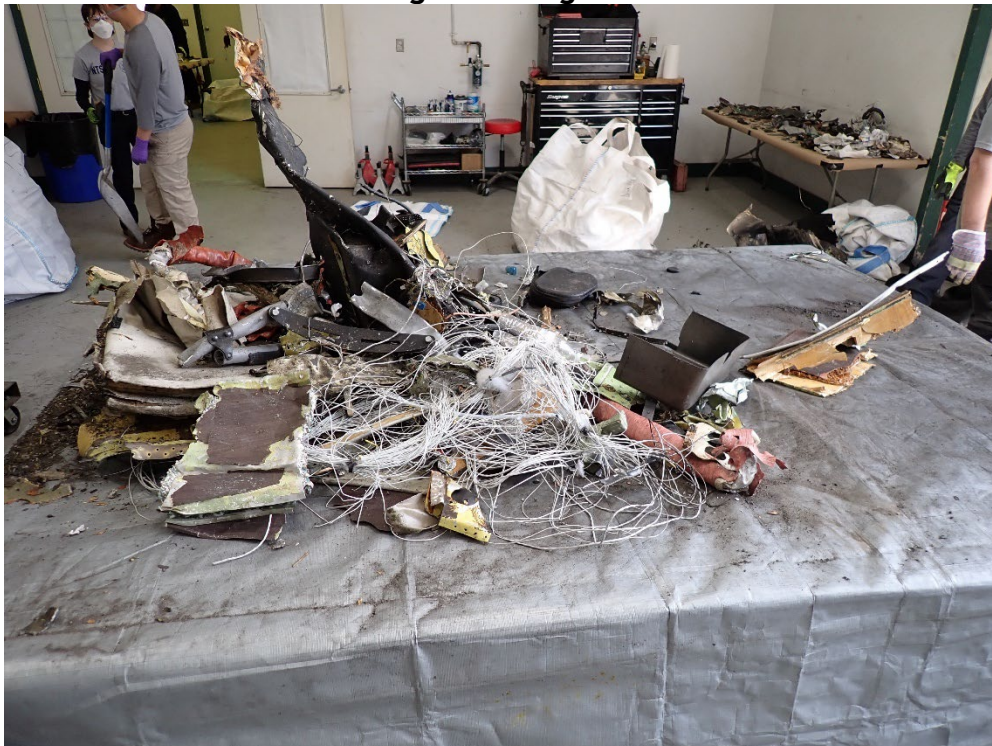
**Figure 32: Bag 46**

Bag 46: Quantities of wiring bundles. Part of control yoke. Bleed air ducting. Seat and seat tracking. 2 fan blades. LPC shroud, 5 fan stators, and 3 LPC axial stators.

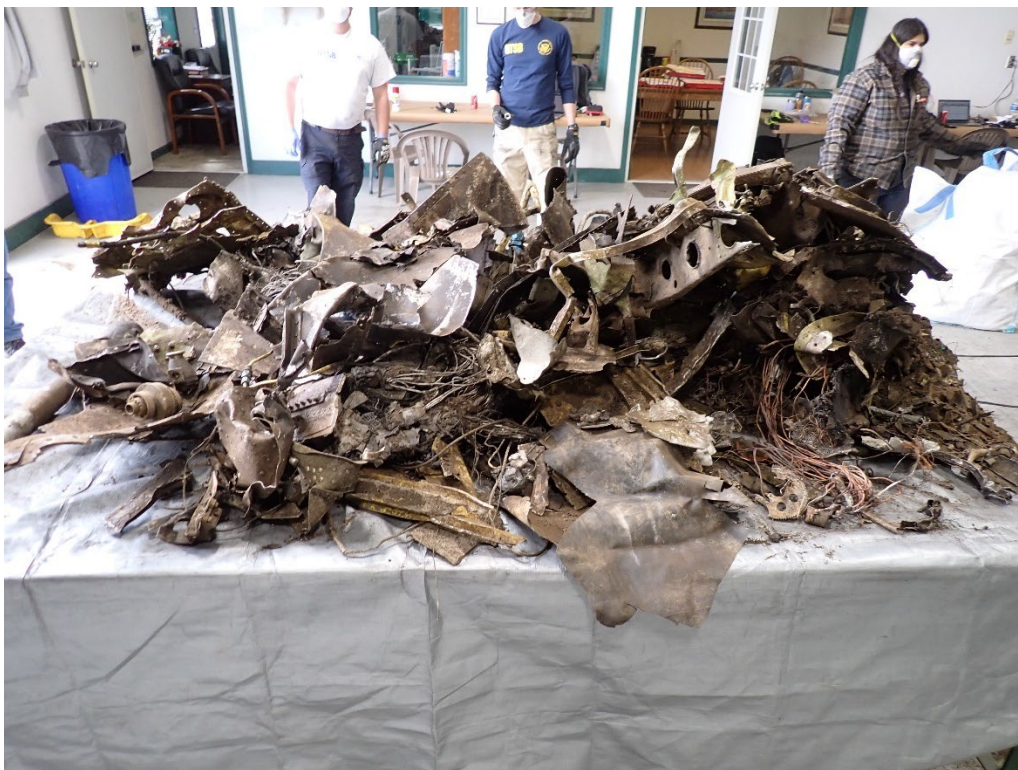
**Figure 33: Bag 24**

Bag 24: Main landing gear actuator. Tail cone structure. Rudder torque tube. Hydraulic shutoff valve. Aft fuselage structure. Generator wiring. Hinge portion of left-hand aileron balance tab. Hydraulic filters. Low pressure fuel filter housing. Control cable and turn buckle pieces. Potential autopilot servo and control cables. Wing attachment. 23 LPC stators, 4 fan stators, 4 LPC blades, a shroud fragment, and a flange fragment. Fan blade fragments and a fragment of transition liner.

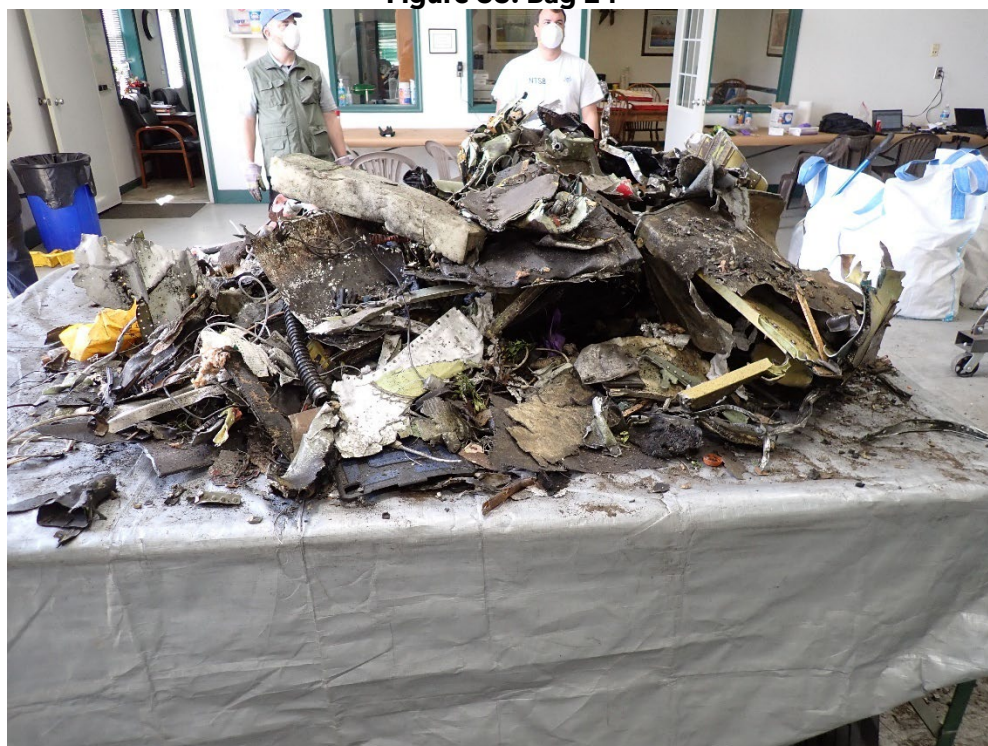
**Figure 34: Bag 15**

Bag 15: Fuel flow indicator dial face. Engine inlet. Pressure bulkhead. Windscreen fragments. 5 fan blade fragments, 8 LPC axial stators, 12 fan stators, and a fan stator shroud fragment.

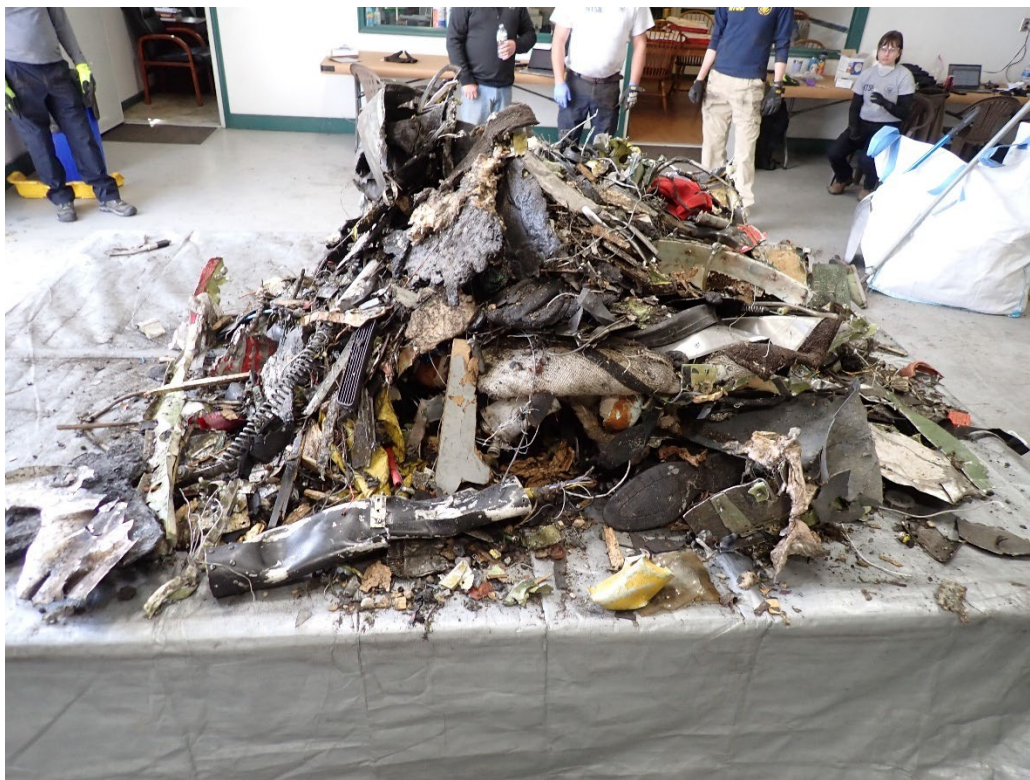
**Figure 35: Bag 7**

Bag 7: Leading edge of the rudder and balance weights. Cockpit switches and breakers. Portion of flight control section. Destroyed iPhone. 5 fan stators, 1 fan blade fragment, 3 LPC axial stators, 3 LPC blade fragments, an accessory gearbox fragment, and a fragment of a spinner.

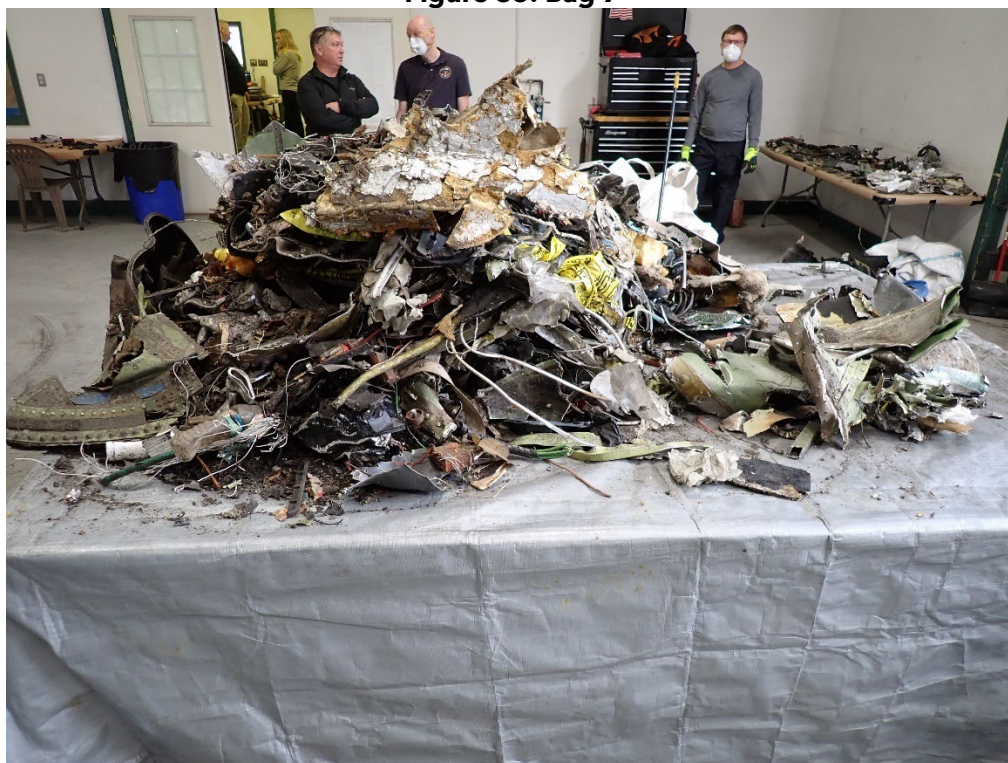
**Figure 36: Bag 2**

Bag 2: Rudder pedals and controls, iPhone (damaged but retained). Cockpit switches. Seatbelts and seats. Portion of control column with cables. Flight control push pull tubes. 3 fan blade fragments, 2 fan stators, oil cooler, a tube, and 1 LPC blade.

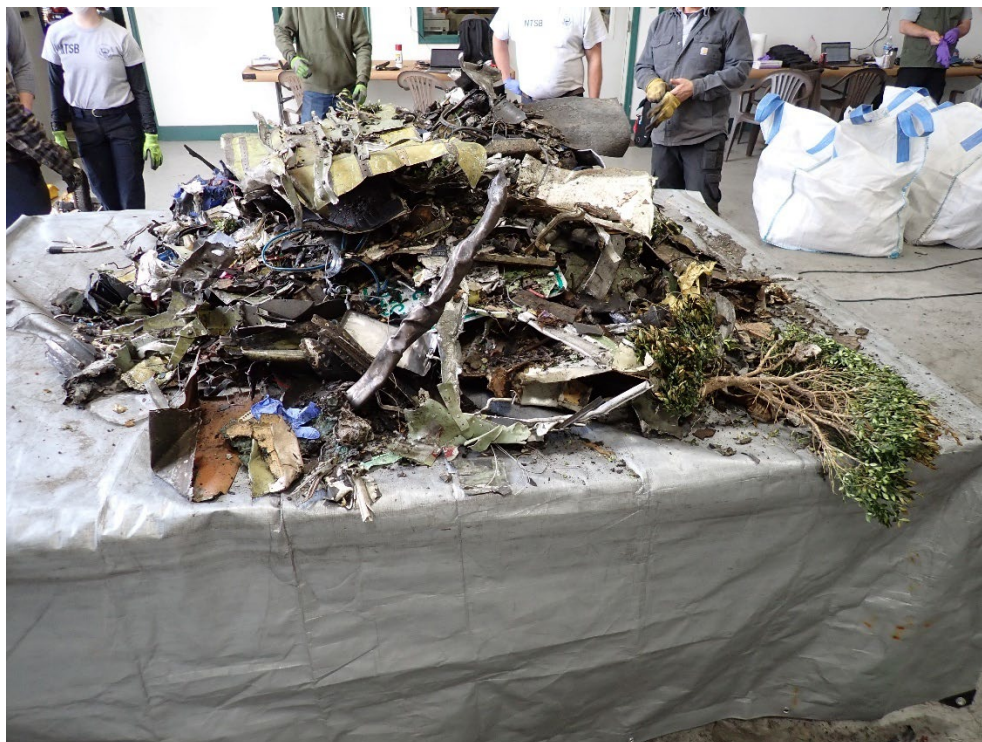
**Figure 37: Bag 16**

Bag 16: Right wing leading edge. Miscellaneous leading-edge pieces. Oil cooler. 4 fan blade fragments, 5 fan stators, front frame fragment, and 2 LPC stator fragments.

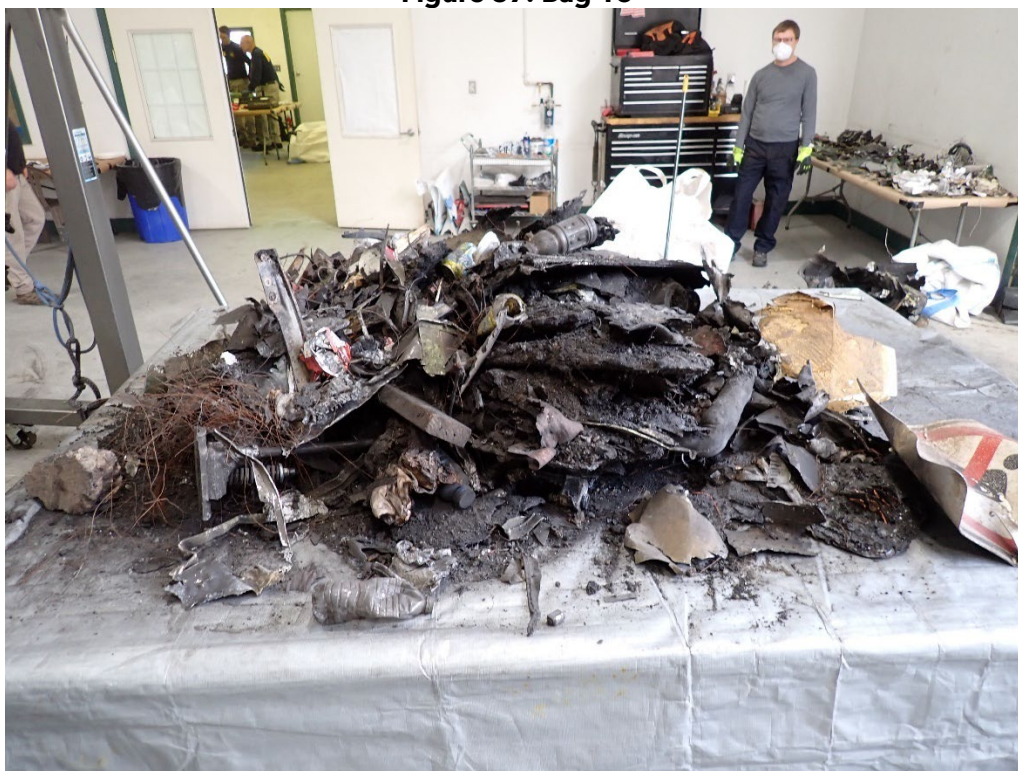
**Figure 38: Bag 18**

Bag 18: Main landing gear support. 1 large engine fan blade. Fan stator shroud and 3 LPC stators.

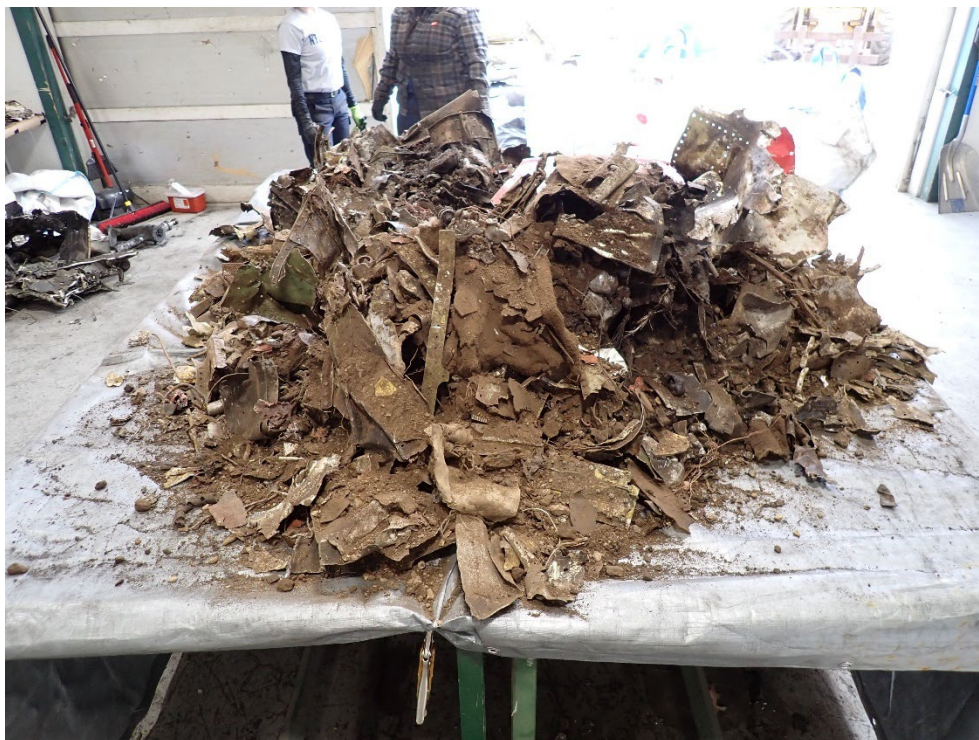
**Figure 39: Bag 23**

Bag 23: Left hand engine mounts, both forward and aft. Flap interconnect cable portion. Autopilot control cable. 3 fan blade fragments, 8 fan stators, 2 gear shaft assemblies, shroud ring, bypass flange fragments, and 7 LPC stators.

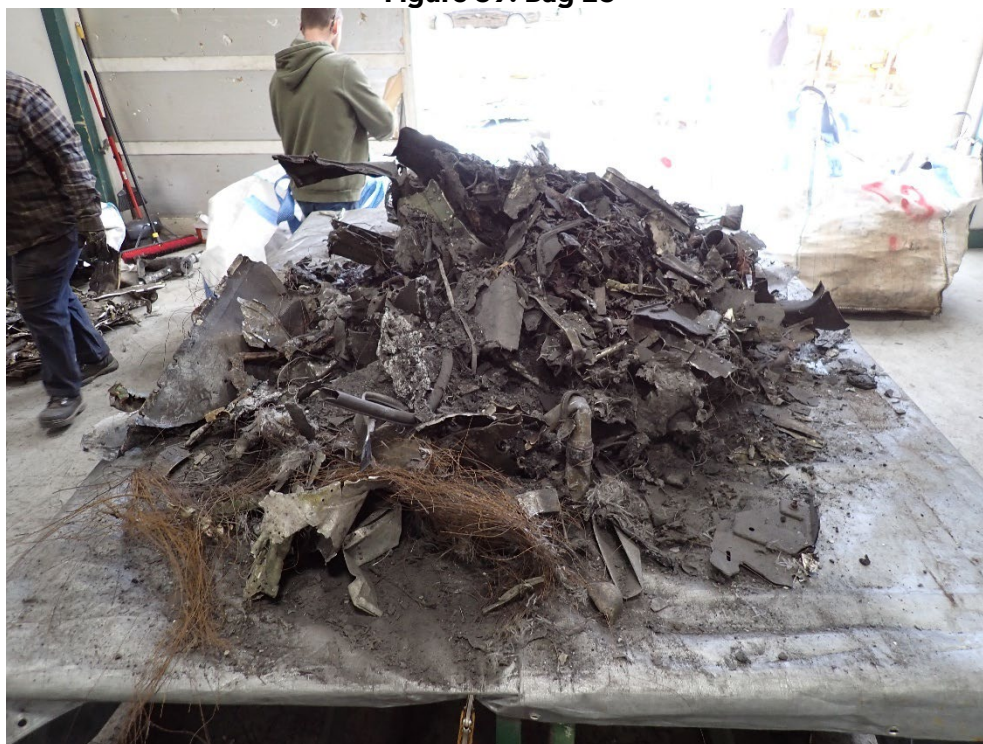
**Figure 40: Bag 11**

Bag 11: Portion of the control column assembly. Main landing gear tire. A portion of a fan engine support housing and intermediate case assembly with engine mount attached. Fan stator shroud fragment, 5 fan stators, and 4 LPC stator fragments.

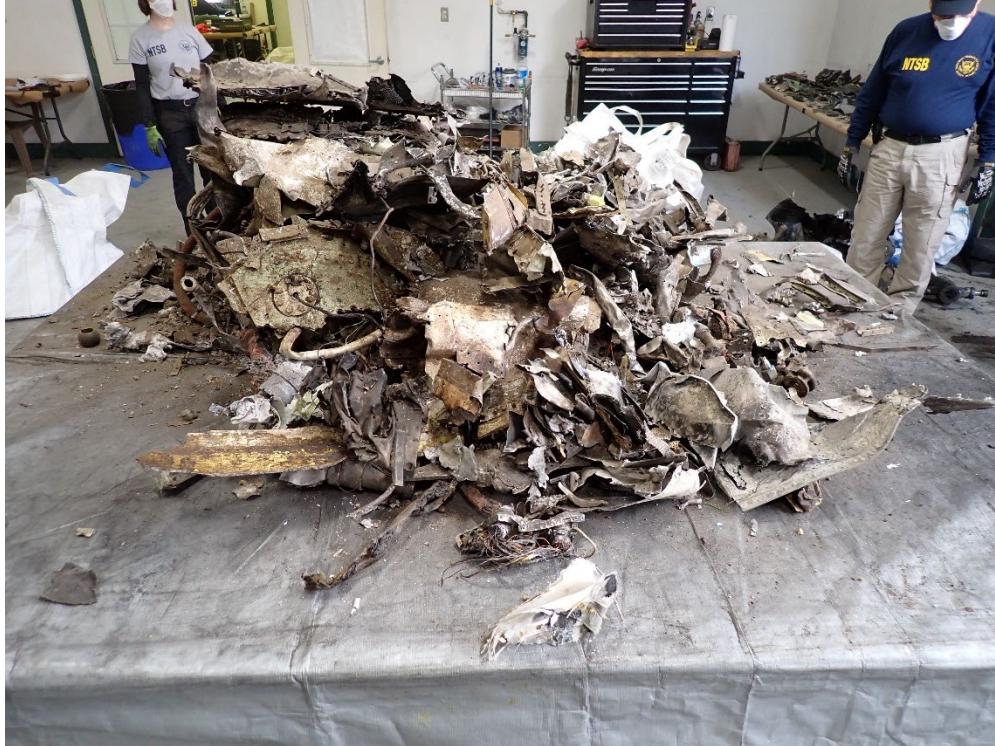
**Figure 41: Bag 26**

Bag 26: Antiskid valve, portion of flap track. Control cables and pulleys. Wire bundles. 3 fan stators and 1 LPC stator.

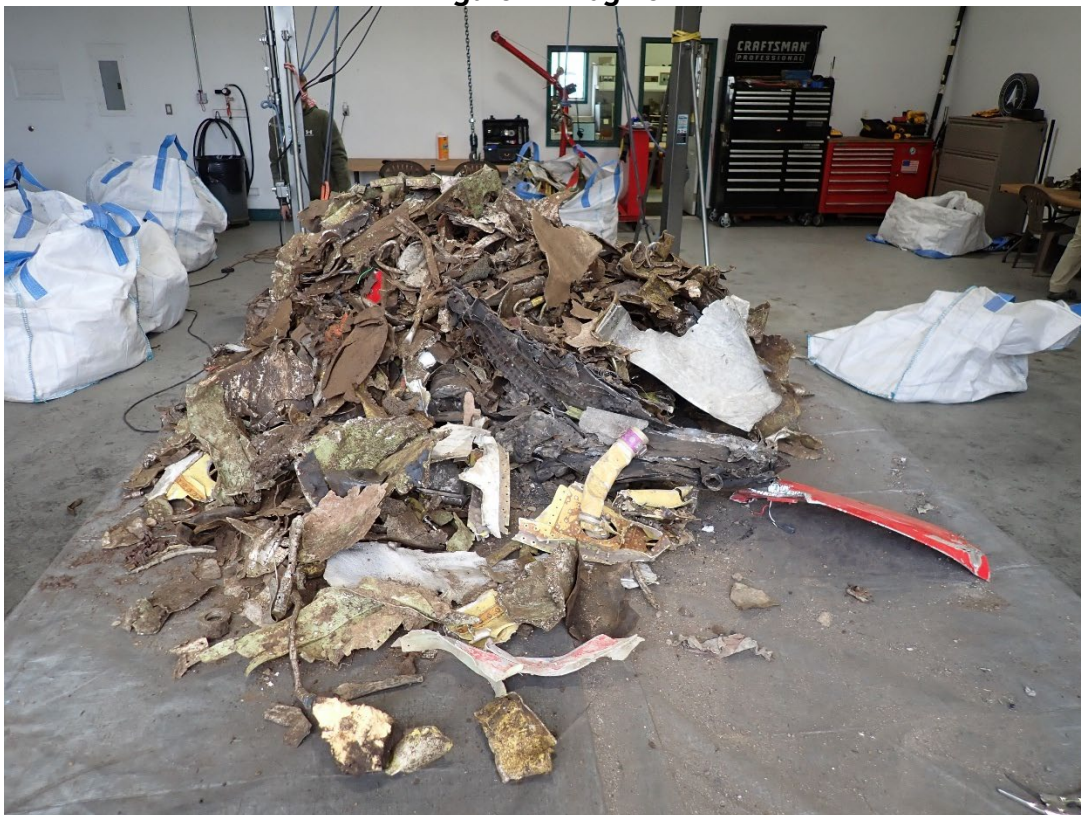
**Figure 42: Bag 22**

Bag 22: Right winglet. Flap actuator. Part of fuel pump. Landing gear fractured pieces. CVR dataplate. Fractured engine mount bolt. Fuel pump impeller and shaft assembly and housing fragment. Support strut fragment, fan shroud case fragments, multiple flange fragments, 11 LPC stators, 9 fan stators, 2 fan blade fragments, 4 LPC blades, bleed duct, and oil pump shaft assembly and housing fragment.

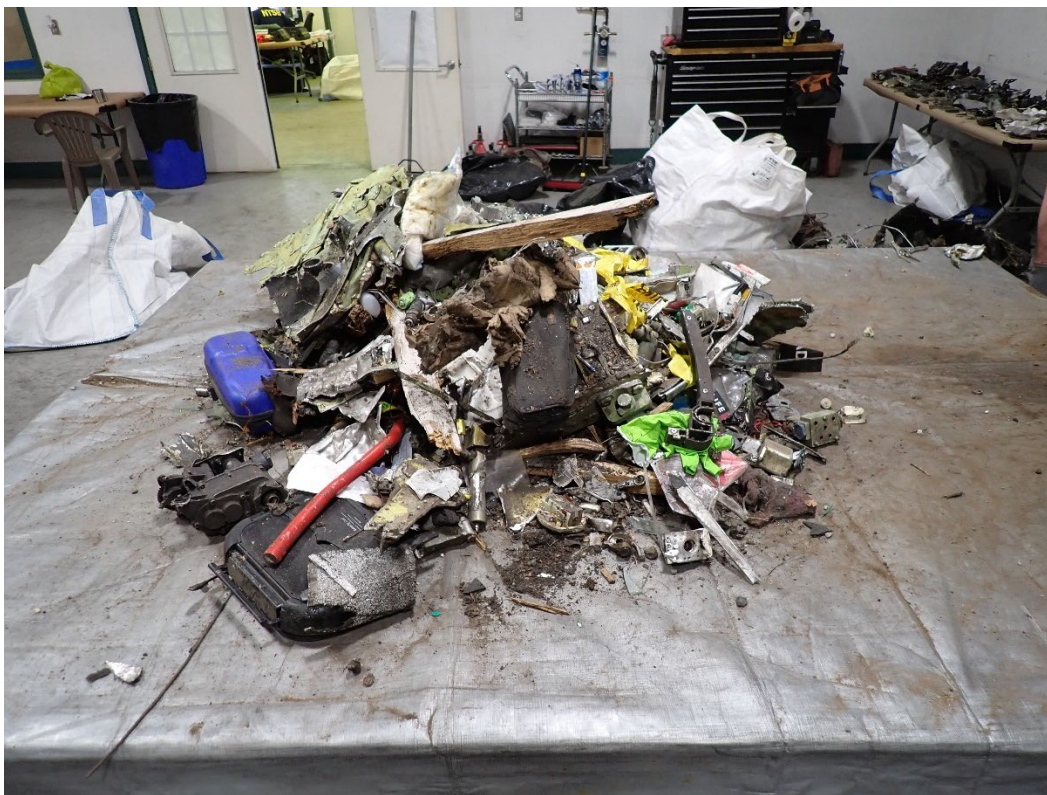
**Figure 43: Bag 47**

Bag 47: Avionics components, medical equipment, oxygen bottle top, engine inlet ring, fire extinguisher. Fuel/oil cooler, fuel pump, and T/R pneumatic drive actuator assembly.

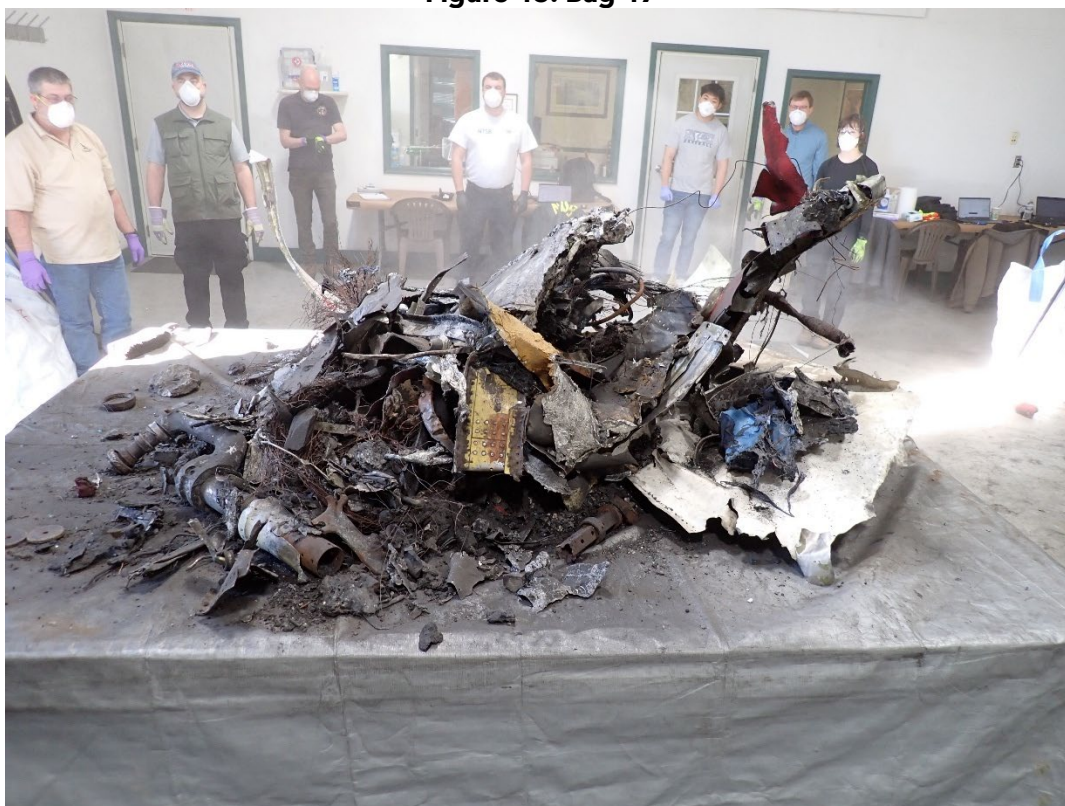
**Figure 44: Bag 19**

Bag 19: Nose landing gear strut. Car parts and car tire. Left hand elevator outboard section. Aft bottom fuselage structure. Engine cowling material. Large piece of wing structure. Control Yoke piece. 9 LPC stator fragments, 1 fan blade fragment, 3 LPC blade fragments, 1 fan stator, case fragments, and a bypass support strut.

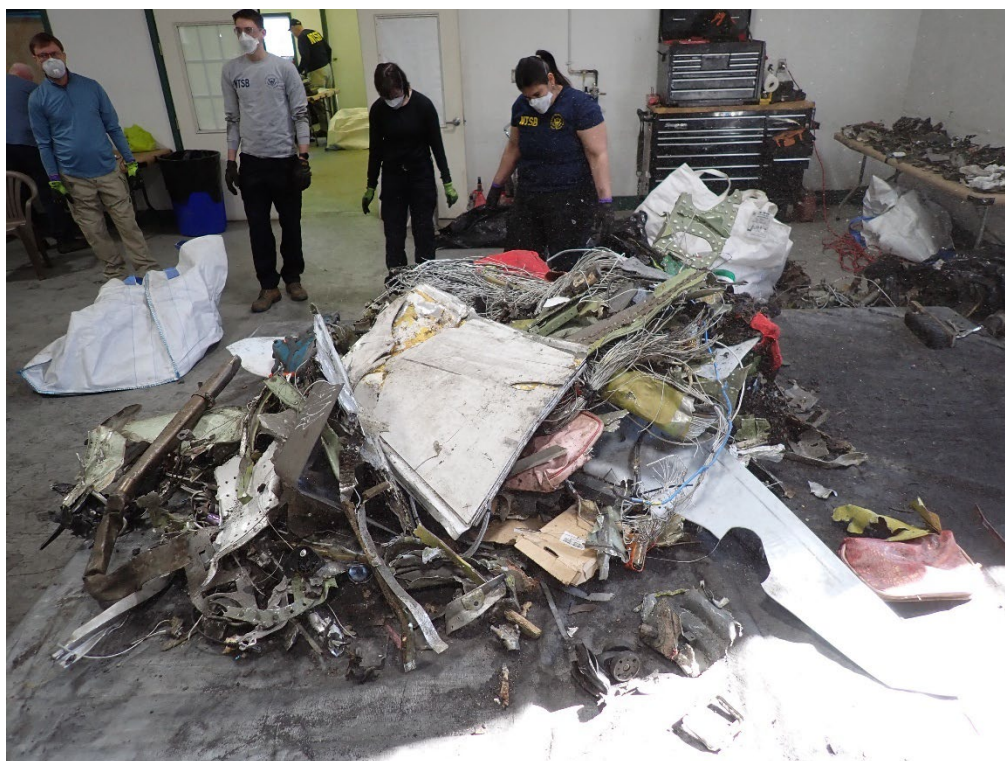
**Figure 45: Bag 50**

Bag 50: Lower wing skin, interior panel. Left side fuselage skin, forward nose skin. Flight control cable. 1 fan blade, 2 fan blade fragments, 6 fan stators, bleed duct fragment, and case fragments.

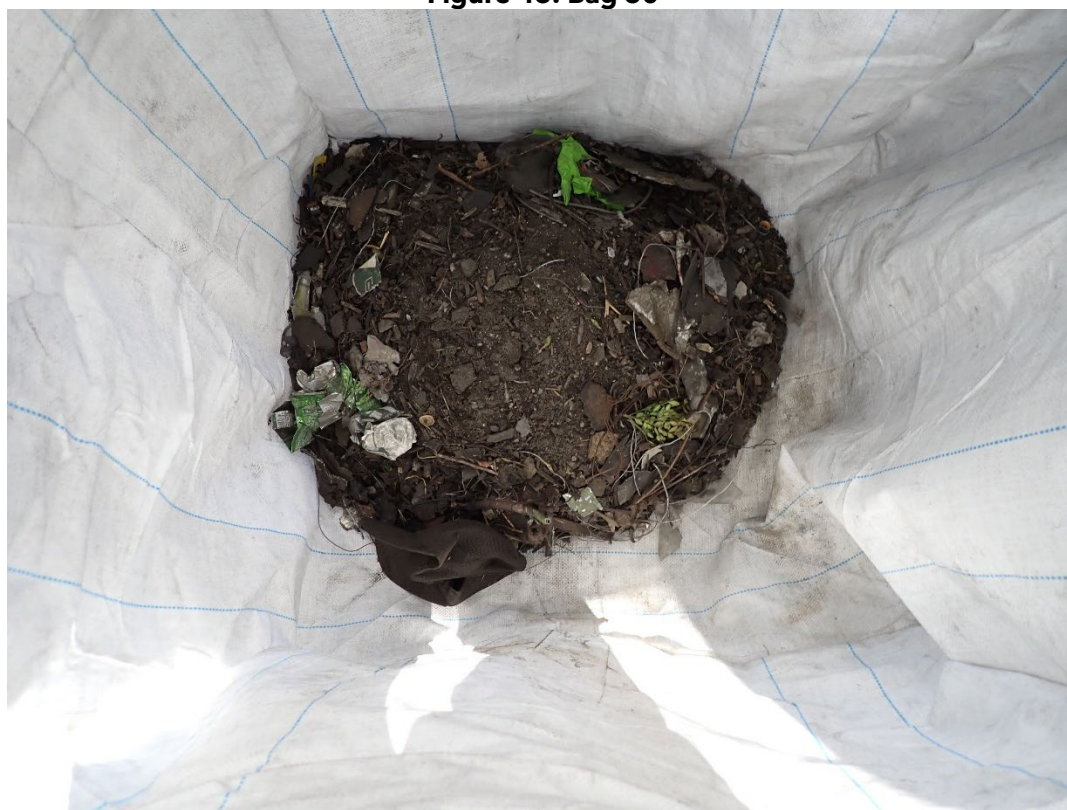
**Figure 46: Bag 51**

Bag 51: Dirt bottom, roof top items on top. Misc electronics and an avionics component. Flight control counterweight. Main landing gear torque link. Seat track. Fan blade fragment, front frame fragment, and 2 LPC stators.

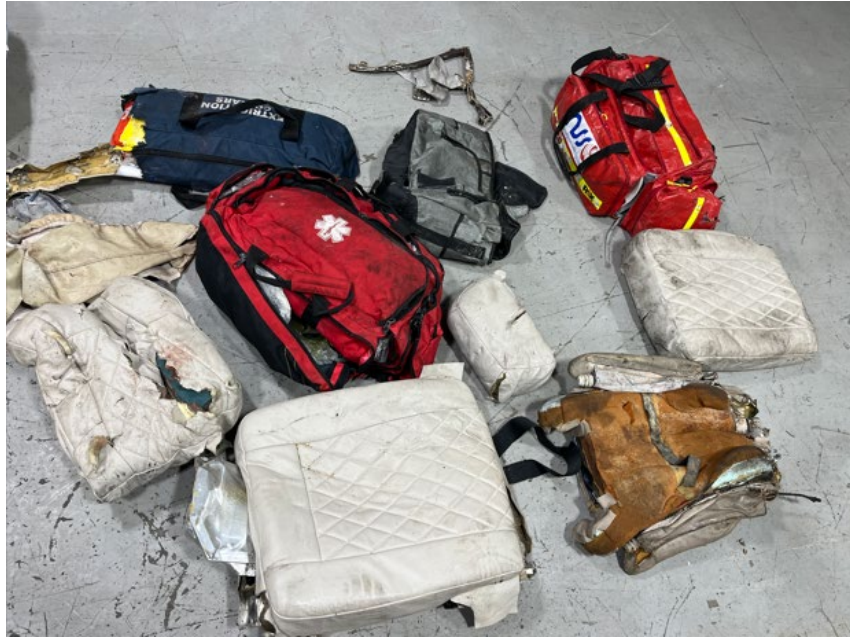
The back portion of the pilot seat was located but could not be identified as pilot or co-pilot. Two passenger bottom seats, and several medical bags from the interior of the airplane were evaluated. None of the remaining seat portions or canvas medical bags displayed signs of sooting.

**Figure 47: Interior Seating and Medical Equipment Absent of Soot**

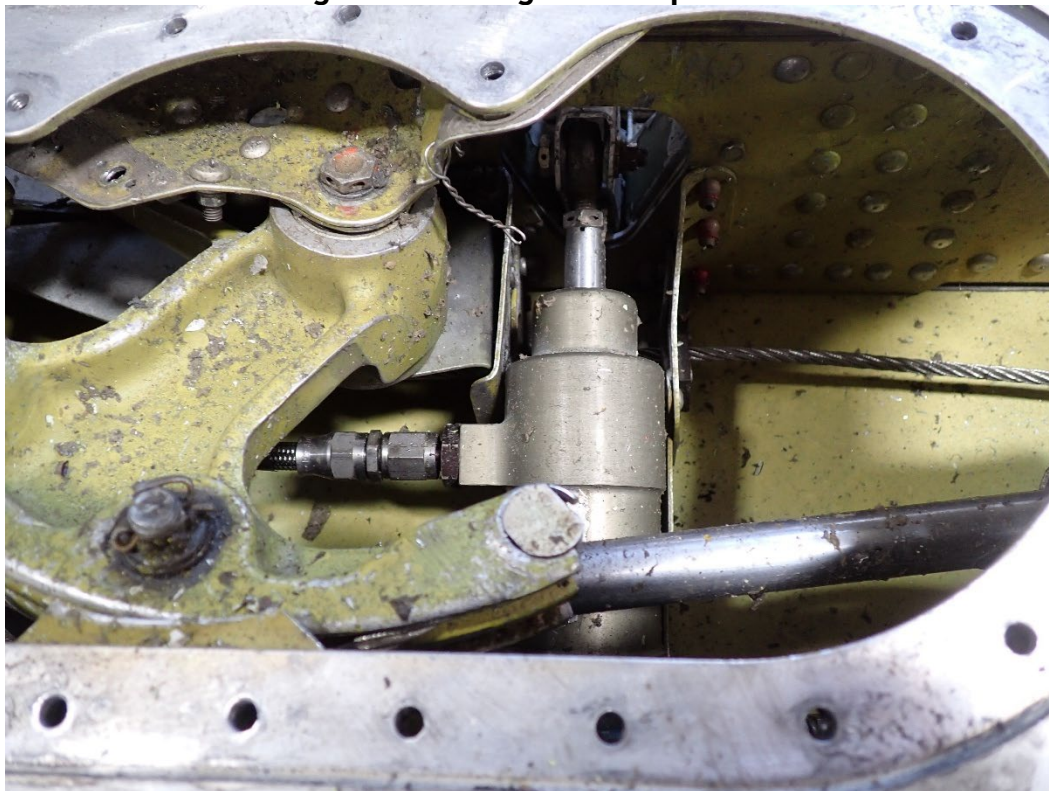
The right-hand wing was placed on a table upside down. The access panels for the right-hand flap actuator were removed. The actuator was verified to be connected at the sector and the mounting lug. The flap interconnect cable was still attached to the flap sector. The hydraulic lines were still attached to the actuator. The spoiler actuator remained in place and undamaged and remained connected to the spoiler. An aileron control cable was observed running through the wing. The flap actuator was removed from the wing but during the removal the actuator piston was pulled/extended about 1-1 ½ ". The righthand flap actuator measurement, post pull, was 19" equating to full extension. Prior to the movement, it would have been about 17 ½ - 18". 17 ½ corresponds to 30 degrees of flap, which is not a standard position (Figure 58).

**Figure 58: Right Flap Actuator as Installed**

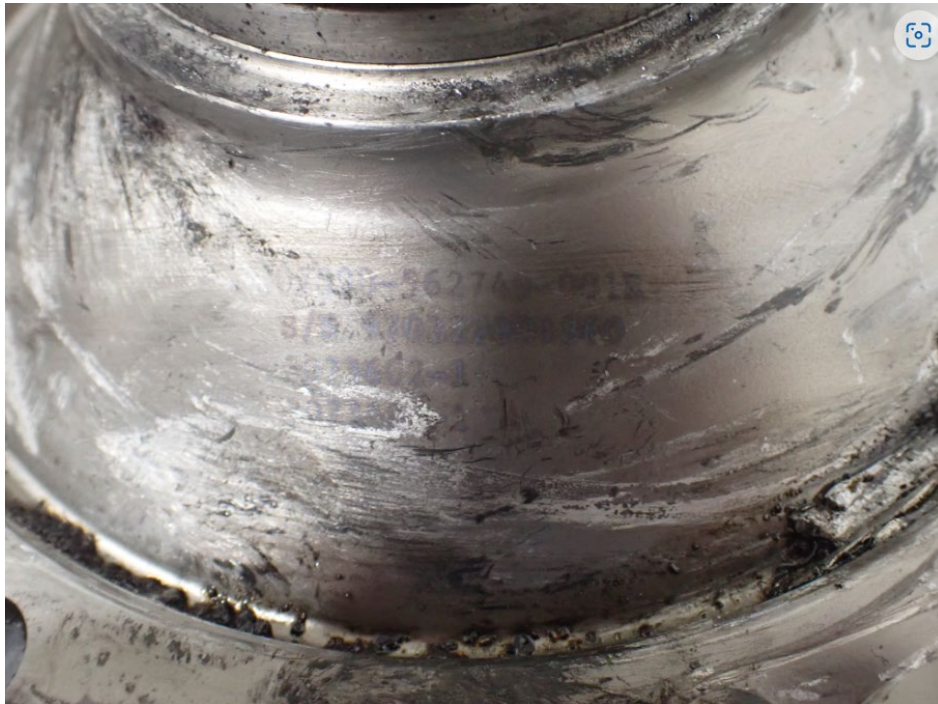
The engine in the street near the impact crater was identified by the engine aft mount damage and from a partial serial number on the first stage compressor disk. The fan assembly under the car had serial number markings with four digits of the fan disk serial number reading "1860". Per engine build book for engine serial number P-

**Figure 62: Left Fan Disc Serial Number (Courtesy of Honeywell)**

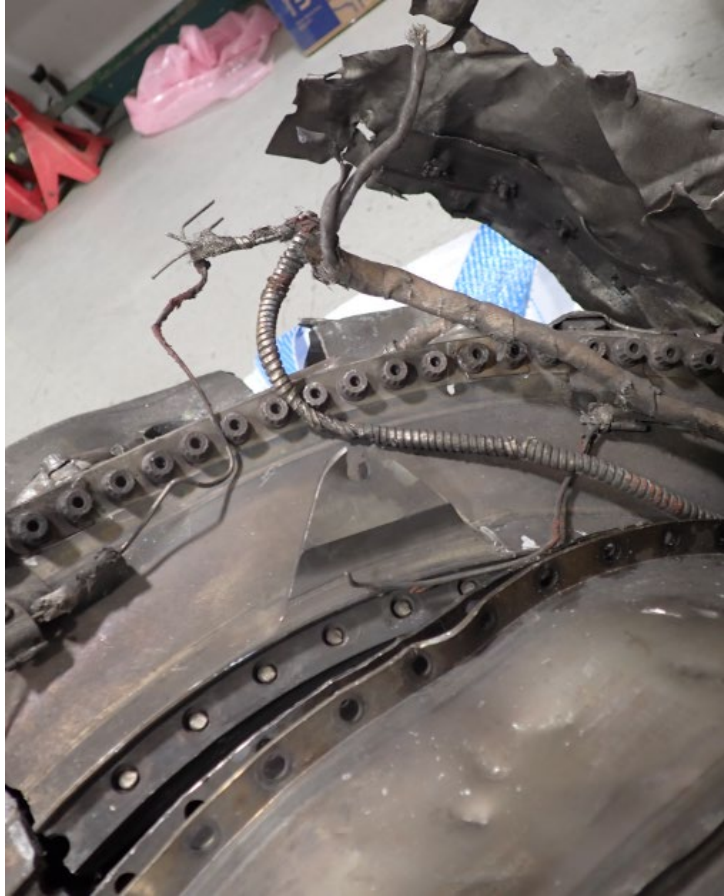
85243, the serial number of the fan disk was 970322901860. From the airplane airworthiness documentation, it was determined that engine serial number P-85243 was in position 1, which is the left engine. The 3 o'clock aft engine mount bolt hole was torn outward, indicating that it was the left engine. The inter-turbine temperature (ITT) harness was routed on the right side of the engine to go to the lefthand engine pylon. The first stage compress disk, part number was identified as 3072395-1 with serial number 1-12112-1548. Per the engine build log, the serial number was 1-12112-1548.

**Figure 64: Left Aft Engine Mount(Courtesy of Honeywell)**

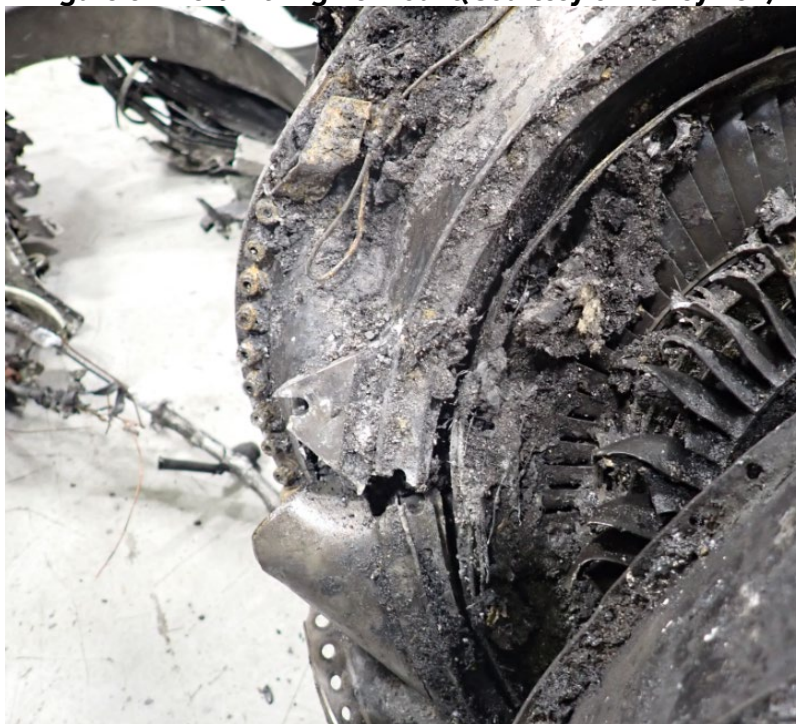
For the engine found in the second-floor bedroom, the 9 o'clock aft engine mount bolt hole was torn outwards, indicating that the engine was mounted in the number 2 position, which is the right side. Through aircraft airworthiness documentation, this engine is identified as P-85139C.

**Figure 65: Right Engine Aft Mount (Courtesy of Honeywell)**

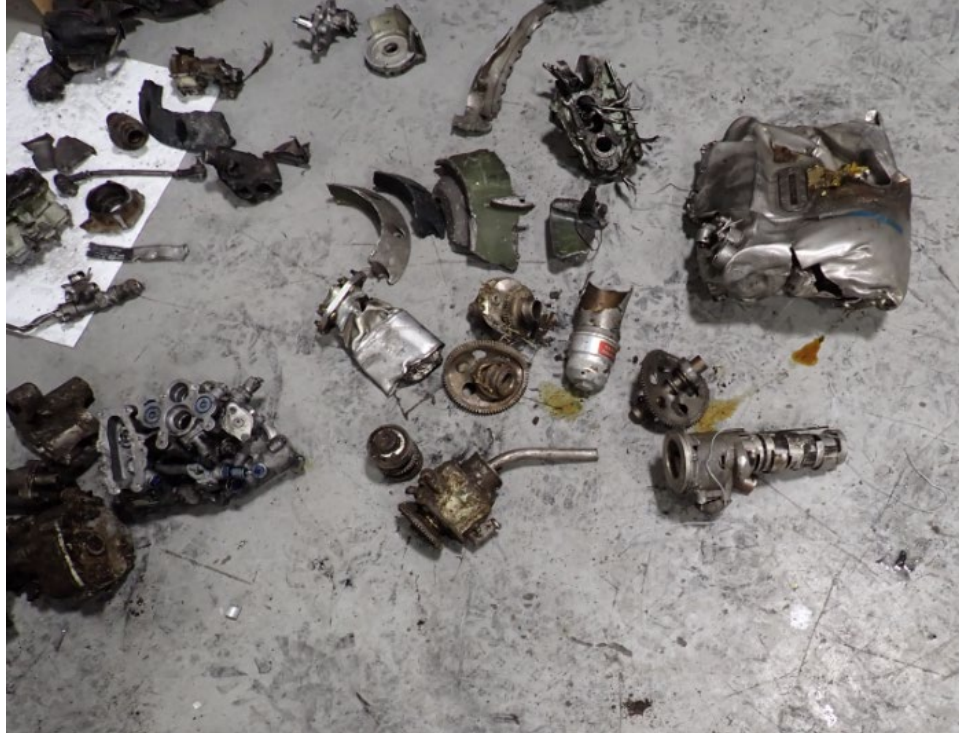
**Figure 66: Loose Engine Hardware**

- PLA portion of the Fuel Control Unit located in impact crater. Debris was on PLA indicator preventing inspection of indicator dial position.
- Remaining portion of FCU inspected in the field.
  - PN: 3070800-22; Series 2; Mod 44
  - SN: A6159C
- Gearbox gears
- Portion of fuel/oil cooler
- Oil tank
- Loose compressor blades
- Oil pump g-rotors
- Portions of a front frame
- Filter housing
- Portions of spinner supports
