# National Transportation Safety Board

ERA25MA106

## **AIRWORTHINESS FACTUAL REPORT- ON-SCENE**

Location: Philadelphia, Pennsylvania  
Date: January 31, 2025  
Time: 1807 eastern standard time  
Airplane: Learjet 55, registration XA-UCI

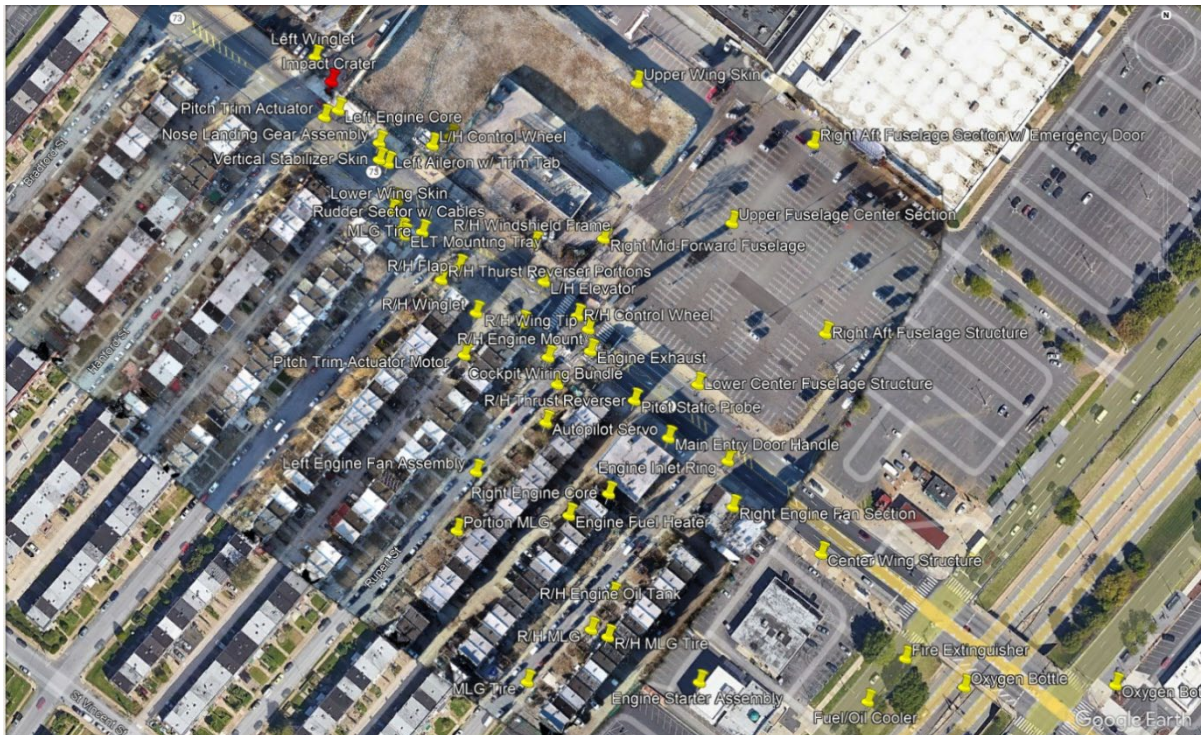
Figure 1: Key Debris

ft. The airplane horizontal stabilizer contacted a business sign beside the main impact crater. White paint transfer was evident at the point of contact with the sign. From the point of contact with the sign to the impact crater measured at an angle of 22°. From

the initial impact crater, the airplane debris fanned outwards, following a heading of about 150°.

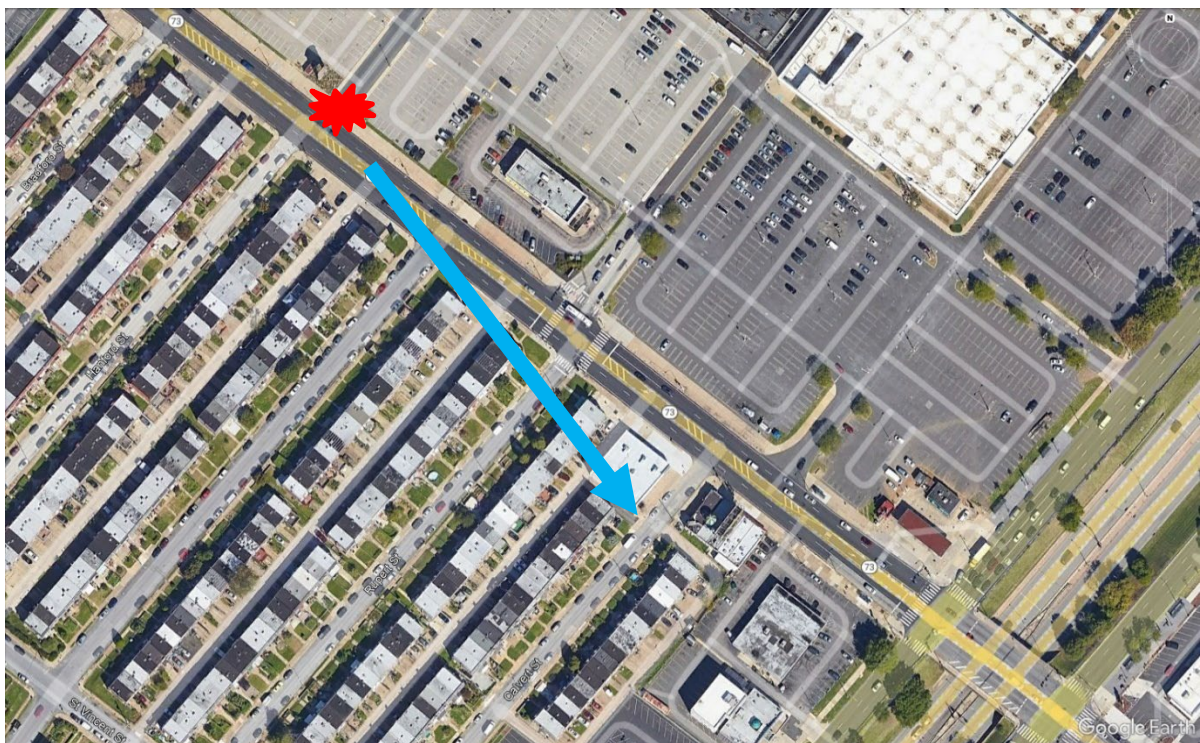
Figure 2: Impact Crater and Main Debris Heading

The initial impact crater, measuring about 8 ft deep and 10 ft in diameter, was located along Cottman Ave., on the northeast sidewalk, between Roosevelt Blvd. and Bustleton Ave. The sidewalk was forced up approximately three feet around the impact crater.

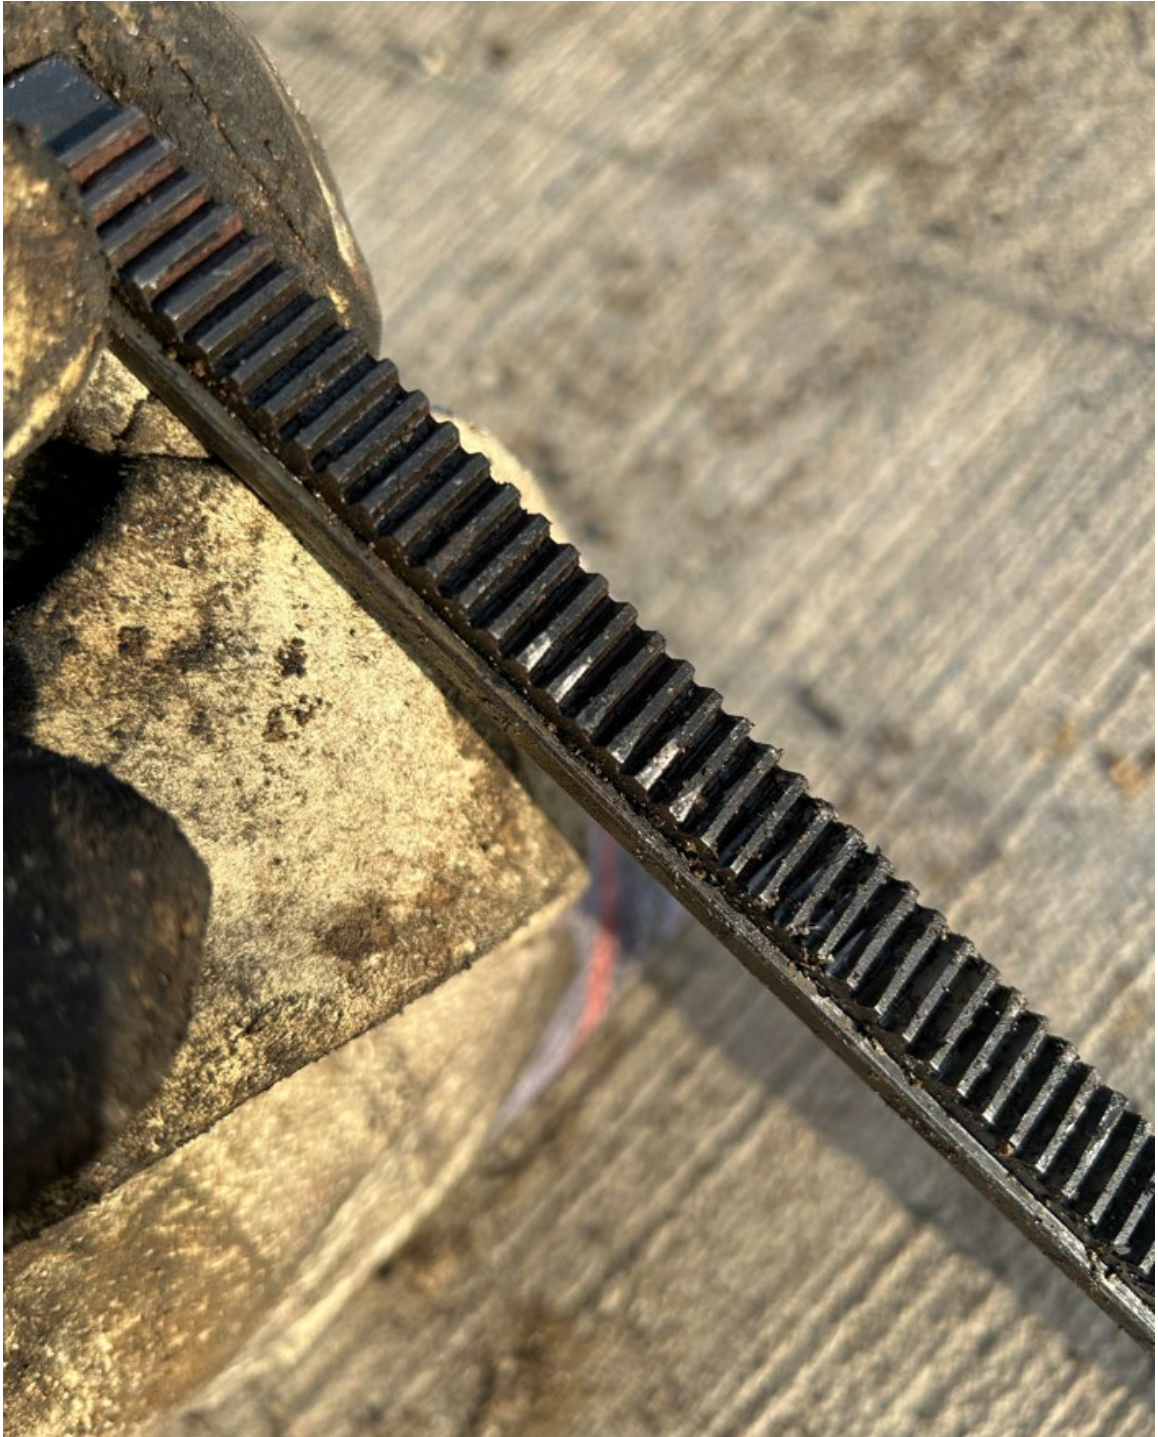
*Figure 32: Possible Witness Marks on Thrust Reverser Rack*

- Cockpit voice recorder
- Portion of left-hand thrust reverser assembly (Appendix A Figure 1), S/N 5015; one of the thrust reversers racks was in the recovered assembly; the other rack was found separately, but also in the crater (Appendix A Figure 2); this rack appeared to have witness marks on it (Appendix A Figure 32)

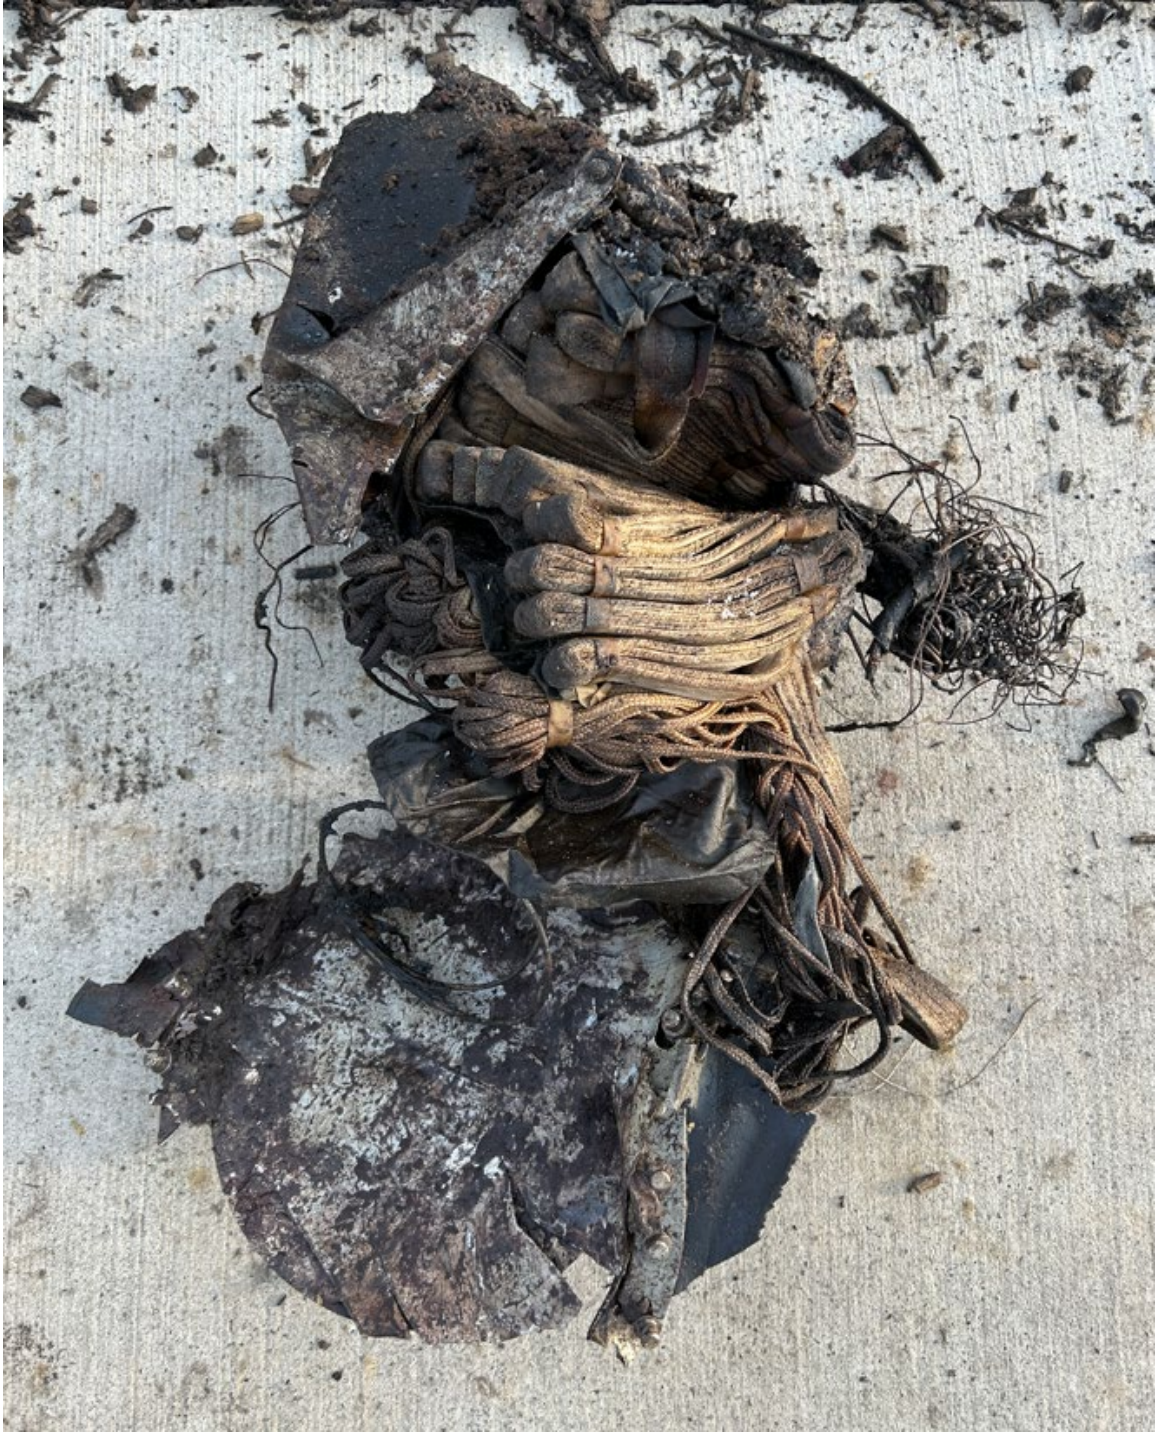
*Figure 35: Drag Chute*

- Autopilot servo, either pitch or yaw
- Air conditioning compressor
- Drag chute, still packed (not deployed) (Appendix A Figure 33)
- Motive flow shutoff valve

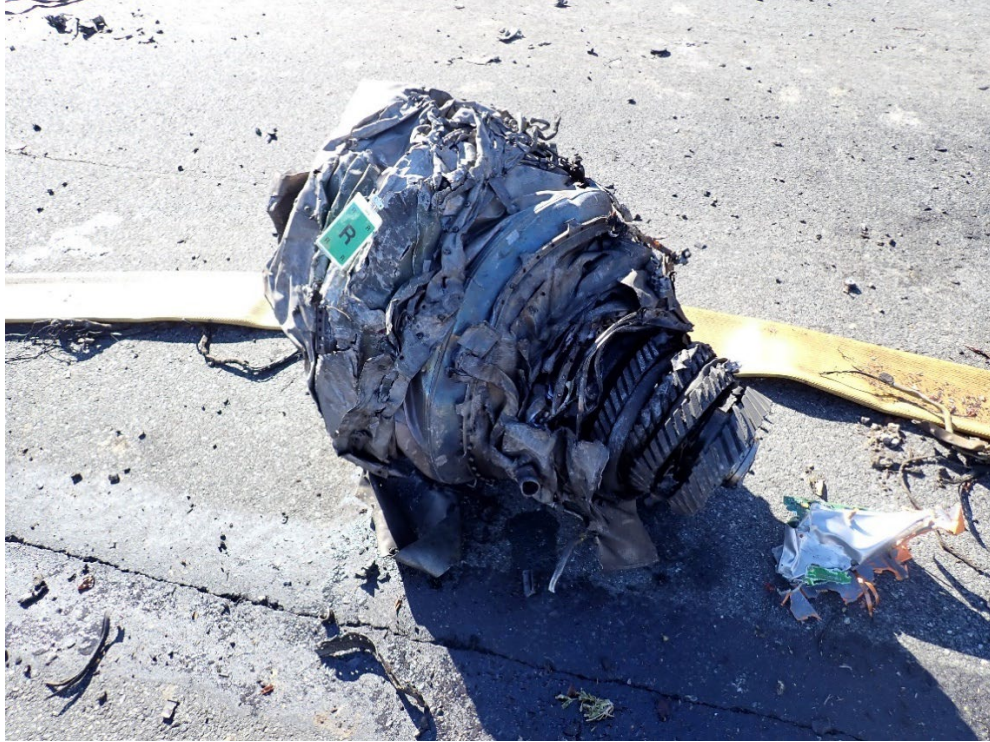
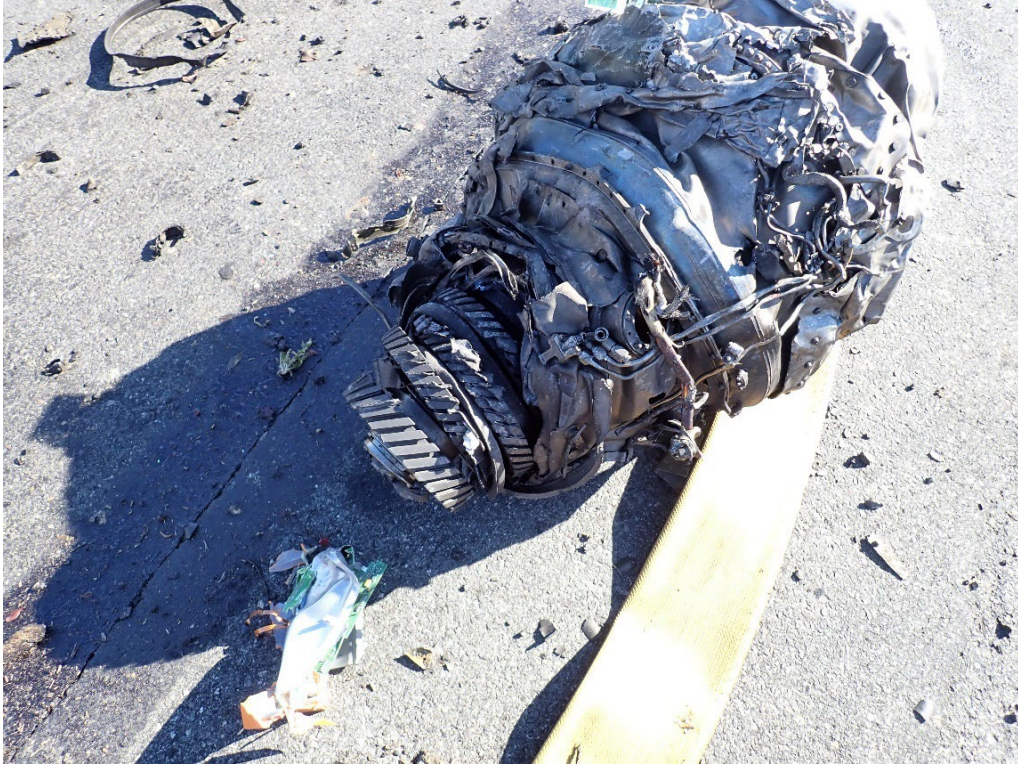
*Figure 39: Engine Core 1 Near the Impact Crater and Later Identified as the Left Engine (Courtesy of Honeywell)*

- For photo documentation purpose the engine was labeled "Right" (Appendix B Figures 39 and 40)
- The fan assembly and planetary gear system were not attached to the engine.
- Some soot adhered to the compressor section of the engine. There was no soot present on the aft section of the engine
- The LPC case was missing, exposing the first, second, third, and fourth stage rotors. No stator assemblies were present with the core (Appendix B Figure 41).
- Majority of blades were missing from first, second, third, and fourth stage compressors with a few blades missing above the platform.
- Portions of LPC bleed pop valves were present

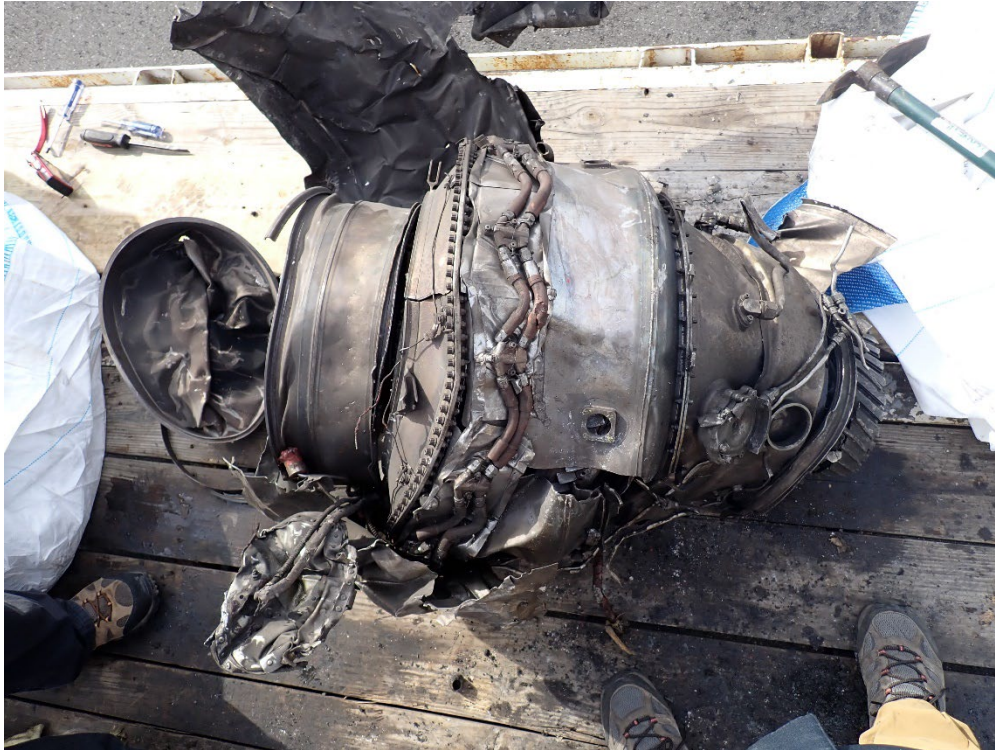
*Figure 42: Engine Core 1 Fractured Plenum and T-Duct (Courtesy of Honeywell)*

- Significant asymmetric crushing of the HPC case and Combustor Plenum.
- Combustor case was fractured at approximately 3 o'clock position from the forward split to aft split line exposing a portion of the front side of the diffuser and exposing deswirl blades. The visible deswirl blades were all bent flat (Appendix B Figure 42).

- T-duct was fractured at approximately 2 o'clock position and 8 o'clock position.
- Aft engine mount at 3 o'clock position the mount bolt hole was torn outward (Appendix B Figure 43).

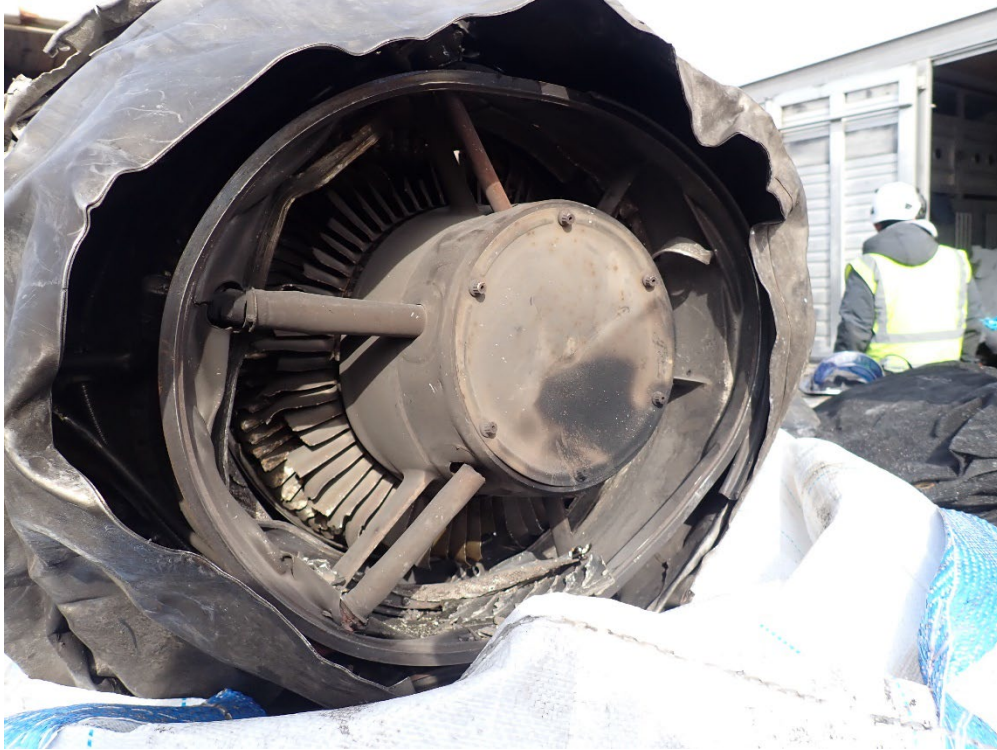
Figure 44: Engine Core 1 Third Stage LPT with View of Second Stage LPT (Courtesy of Honeywell)

- Core exhaust nozzle was crushed.
- After removal of core exhaust nozzle, the second and third stage Low Pressure Turbine (LPT) rotors were present with varying degrees of damage to rotor blades (Appendix B Figure 44).

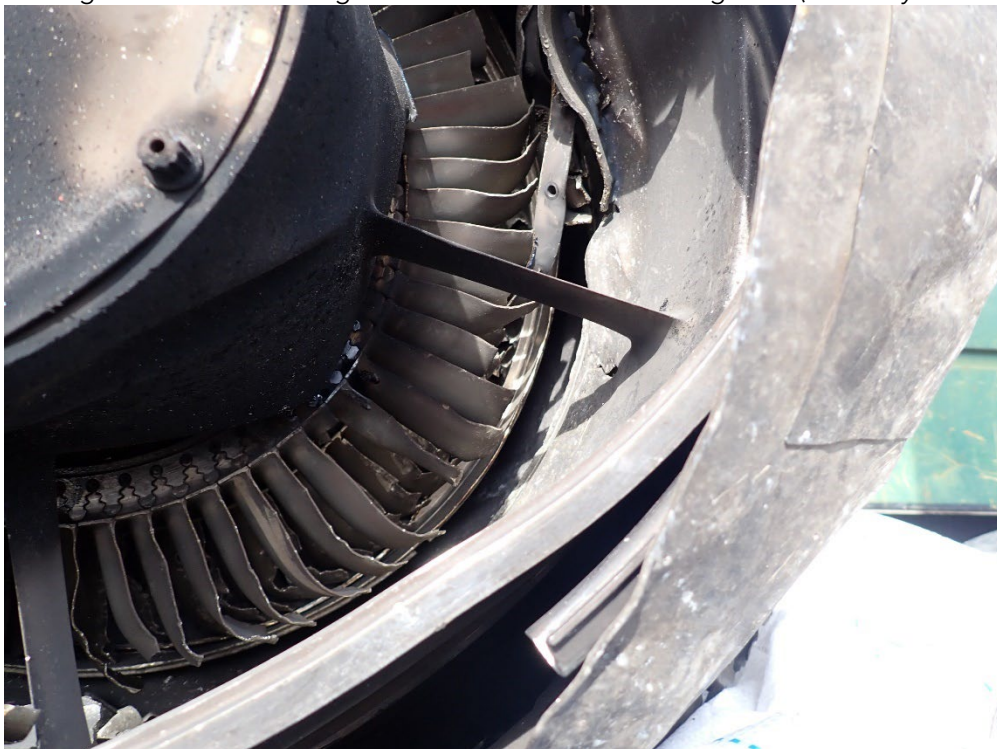
Figure 45: Engine Core 1 Third Stage LPT Blades with Rotational Bending Opposite Direction of Rotation (Courtesy of Honeywell)

- Second stage stator present with blade trailing edge tearing.
- Third stage rotor blades were bent opposite direction of rotation (Appendix B Figure 45).

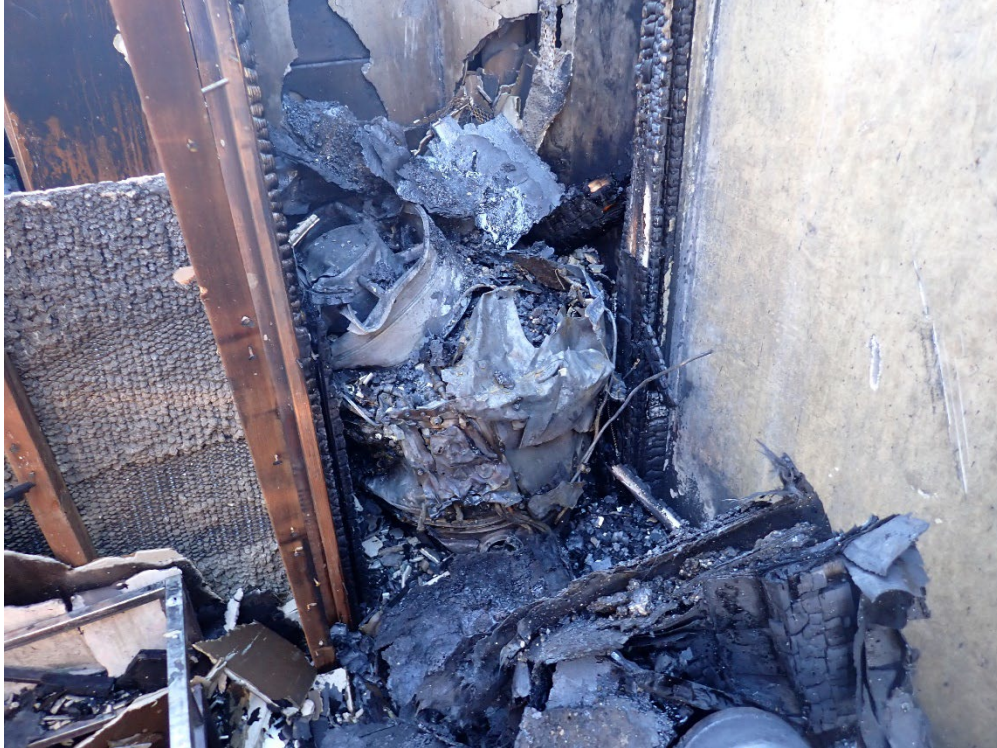
Figure 46: Engine Core 2 In the Resident Structure and Later Identified as the Right Engine (Courtesy of Honeywell)

- For photo documentation purpose the engine was labeled "Left".
- Engine was found in a vertical position, nose down on the second floor of a residential property (Appendix B Figure 46).

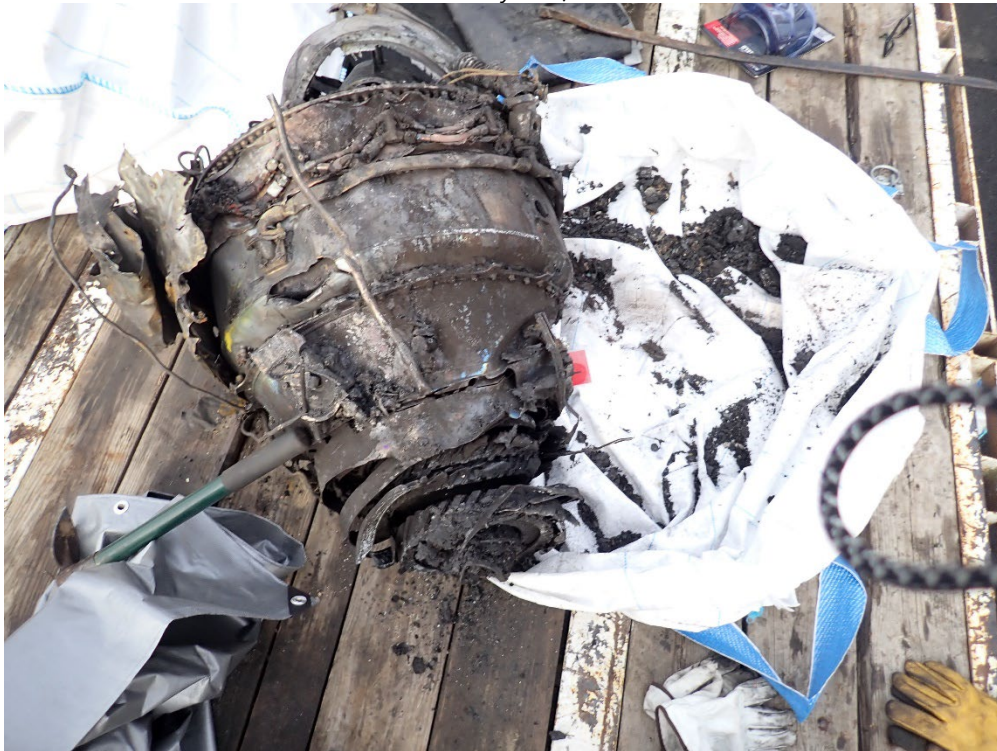
Figure 47: Engine Core 2 - Right Engine (Courtesy of Honeywell)

- Engine was covered with soot from fire damage (Appendix B Figure 47).
- Fan assembly was missing from the core.
- LPC case was missing from the third stage stator forward, exposing the 1<sup>st</sup>, 2<sup>nd</sup>, and 3<sup>rd</sup> stage compressor rotors (Appendix B Figure 48).

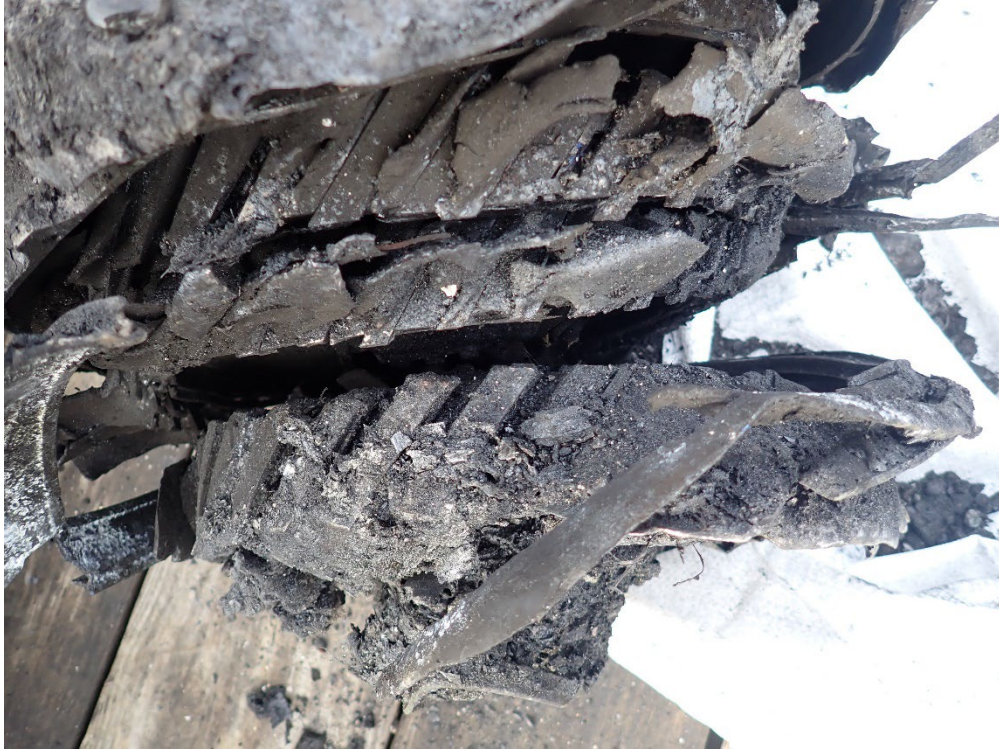
*Figure 48: Engine Core 2 Compressor Section (Courtesy of Honeywell)*

- Approximately half of the first stage rotor blades were present with bending opposite direction of rotation. Blades were also bent forward.
- Uncoupled curvics were present between first and second stage LPC rotors and were intact

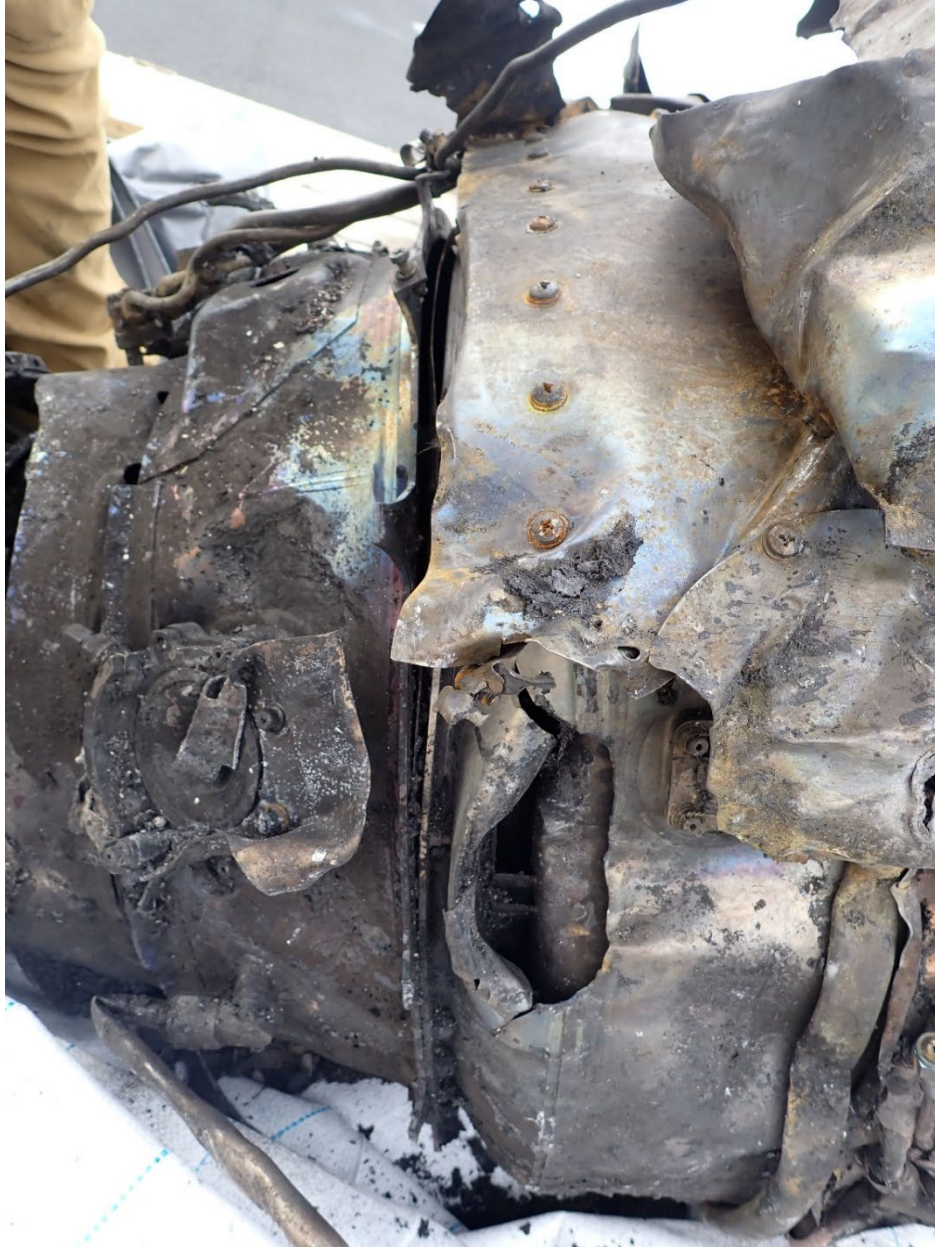
*Figure 49: Engine Core 2 Compressor Plenum and Exposed Diffuser and Combustor Liner (Courtesy of Honeywell)*

- Combustor case had multiple tears. Combustor case tear near forward flange exposed forward portion of centrifugal compressor diffuser (Appendix B Figure 49).

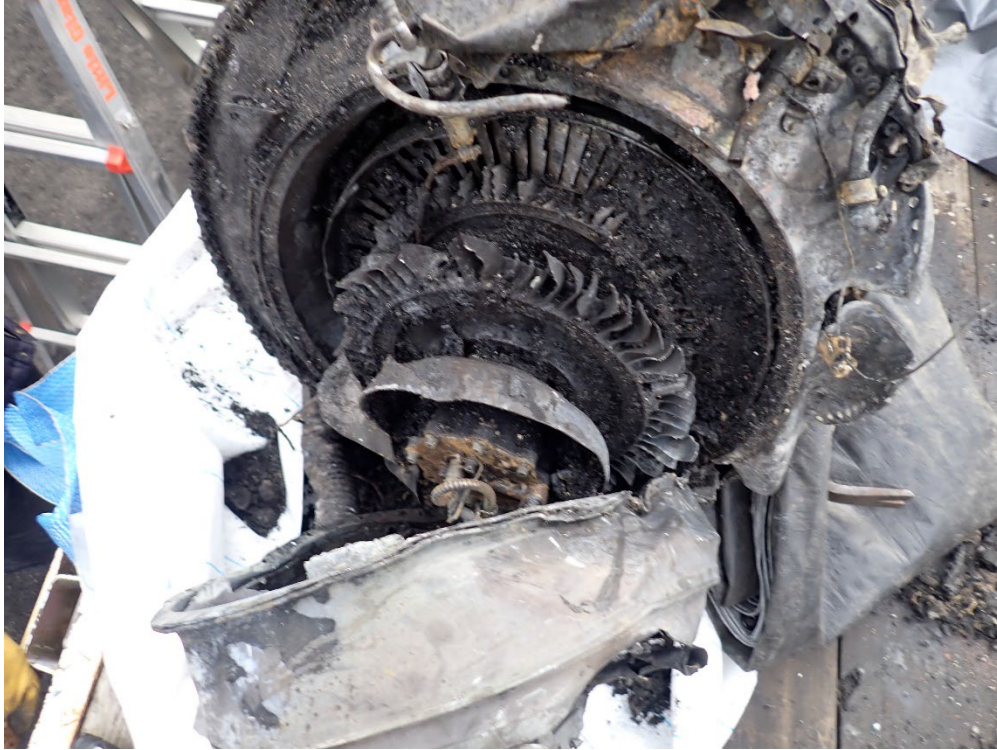
Figure 50: Engine Core 2 LPT Section and Displaced Rear Bearing Support Housing (Courtesy of Honeywell)

- Fuel manifold was present but had fire damage and was broken in multiple locations.
- T-duct was fractured but attached to combustor plenum.
- Rear bearing support housing was displaced aft from flange of T-duct and is loosely attached to engine, exposing second and third LPT rotors (Appendix B Figure 50).

- Third stage blades were fractured with varying degrees of damage. Indications of rotational bending opposite direction of rotation.
- Second stage turbine rotor had majority of blades missing. Remaining second stage turbine blades were damaged and fractured at either mid-span or at the blade platform.

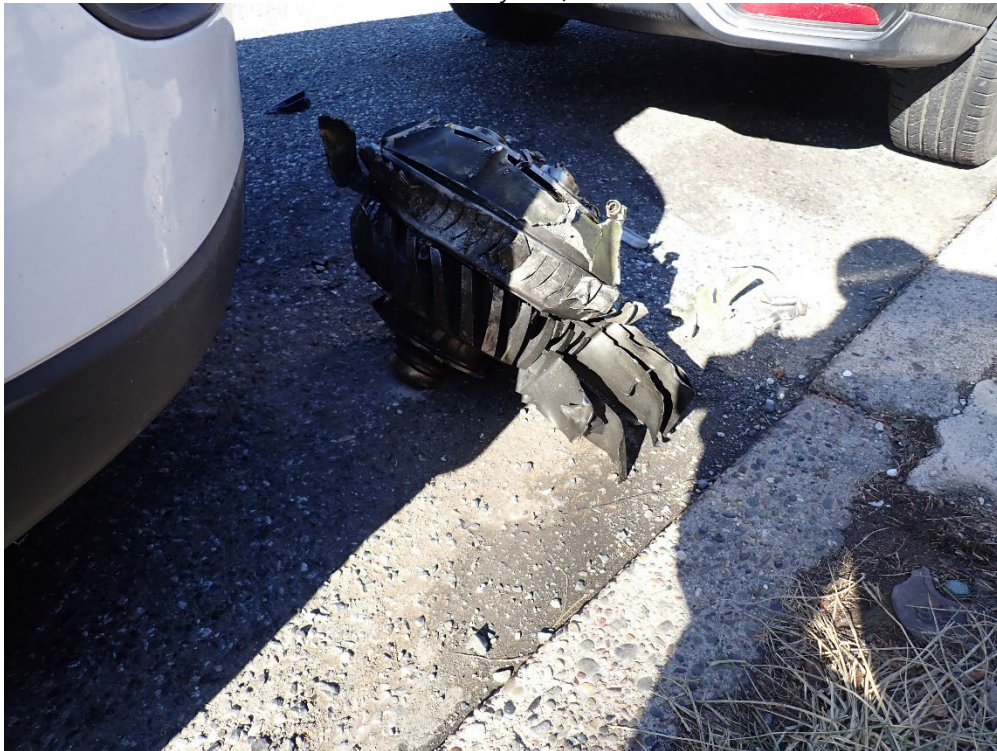
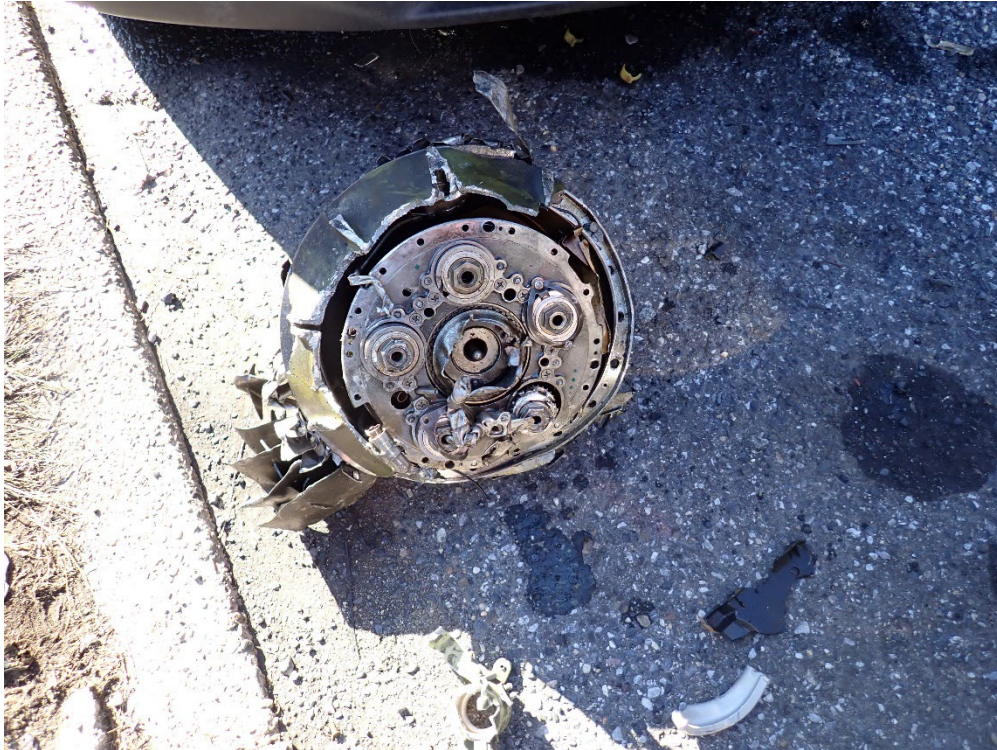
Figure 51: Fan Assembly 1 Located on Rupert St. (Courtesy of Honeywell)

- Identified in photos as "Right".
- Fan assembly found under car (Appendix B Figure 51).
- Fan spinner not present with the fan assembly.
- Planetary gear assembly is present.
- Crushing damage to aft side of planetary gears (Appendix B Figure 52).
- Oil system for planetary gears is mostly missing with remaining portion exhibiting crushing damage.
- Fan shaft had sheared.
- Approximately 180° of the inner flow path section of front main frame was present. Struts have been sheared off at inner flow path.
- Aft flange was missing.
- Clockwise forward looking aft

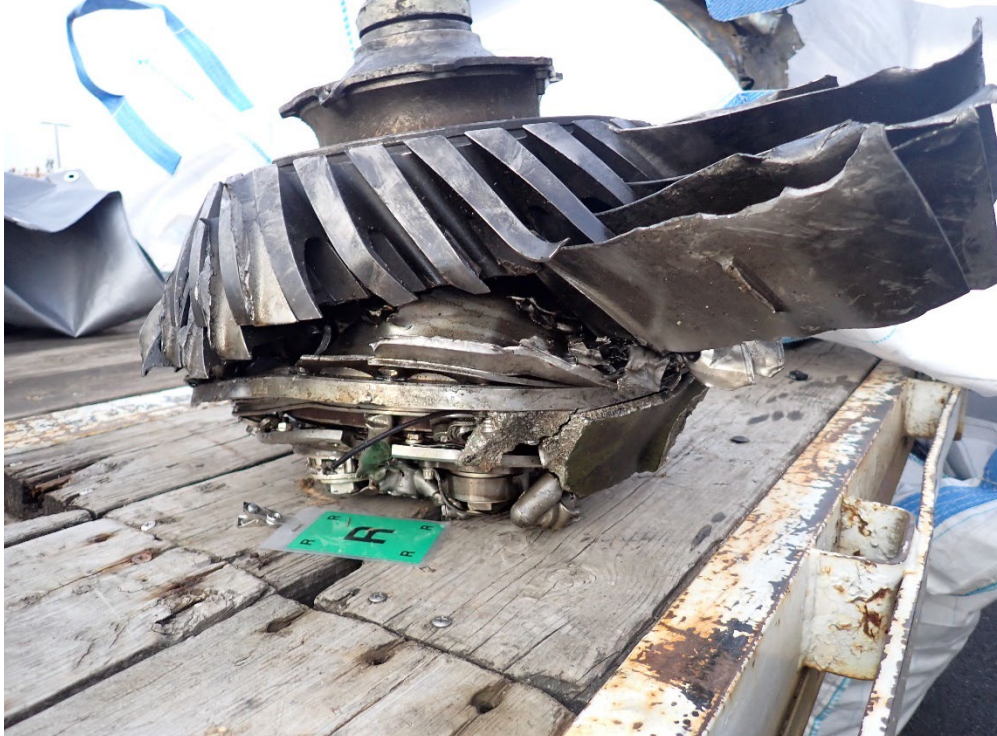
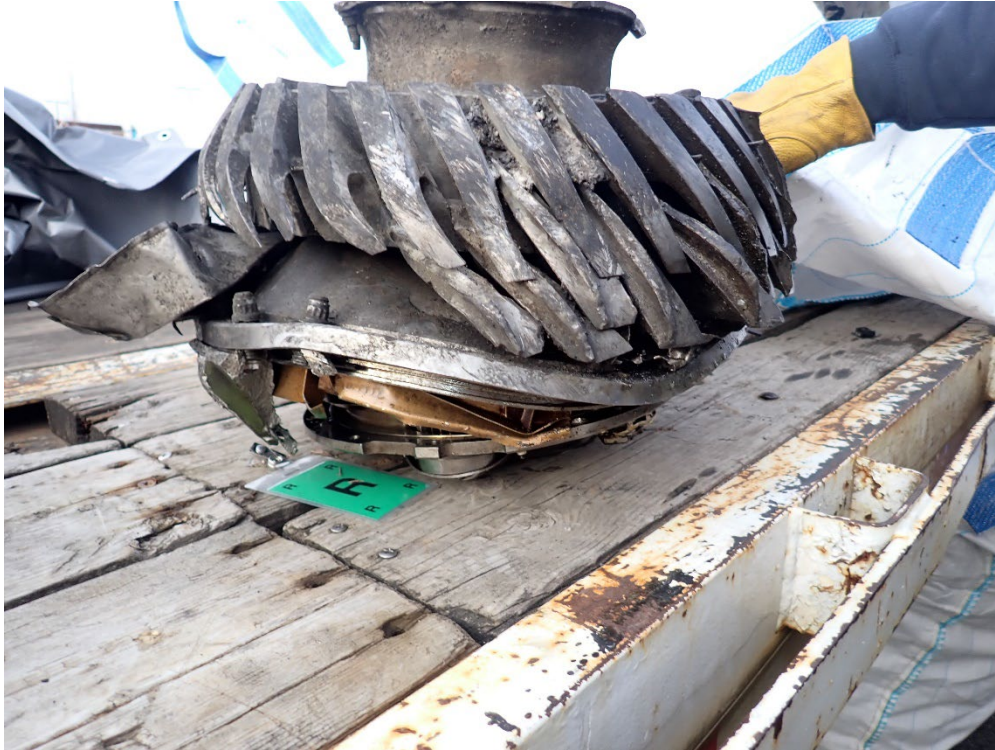
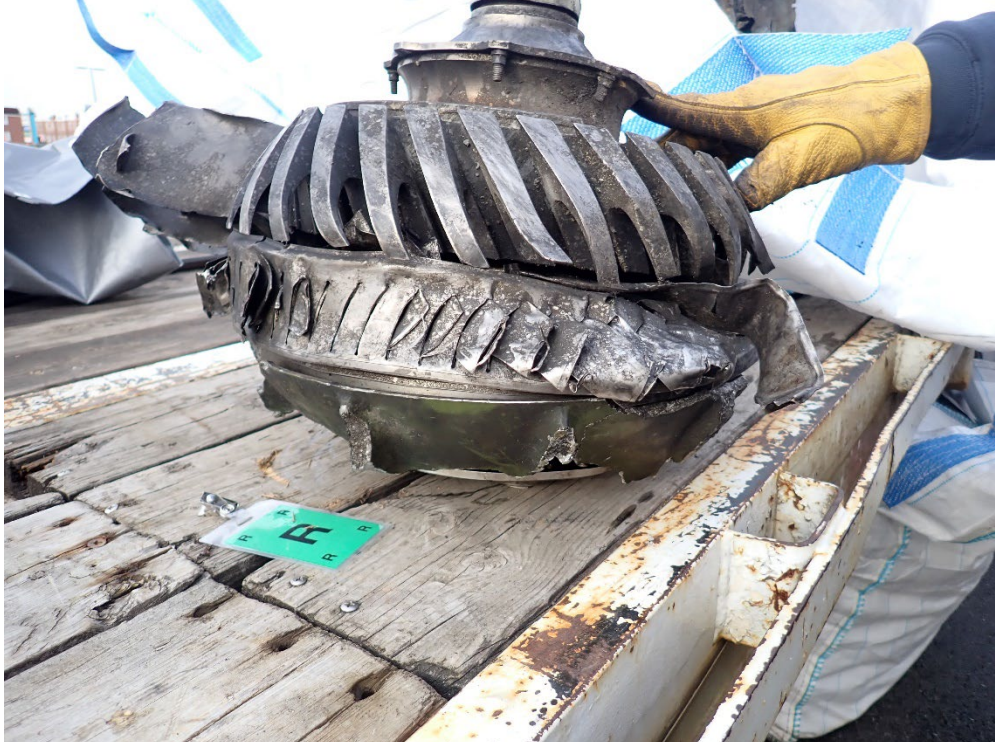
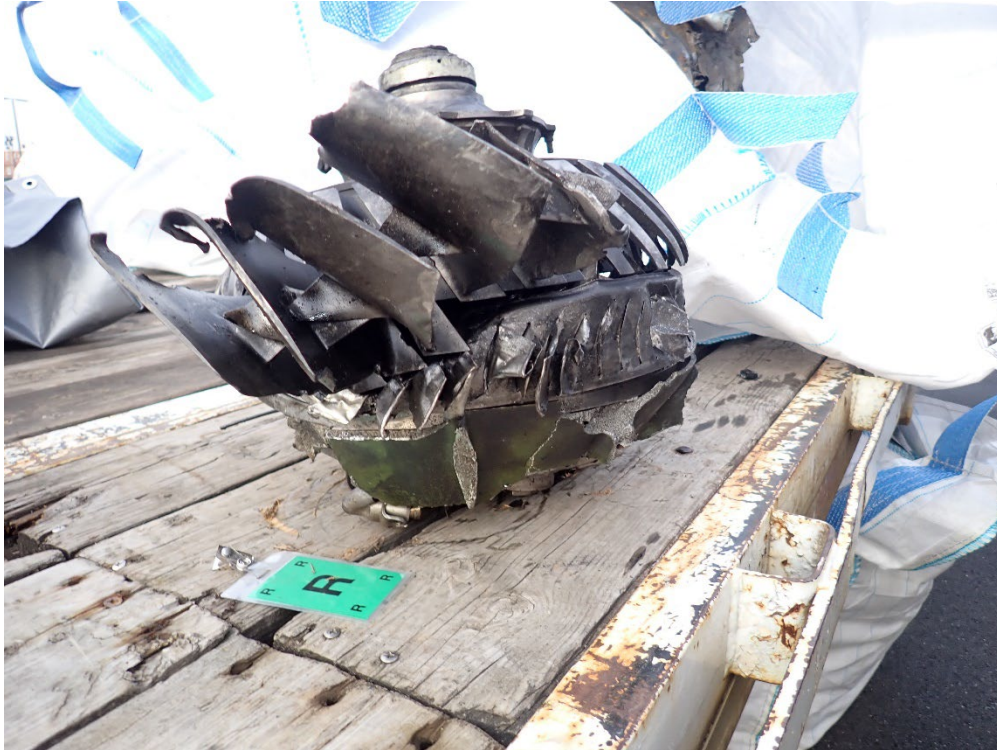
- Fan disk had non-uniform impact damage to the inner flow path portion between the dovetails. Aft section of inner flow path surface had varying degrees of damage with some areas bent in and some bent out (Appendix B Figures 53, 54, 55, and 56).

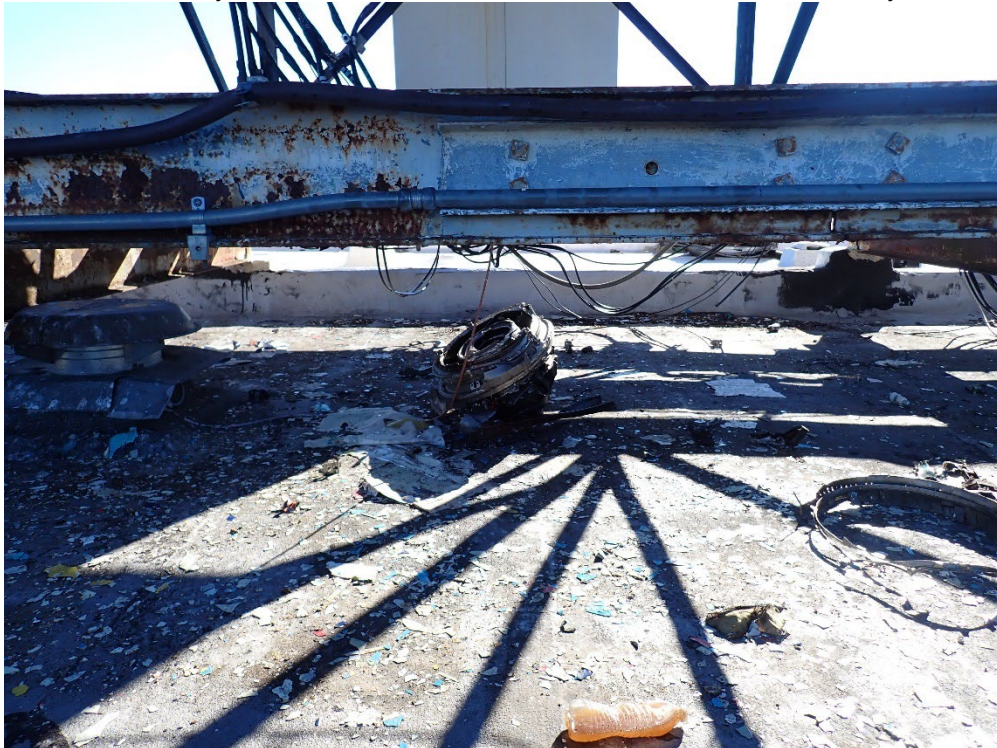
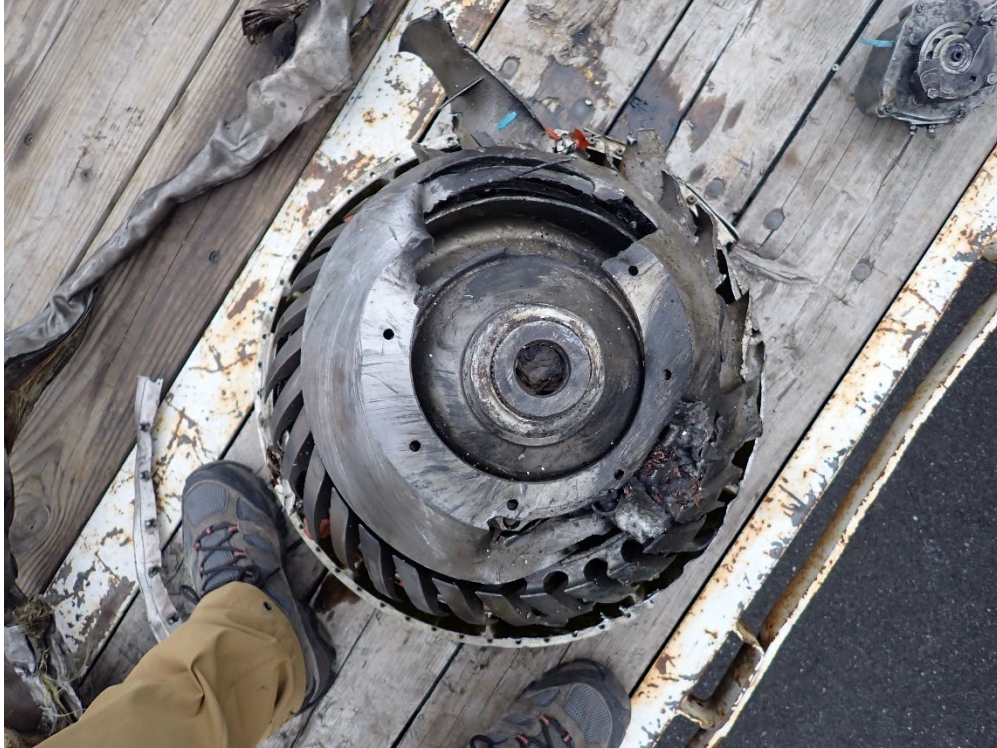
Figure 57: Fan Assembly 2 on Roof of Commercial Building (Courtesy of Honeywell)

- Identified in photos as "Left" (Appendix B Figure 57).
- Fan assembly separated from engine at aft front frame flange.
- Forward looking after (FLA) from the clockwise direction from the one mostly full-length blade there were 10 blades that were fractured at the platforms. All other blades were missing from the fan assembly (Appendix B Figure 58).

- For the one mostly full-length blade, there was rotational bending and significant fractures on the leading edge.
- One missing dovetail, one dovetail bent back beside the missing location.

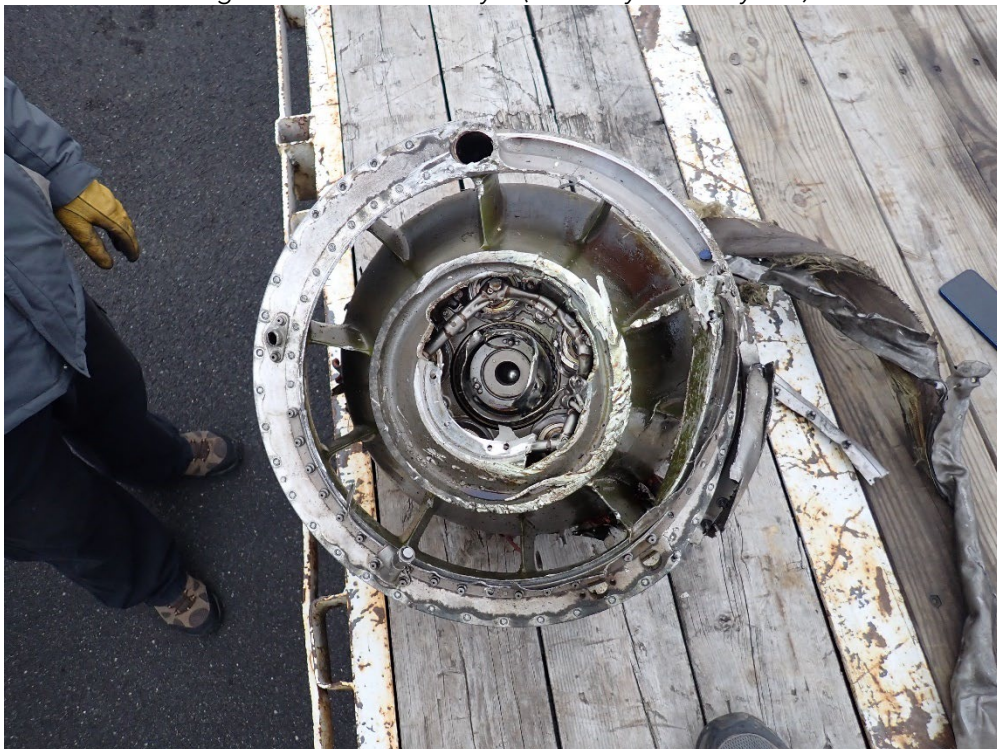
*Figure 59: Fan Assembly 2 (Courtesy of Honeywell)*

- Spinner was not present.
- Impact damage on aft face of planetary gears (Appendix B Figure 59).
- Inner flow path aft face had rotational scaring over 270°.

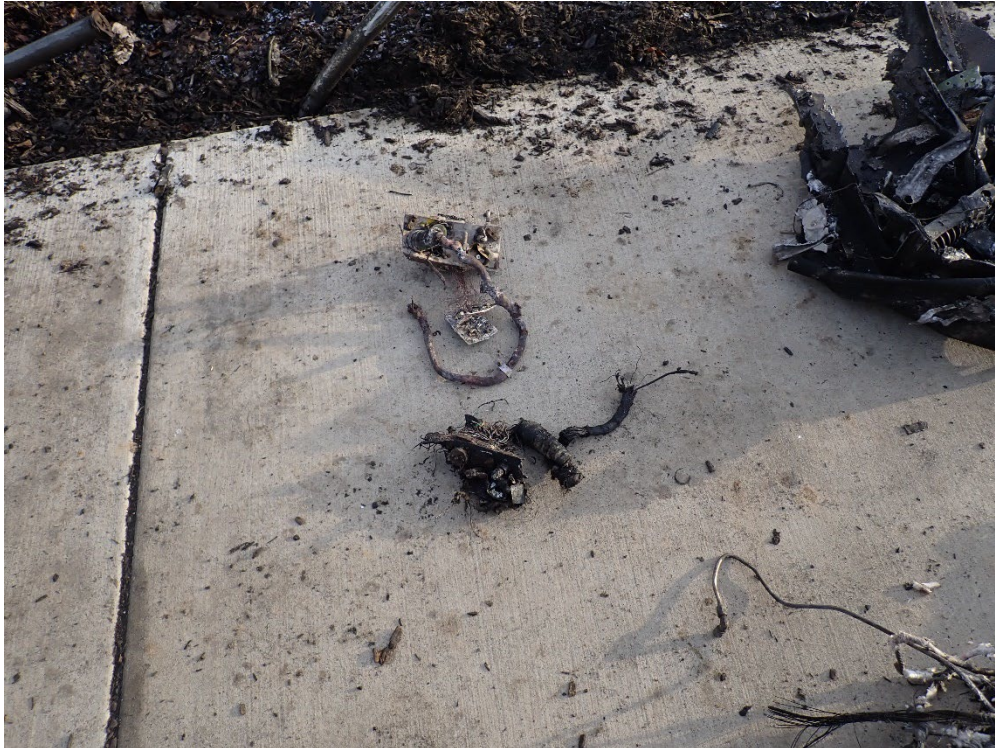
*Figure 60: Remains of Engine EEC's (Courtesy of Honeywell)*

- Only the front face plate of both EECs were recovered with some wiring. The internals and case were not recovered (Appendix B Figure 60).
