# National Transportation Safety Board

ERA25MA106

## **AIRWORTHINESS FACTUAL REPORT- ON-SCENE**

Location: Philadelphia, Pennsylvania  
Date: January 31, 2025  
Time: 1807 eastern standard time  
Airplane: Learjet 55, registration XA-UCI

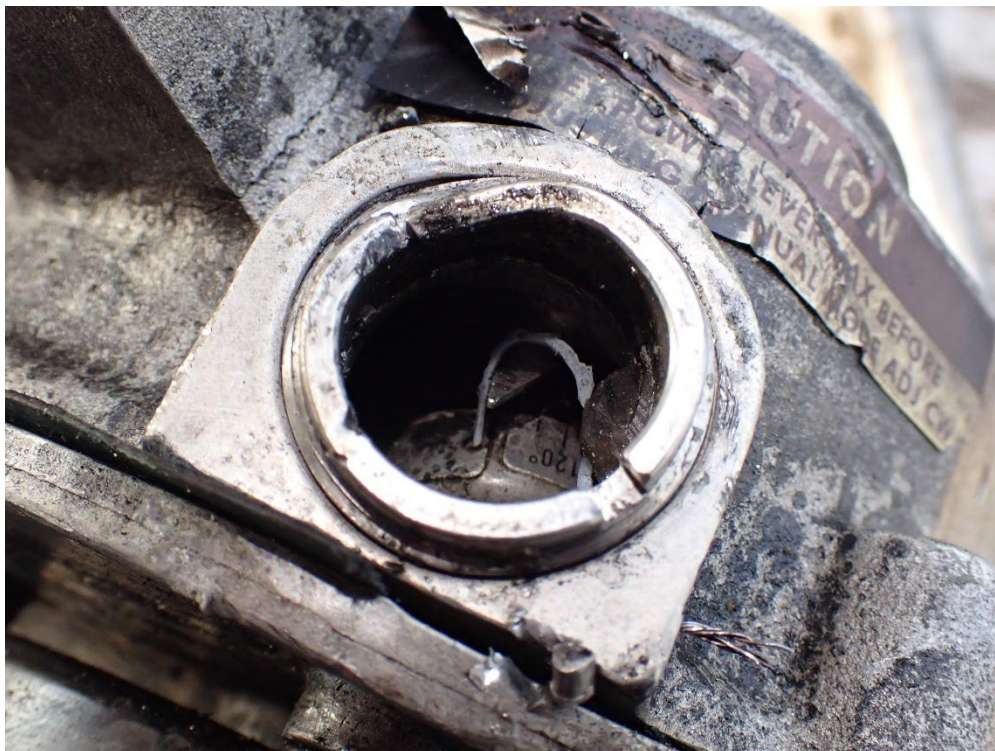
*Figure 62: A PLA Indicator and Dial Indicator (Courtesy of Honeywell)*

- PLA window shattered. Indicator visible.
- Dial was displaced from its proper position and cocked (Appendix B Figure 62).
- Indicator was beyond 120 at the end of the gauge.
