# National Transportation Safety Board

ERA25MA106

## **HUMAN PERFORMANCE**

Location: Philadelphia, Pennsylvania  
Date: January 31, 2025  
Time: 1807 EST  
2307 UTC  
Airplane: Learjet 55, XA-UCI

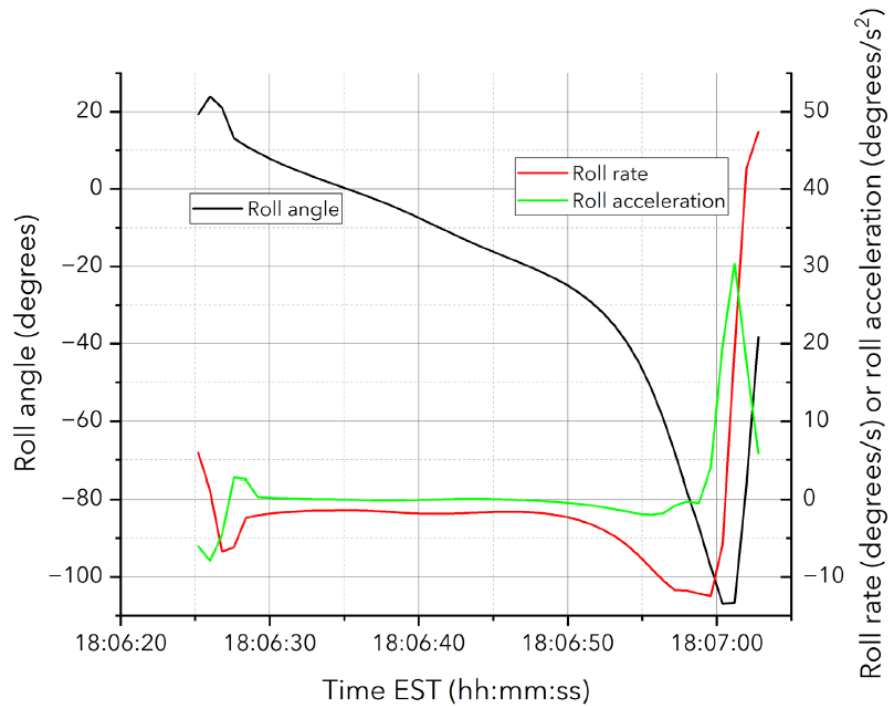
The vehicle performance specialist's study calculated roll angle throughout the flight. This analysis indicated that the airplane's roll angle was +22 degrees (right) at 1806:26 (right after the first ADS-B data point was received). It decreased to +12 degrees by 1806:28. Roll angle decreased thereafter in linear fashion at a rate of approximately 1.7 degrees per second with very little roll acceleration (average -0.3 degrees per second squared) until 1806:50. At that time, roll angle was -23 degrees (left). After that, roll angle began to rapidly decrease. By 18:07:00, roll angle was less than -100 degrees. The last two data points indicated a rapid increase in the roll angle, but the airplane remained in a steep left bank by the final data point (figure 1).

**Figure 1. Calculated roll angle, roll rate and roll acceleration (figure 10 in the vehicle performance specialist's study).**

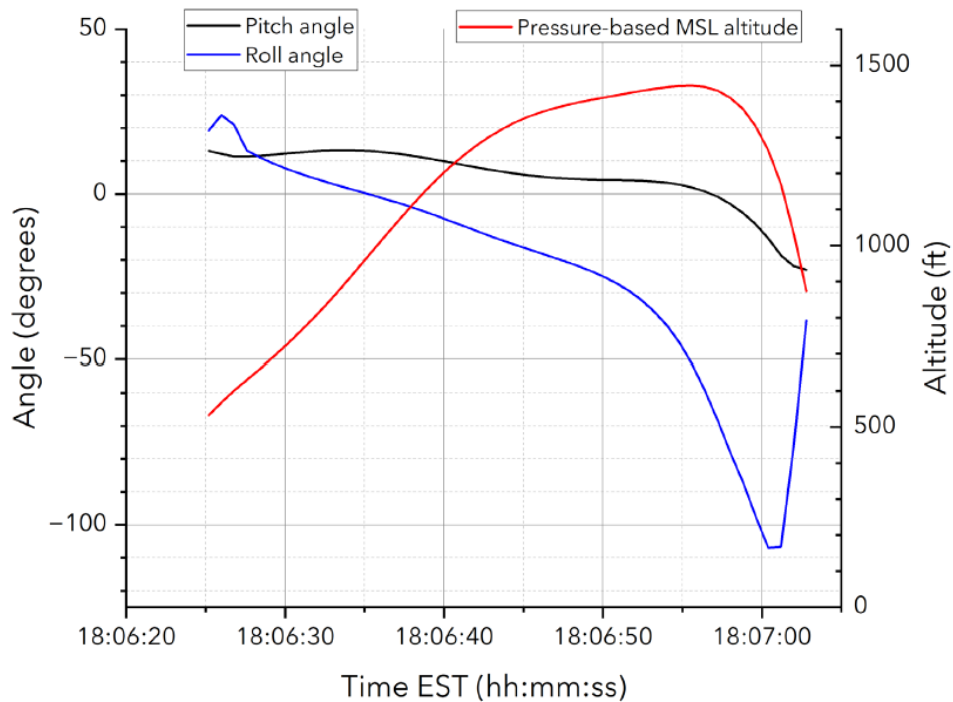
Altitude peaked at 1,320 ft agl at 1806:56. About 18:06:57, pitch dropped below zero degrees and continued decreasing as roll decreased through -65 degrees. By 18:06:59, altitude was also decreasing. By the final ADS-B data point, pitch was less than -20 degrees, and the airplane was in a rapid descent (figure 2).

**Figure 2. Pitch angle, roll angle, and curve fit to the GNSS-based MSL altitude (Figure 8 in the vehicle performance specialist's study).**

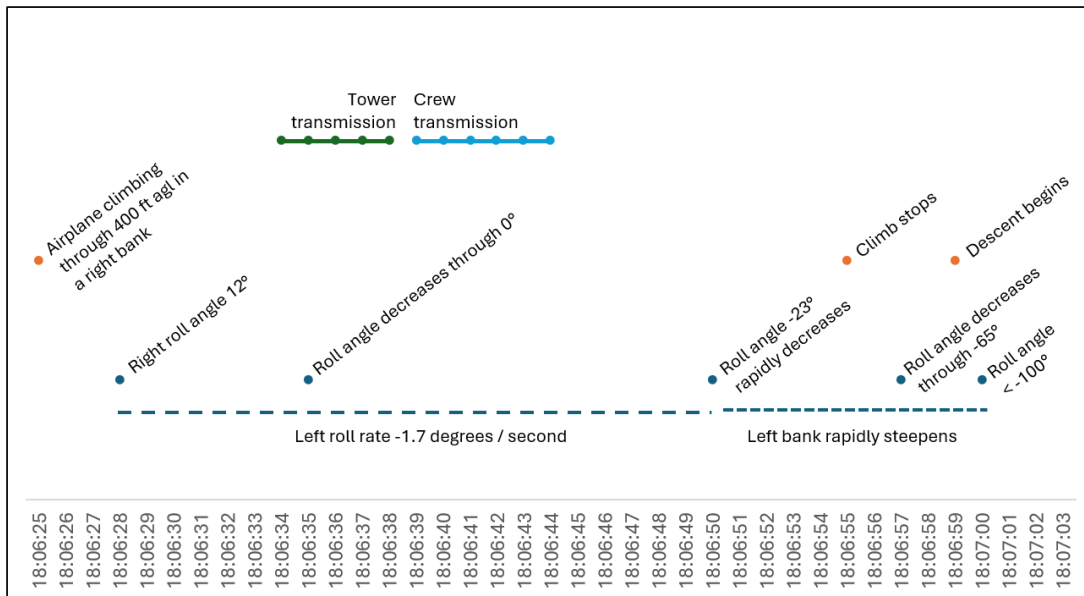
**Figure 3. Timeline of communication, climb, and roll events.**

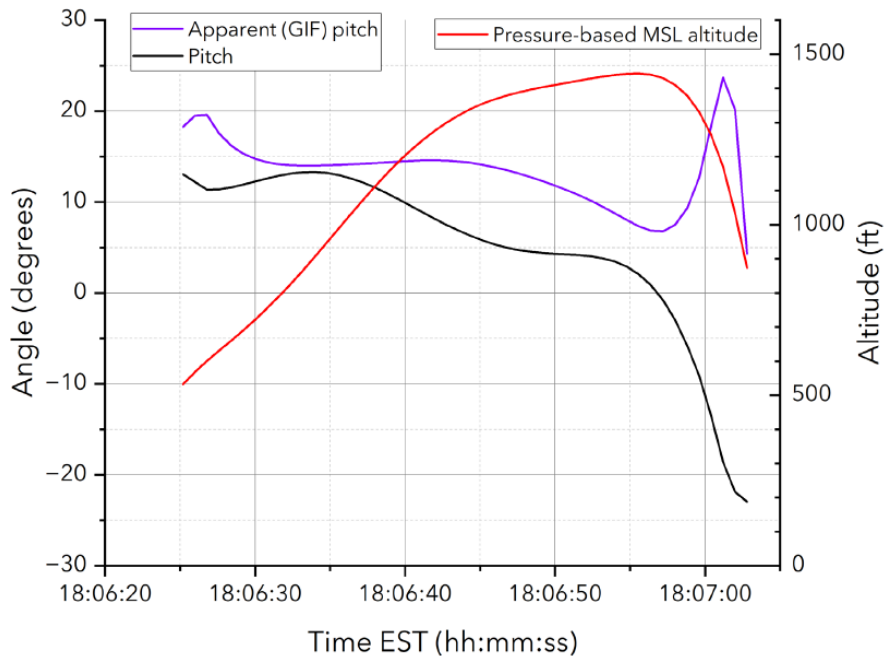
The vehicle performance specialist calculated gravitoinertial force (GIF) vector (the sum of gravity and inertial forces) throughout the flight. The result was used to compute the gravitoinertial force angle in pitch (the angle between the GIF vector and the true gravity vector). GIF angle in pitch was positive for the entire portion of the flight for which ADS-B data were available (figure 4).

**Figure 4. GIF angle in pitch, pitch angle, and pressure-based MSL altitude (Figure 13 in the vehicle performance specialist's study).**
