# National Transportation Safety Board

Office of Research and Engineering

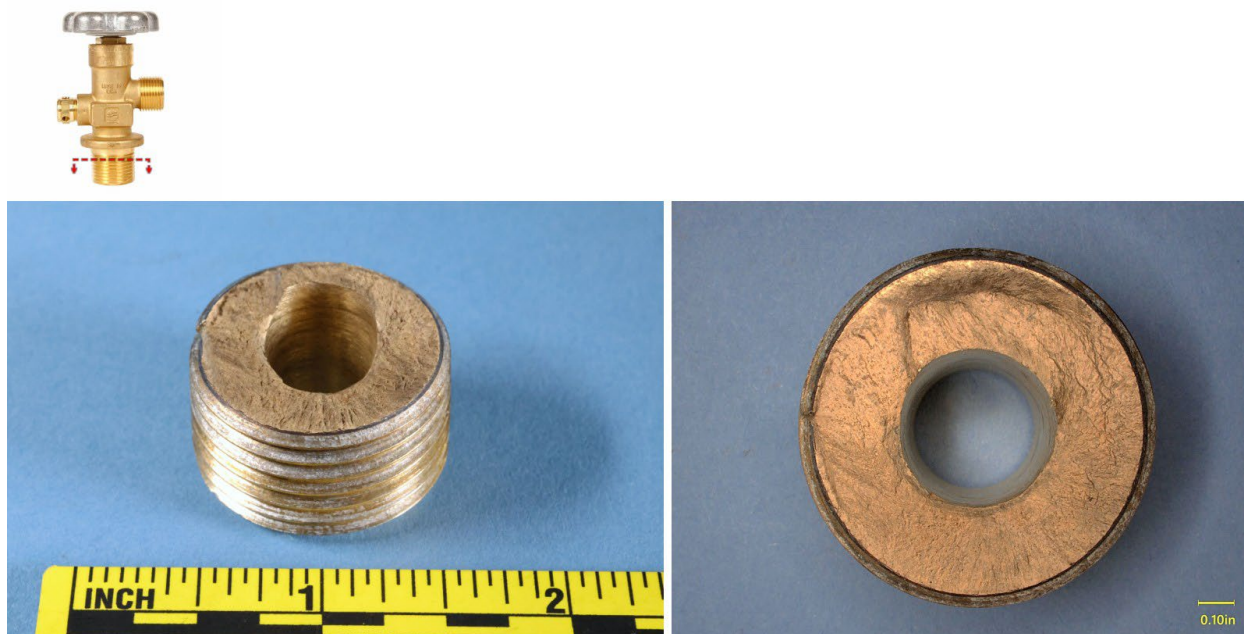
**Figure 1.** Perspective view (left) and birds-eye view of the fracture surface (right) of the fractured valve inlet stem (HAZ-02) from a CGA540 type valve. An example of the valve ([gascylindersource.com](http://gascylindersource.com)) is shown in the upper left with the approximate fracture plane indicated.

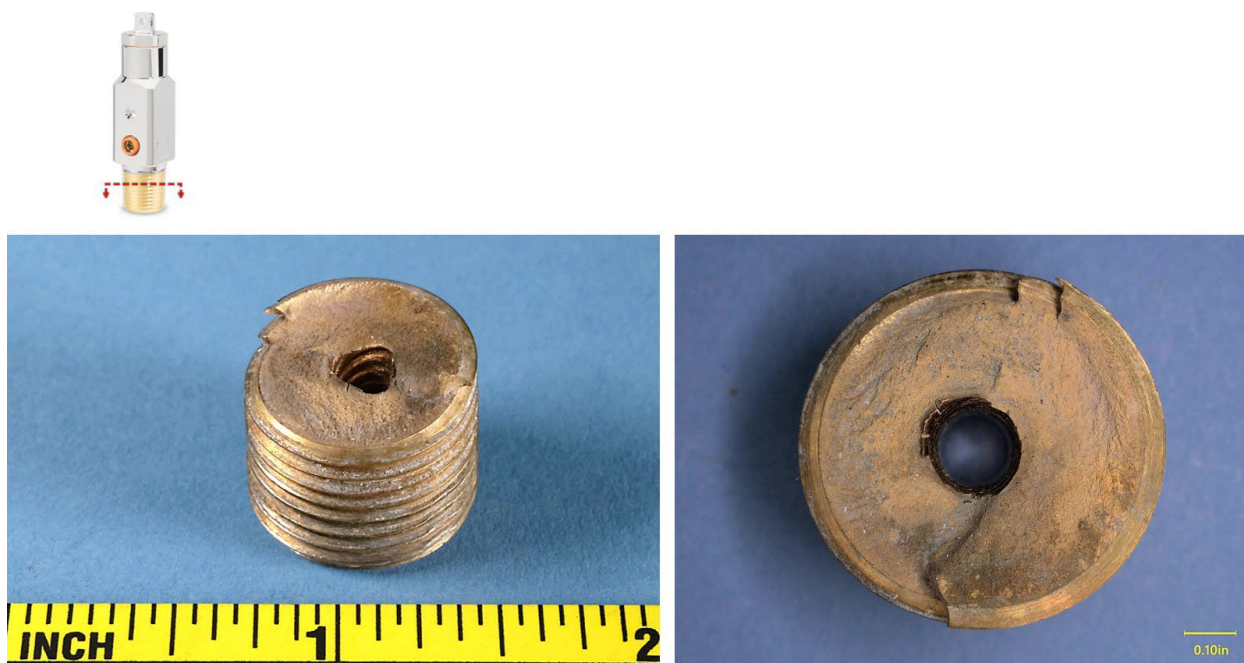
**Figure 2.** Perspective view (left) and birds-eye view of the fracture surface (right) of the fractured valve inlet stem (HAZ-04) from a CGA870 type valve. An example of the valve ([gascylindersource.com](http://gascylindersource.com)) is shown in the upper left with the approximate fracture plane indicated.

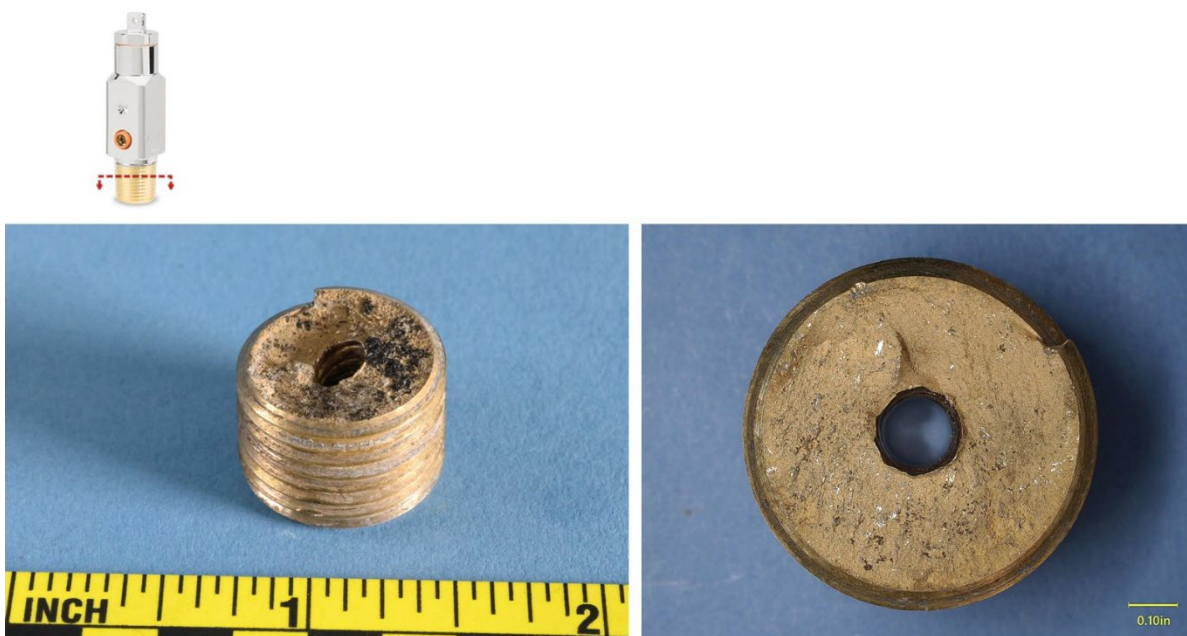
**Figure 3.** Perspective view (left) and birds-eye view of the fracture surface (right) of the fractured valve inlet stem (HAZ-05) from a CGA870 type valve. An example of the valve ([gascylindersource.com](http://gascylindersource.com)) is shown in the upper left with the approximate fracture plane indicated.

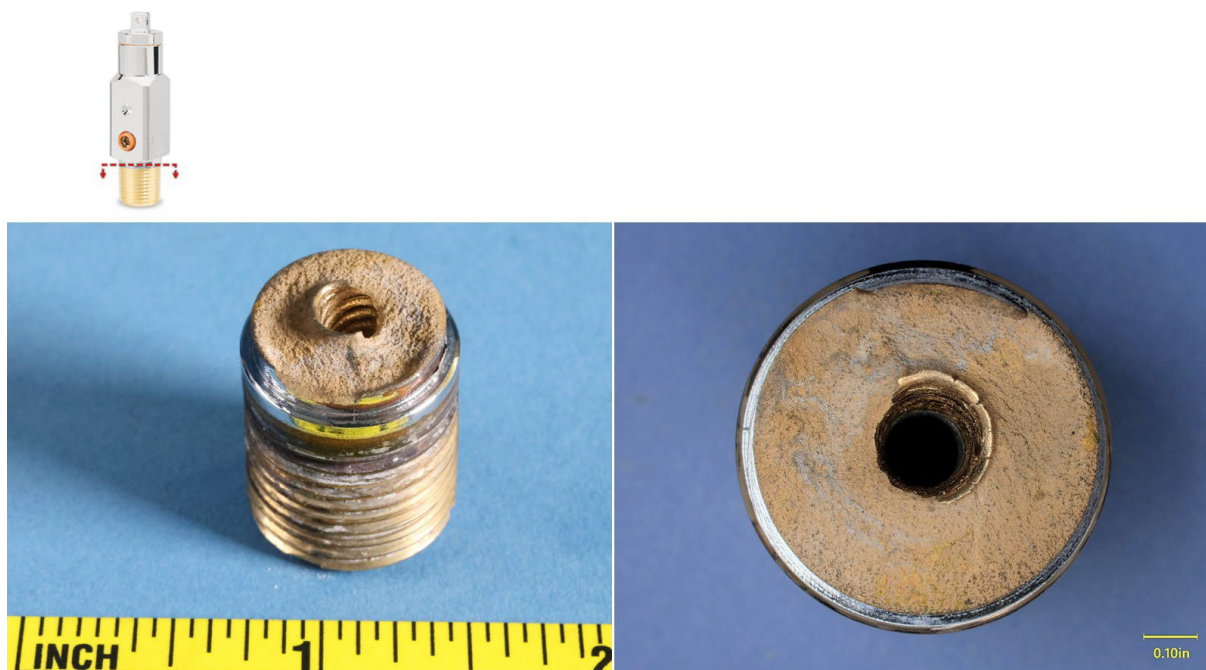
**Figure 4.** Perspective view (left) and birds-eye view of the fracture surface (right) of the fractured valve inlet stem (HAZ-06) from a CGA870 type valve. An example of the valve ([gascylindersource.com](http://gascylindersource.com)) is shown in the upper left with the approximate fracture plane indicated.

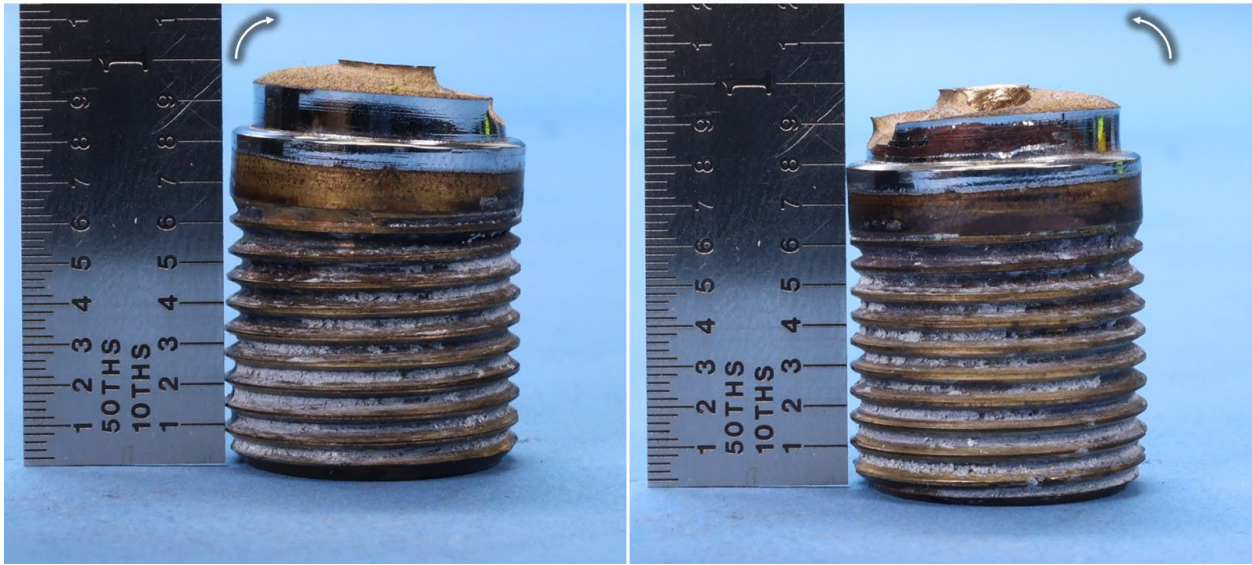
**Figure 5.** Diametrically opposite side profile views of HAZ-06 relative to a straight edge showing bending deformation in the direction indicated by arrows.

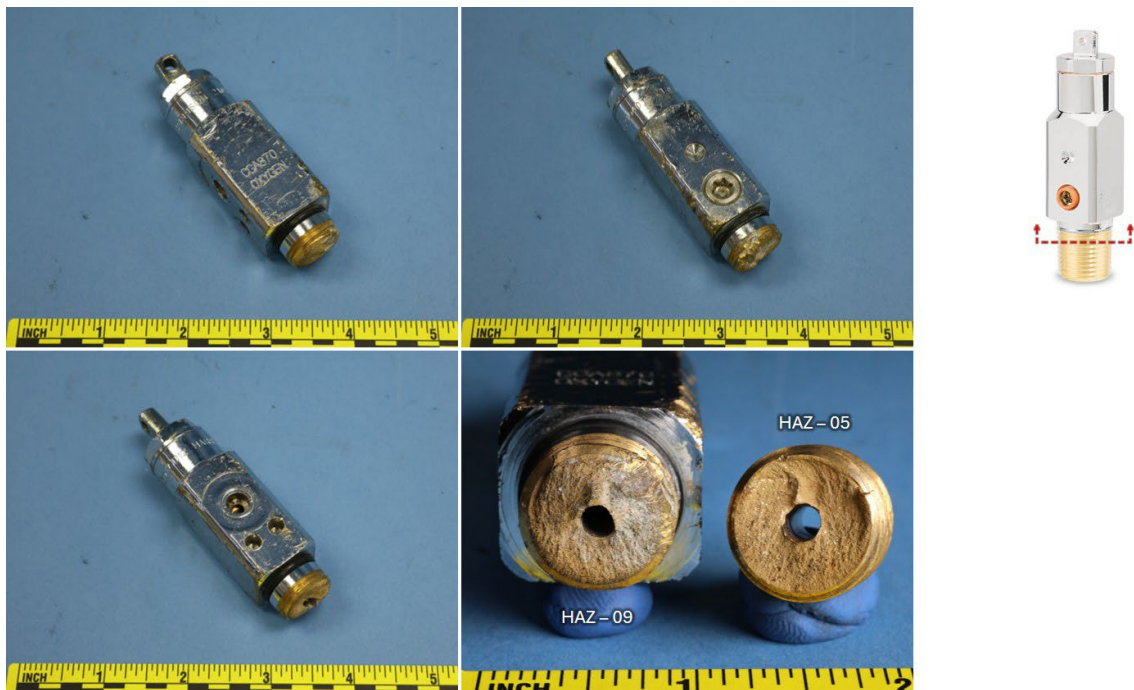
**Figure 6.** Photographs of the fractured CGA870 type valve (HAZ-09). The bottom right image shows the mating fracture surfaces (HAZ-09 and HAZ-05). An example of the valve (gascylindersource.com) is shown in the upper right with the approximate fracture plane indicated.

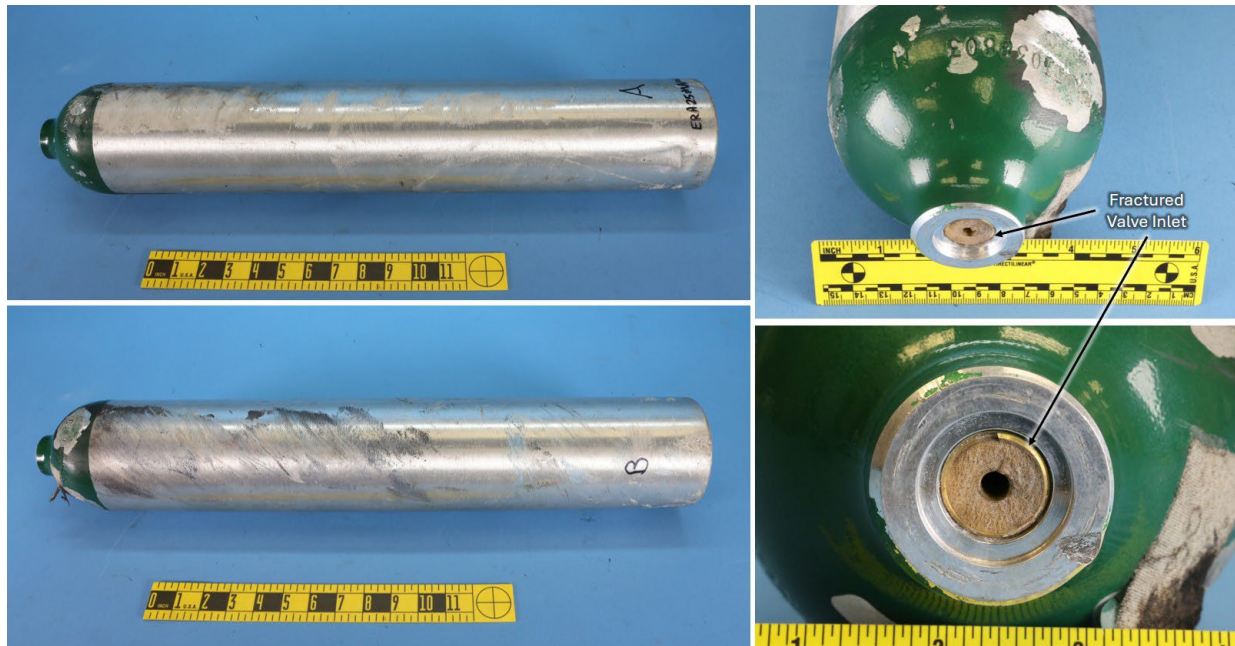
**Figure 7.** Photographs of the compressed oxygen cylinder with a portion of a fractured valve inlet retained in the cylinder boss (HAZ-03).

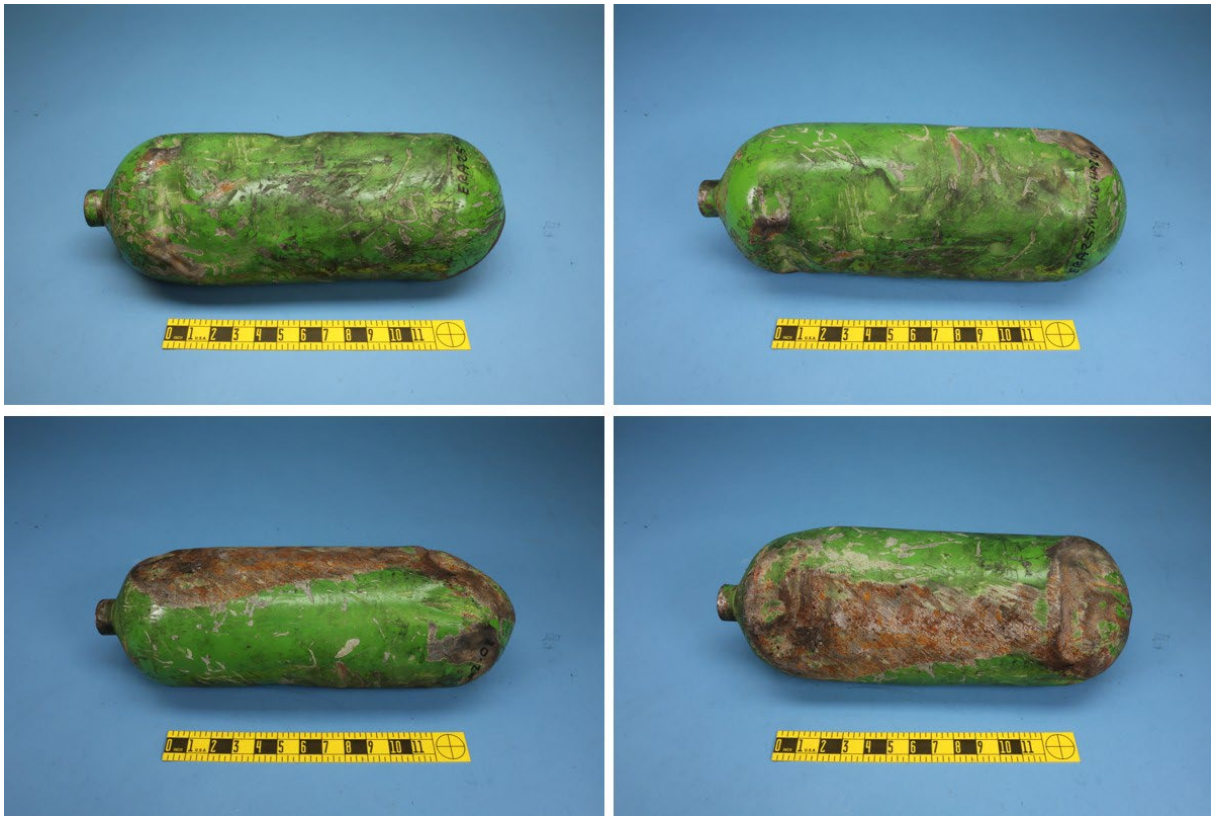
**Figure 8.** Photographs showing multiple sides of the dented and deformed compressed oxygen cylinder (HAZ-08).

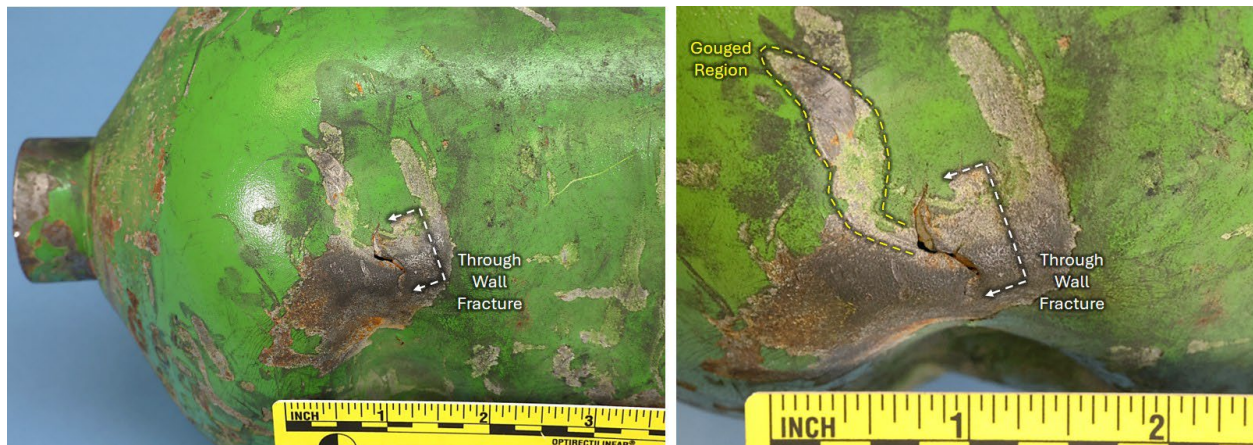
**Figure 9.** Closer photographs of the through wall fracture observed along a bulge between dented regions (HAZ-08). A gouged region, bound by a yellow dashed line intersected the through wall fracture.

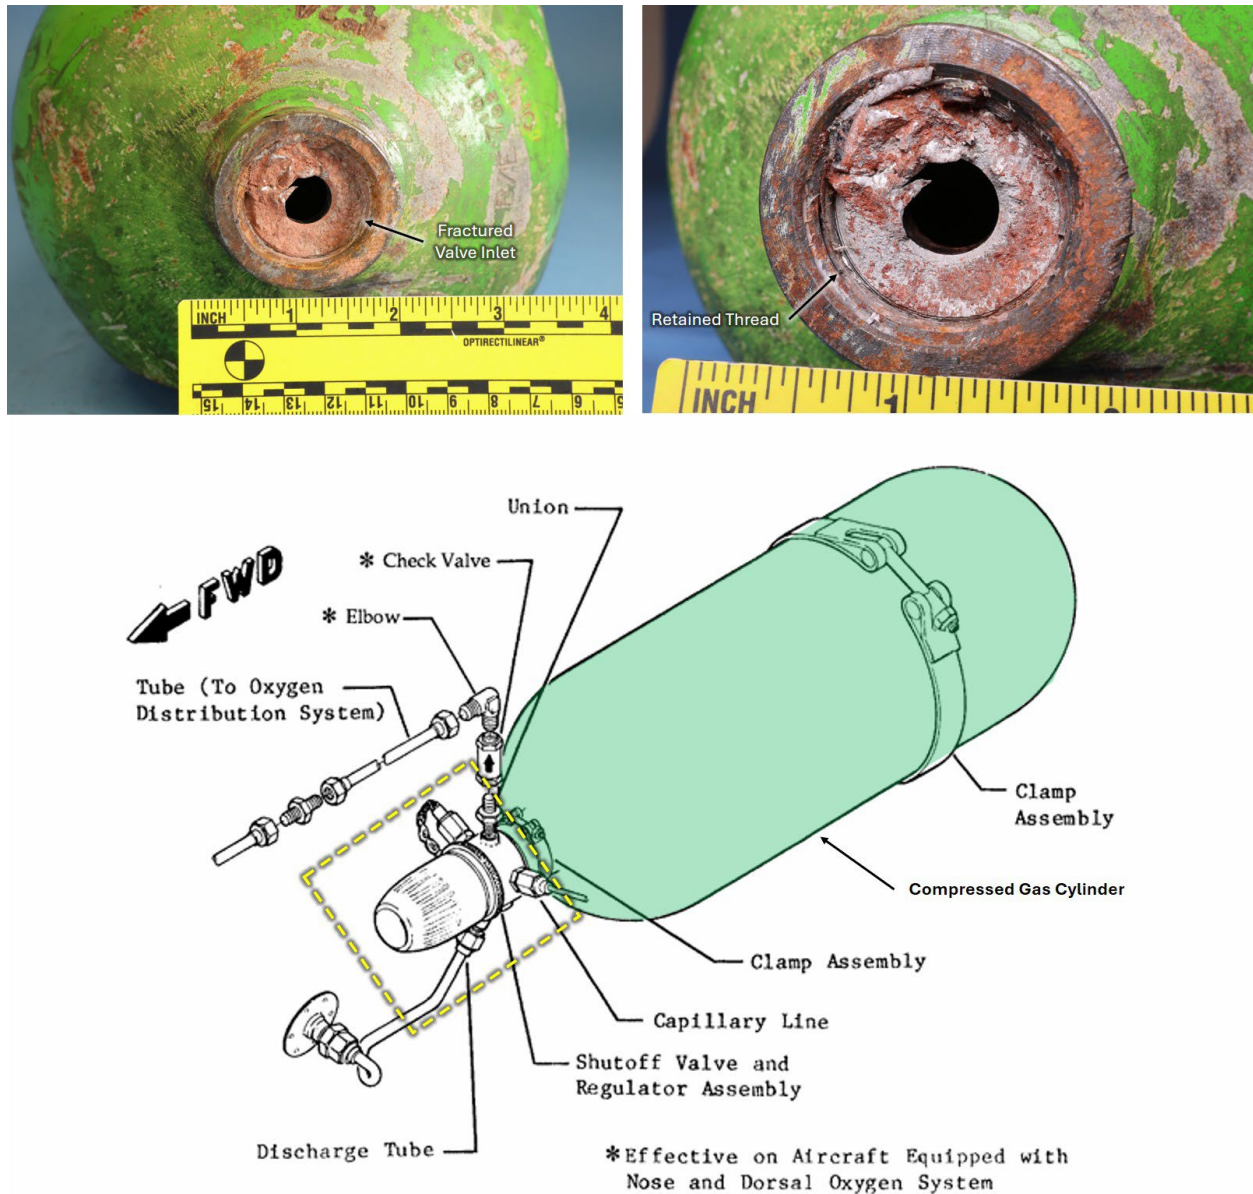
**Figure 10.** Photographs of the fractured shutoff valve/regulator assembly inlet (HAZ-08) retained in the cylinder boss before cleaning (left) and after cleaning (right). A schematic of the oxygen cylinder (highlighted green) and the shutoff valve/regulator assembly is shown below for reference. The boxed area indicates the portion of the valve that fractured and was not recovered. Schematic Source: Learjet 35/35A/36/36A Maintenance Manual Chapter 35-20-01 Figure 203 dated January 12, 2001 modified by NTSB.

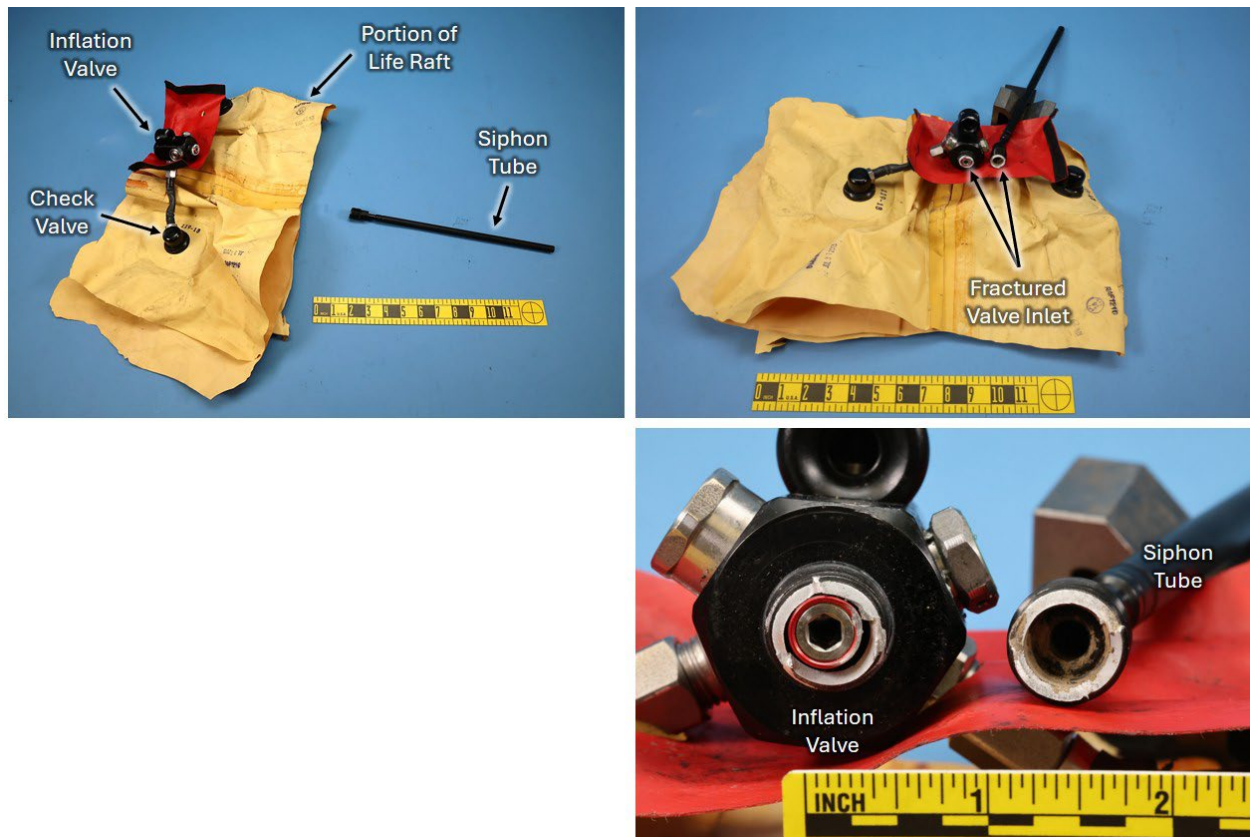
**Figure 11.** Photographs of the portion of the life raft with the fractured inflation valve inlet placed in close proximity to the mating fracture and siphon tube (HAZ-10).

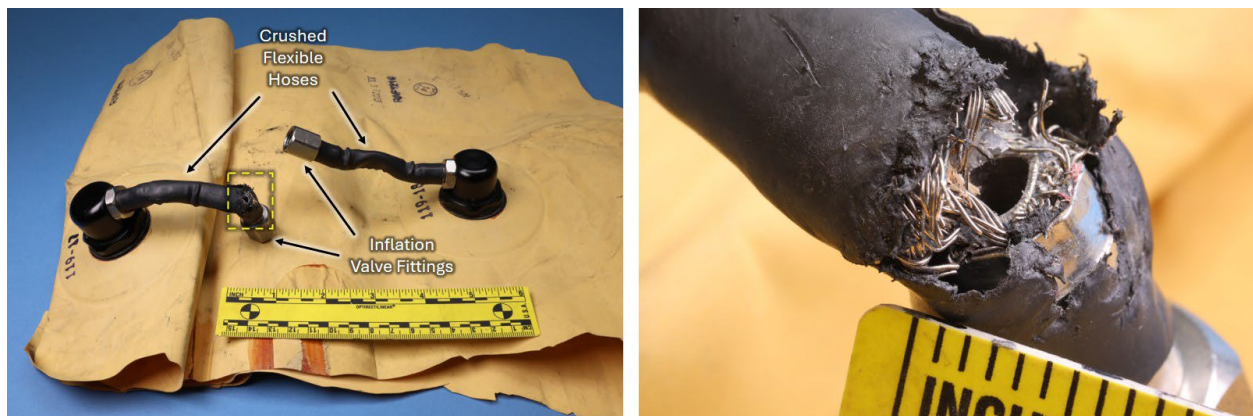
**Figure 12.** Photographs of the crushed flexible inflation hoses with the life raft inflation valve removed (HAZ-10). A closer view of the bent and fractured end of one of the inflation hoses (boxed area) is shown in the right image.
