National Transportation Safety Board  
Office of Railroad, Pipeline and Hazardous Materials  
Washington, DC 20594

ERA25MA106

## **HAZARDOUS MATERIALS CARGO/GAS CYLINDERS**

Specialist's Factual Report  
April 2, 2026

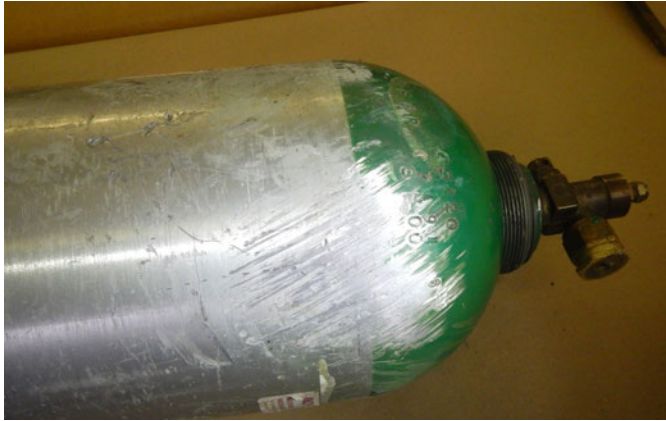
According to operator procedures, Cylinder #1 was likely installed in the bottom section of a *Lifeport 2* patient transport bed onboard the aircraft. The cylinder was found intact and under pressure.<sup>3</sup> Visual inspection of the exterior of the cylinder revealed a bent valve stem and several scrapes and scratches on the cylinder crown and wall (Figure 1). The inspection also revealed several gouges in the cylinder wall, the most significant of which measured 0.22-inches in depth (Figure 2). No hazardous materials labels or hazard communications were found on the cylinder.

In addition to completing external visual inspection of Cylinder #1, a borescope was used to complete an interior visual inspection of the cylinder. No cracks were observed in the valve threads or in the crown area, and the bottom of cylinder was clean and unremarkable. Investigators also x-rayed the cylinder and found no remarkable features. Additional stamps were found on the bottom of the cylinder (X5811, MM882), the valve stem (CGA540, B22, V18, EN849, CV05) and on the pressure relief device cap (3320, P625-19N) that refer to either manufacturing standards, internal tracking or serial numbers, or batch production codes.

**Figure 1: Cylinder #1, crown, scrape, and intact bent valve stem (March 26, 2025).**

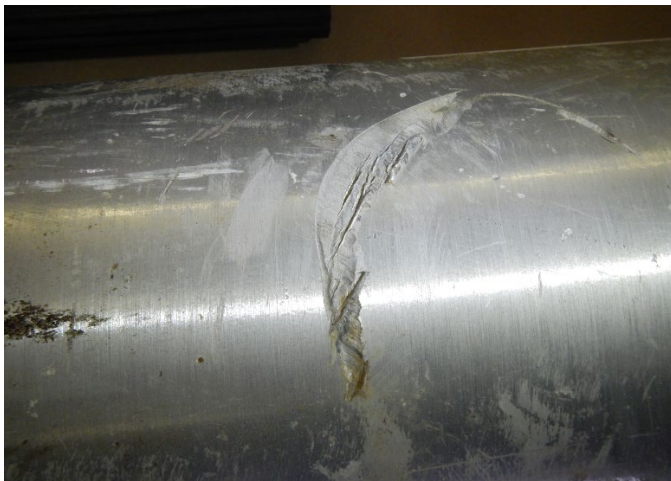
**Figure 2: Cylinder #1, exterior wall gouge (March 26, 2025).**

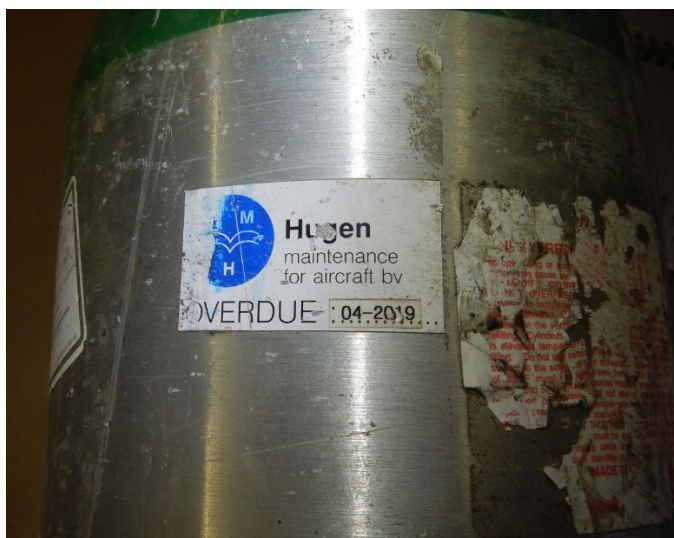
**Figure 3: Cylinder #1, maintenance overdue sticker (March 26, 2025).**

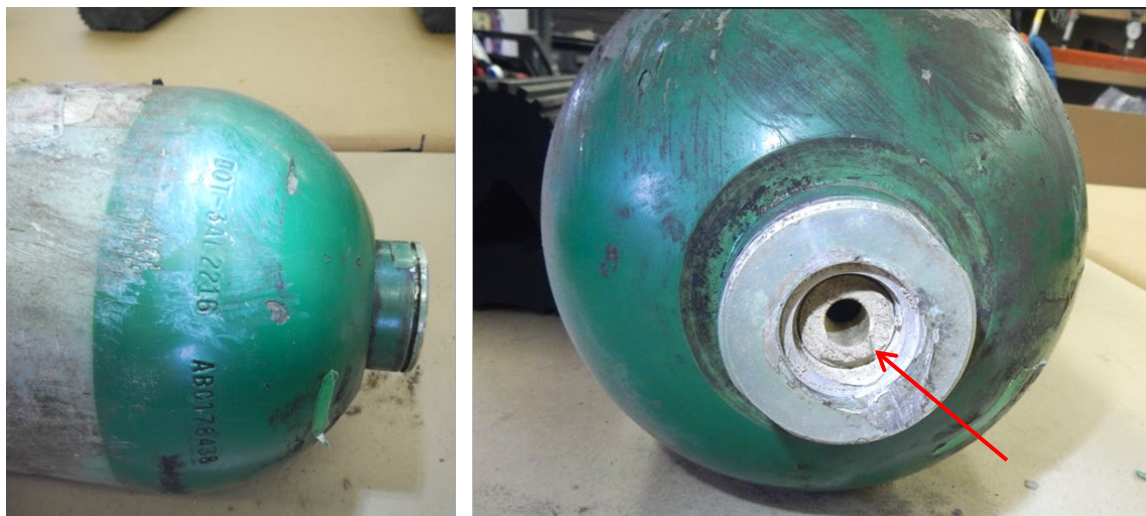
Based on a video obtained by the operator, Cylinder #2 was likely stored upright in a storage cabinet in the aft of the aircraft and strapped to the cabinet wall with a metal band.<sup>4</sup> Cylinder #2 was recovered with the valve missing and the bottom portion of the valve stem fractured and remained within the cylinder threads (Figure 4). Post-accident visual inspection of the cylinder revealed a witness mark on the top surface of the cylinder collar, adjacent to the fractured valve stem. Several scrapes and gouges were observed on the cylinder, including a deep scrape and gouge in the crown. No through-wall breaches were observed on the cylinder. Labels affixed to cylinder wall included hazardous materials labels for non-flammable gas 2.2 and oxidizer 5.1 (in Spanish), along with partially legible hazardous materials warnings and hazard communications. Interior inspection of Cylinder #2 using a borescope revealed no remarkable features on the internal surfaces of the cylinder, and no remarkable features were identified in x-rays taken of the cylinder. An additional stamp was observed on the bottom of the cylinder (AF268) that refers to the batch production code.

The fractured valve stem was removed from the tank and submitted to the NTSB Materials Laboratory for metallurgical examination and failure analysis.

**Figure 4: Photos of Cylinder #2 crown and bottom portion of fractured valve stem (red arrow) (March 26, 2025).**

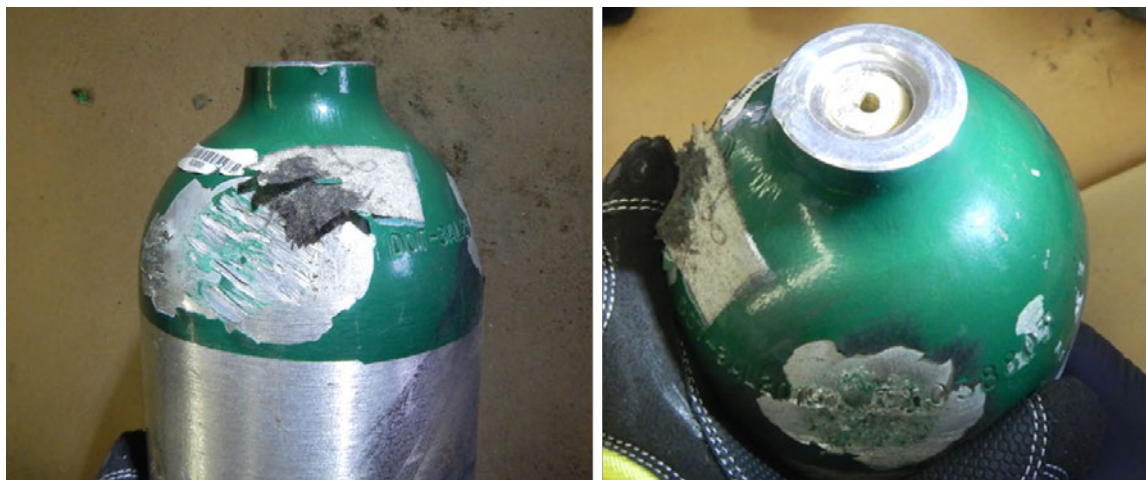
Based on a video obtained by the operator, Cylinder #3 was likely secured upright in a rack in the aft of the aircraft, with Cylinders #4, #5, #6. Cylinder #3 was found with the top portion of the valve stem missing and bottom portion of the valve stem fractured and still threaded into the neck of the cylinder (Figure 4). A witness mark was noted on the collar adjacent to the fractured valve stem. Post-accident visual inspection of the cylinder revealed a significant gouge and scrape on the crown of the cylinder (Figure 5). Additionally, the cylinder appeared to be bowed, and a significant dent was observed on the bottom of the cylinder (Figure 6). No wall breaching damage was observed. No hazardous materials labels or hazard communications were found on the cylinder. An internal visual inspection was not completed to protect the metallurgical evidentiary value of the fractured valve stem, however x-rays taken of the cylinder revealed no remarkable features. Additional stamps were found on the bottom of the cylinder (C7794, AB177) indicating batch production code and internal tracking numbers.

The entire cylinder was submitted to the NTSB Materials Laboratory for a metallurgical examination of the valve stem fracture and failure analysis.

**Figure 5: Photos of Cylinder #3 showing observed crown gouge (left) and fractured valve stem (right) (March 26, 2025).**

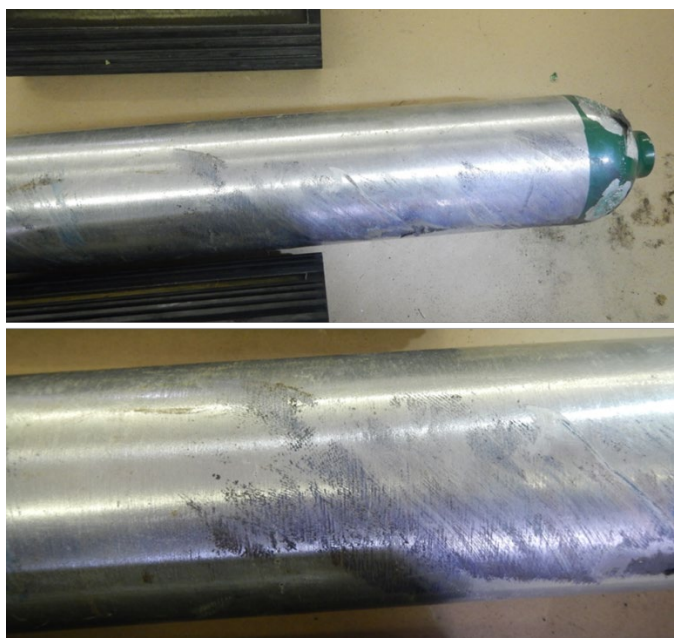
**Figure 6: Photos of Cylinder #3 showing notable fabric impression on cylinder wall (March 26, 2025).**

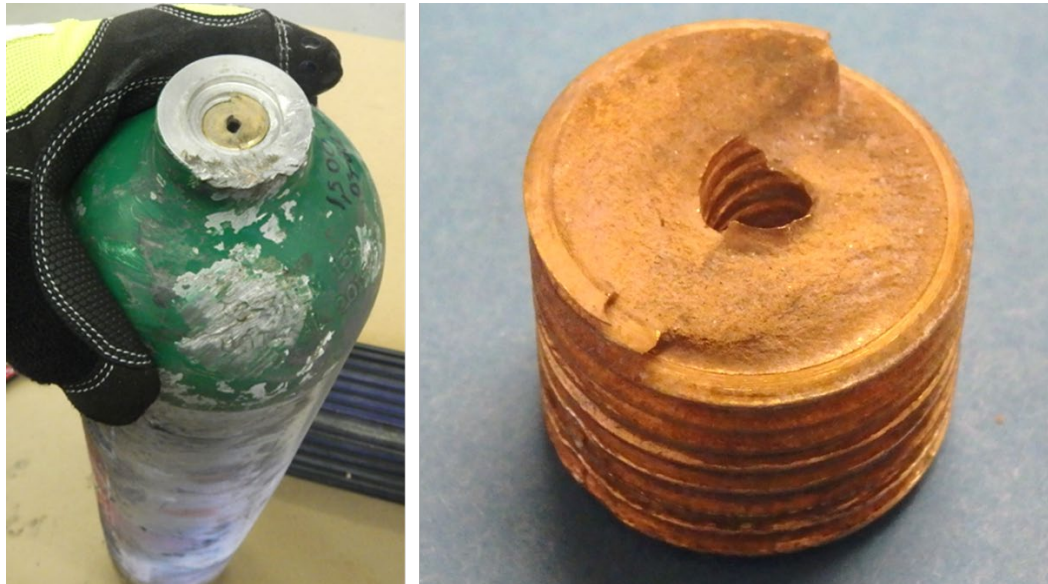
Based on a video obtained by the operator, Cylinder #4 was likely secured upright in a rack in the aft of the aircraft, with Cylinders #3, #5, #6. The cylinder was found with the top portion of the valve stem missing and bottom portion of the valve stem fractured and remaining within the cylinder neck threads (Figure 7). Post-accident visual inspection of the cylinder revealed a witness mark was found on the collar adjacent to the fractured valve stem. Additionally, a scrape was observed on the

The fractured bottom portion of the valve stem was removed from cylinder and was submitted to the NTSB laboratory for metallurgical examination and failure analysis.

**Figure 7: Photo of Cylinder #4 showing fractured valve stem and witness mark on collar (left), and fractured valve stem removed from cylinder (right) (March 26, 2025).**

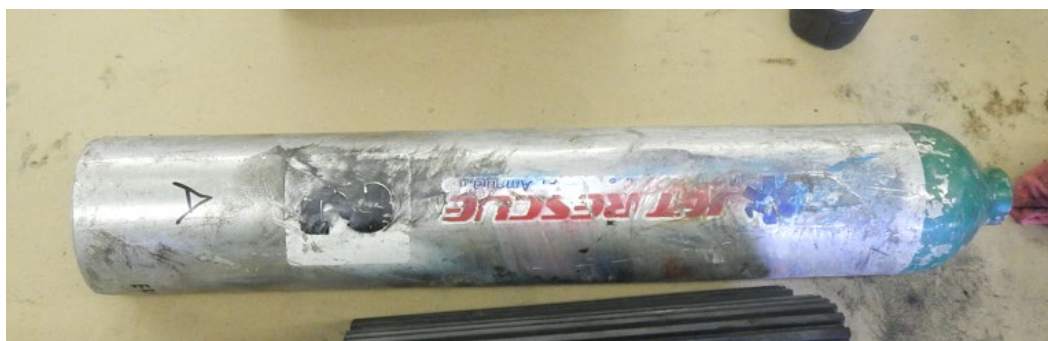
crown and collar near the valve stem, and black, blue, and red impressions were observed on the cylinder wall (Figure 8). No breaching of the cylinder wall was observed. No hazardous materials labels or hazard communications were found on the cylinder. Internal visual inspection using a borescope revealed slight pitting on cylinder wall. X-rays taken of the cylinder revealed no remarkable features.

**Figure 8: Photo of Cylinder #4 showing black, blue, and red impressions on cylinder wall (March 26, 2025).**

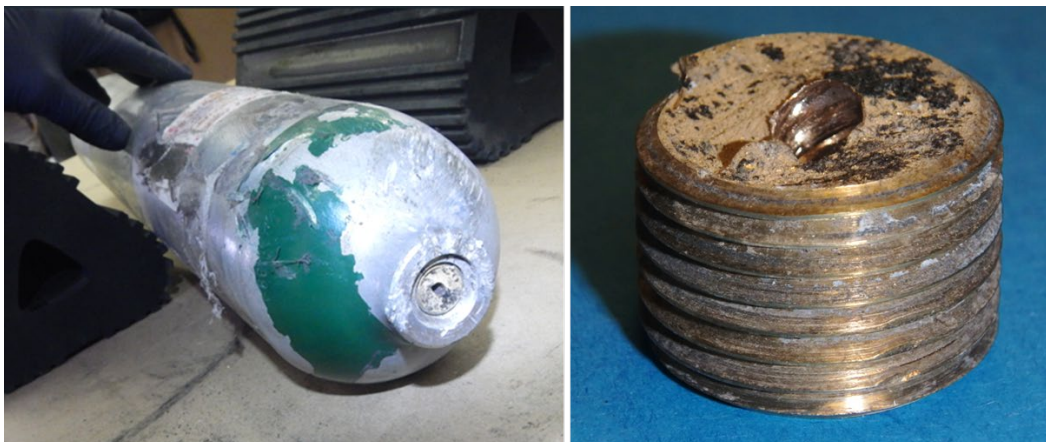
Based on a video obtained by the operator, Cylinder #5 was likely secured upright in a rack in the aft of the aircraft, with Cylinders #3, #4, #6. The cylinder was found with the top portion of the valve stem missing and the bottom portion of the valve stem fractured and remained within the cylinder neck threads (Figure 9). Post-accident visual examination of the cylinder revealed a witness mark on the collar adjacent to the fractured valve stem. Additionally, a scrape and gouge that extended from the collar across the crown of the cylinder were observed, as well as dents in the wall at the base of the crown (Figure 9). No breaching damage was observed. No hazardous materials labels or hazard communications were found on the cylinder. Internal visual inspection of the cylinder using a borescope found no thread damage, however some scaling and minor pitting was observed on the interior surface of the cylinder. X-ray examination identified no additional features.

The fractured bottom portion of the valve stem was removed from cylinder and was submitted to the NTSB Materials Laboratory for metallurgical examination and failure analysis.

**Figure 9: Photos of Cylinder #5 showing fractured valve stem and collar witness mark (left), and fractured valve stem removed (right).**

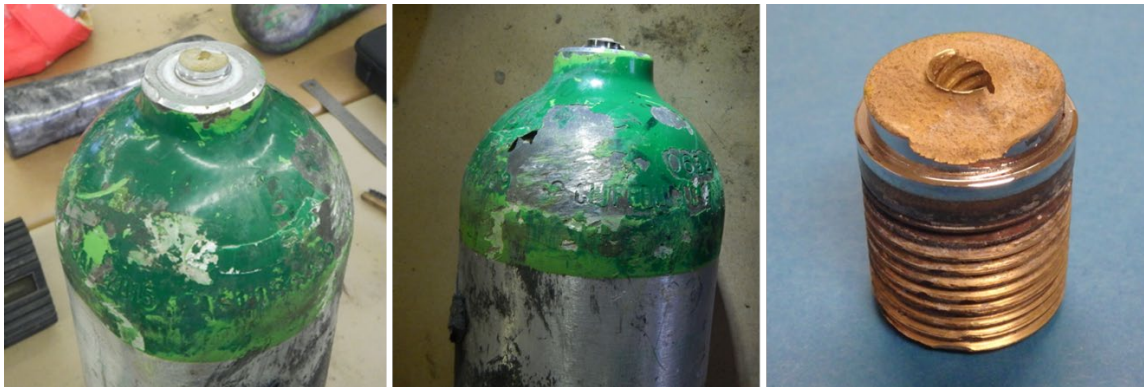
Based on a video obtained by the operator, Cylinder #6 was likely secured upright in a rack in the aft of the aircraft, with cylinders #3, #4, #5. The cylinder was found with the top portion of the valve stem missing and the bottom portion of the valve stem fractured and remaining within the cylinder threads (Figure 9). Post-accident inspection of the cylinder revealed a witness mark on the collar adjacent to the fractured valve stem. Additionally, a scrape and gouges were observed in crown and collar adjacent to broken valve stem. Black fabric impressions were observed, and a

The fractured bottom portion of the valve stem was removed from cylinder and was submitted to the NTSB laboratory for metallurgical examination.

**Figure 10: Photos of Cylinder #6 showing fractured valve stem remaining in cylinder neck (left), gouge observed in crown (center), and fractured valve stem removed from cylinder (right).**

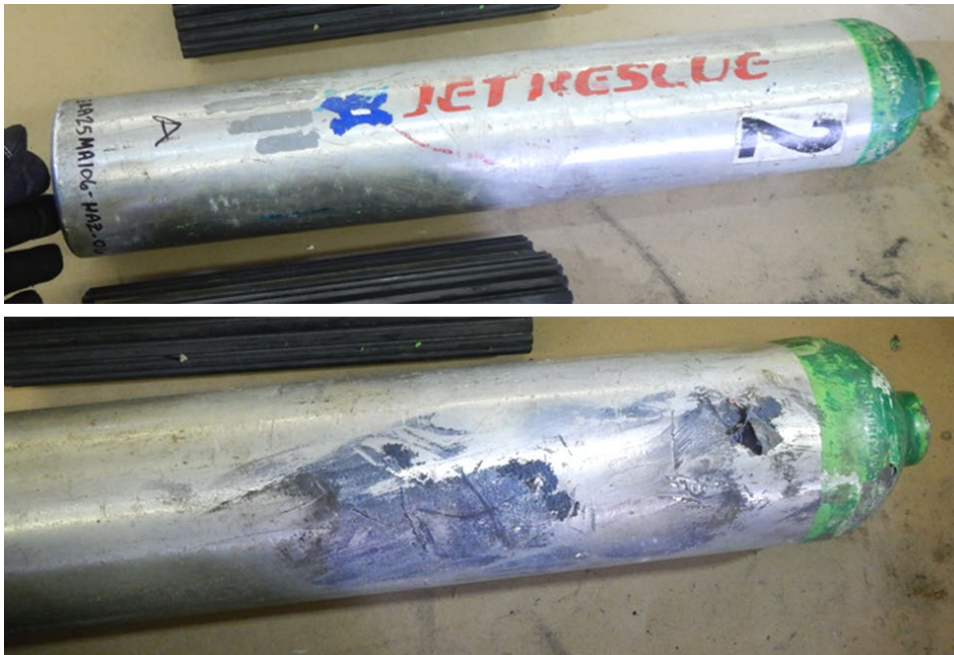
piece of blue fabric was found adhered to the tank wall (Figure 10). Further, the cylinder appeared to bowed. No breaching damage was observed. No hazardous materials labels or hazard communications were found on the cylinder. Internal borescope inspection of the cylinder revealed thread corrosion and evidence of scaling on the interior walls of the cylinder. The X-ray examination of the cylinder revealed no remarkable features.

**Figure 11: Photo of Cylinder #6 showing dents observed on the wall of the cylinder at the base of the crown and fabric adhered to tank wall.**

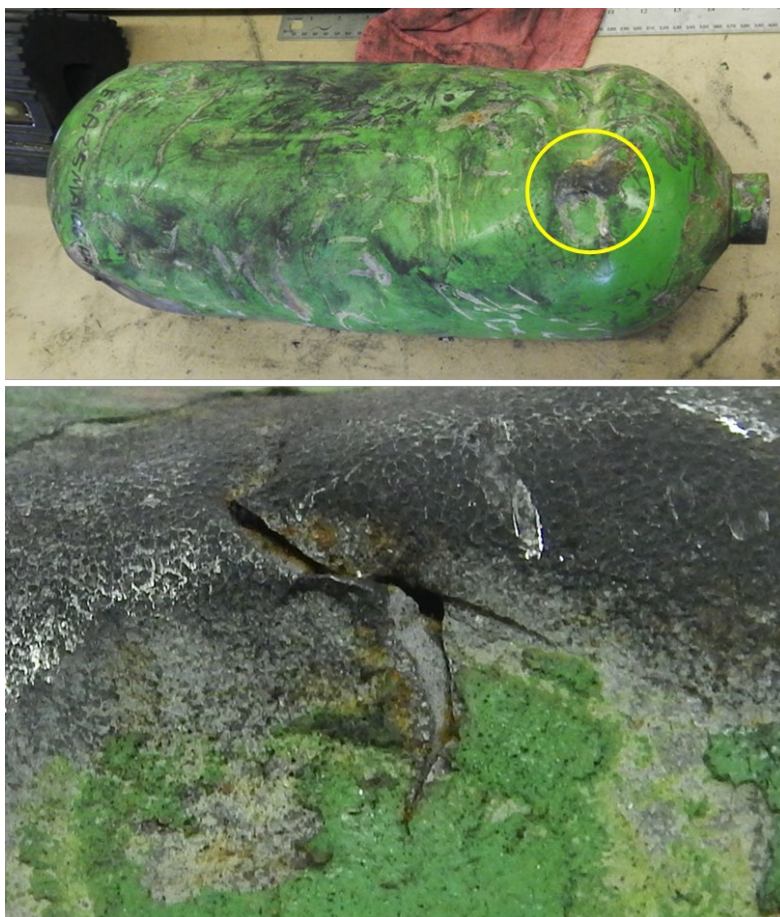
Cylinder #8 was likely in the tail of the aircraft in the vertical stabilizer, according to Illustrated Parts Catalogue (IPC) for the Learjet 55. The cylinder was found with the top portion valve stem missing and the bottom portion of the valve stem fractured and remaining within the cylinder threads. Post-accident examination of the cylinder revealed dents on all sides, including the crown and bottom. Additionally, a through-wall crack was observed in the cylinder near the crown and adjacent to two dents (Figure 12). No hazardous materials labels or hazard communications were found on the cylinder. An internal borescope examination revealed the area near the through-wall crack had evidence of stress cracking to either side. Rust was observed throughout the interior surfaces of the cylinder walls and crown, including a “bathtub ring” feature near the bottom of the cylinder (Figure 13). X-ray examination identified no additional features. The cylinder was submitted to the NTSB laboratory for metallurgical examination and failure analysis.

**Figure 12: Photos of Cylinder #8 showing dents observed on cylinder (top) and through-wall crack (bottom)(March 26, 2025).**

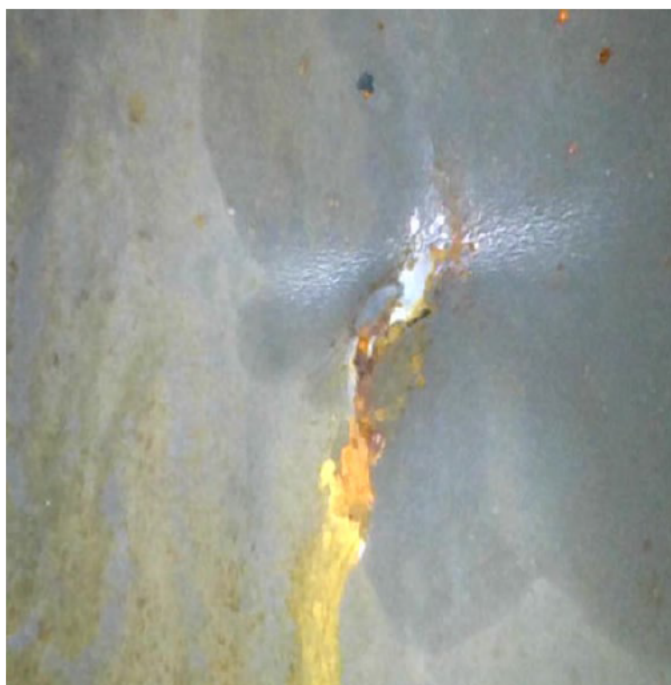
**Figure 13: Photo of Cylinder #8, showing internal view of through-wall crack and rust observed on interior surface of cylinder during borescope examination (March 26, 2025).**

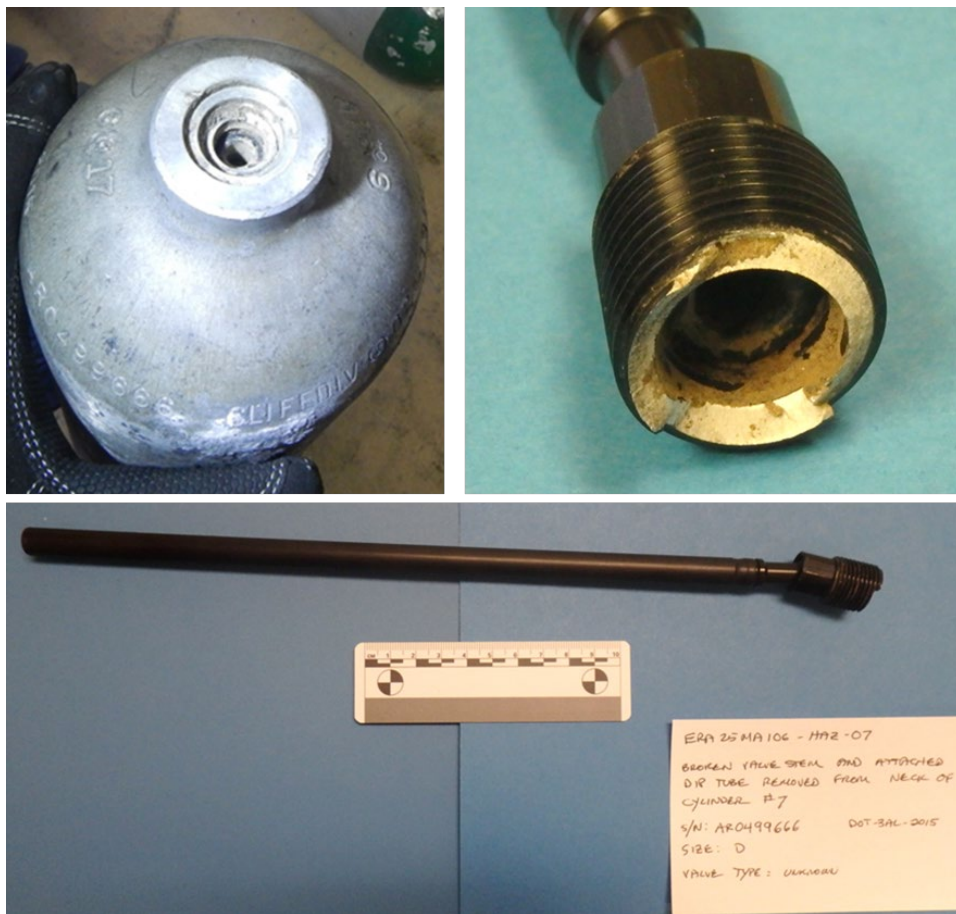
Cylinder #7 was associated with an onboard life raft manufactured by AVI Survival Products that was located next to the packaged life raft in its valise. The cylinder was found with the top portion of the valve stem missing and bottom portion of the valve stem fractured and remaining within the cylinder neck threads (Figure 14). The fractured valve stem was attached to a dip tube that extended to the bottom of the cylinder. Post-accident visual inspection of the cylinder revealed the cylinder walls

The valve stem/dip tube was removed from the cylinder and was submitted to the NTSB Materials Laboratory for metallurgical examination and failure analysis.

**Figure 14: Photos of Cylinder #7 crown and collar (top left), fractured valve stem (top right), and dip tube (bottom) (March 26, 2025).**

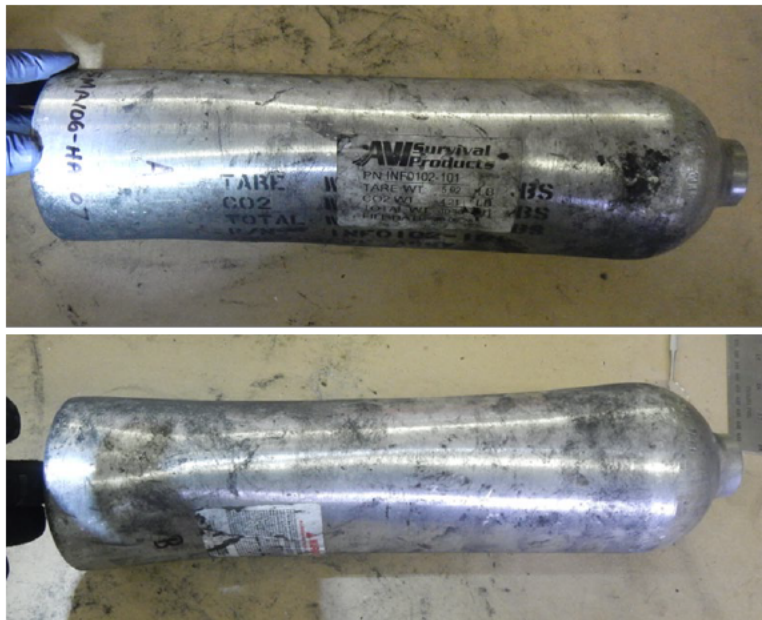
were flattened and dented, and the cylinder appeared to be bowed outward on one side and inward on the adjacent side (Figure 15). Some corrosion was observed on the external collar surface and black soot was observed on the cylinder walls. No breaching of the cylinder wall was observed. No hazardous materials labels or hazard communications were found on the cylinder. Internal visual inspection using a borescope revealed some corrosion on the top neck threads, but the remaining threads were clean. Evidence of cylinder wall scale and pitting were also observed, as was a "bathtub ring" at two levels in bottom half of the cylinder. X-rays taken of the cylinder revealed no remarkable features.

**Figure 15: Photos of Cylinder #7 walls dented and bowed out (March 26, 2025).**

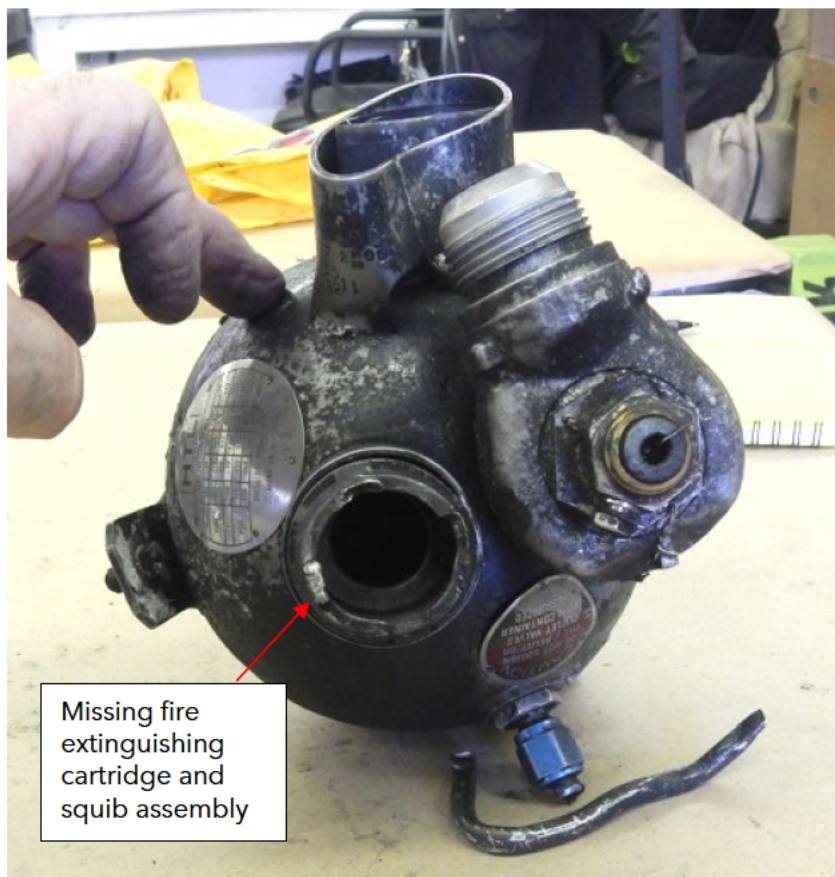
Halon Cylinder #1 was a compressed gas welded stainless steel cylinder used for aircraft engine fire suppression and installed above the engines. The cylinder was found discharged (empty), as evidenced by a fractured diaphragm disc. Post-accident inspection of the cylinder revealed one of the fire extinguisher cartridges with its squib assembly missing and the other intact (Figure 16).

**Figure 16: Photo of actuated Halon Cylinder #1 with one of its fire extinguisher cartridge and squib assembly missing (March 26, 2025).**

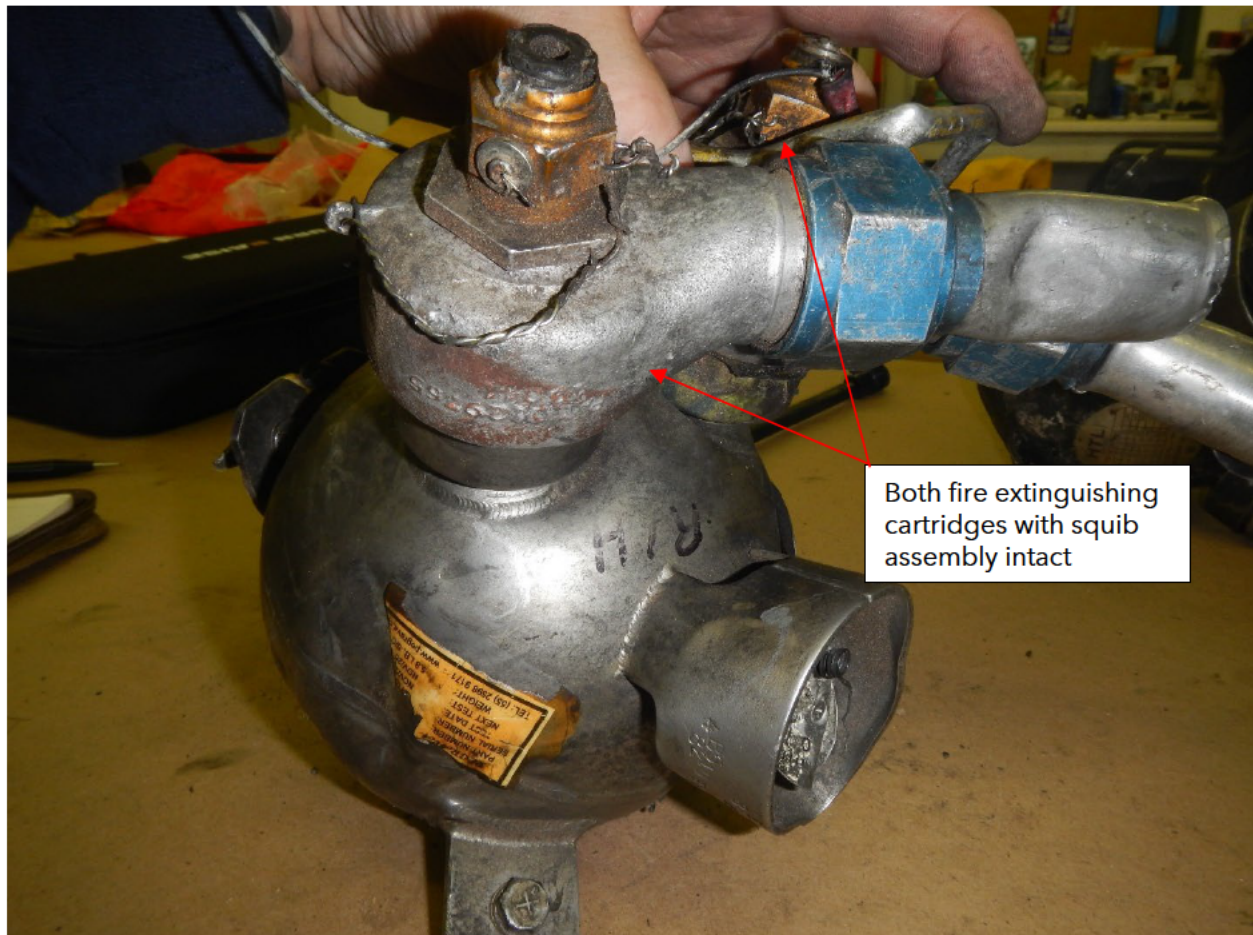
Halon Cylinder #2 was a compressed gas welded stainless steel cylinder used for aircraft engine fire suppression and installed above the engines. The cylinder was found fully charged, as evidenced by its weight and sloshing. Post-accident

inspection of the cylinder revealed the fire extinguisher actuation cartridge intact (Figure 17).

**Figure 17: Photo of non-actuated Halon Cylinder #2 with both fire extinguisher cartridges intact (March 26, 2025).**

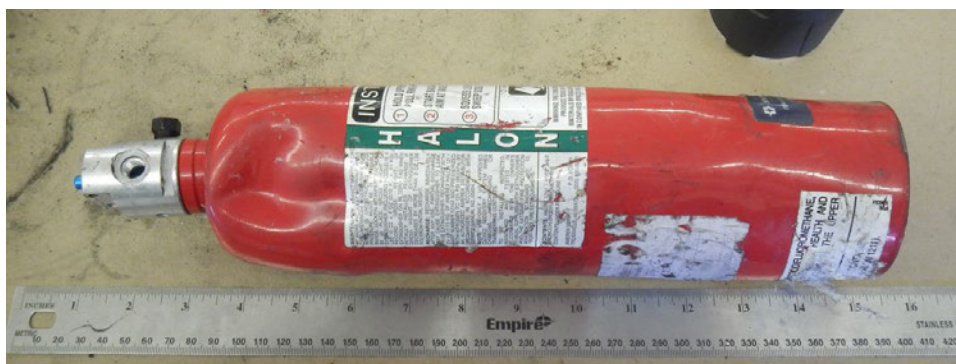
Halon Cylinder #3 was a "DOT approved" liquefied gas type handheld portable marine fire extinguisher installed on the aircraft for emergency use. Post-accident inspection of the cylinder revealed severe dents on all sides of the cylinder (Figure 18). Additionally, the valve stem was bent. The top valve stem was intact but the operating handle and pressure gauge were missing and the discharge port was open.

**Figure 18: Photo of Halon Cylinder #3 (March 26, 2025).**

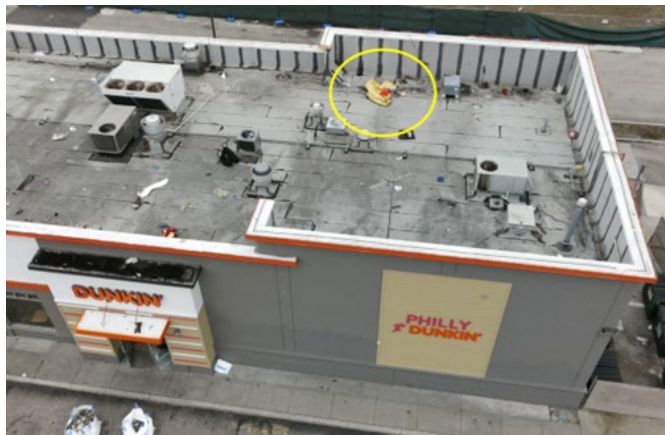
Following the accident, the life raft came to rest on the northeast side roof of the Dunkin', 1230 Cottman Avenue, Philadelphia PA, adjacent to the crash site (Figure 22 and Figure 23). A lanyard was stretched along the edge of the roof and draped over the side of the building. The inflation lanyard was found coiled next to the raft.

**Figure 22: Aerial view of the aircraft's life raft on the roof of the Dunkin', 1230 Cottman Avenue, Philadelphia, PA, looking north. (February 2, 2025, annotation by NTSB).**

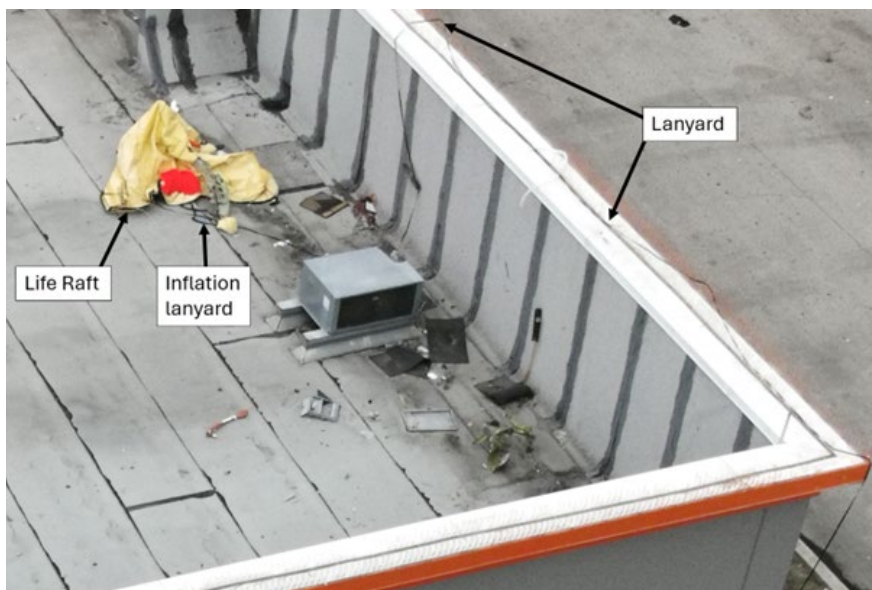
**Figure 23: Close-up aerial view of life raft and components on the roof of the Dunkin', 1230 Cottman Avenue, Philadelphia, PA. (February 2, 2025, annotations by NTSB).**

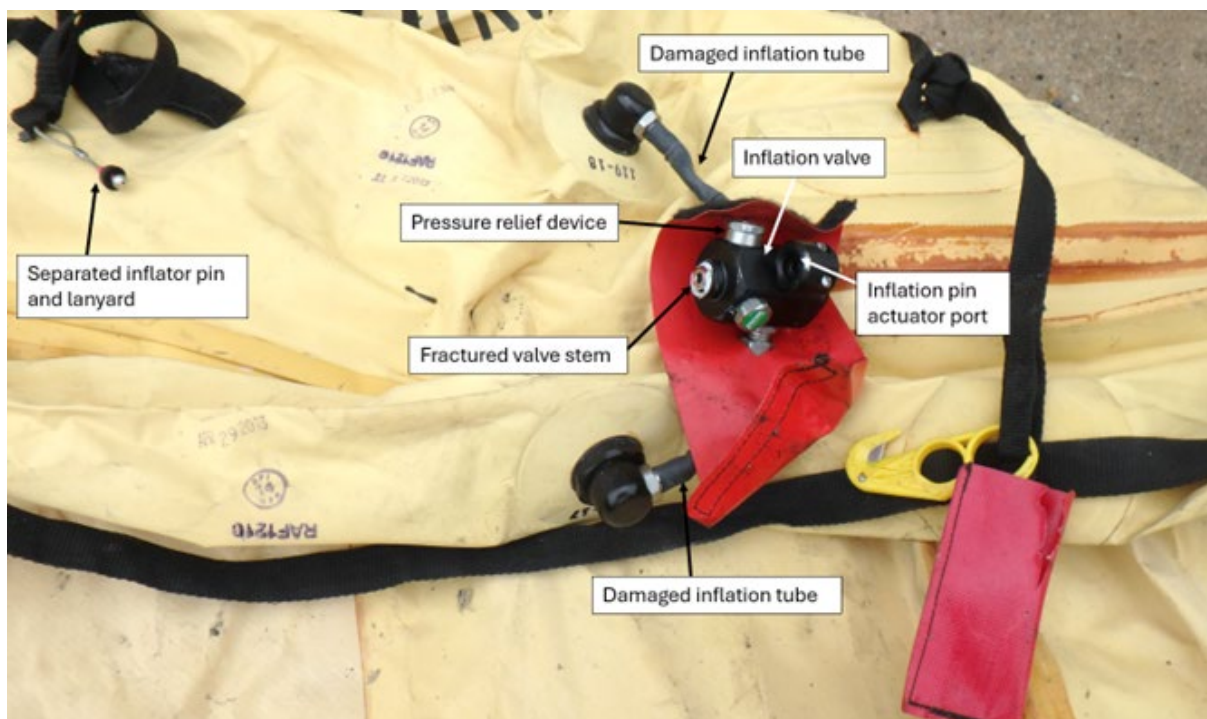
Visual inspection of the life raft revealed that the yellow tube life raft walls were not inflated. No loss of integrity was identified in the life raft walls. A tear was observed in the center of the raft floor. The inflator pin on the life raft was observed as separated from the inflation valve but still attached to its lanyard (Figure 24). Beyond the inflator pin, the lanyard was tied off to a hardpoint on a patch of reinforced life raft wall. The red inflation valve pouch Velcro closure was unfastened. The inflation valve contained a portion of the fractured valve stem that would have been connected to Cylinder #7. The inflation pin actuator port was observed as open, within which was a protruding a spring-loaded pin/valve. The pressure relief device discharge port contained a silver-colored disc. The portion of the disc visible within the exposed discharge port was not ruptured and its fitting was still secured (Figure 25). The two ¼-inch-diameter inflation tubes attached to the life raft chambers were crushed, and beneath the rubber sleeve of one of these tubes crushed/frayed stainless-steel braided tubing was observed. Additionally, a representative from AVI examined photos of the life-raft in situ on the roof and stated that the raft appeared to not be inflated.

**Figure 24: Close-up aerial view of life raft inflation valve assembly on the roof of the Dunkin', 1230 Cottman Avenue, Philadelphia, PA, (February 2, 2025, annotations by NTSB).**

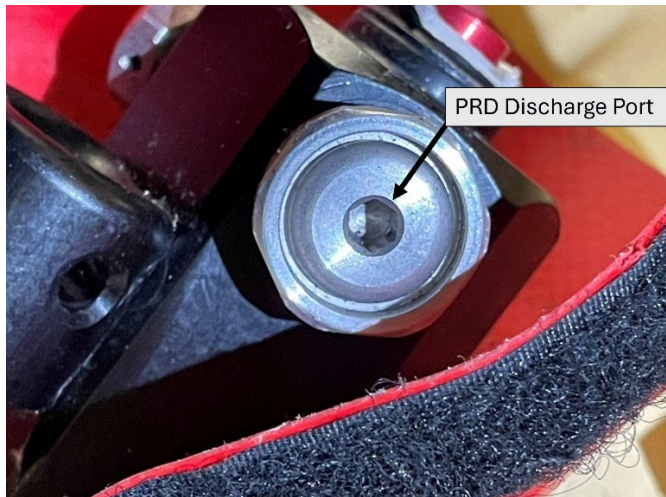
**Figure 25: Close-up of pressure relief device discharge port with disc visibly in place (February 2, 2025, annotation by NTSB).**

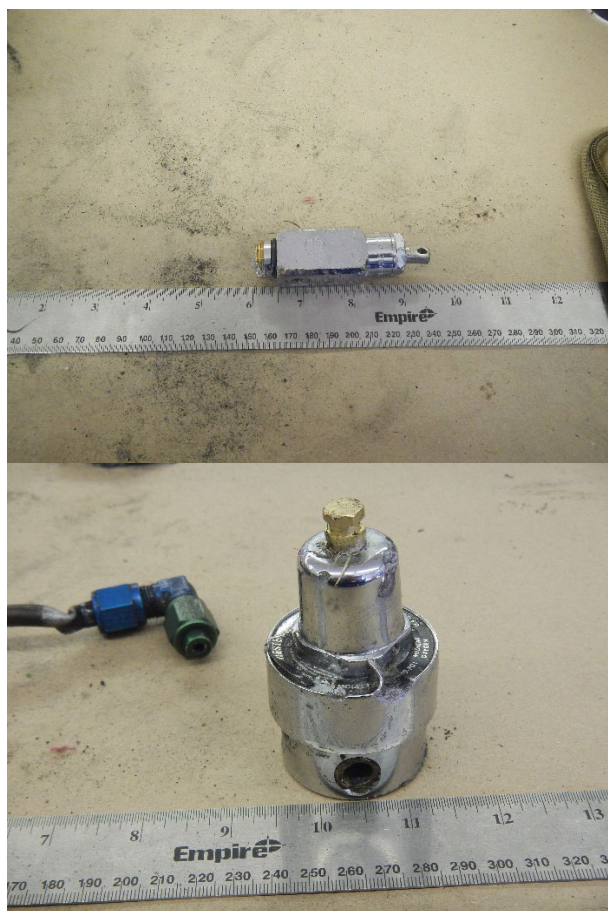
The oxygen valve body was manufactured by Harrison MFG and was stamped "2104015 21/04 V9 ISO V U12." The valve body was also stamped "CGA870 Oxygen" referring to the manufacturing standard. The valve is used as a high-pressure control point to open and close cylinder gas flow.

A recovered oxygen pressure regulator, used to reduce pressure from an oxygen tank and typically attached to the oxygen valve body, was marked "Property of St. Johns R.M.S." It also displayed a bar code with property number 1681. Additional stampings included "AM2901, 0528." The ports were stamped "IN", "HP." Labeled "Western, model No. M?70-FG1, Made in USA, Medical Oxygen" (Figure 26).

**Figure 26: Photos of oxygen valve body stamped CGA870 (top) and an oxygen pressure regulator (bottom) (March 26, 2025).**

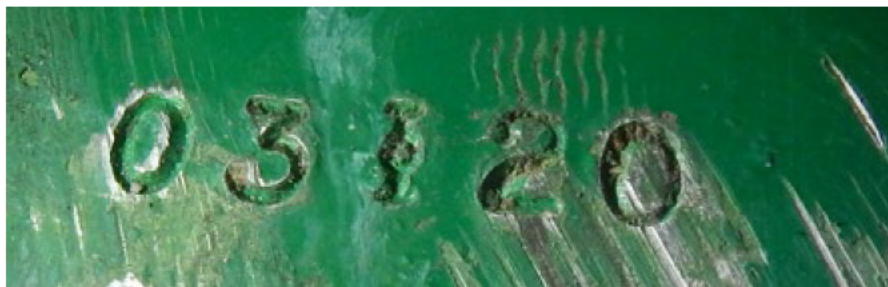
Three of the oxygen cylinders were marked with a requalifier stamp, which identifies the facility that certified the cylinder on the date of the inspection (see Figure 27). The operator reported that the three oxygen cylinders were qualified in March 2020 by Infra Toluca, a facility in Santa Maria Totoltepec, Mexico. This facility did not receive an approval through PHMSA, indicating that the requalification was not done in compliance with U.S. regulations. The operator also reported that the medical oxygen cylinders were installed inside the aircraft and therefore recharged through a reservoir tank, but did not provide a date of the last refill.<sup>9</sup> The two halon cylinders for the fire protection systems and the crew oxygen cylinder were requalified by a PHMSA approved cylinder requalifier, "I022", listed as Mantenimiento Aereo Y Partes Pegrava, S.A. DE C.V.

**Figure 27: Requalifier stamp found on oxygen Cylinder #1.**
