# National Transportation Safety Board

ERA25MA106

## **AIRWORTHINESS**

Location: Philadelphia, Pennsylvania  
Date: January 31, 2025  
Time: 1807 eastern standard time  
Airplane: Learjet 55, registration XA-UCI

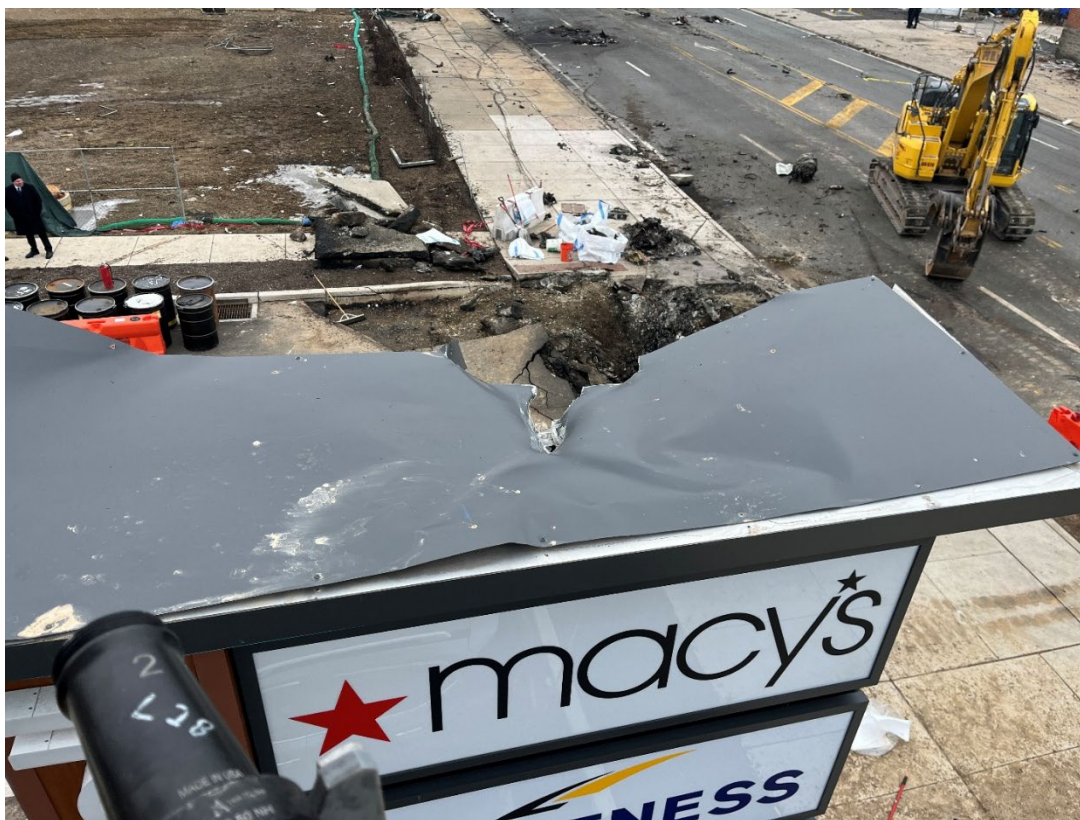
The main wreckage debris field was located between the intersections of Hanford St. at Cottman Ave. and Roosevelt Blvd. and the wreckage debris field was about 1,410 ft in length and 840 ft wide, oriented on a magnetic heading of about 150°. The airplane horizontal stabilizer contacted a business sign beside the main impact crater and the calculated descent angle based on the height of the observed damage to the sign was about 22°. White paint transfer was evident at the point of contact with the sign.

**Figure 3: The First Point of Impact atop a Commercial Sign with the Impact Crater**

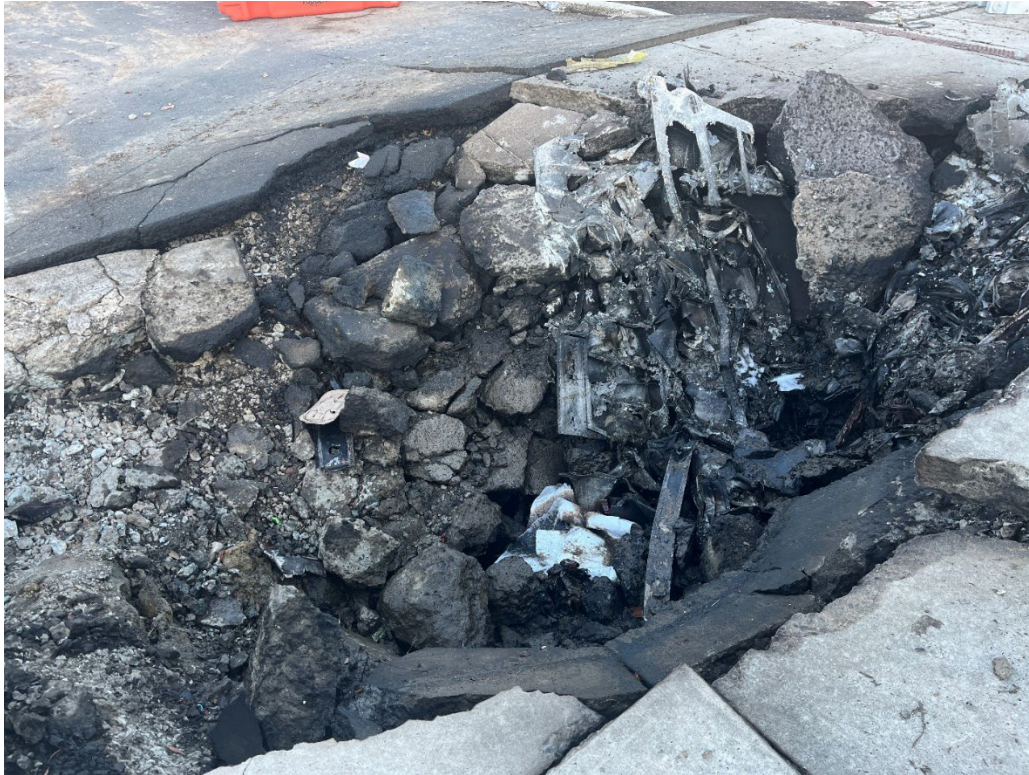
The initial impact crater, measuring about 8 ft deep and 10 ft in diameter, was located centered in a commercial driveway along Cottman Ave., on the northeast sidewalk, between Roosevelt Blvd. and Bustleton Ave. The sidewalk was displaced upwards 3 ft surrounding the impact crater.

**Figure 7: Impact Crater Prior to Debris Removal**

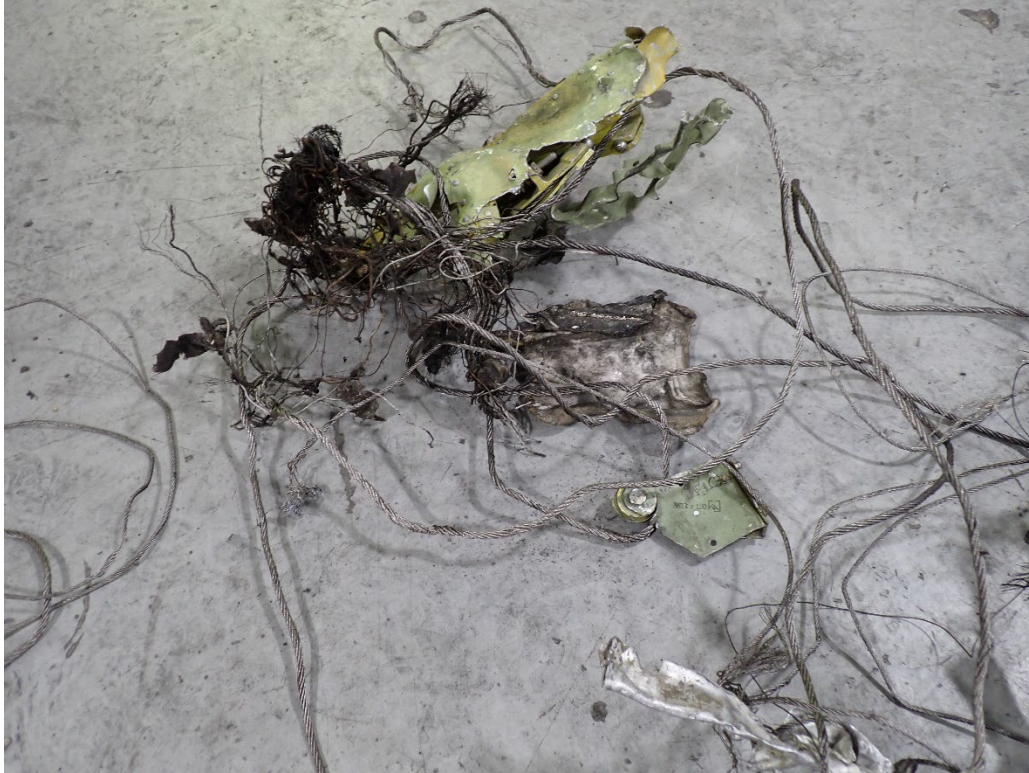
Several control cables were found throughout the debris field and during the wreckage examinations. The control cables were all damaged by impact forces and displayed overload signatures at their respective breaking points. Control cable continuity from the cockpit to the respective control surfaces could not be confirmed due to the damage the airplane sustained during the accident sequence.

**Figure 10: Control Cables Extending From the Cockpit Debris**

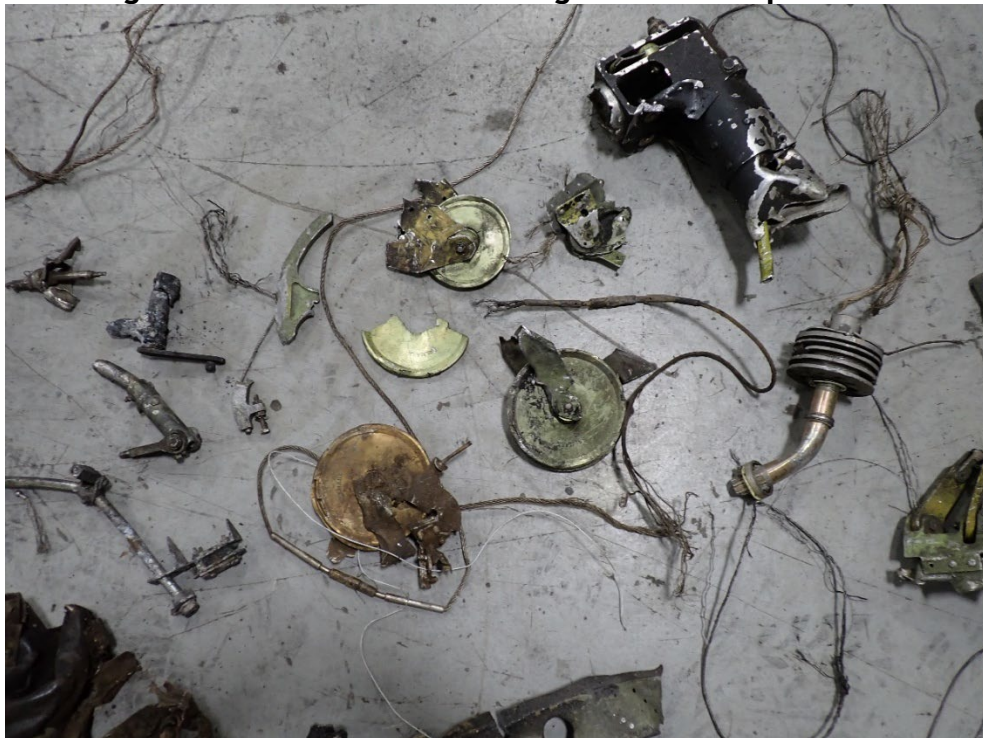
**Figure 11: Miscellaneous Control Cables and Pulleys**

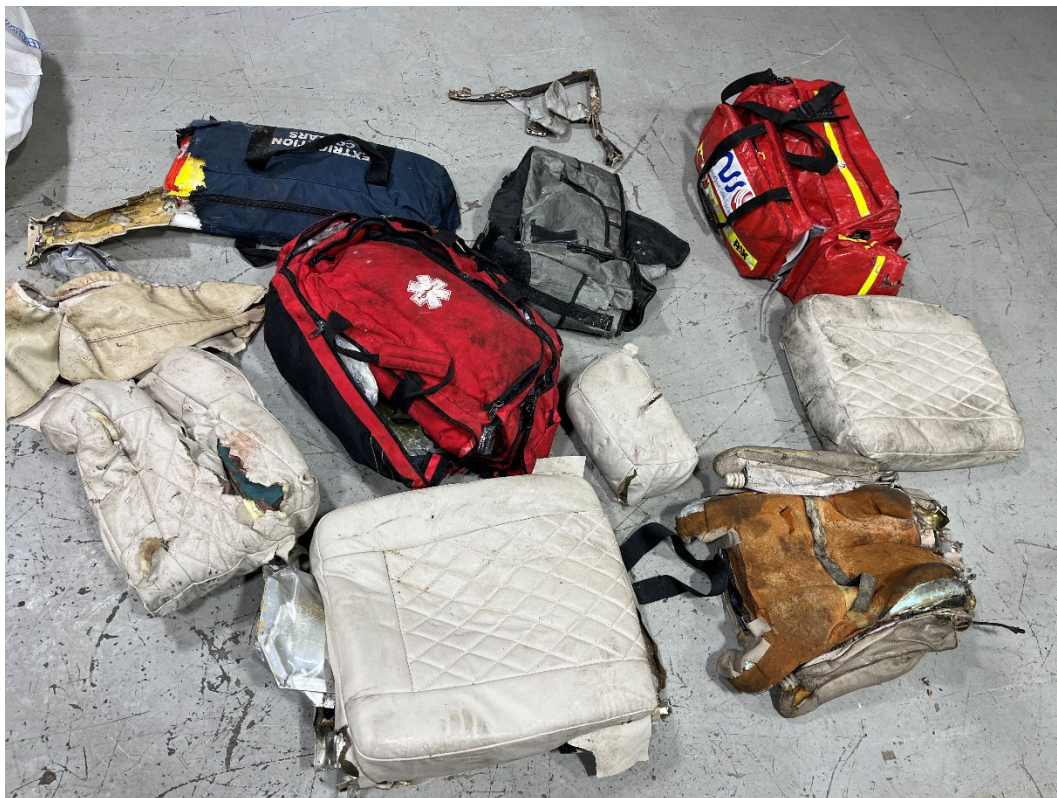
The back portion of a pilot seat was located but could not be identified as pilot or co-pilot. Two passenger bottom seats, and several medical bags from the interior of the airplane were evaluated. None of the seat portions or canvas medical bags displayed signs of sooting.

**Figure 21: Cabin Seating and Miscellaneous Medical Supplies Absent of Sooting**

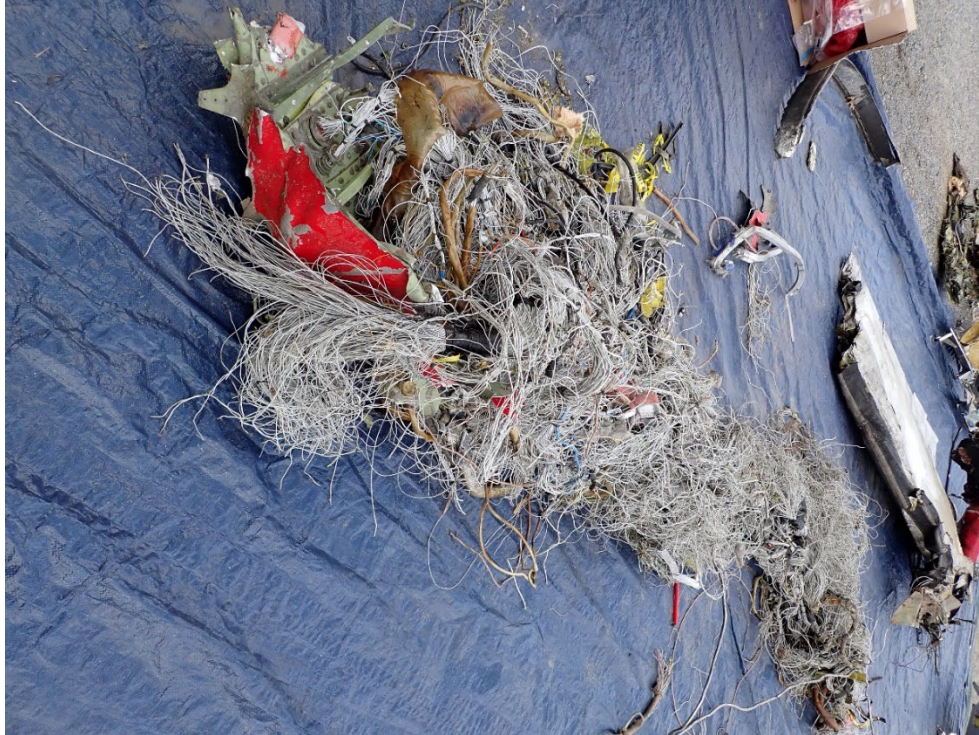
A large section of electrical wiring harness was located on Cottman Ave. and was partially wrapped around a passenger vehicle. The bundle was recovered and examined with no discrepancies noted.

**Figure 22: Large Wiring Harness and Bundles as Recovered**

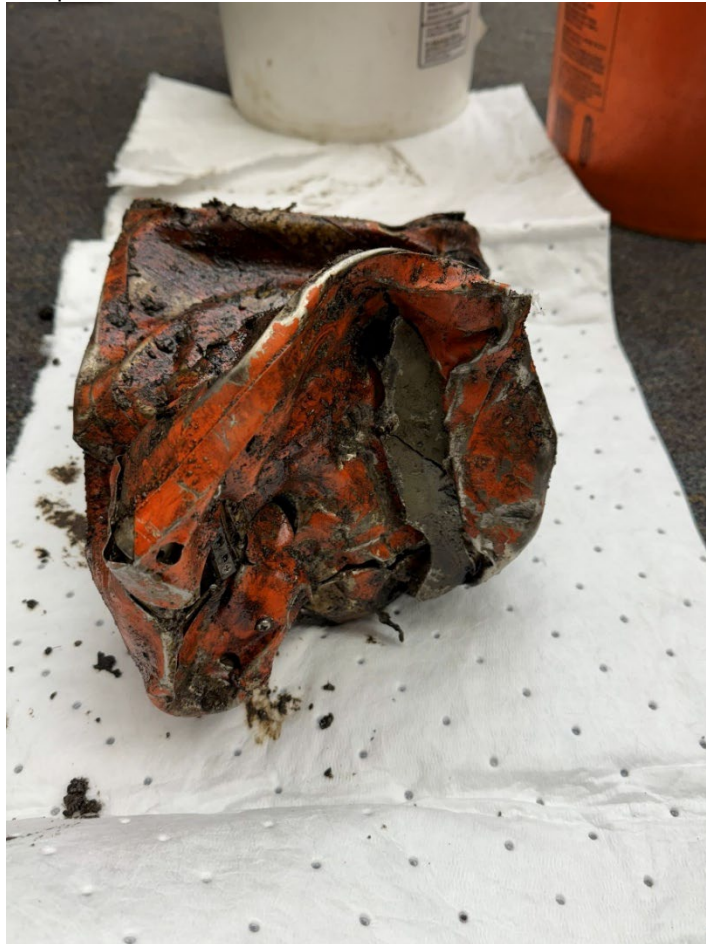
The cockpit voice recorder (CVR) was found within the impact crater and exhibited impact damage. The CVR was sent to the NTSB recorders laboratory for data extraction. It was opened and the tape within the unit was soaked in a combination of fuel and water that required cleaning and drying prior to readout. The recording tape was spliced and repaired in various locations. The CVR did not record the accident flight and was inoperative for several years. Reference the Cockpit Voice Recorder Specialists Report. According to the DAAIA, based on the age of the airplane, it was not required to be equipped with a CVR. According to the Mexican regulations and mandatory circular CO V-022/22 R2, the installed CVR was not required to be operationally checked. The operator of the airplane followed the manufacturers maintenance program which called for inspection of the locator beacon and the associated battery. The engine start checklist for the airplane required and operational test of the CVR, but it is likely that this test was failing and was ignored by the flight crew as a result of the CVR not being required. It is unknown if the CVR was placarded inoperative due to extensive damage sustained during the accident sequence.

**Figure 31: CVR Post Removal from the Impact Crater with Exterior Damage**

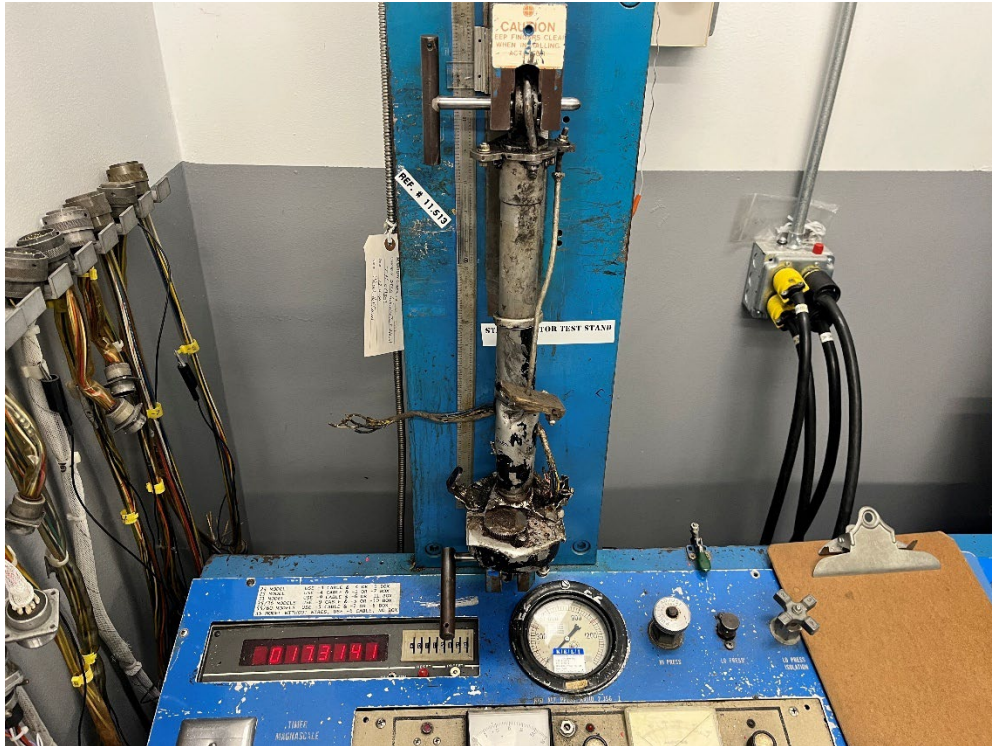
The pitch trim motor and actuator were sent to the manufacturer for measurement and disassembly. The pitch trim actuator consisted of a jackscrew assembly and two motors. The primary motor was recovered but the secondary motor was not present during the examination. The secondary motor was later recovered within the wreckage and was damaged by impact forces. The actuator

remained connected to the gear box, but the actuator was jammed from impact forces. Portions of airplane structure remained attached to the mounting surfaces and were removed to facilitate the investigation. The jackscrew would turn but turning it did not change the extension of the assembly. An attempt to check for free play in actuator extension was not possible because of the screw being jammed by impact damage. The pitch trim assembly was installed into the manufacturers test fixture, and the calibration of the fixture was verified. According to the manufacturer, a fully extended (nose down pitch) measurement is  $18.77 \pm 0.030$  inches. A fully retracted (nose up pitch) would measure  $13.87 \pm 0.030$  inches. The pitch trim actuator was measured at 17.3141 inches; according to the manufacturer, this equates to 3.97 trim units on the cockpit pitch trim indicator, where 1 is full nose down trim and 11 is full nose up trim. The take-off trim 'green' band is between 4 and 8 units of trim. A compression load and a tension load of about 100 lbs was applied to the pitch trim assembly which revealed no sign of the internal threads of the jackscrew being stripped. The screw and screw dust cover were bent from impact forces which required destructive disassembly to evaluate the screw thread condition. Once disassembled, the screw threads were found intact with no overload signatures and no stripped threads observed. The actuator gear box was disassembled and there were no broken gear teeth or signs of overload or jamming. Based on the measurements obtained and physical observations during the actuator disassembly, it was concluded that the measured extension of the actuator was the extension immediately prior to impact. Checklists found in the wreckage indicate that with the 16.85% MAC, noted on the accident flight weight and balance provided by the operator, the takeoff pitch trim should have been set to  $5.6^\circ$ . The motors were not disassembled.

**Figure 32: Pitch Trim Actuator in the Manufacturer's Test Bench**

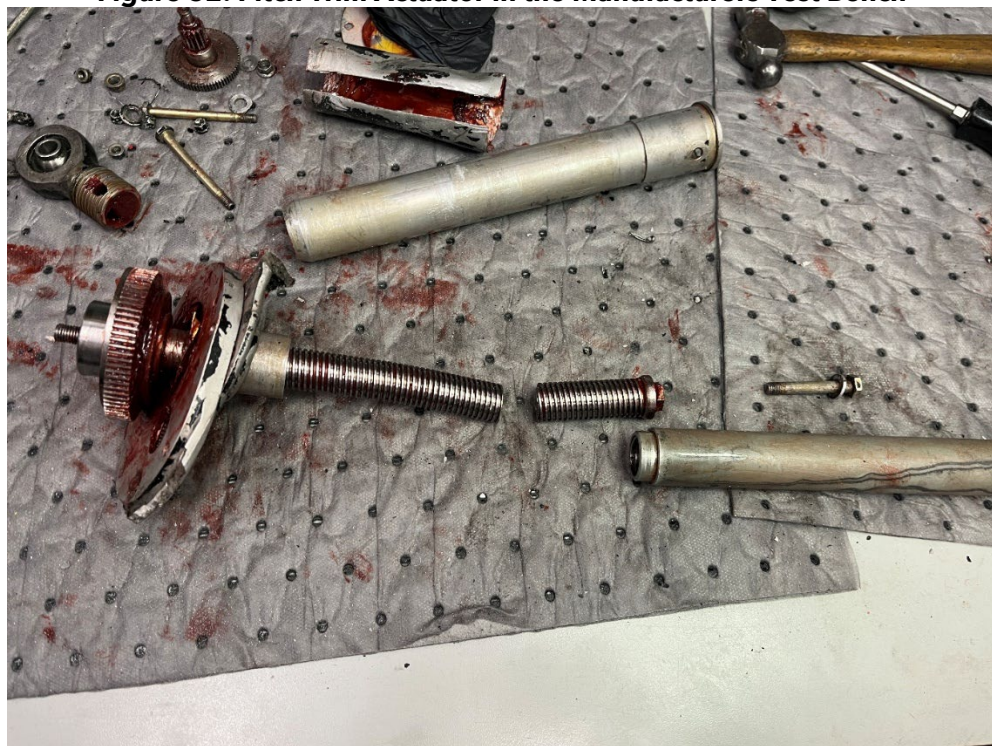
**Figure 33: Pitch Trim Actuator Displaying Bending and Fracture to the Screw Assembly**

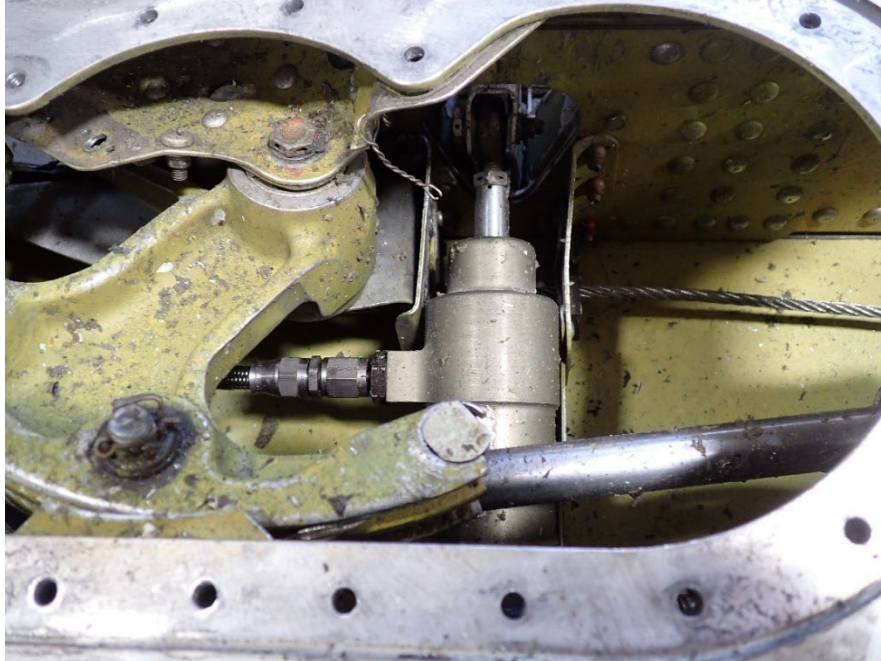
The right flap actuator remained contained within the right wing and the access panel was opened to access it. The right actuator was verified to be connected at the sector and the mounting lug. The hydraulic lines were still attached to the actuator. The flap actuator was removed from the wing but during the removal the actuator piston was pulled/extended about 1-1 1/2 ". The righthand flap actuator measurement, post pull, was 19" equating to full extension. Prior to the movement, it would have been about 17 1/2 - 18". 17 1/2 corresponds to 30 degrees of flap, which was determined to not be a standard flap setting position. The left-hand flap actuator was impact separated and found within a recovery bag during a wreckage examination. The left-hand flap actuator was measured at about 13 1/4" corresponding to about 2 degrees of flap (retracted). The piston was jammed and could not be moved by hand and indicated, per the Learjet standard flap settings for takeoff, this was likely the flap setting at the time of the accident. The right and left flap actuators were scanned using computed tomography (CT) to document the position and condition of the internal components. Reference the Computed Tomography Specialists factual report.

**Figure 34: Right Wing Flap Actuator as Found in the Right Wing**

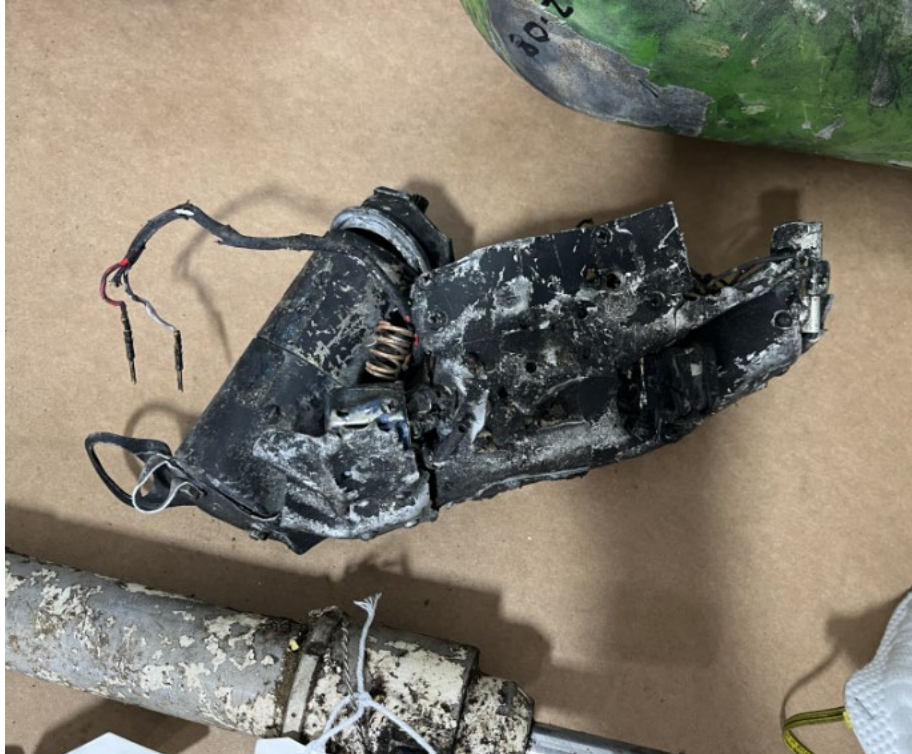
**Figure 36: Secondary Pitch Trim Motor Found within the Debris**

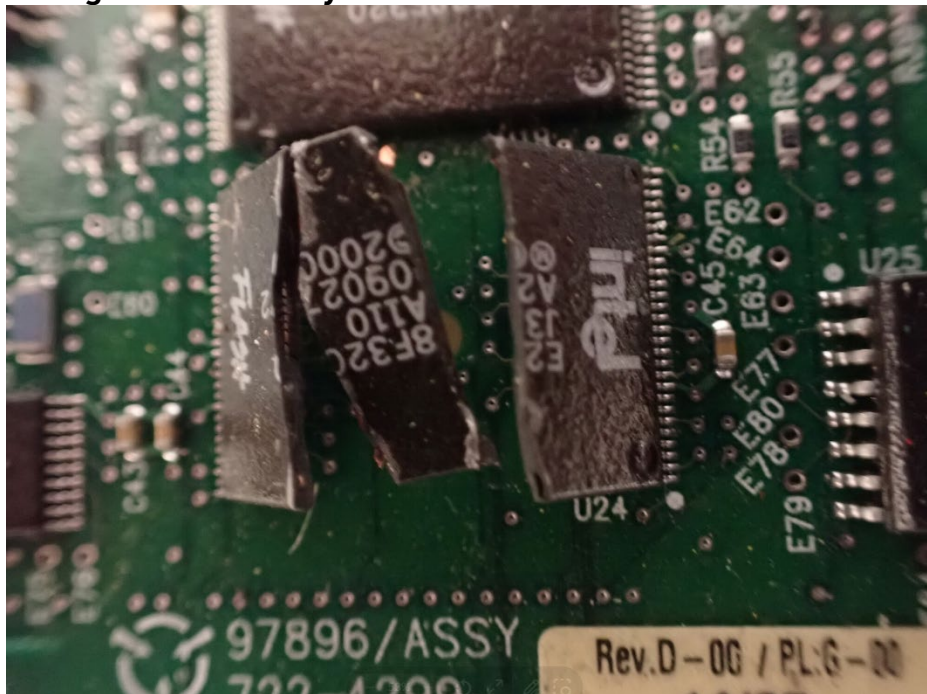
The Enhanced Ground Proximity Warning Systems (EGPWS) was recovered from the wreckage and sent to the manufacturer for evaluation. The unit exhibited crush damage as a result of the impact. The flash chip that contained the flight history

was cracked completely across the chip in two locations. A microscope inspection showed cracking that ran along the ground plane that contained the die. Bond wires were severed. X-ray images of the ground plane show that it was intact. As a result of the damage to the chip, the data was not able to be recovered from the EGPWS.

**Figure 37: The flash chip of the EGPWS that contained the flight history was cracked completely across the chip in two locations**

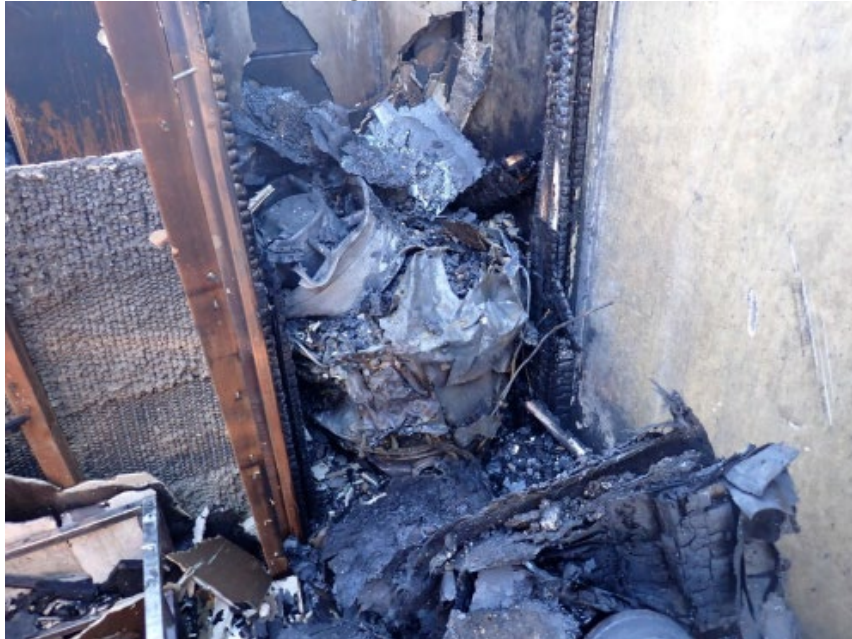
The right engine was found in the second-floor residential bedroom. The 9 o'clock aft engine mount bolt hole was torn outwards, indicating that the engine was mounted in the number 2 position, which is the right side. Through aircraft airworthiness documentation, this engine is identified as P-85139C.

**Figure 40: Right Engine Core as Found on the Second Floor of a Residential Structure**

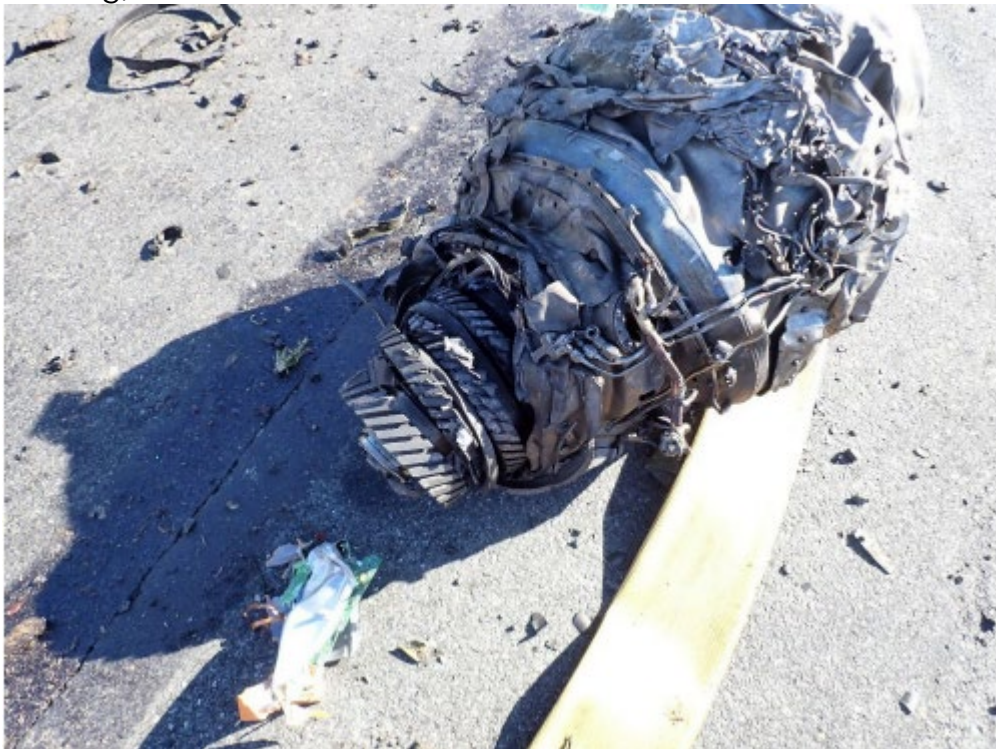
The left engine was found in the street near the impact crater and was identified by the engine aft mount damage and from a partial serial number on the first stage compressor disk. The fan assembly under the car had serial number markings with four digits of the fan disk serial number reading "1860". Per engine build book for engine serial number P-85243, the serial number of the fan disk was 970322901860. From the airplane airworthiness documentation, it was determined that engine serial number P-85243 was in position 1, which is the left engine. The 3 o'clock aft engine mount bolt hole was torn outward, indicating that it was the left engine. The inter-turbine temperature (ITT) harness was routed on the right side of the engine to go to the lefthand engine pylon. The first stage compressor disk, part number was identified as 3072395-1 with serial number 1-12112-1548. Per the engine build log, the serial number was 1- 12112-1548.

**Figure 41: Left Engine Core as Found Adjacent to the Impact Crater**
