# National Transportation Safety Board

ERA25MA171

## **MATERIALS LABORATORY**

Factual Report 25-077

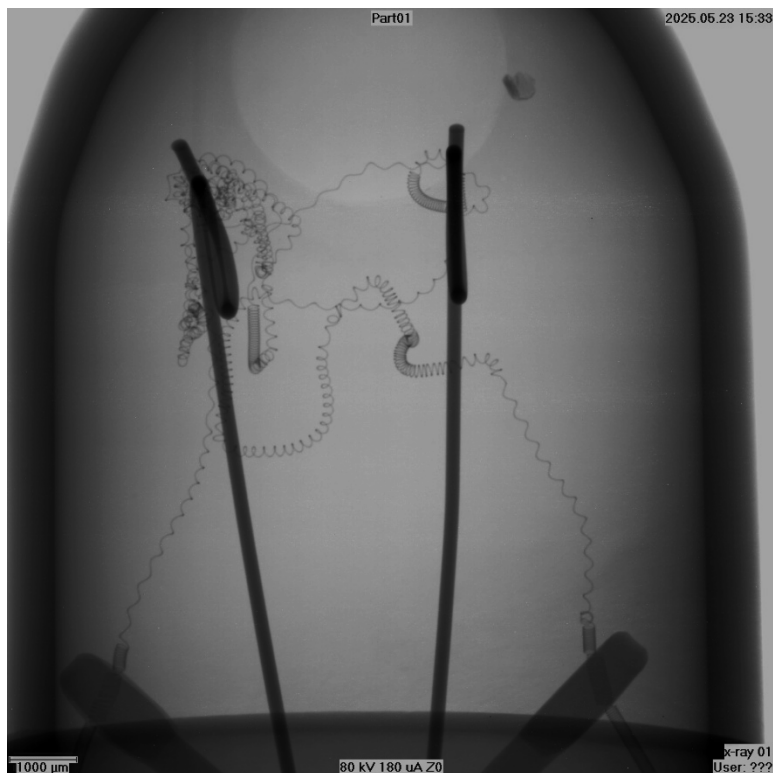
| <b>Annunciator (top row)</b> | <b>Bulb #1</b> | <b>Bulb #2</b> |
|---|---|---|
| FUEL LOW | Intact; Stretched | Intact; Stretched |

**Figure 3.** Radiograph of FUEL LOW Bulb 1.

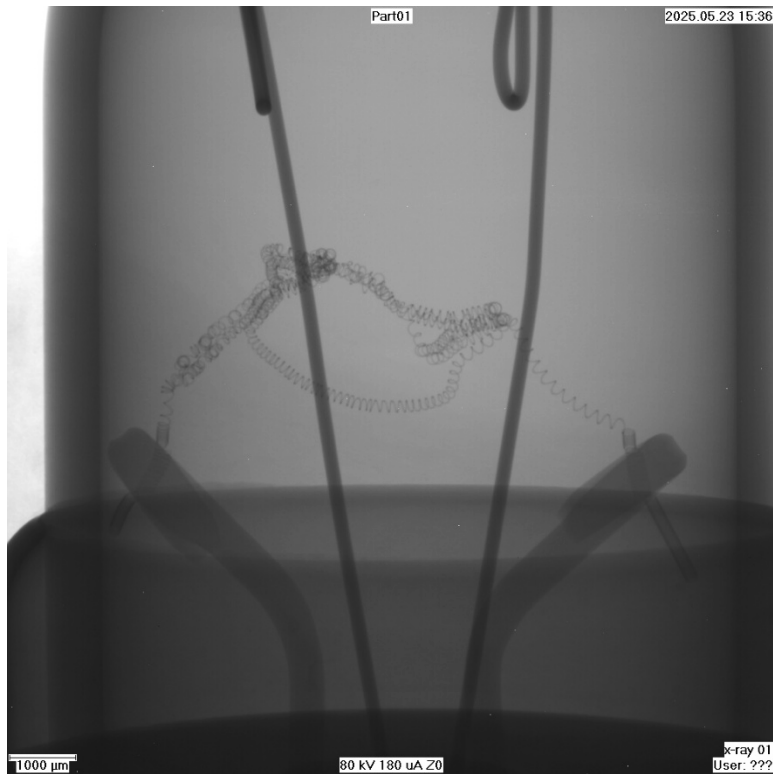
**Figure 4.** Radiograph of FUEL LOW Bulb 2.

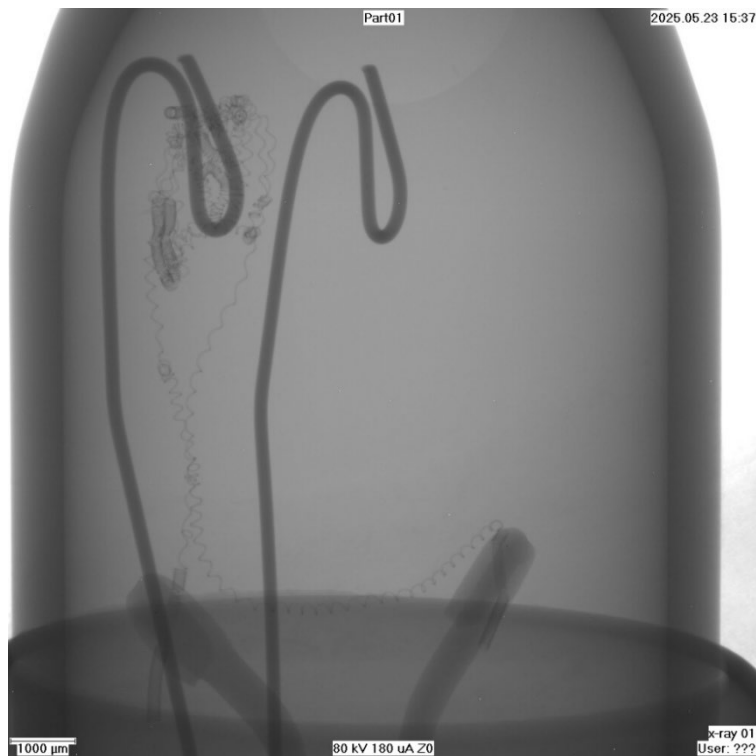
| <b>Annunciator (top row)</b> | <b>Bulb #1</b> | <b>Bulb #2</b> |
|---|---|---|
| R/F FUEL PUMP | Broken; Stretched | Broken; Stretched |

**Figure 5.** Radiograph of RF FUEL PUMP Bulb 1.

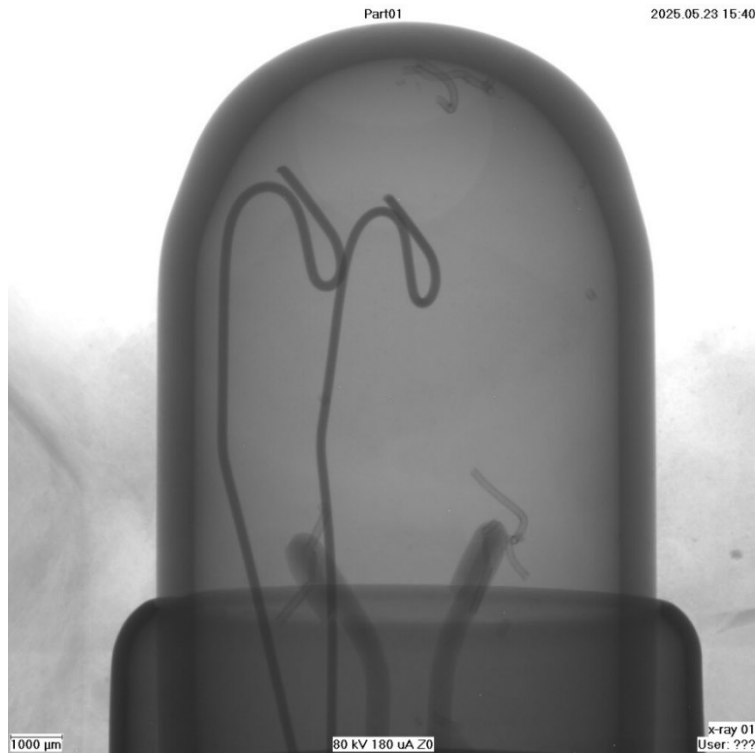
**Figure 6.** Radiograph of RF FUEL PUMP Bulb 2.

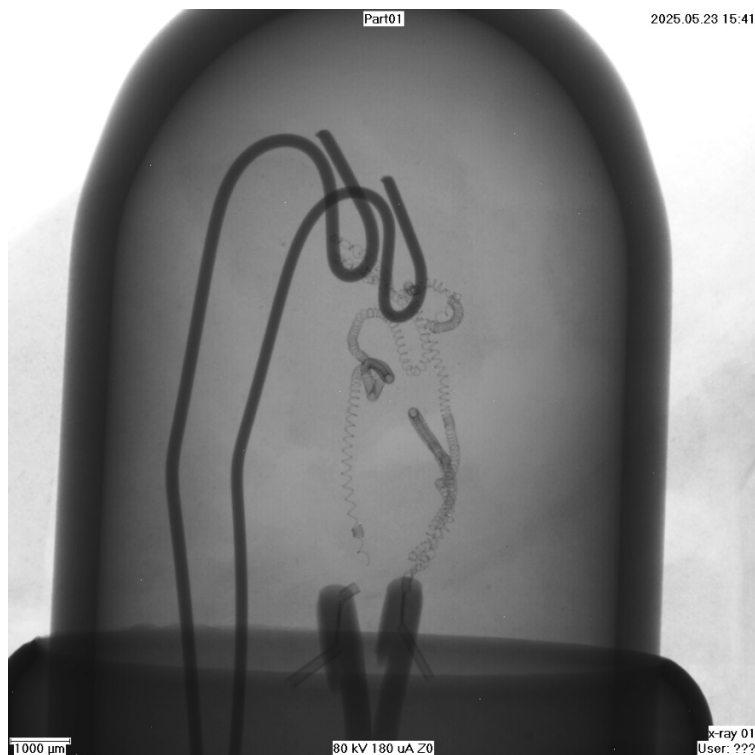
| <b>Annunciator (top row)</b> | <b>Bulb #1</b> | <b>Bulb #2</b> |
|---|---|---|
| ENG OUT | Broken; Stretched | Intact; Stretched |

**Figure 7.** Radiograph of ENG OUT Bulb 1.

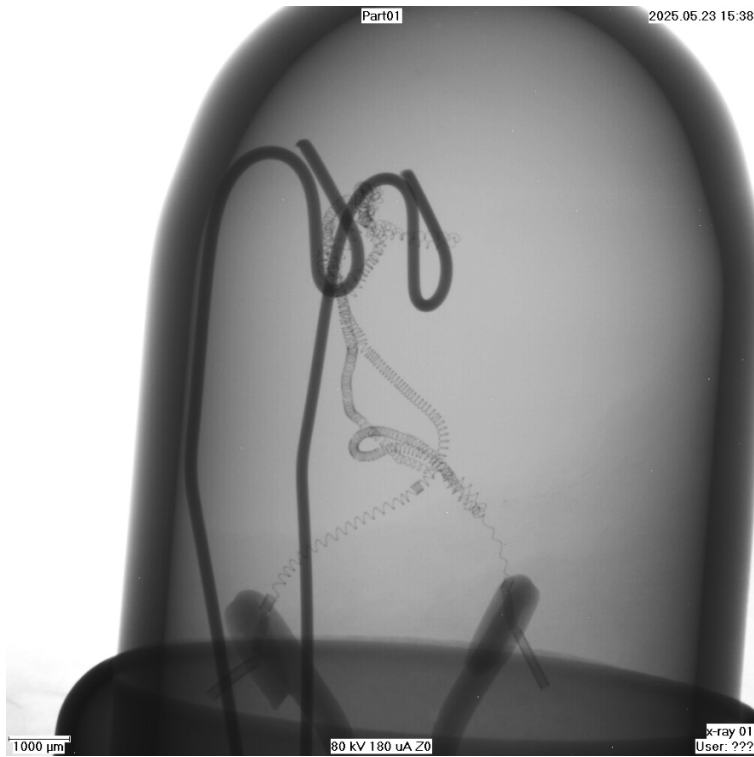
**Figure 8.** Radiograph of ENG OUT Bulb 2.

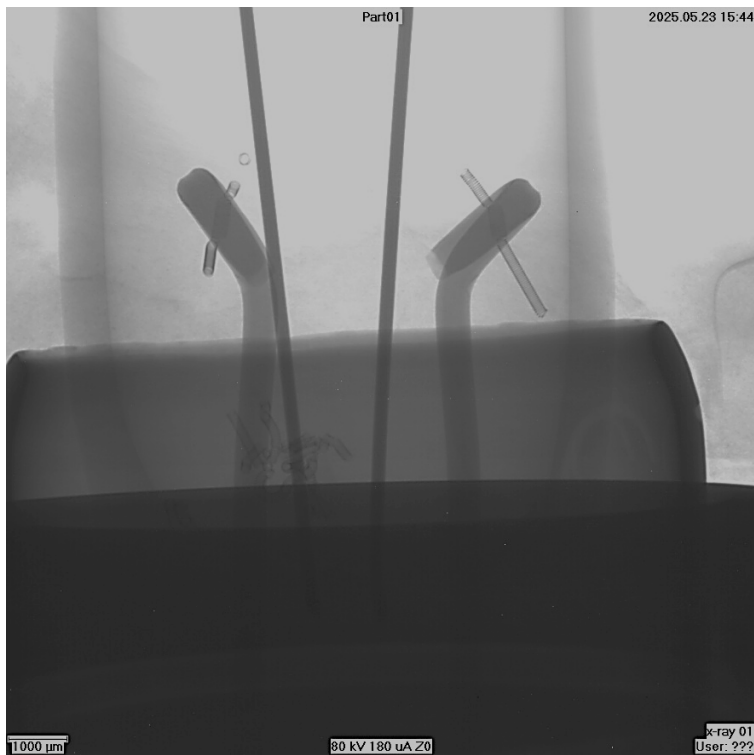
| <b>Annunciator (top row)</b> | <b>Bulb #1</b> | <b>Bulb #2</b> |
|---|---|---|
| L/F FUEL PUMP | Bulb broken; No filament | Intact; Stretched |

**Figure 9.** Radiograph of LF FUEL PUMP Bulb 2.

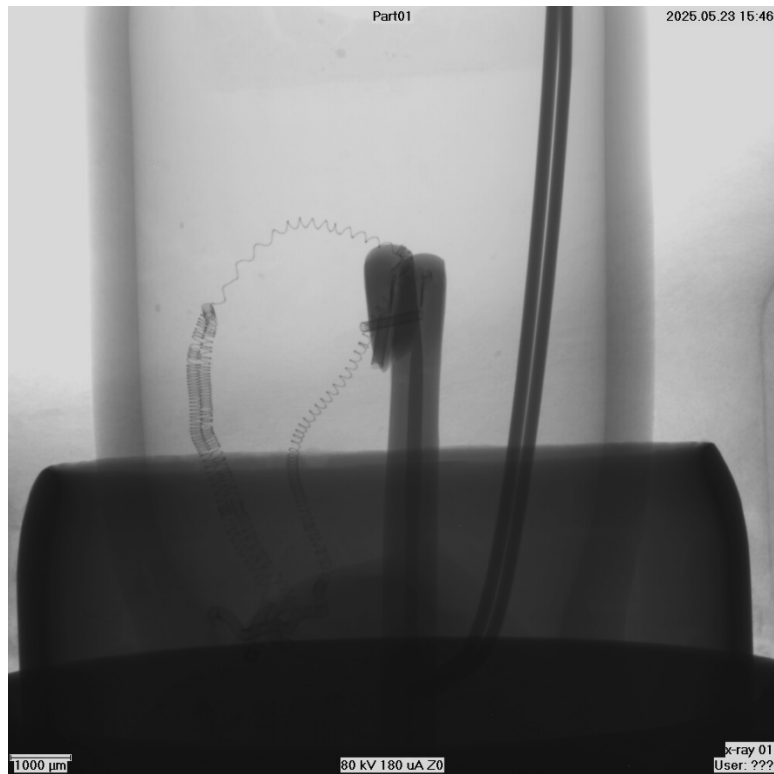
| <b>Annunciator (top row)</b> | <b>Bulb #1</b> | <b>Bulb #2</b> |
|---|---|---|
| ROTOR LOW RPM* | Broken; Not stretched | Intact; Stretched |

\* ROTOR LOW RPM had one broken, not stretched filament and one intact stretched filament indicating that the broken filament was burned out/broken prior to impact.

**Figure 10.** Radiograph of ROTOR LOW RPM Bulb 1.
