# National Transportation Safety Board

Office of Research and Engineering

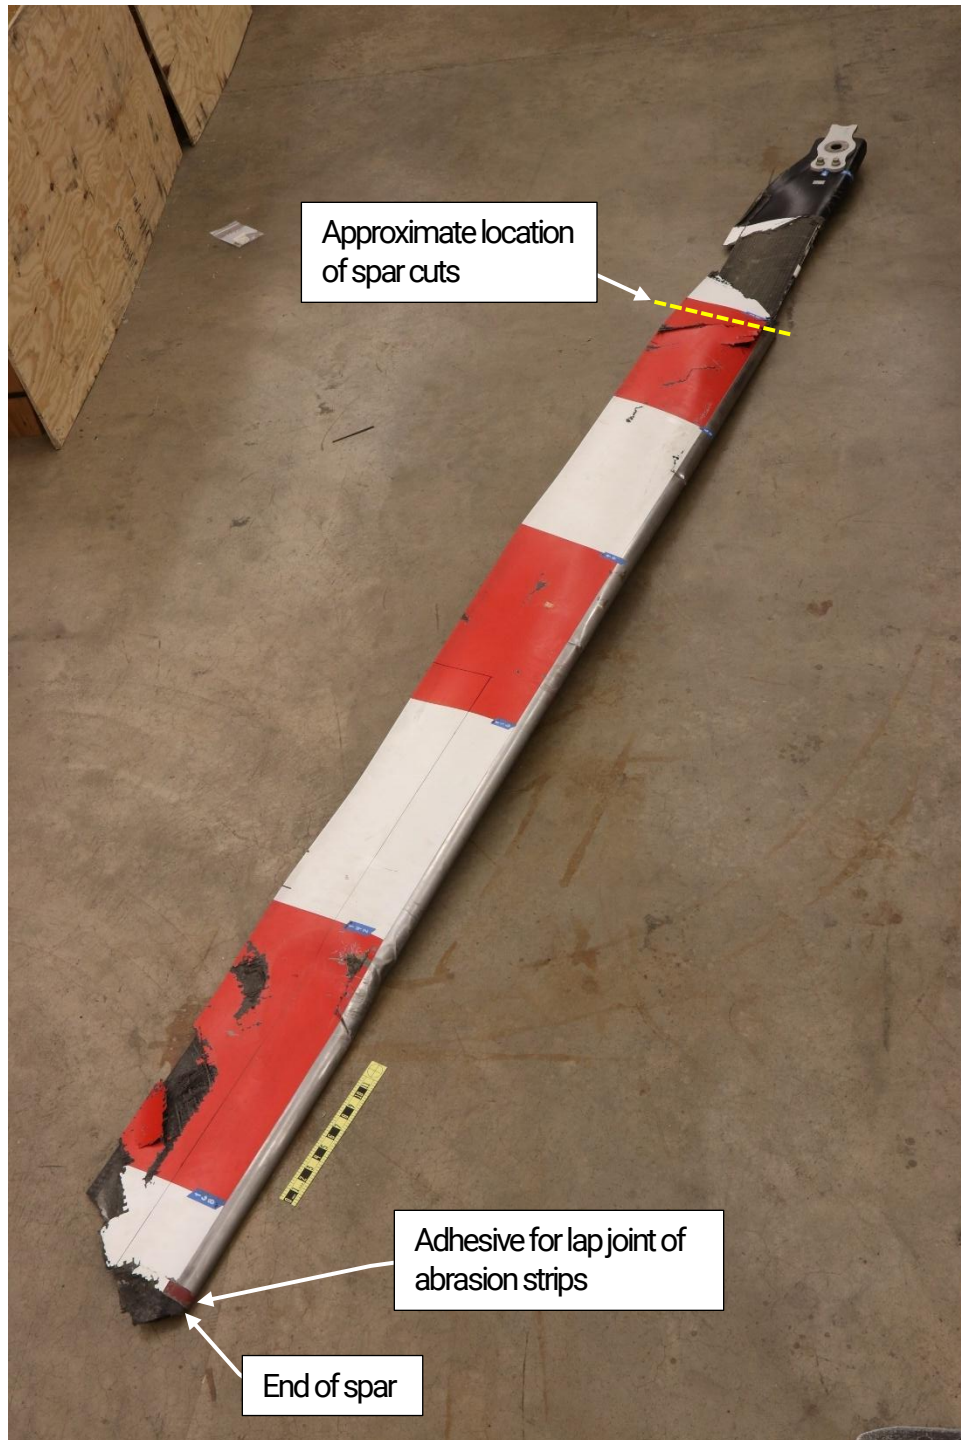
**Figure 1.** Overview of S/N A304 blade pieces, upper side. The blade was fractured near the end of the spar. The blade tip (about 20 inches long) was missing.

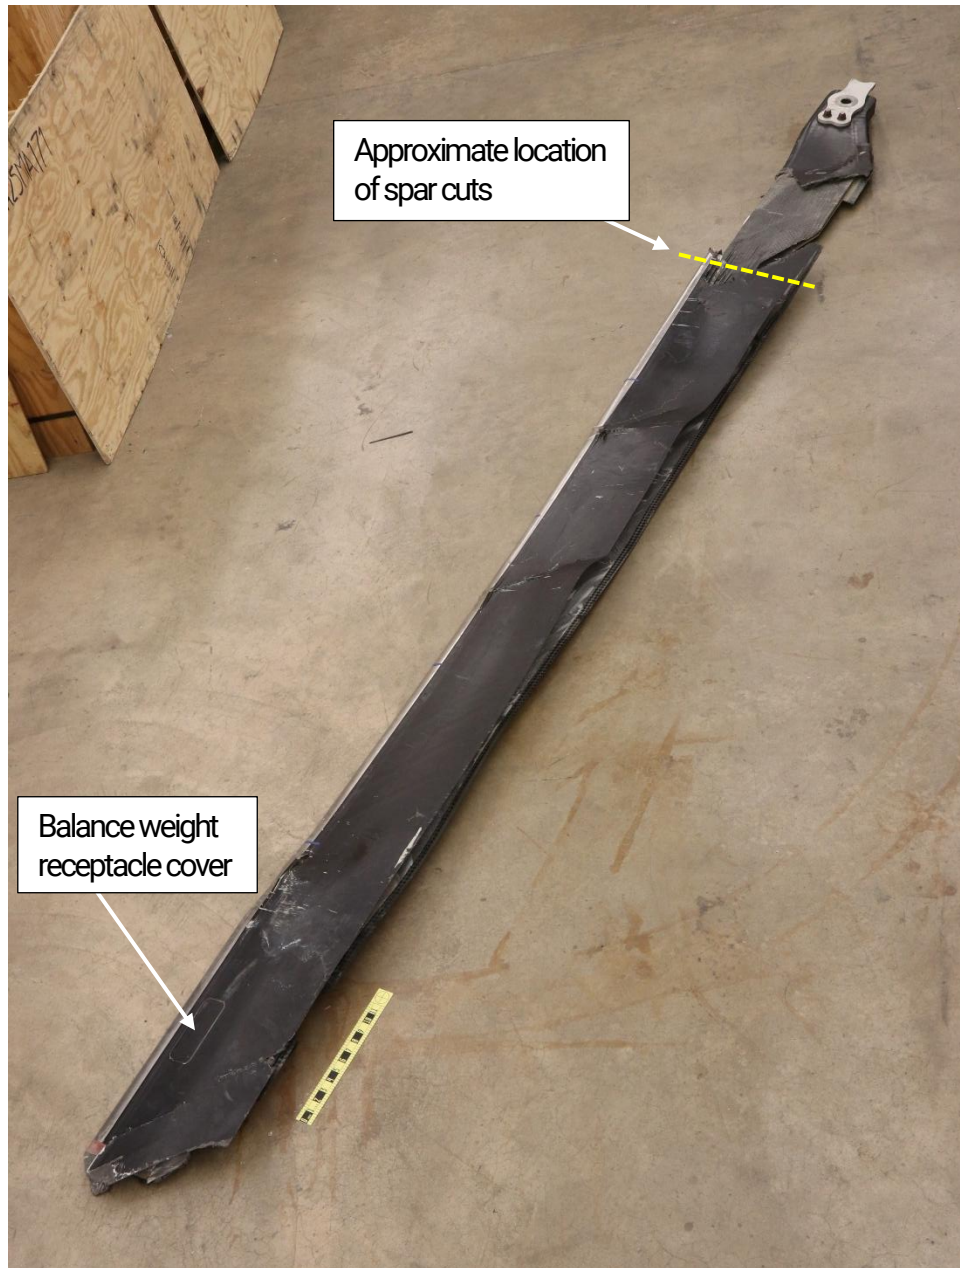
**Figure 2.** Overview of S/N A304 blade pieces, lower side.

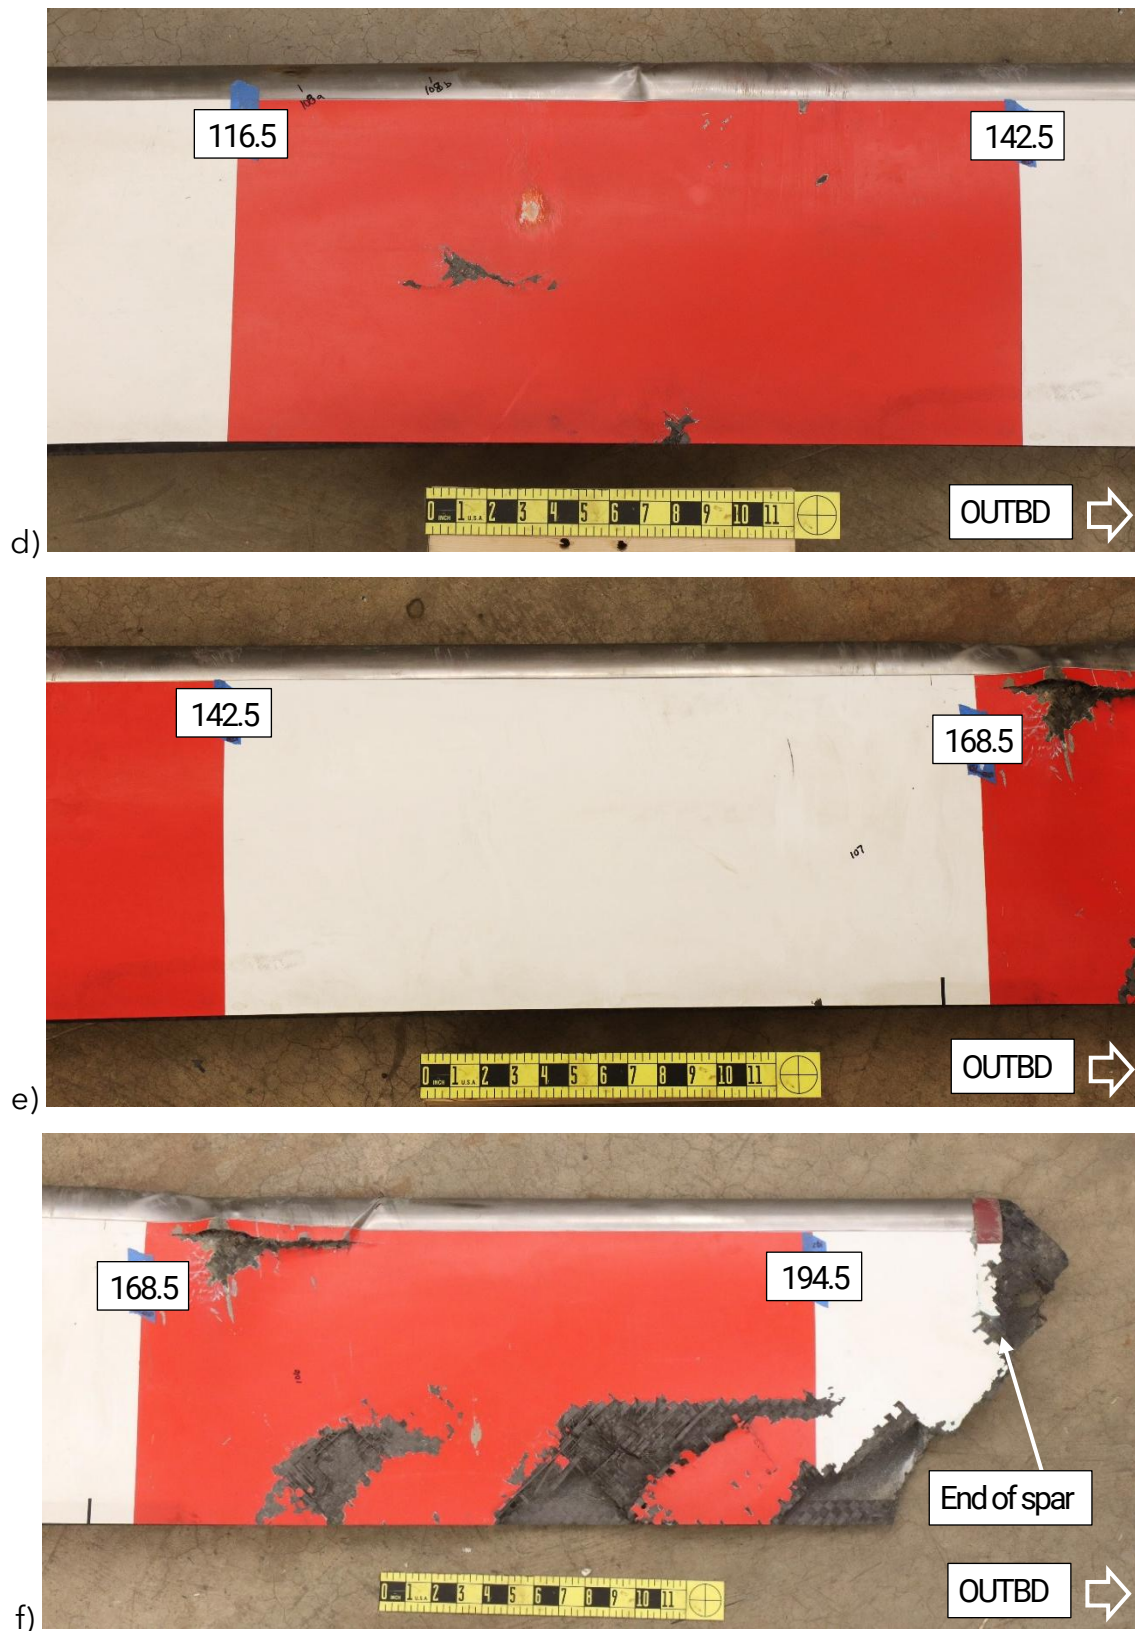
**Figure 6 (cont.).** d) STA 116.5 to 142.5; e) STA 142.5 to 168.5; and f) STA 168.5 to fracture at the end of the blade spar near STA 202.

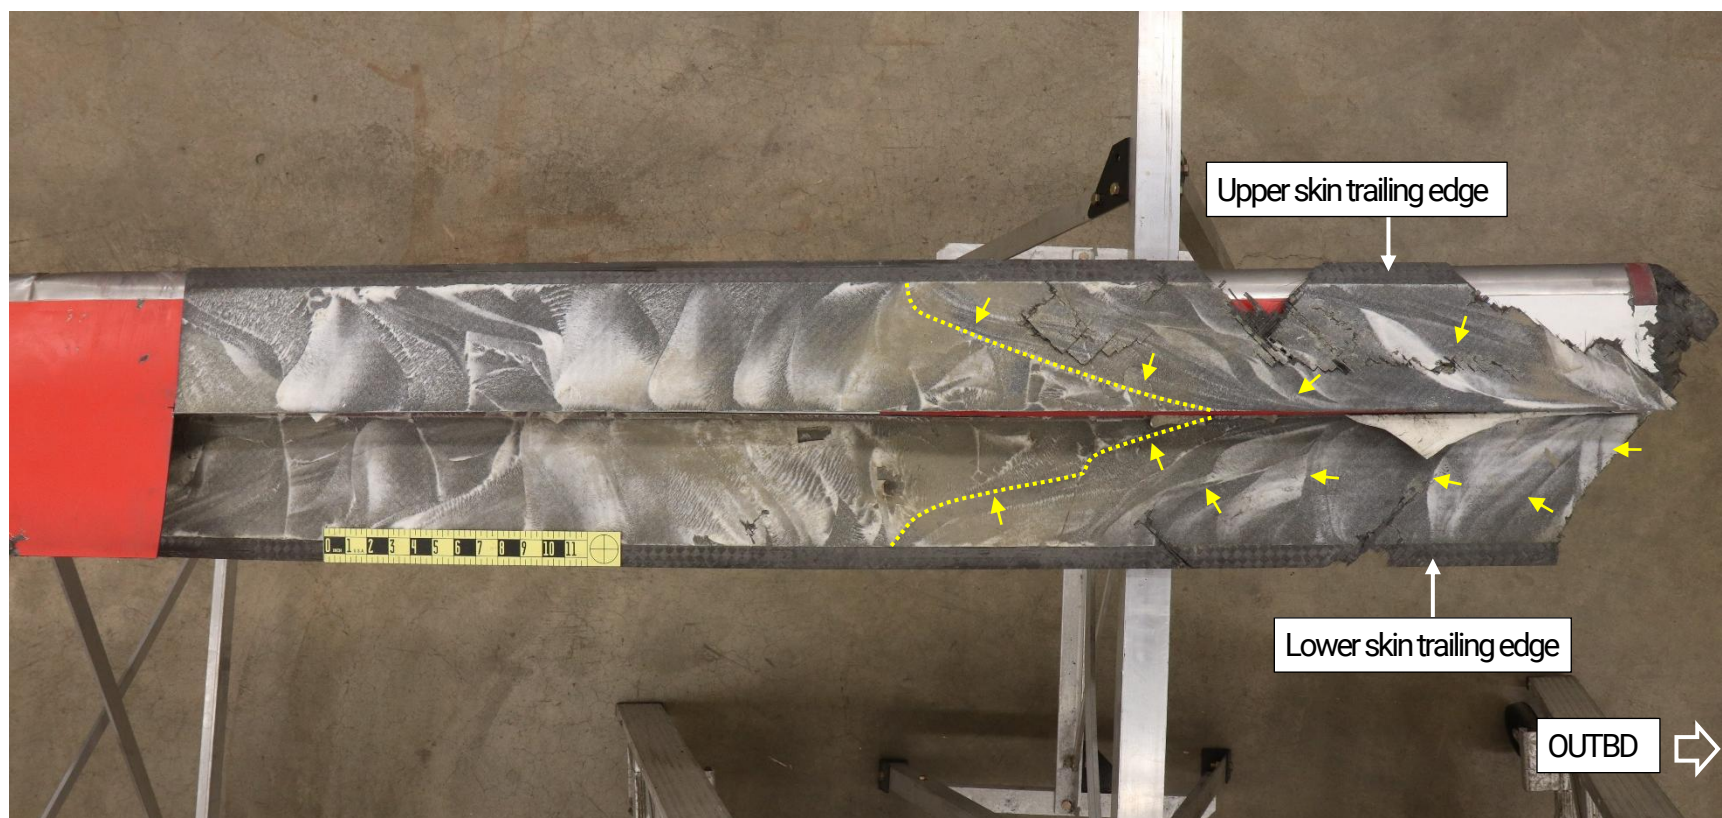
**Figure 7.** Blade A304 with upper skin in the afterbody section of the blade cut, flipped over, and laid on top of the spar, from about STA 137.5 to the outboard fractured end.

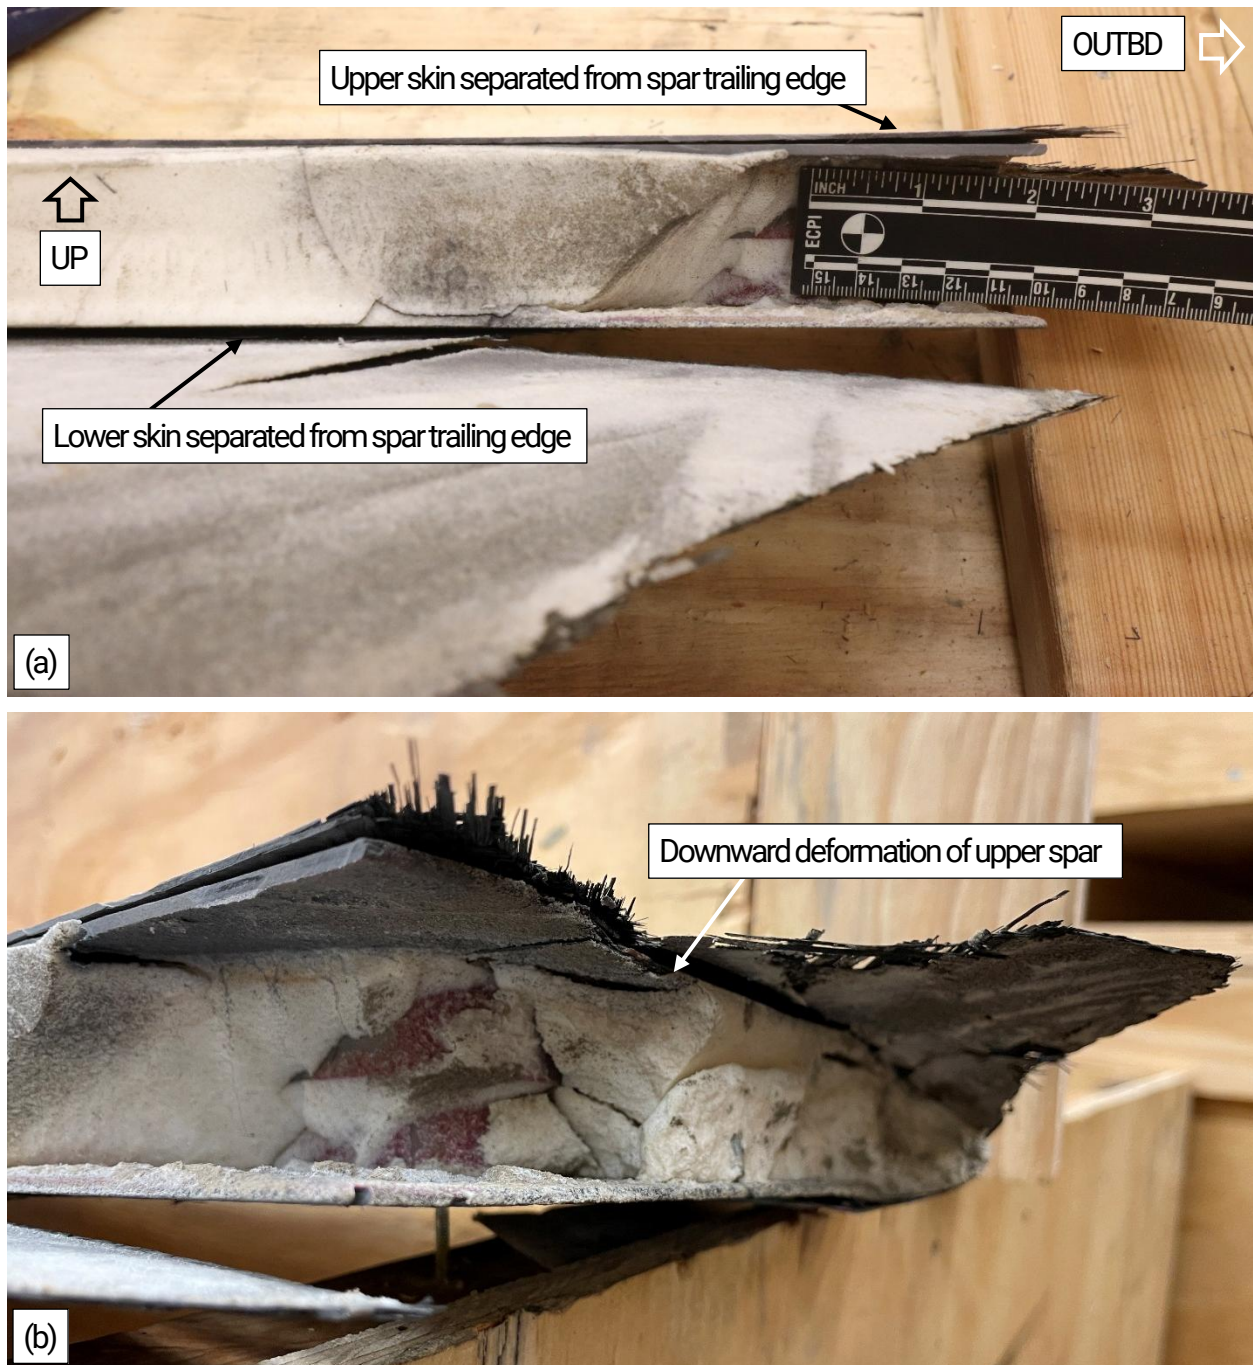
**Figure 8.** Fractured outboard end of main rotor blade A304: a) viewed from the trailing edge looking toward the leading edge showing skin separations from upper and lower spars and b) viewed looking inboard and toward the leading edge showing downward deformation to the end of the upper spar.

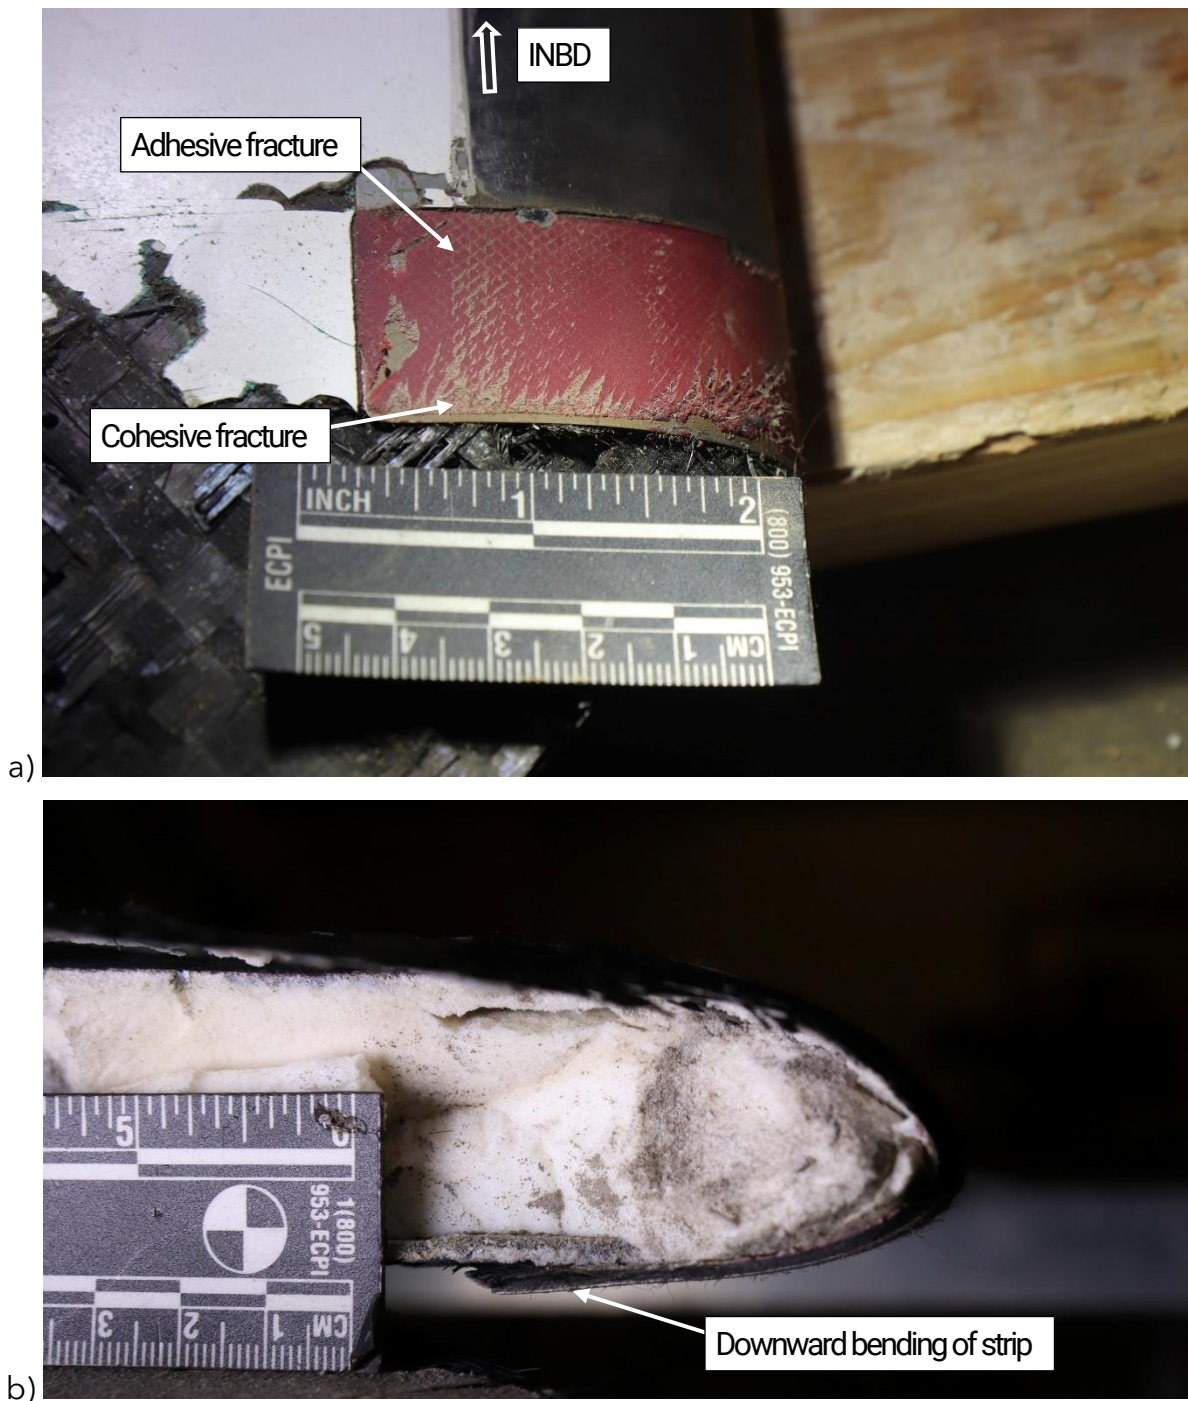
**Figure 9.** a) Image of the adhesive left behind on the main span abrasion strip showing adhesive and cohesive fracture and b) end view of the abrasion strip with the lower portion showing downward bending.

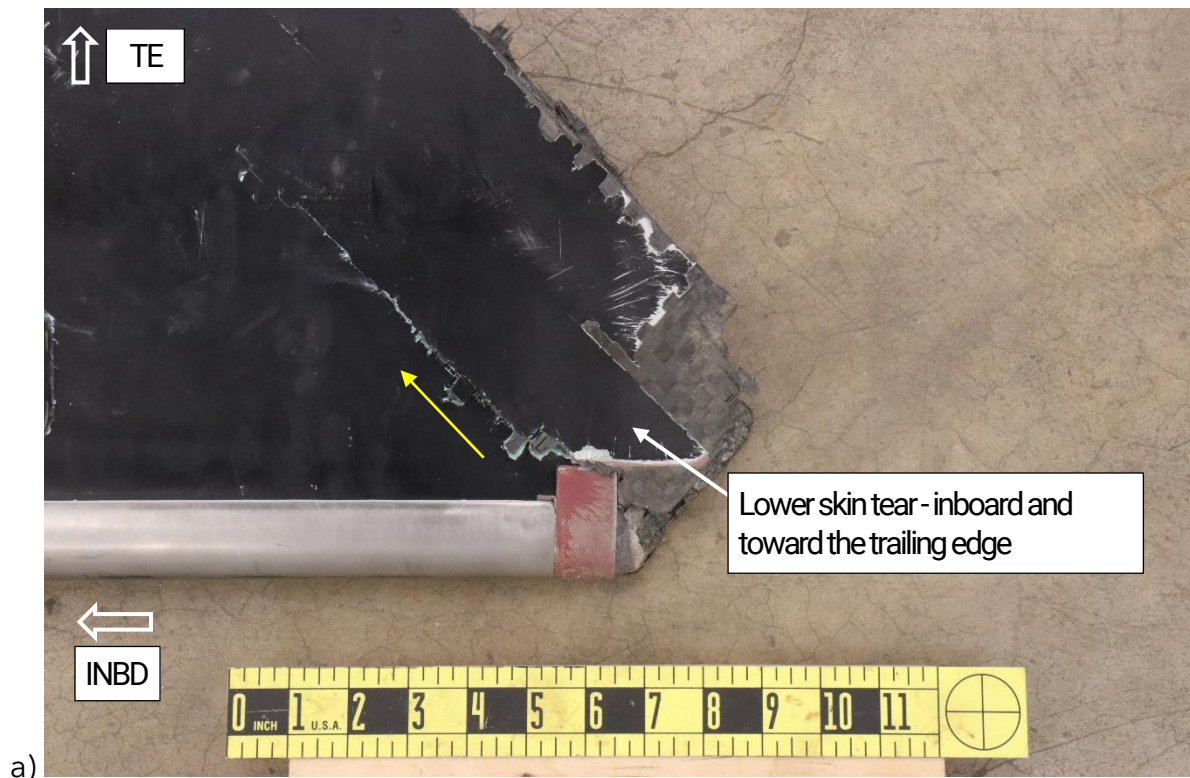
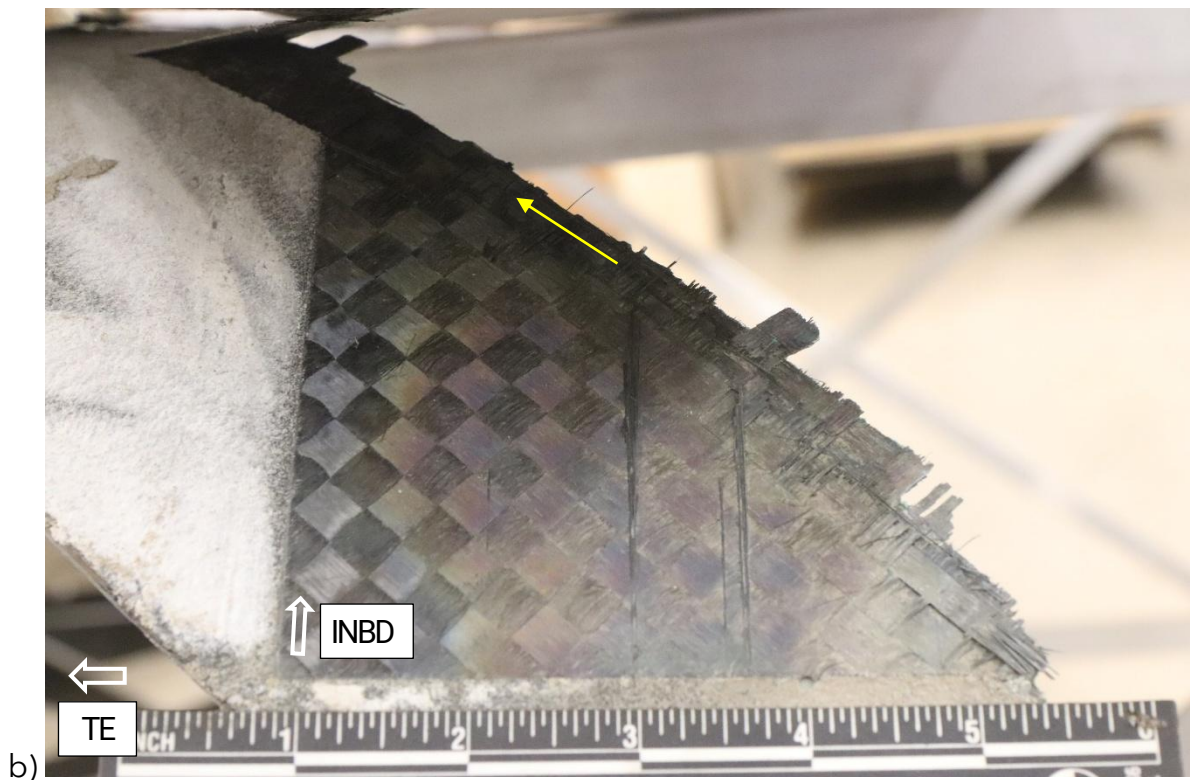
**Figure 10.** Lower skin tear near the end of the spar: a) lower outer surface showing tear progressing away from the edge of the abrasion strip and b) lower inner surface.

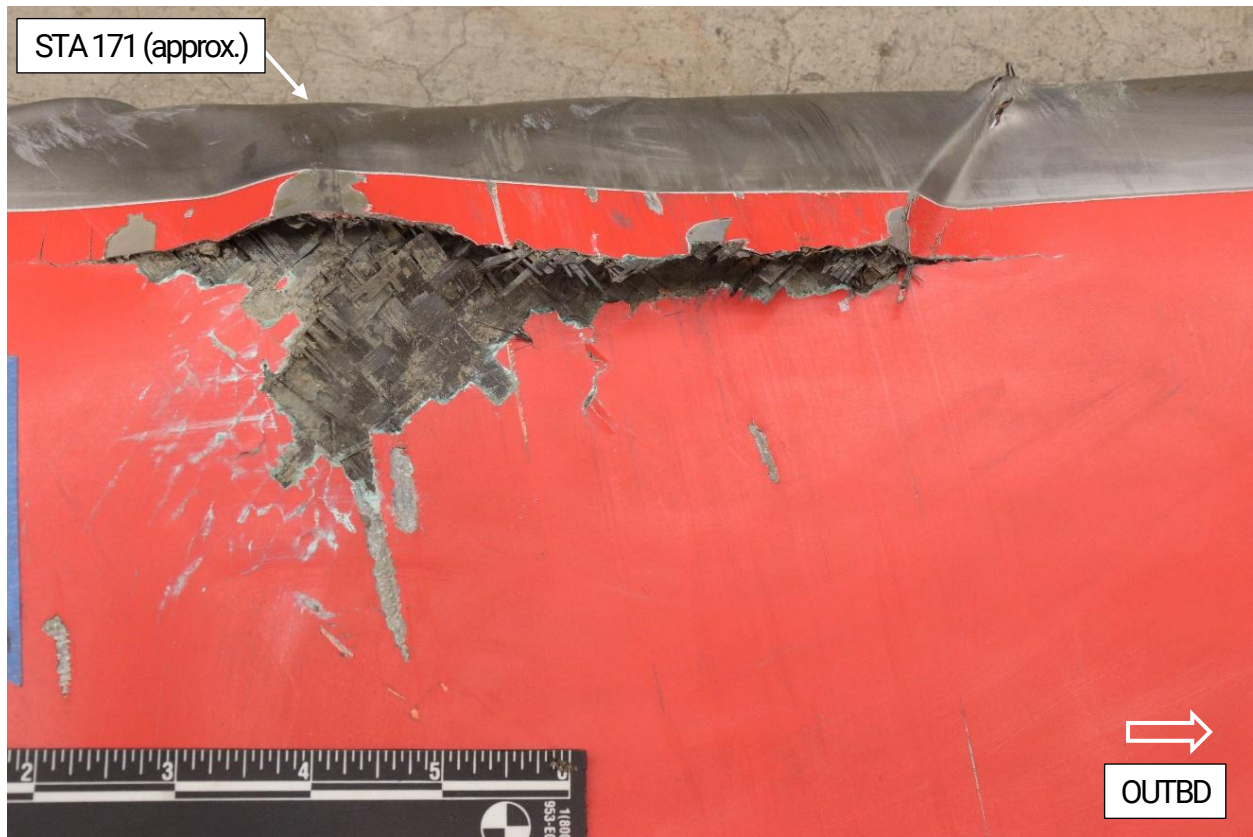
**Figure 13.** Image of the impact damage showing buckling and bulging of the abrasion strip. Multiple scrape marks in the paint are continuous across the deformed region.

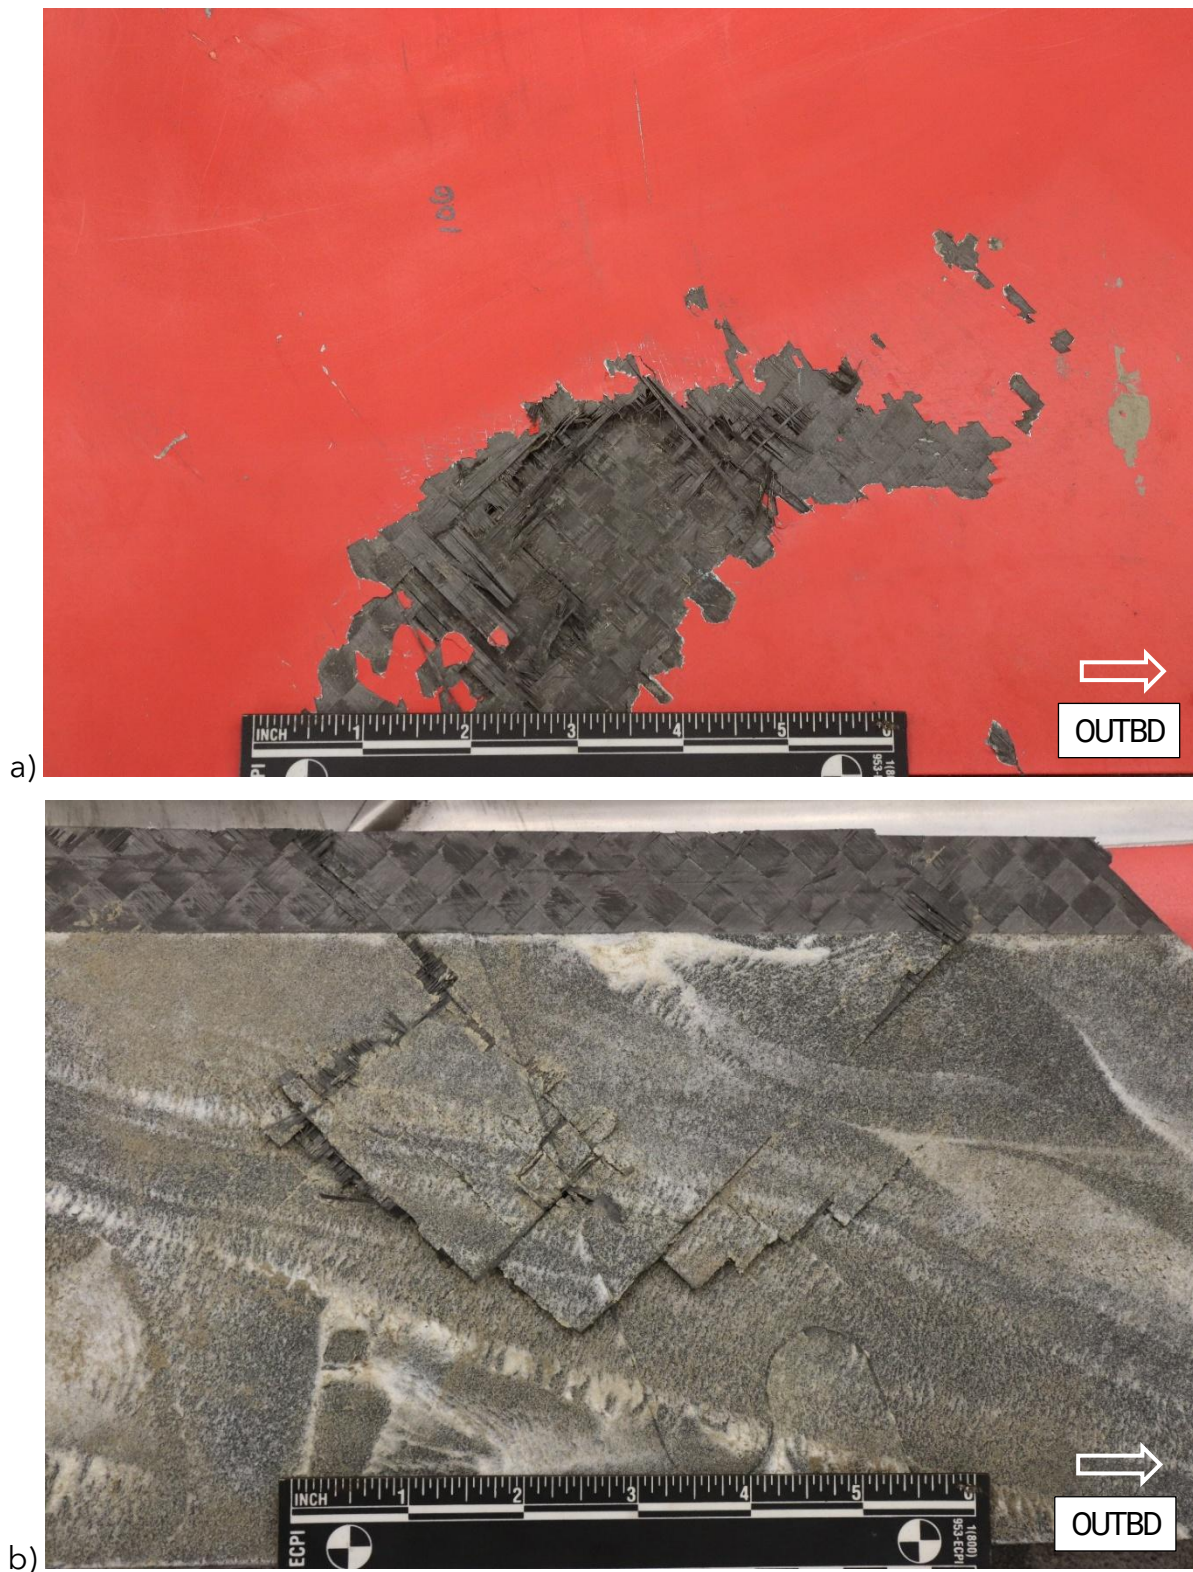
**Figure 14.** Circular fracture region punched into upper skin at about STA 176: a) outer surface of upper skin and b) inner surface of upper skin showing skin to foam core separation features that are continuous across cracks in the skin.

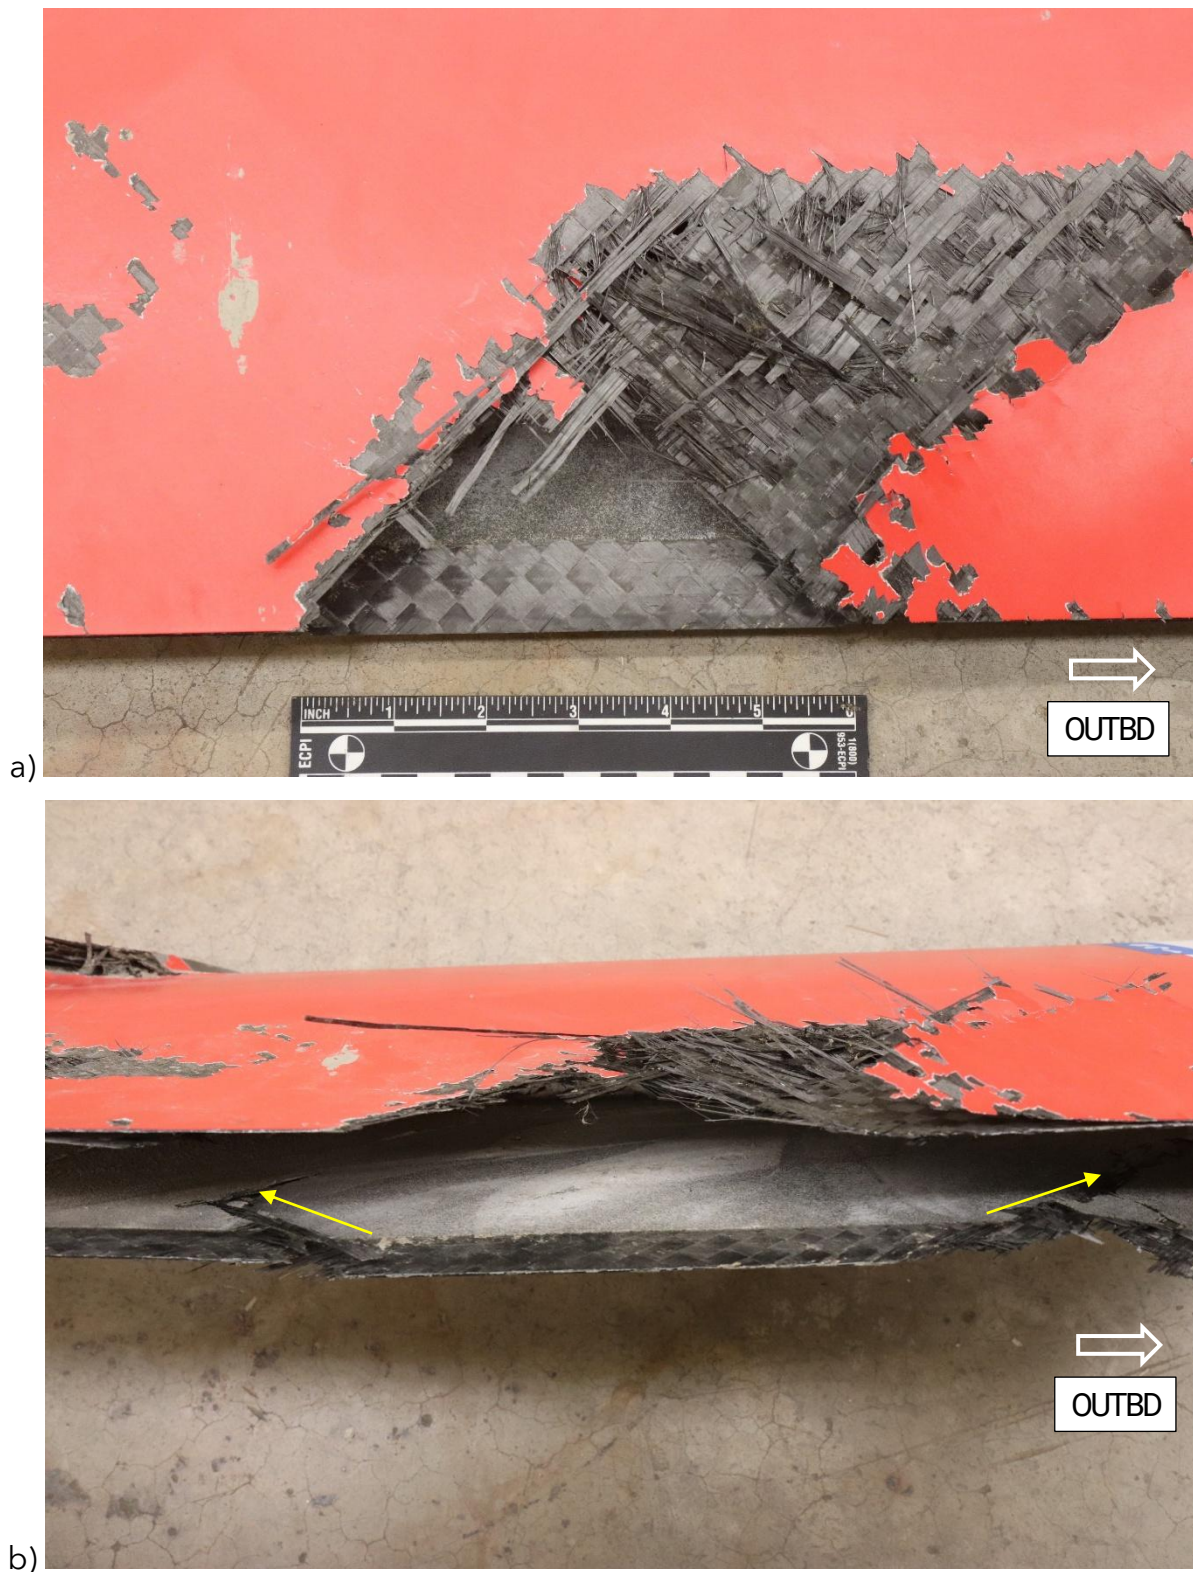
**Figure 15.** a) Wedge-shaped fracture in upper skin between STA 182 and STA 187.5 and b) image showing corresponding trapezoid-shaped region formed by tears in lower skin at STA 182 and STA 188.75.

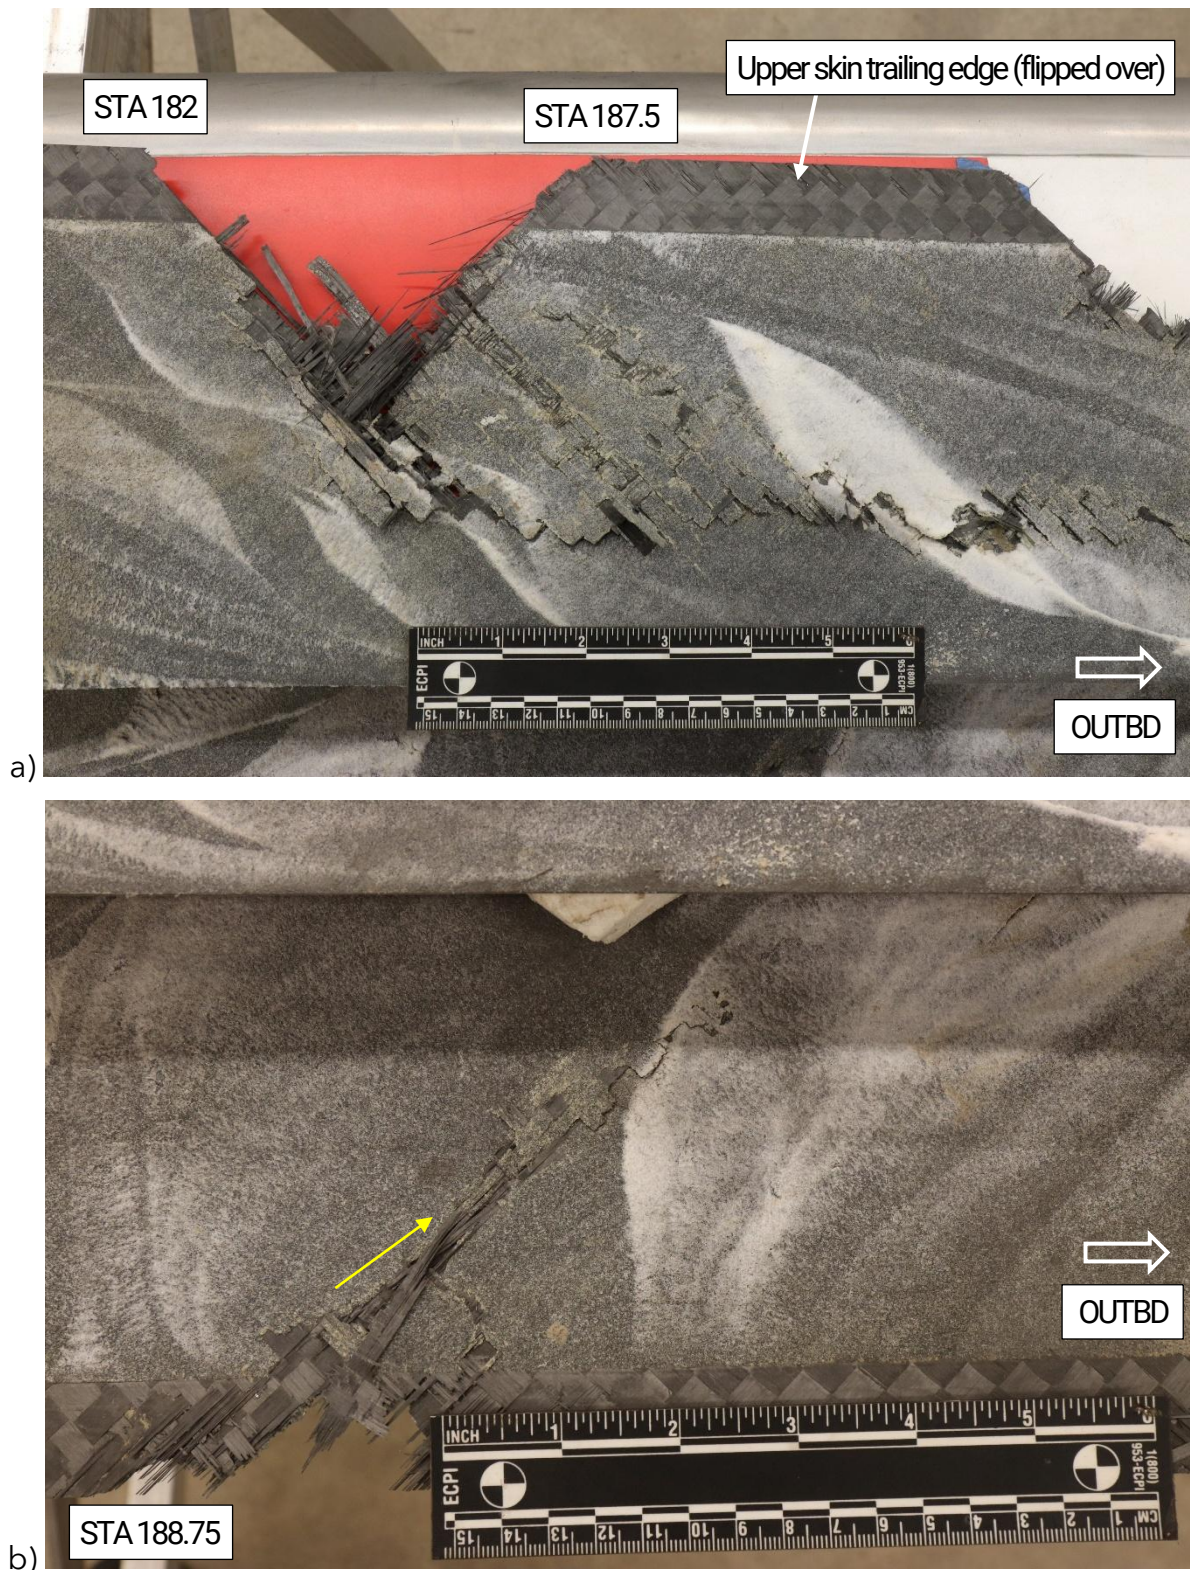
**Figure 16.** Inner surface of upper skin at wedge-shaped fracture showing skin to core separation features that are continuous across cracks in the skin; b) inner surface of the lower skin showing the outboard tear extending into a continuous skin to core separation feature; and

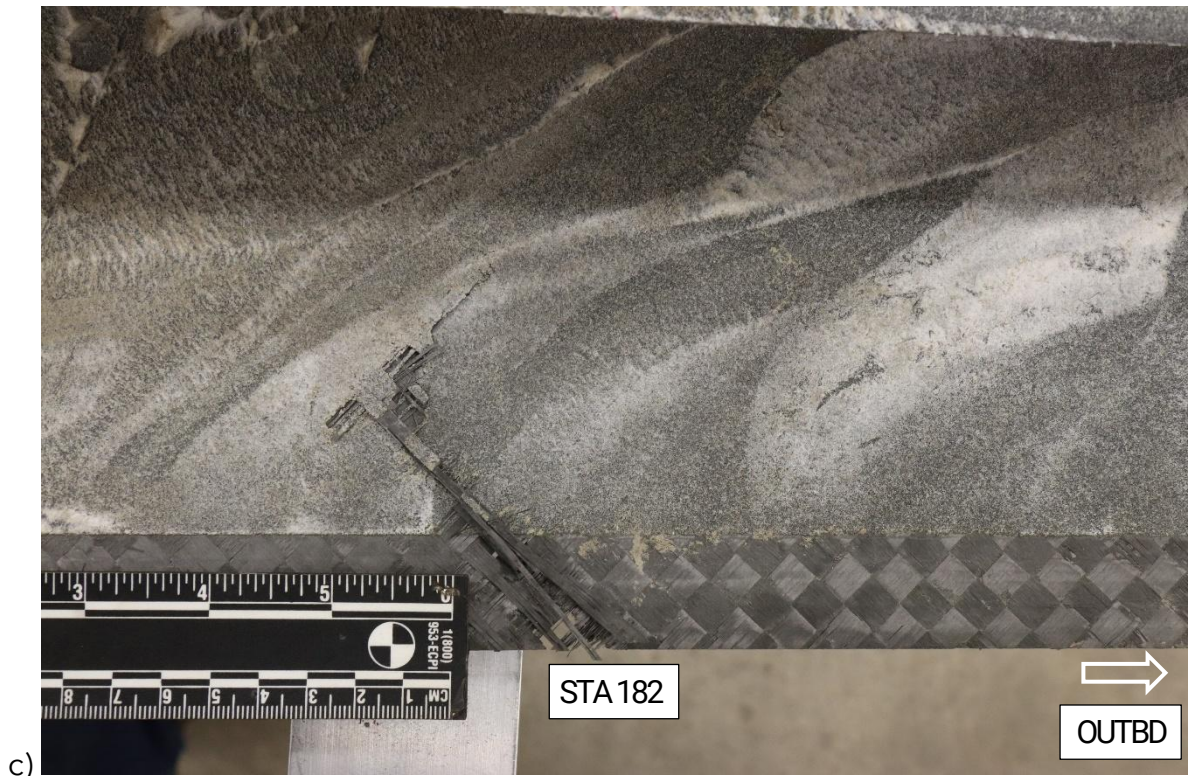
**Figure 16 (cont.).** c) inner surface of the lower skin showing the inboard tear with an inconclusive determination of continuity of the skin to core separation features.

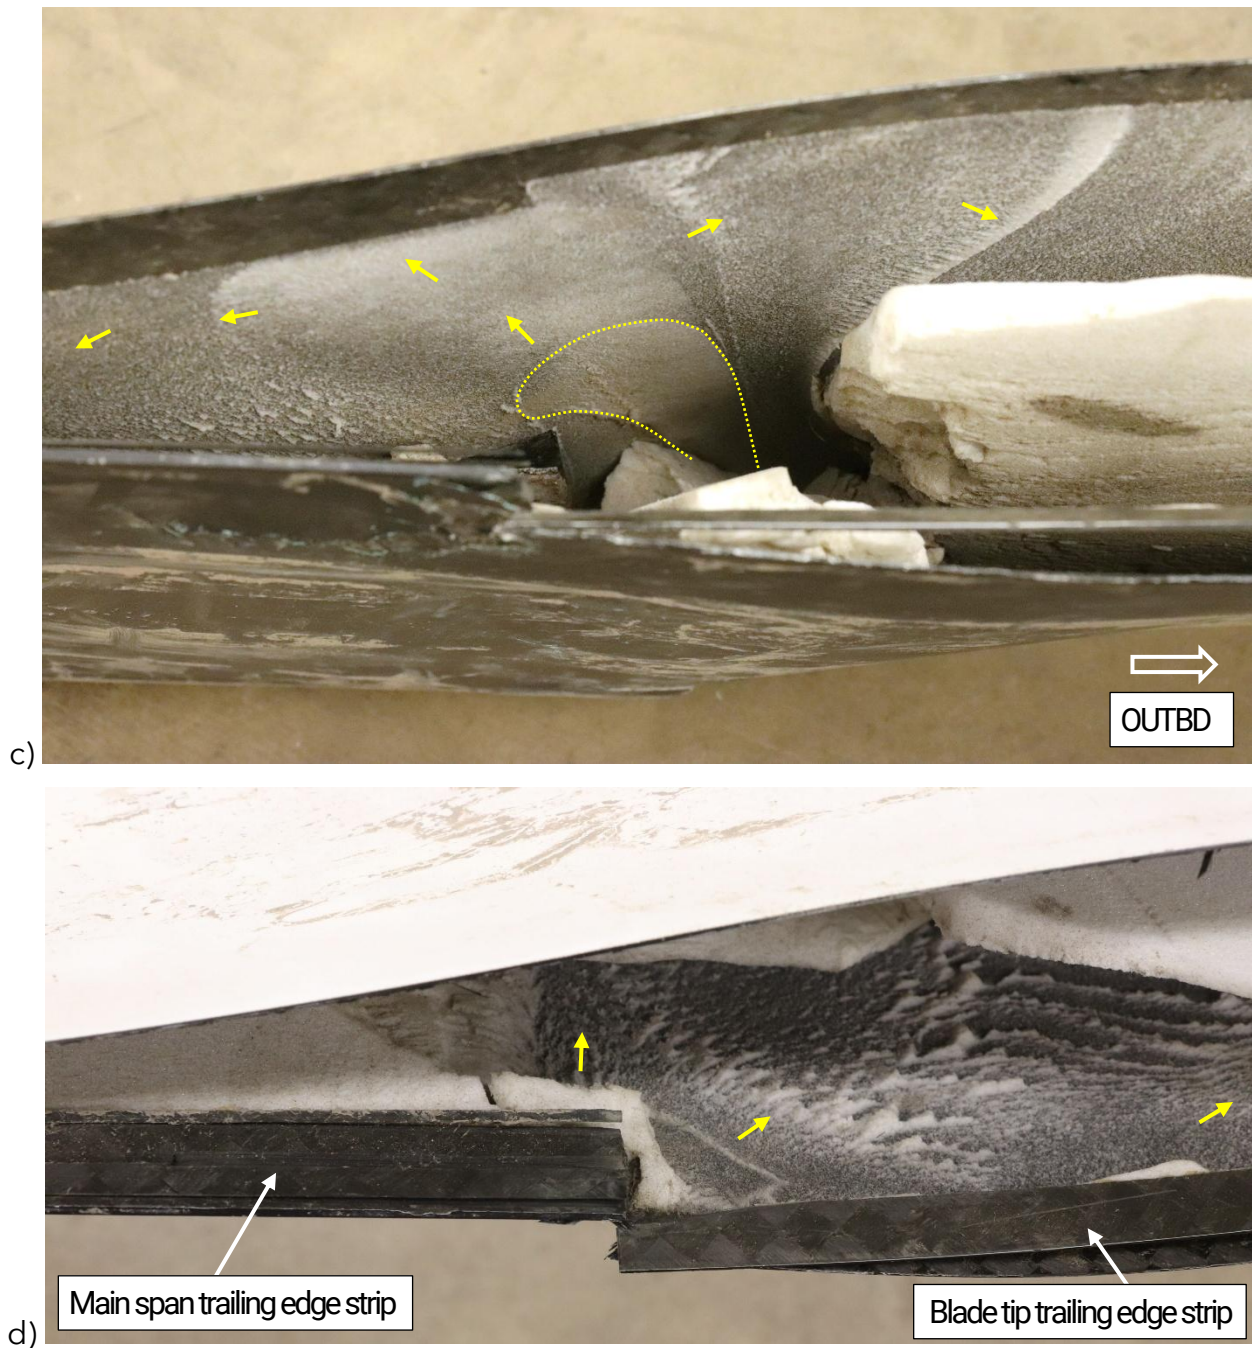
**Figure 25 (cont.).** c) closer view of the upper skin separation from the core. An elongated separated region was observed near the leading edge, indicated by the yellow dashed line. Yellow arrows indicate the local direction of skin separation; and d) closer view of the trailing edge strip transition showing tear ridges radiating away from the main span-to-tip trailing edge transition.

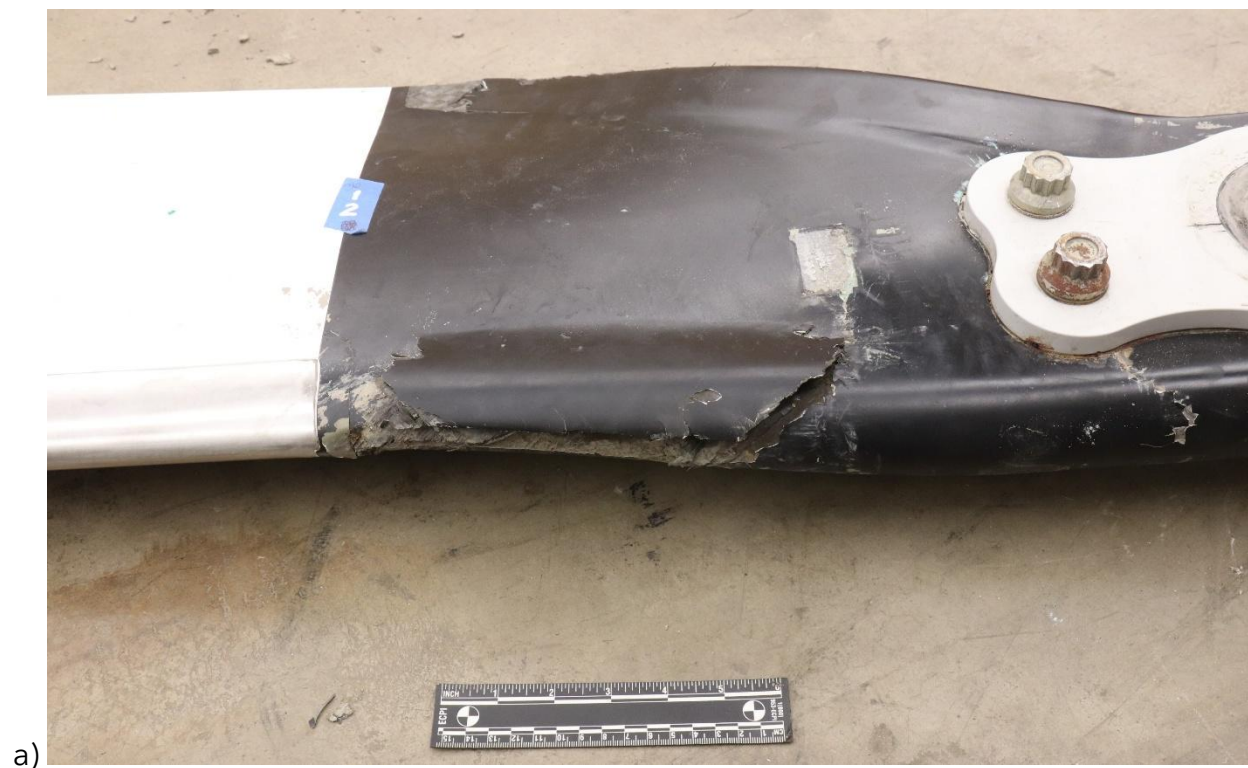
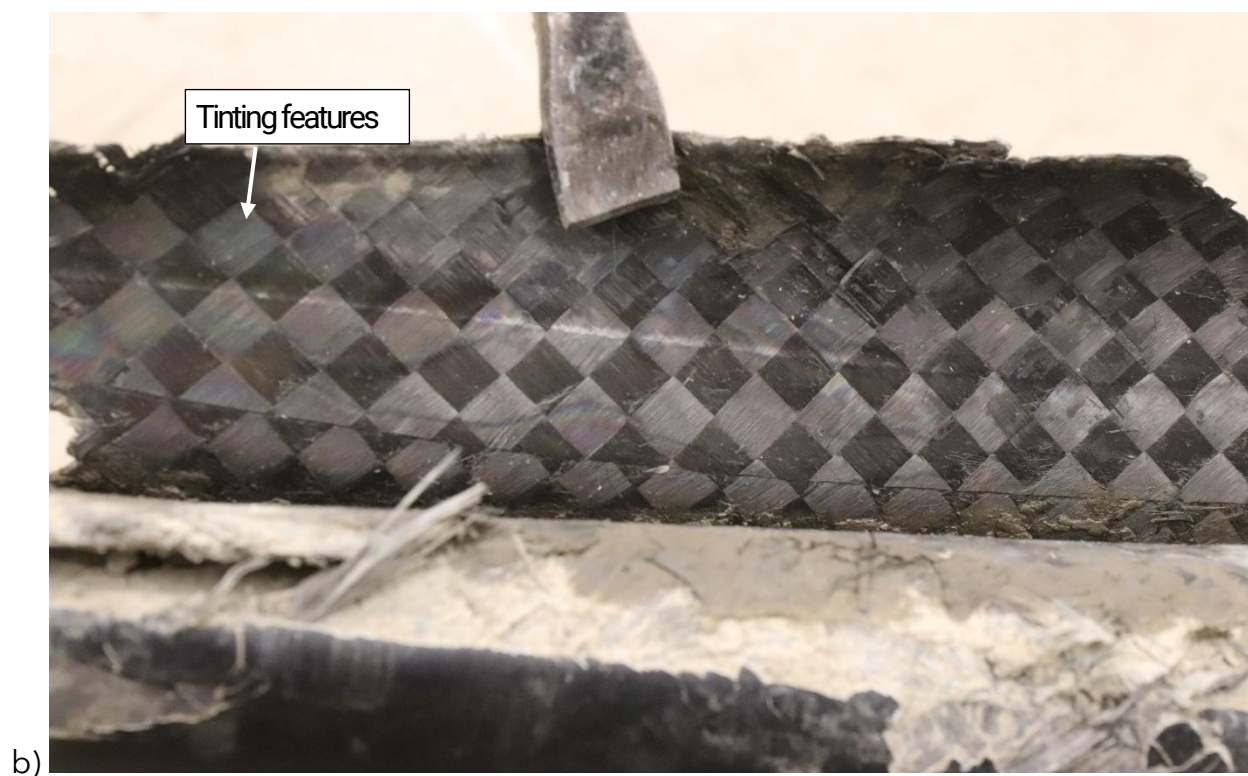
**Figure 26.** a) Flap of torn skin material on blade A303 along the leading edge near the blade grip and b) image showing slight tinting of the separated skin after cleaning.
