# National Transportation Safety Board

Office of Research and Engineering

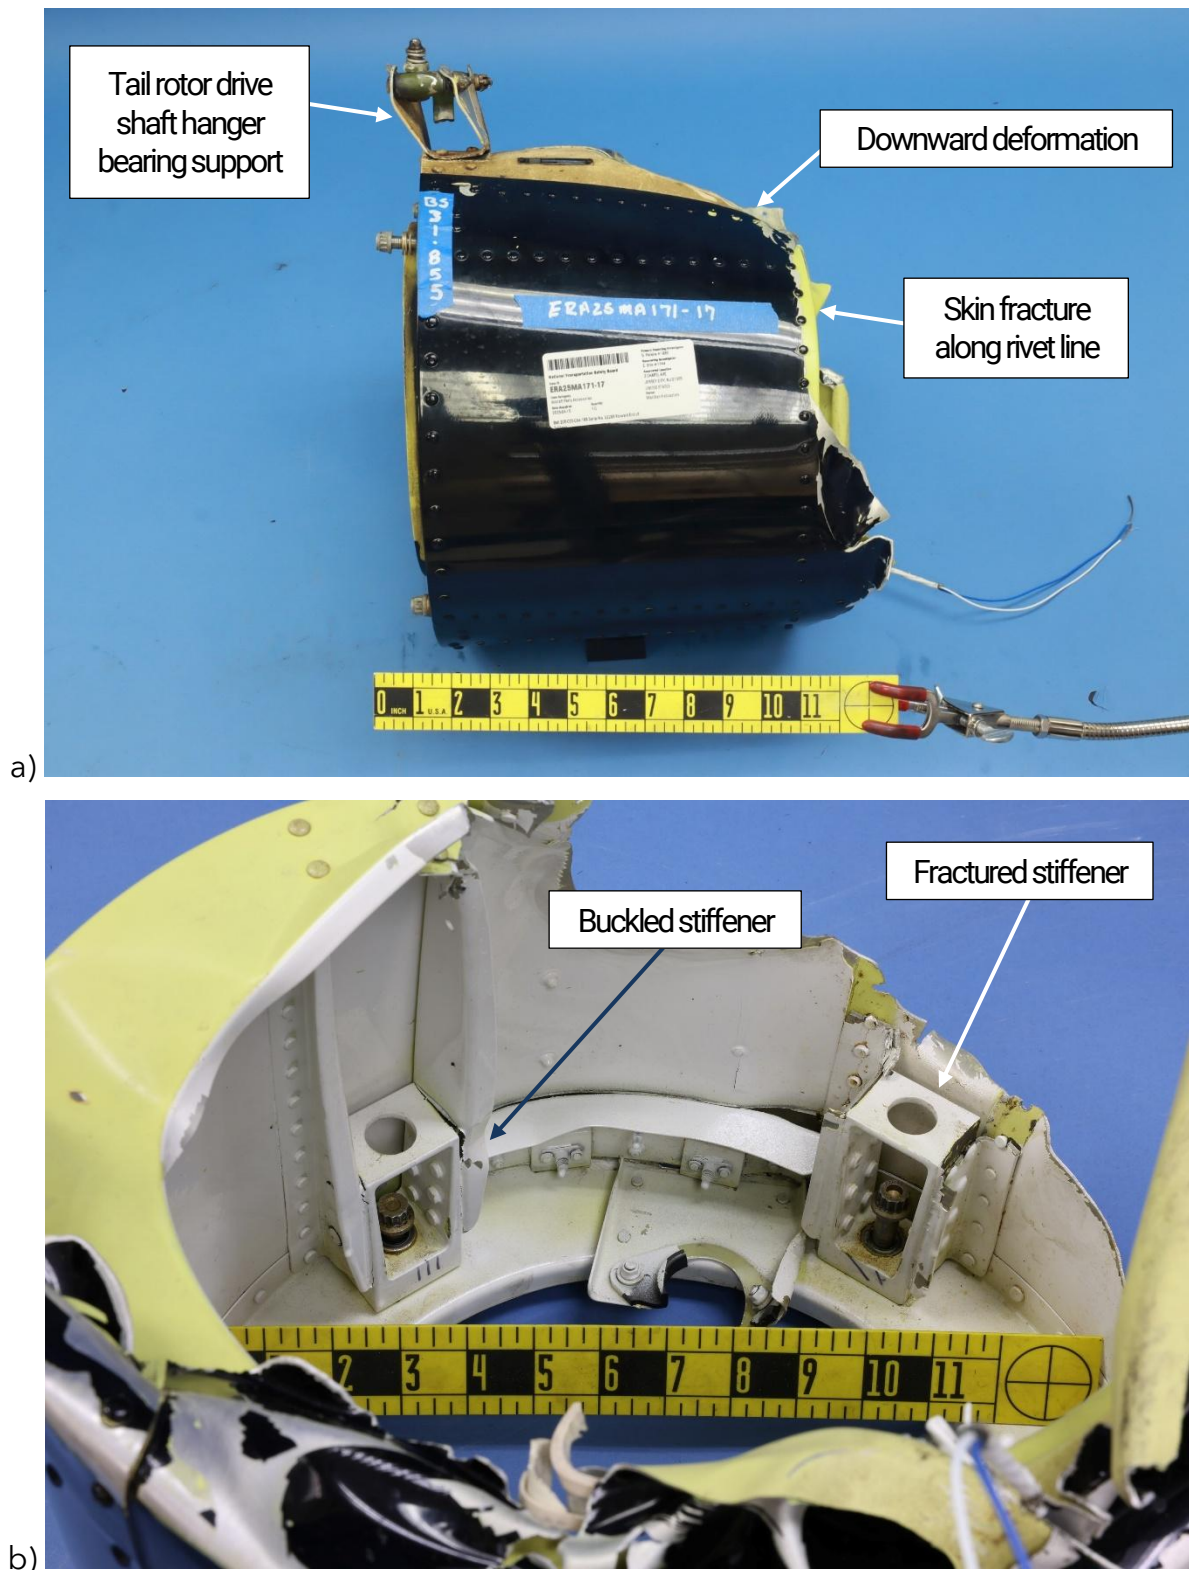
**Figure 2.** a) Left side of the forward tail boom section; b) interior view of upper left and right quadrants showing a buckled and bent stiffener and a fractured stiffener; and

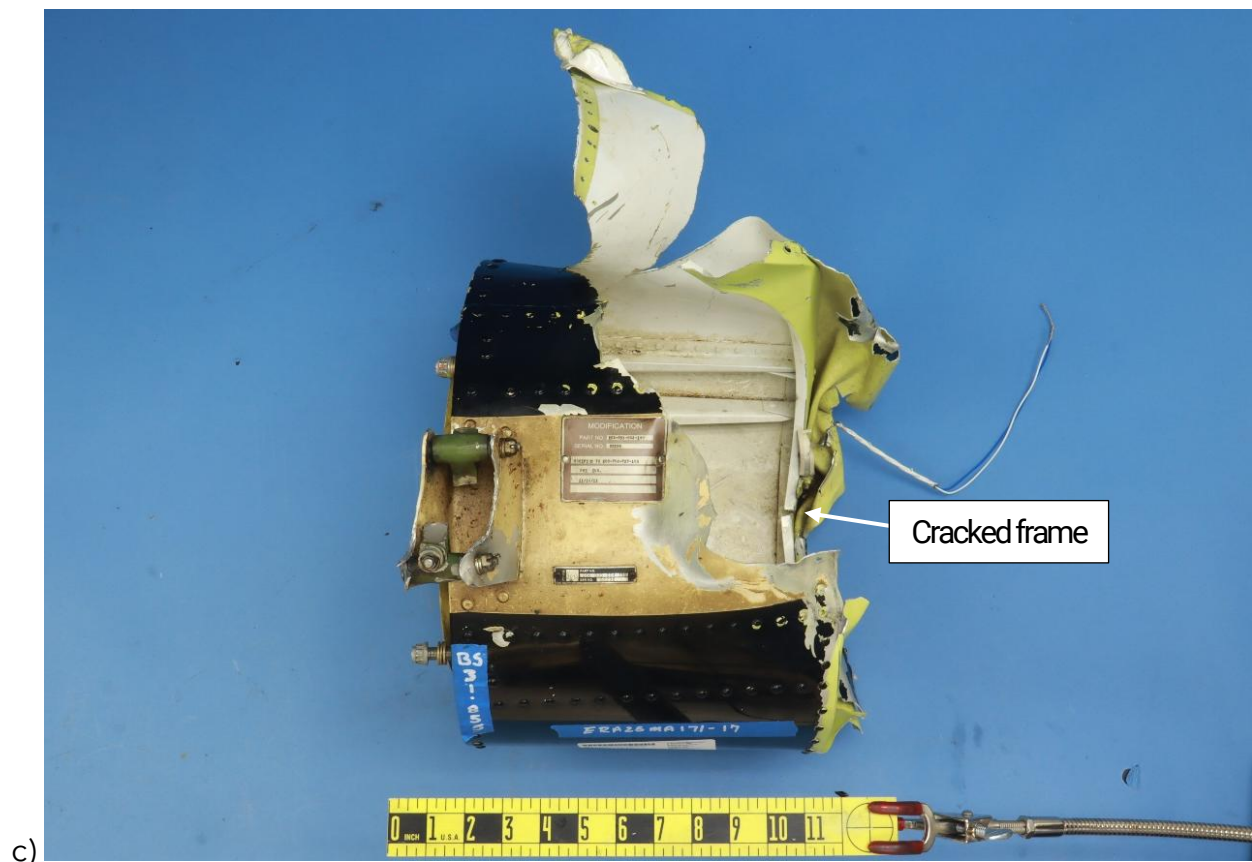
**Figure 2 (cont.).** c) top-down view of the forward tail boom section.

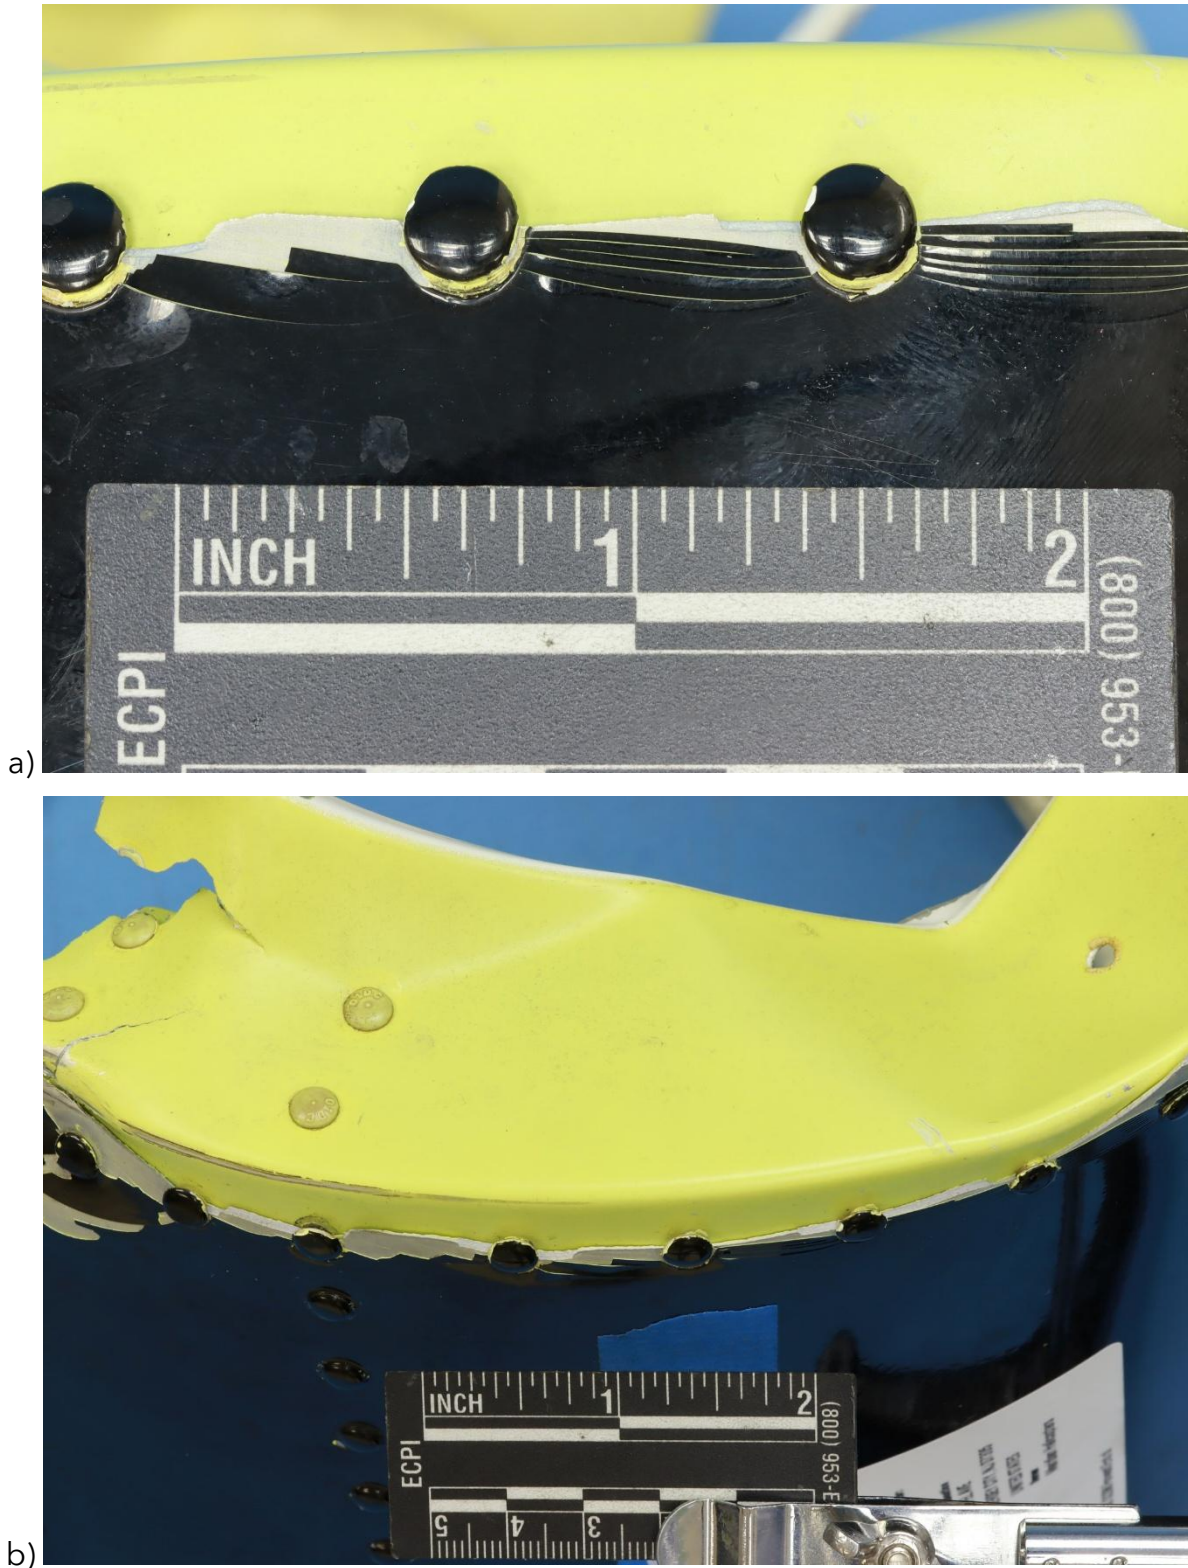
**Figure 3.** Images of the skin fracture along the rivet line on the upper left quadrant of the tail boom: a) close-in side view showing spalling and cracking of the paint and b) oblique view showing inclined fracture surfaces consistent with ductile overstress fracture.
