# National Transportation Safety Board

ERA25MA171

Group Chair's Factual Report

Location:     Jersey City, New Jersey  
Date:          April 10, 2025  
Time:          1515 eastern daylight time  
Helicopter:   Bell 206L-4, registration N216MH

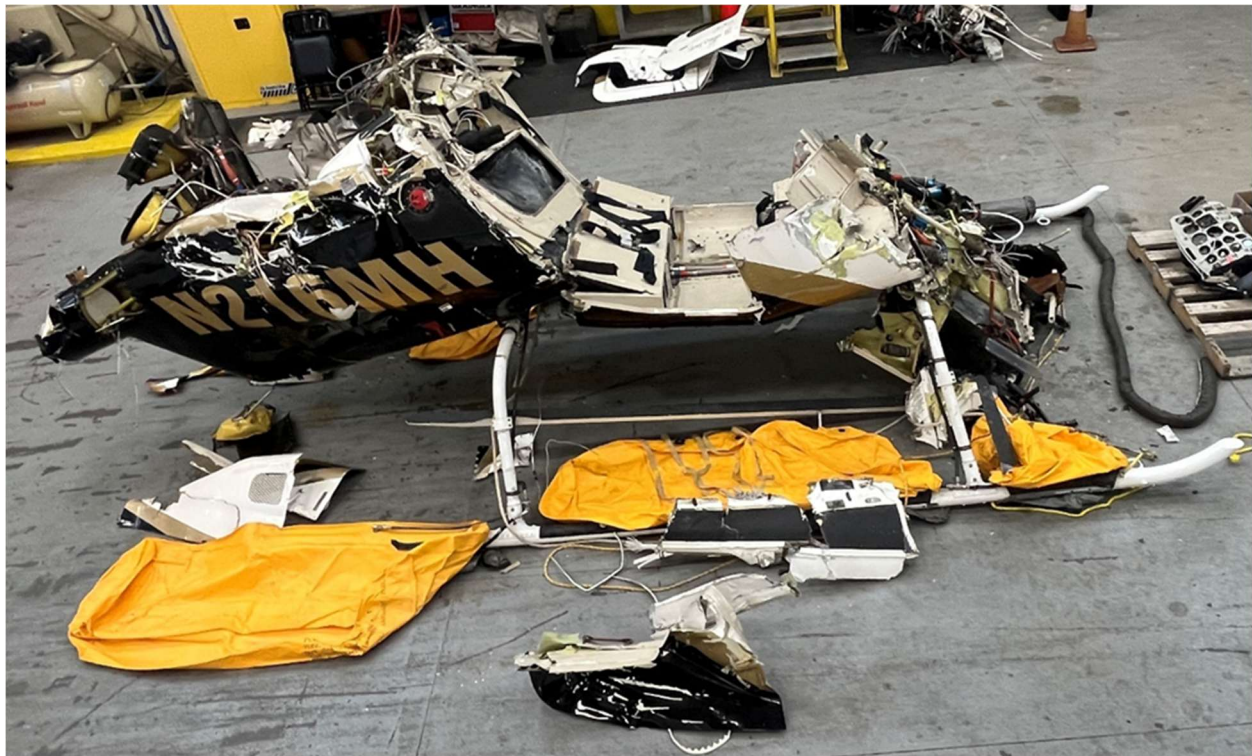
The main fuselage showed significant impact damage throughout (**figure 3**). The nose of the fuselage was partially separated and was found in the area of the

right cockpit seat. The forward crew bulkhead's left-side vertical structure was present but had fractured and separated at its lower end. The left-side vertical structure continued to the left-side lateral structure, the latter of which remained connected to the center post assembly. The right-side vertical structure was fractured and separated at its lower end. The right-side vertical structure exhibited multiple fractures, was deformed, and had a flattened appearance. Black-colored scuff marks were observed on the outboard painted surfaces and on the lower portion of the skin that attaches to the right-side vertical structure. The upper end of the right-side vertical structure was fractured and separated from the right-side lateral structure. The right-side lateral structure was partially separated from the center post assembly.

**Figure 3.** The right side of the main fuselage.

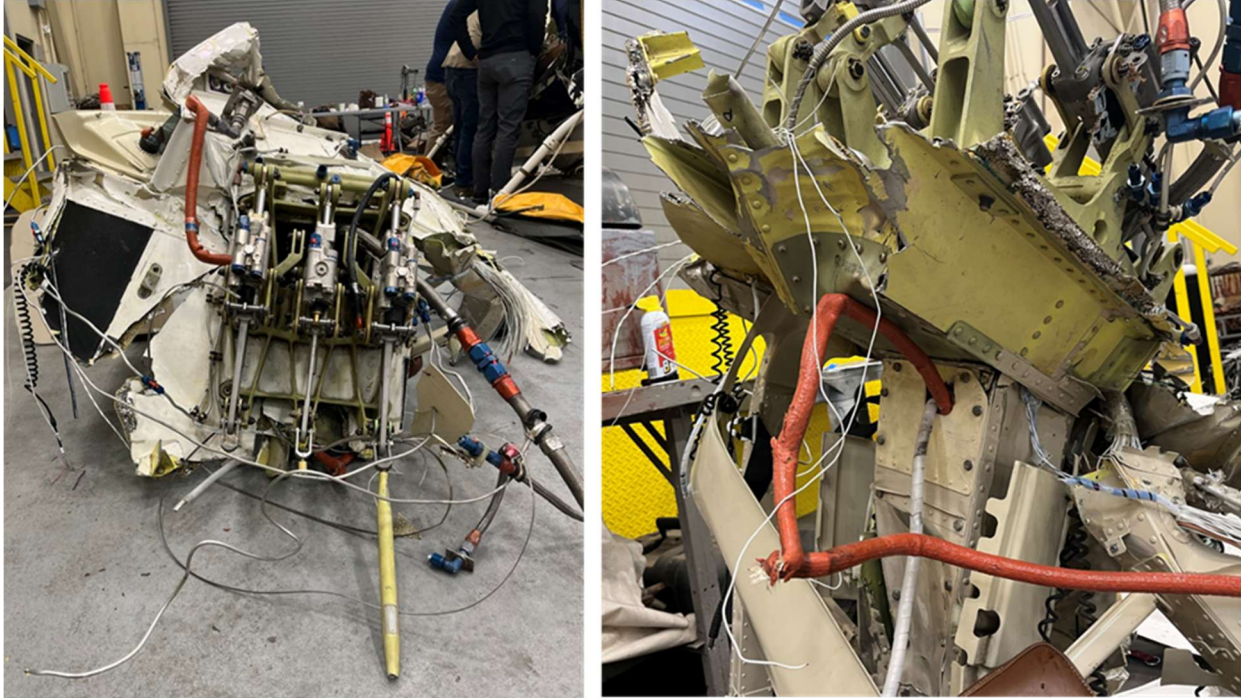
**Figure 4.** The forward section of the cabin roof beam assembly.

The fractured surfaces were visually inspected, and they had a dull, grainy appearance consistent with overstress fractures. All deformations at the fractured surfaces of the forward section of the cabin roof beam assembly had a torsional counterclockwise (up-looking-down) directionality, with the right side of the roof beam having a downward directionality. All deformations at the fractured surfaces of the aft section of the cabin roof beam assembly (containing the main transmission) had a torsional counterclockwise (up-looking-down) directionality with a downward component to the right.

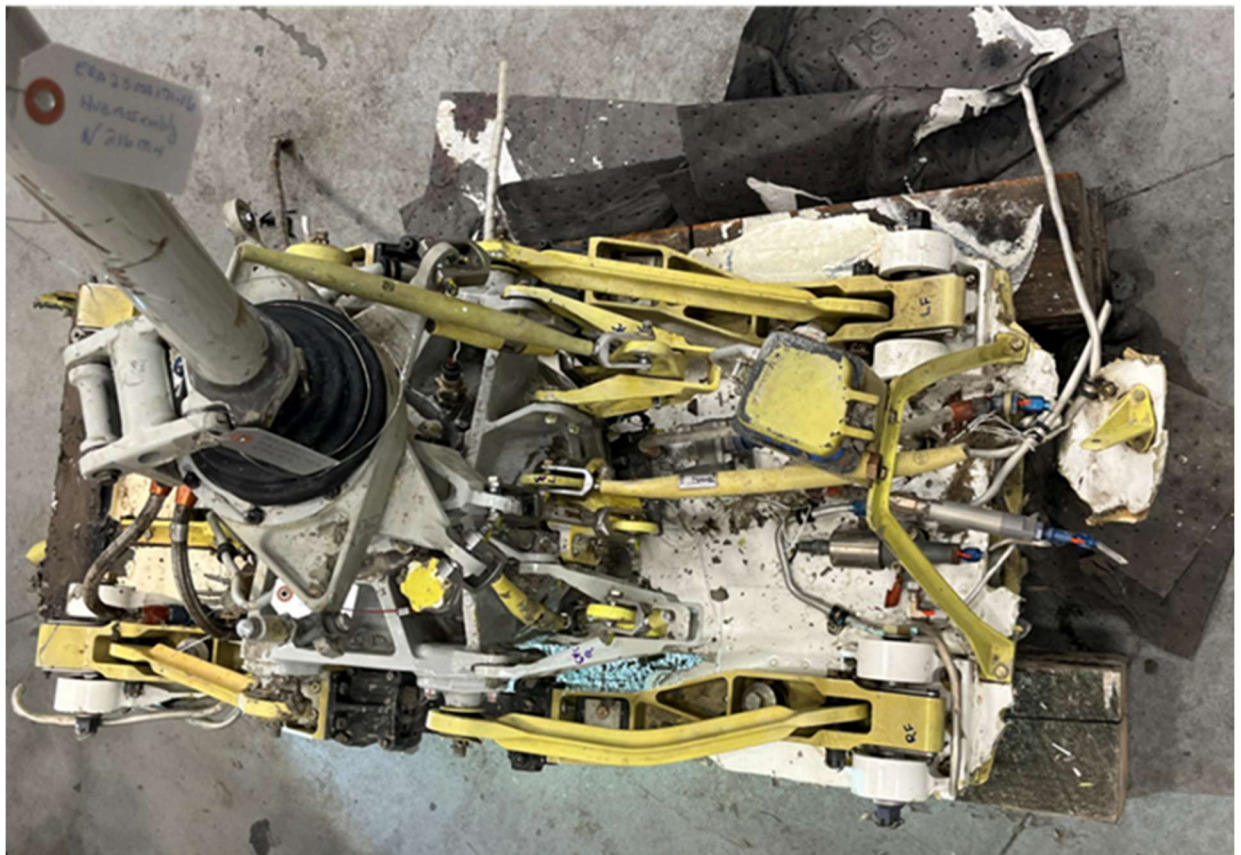
**Figure 5.** The aft section of the cabin roof beam assembly.

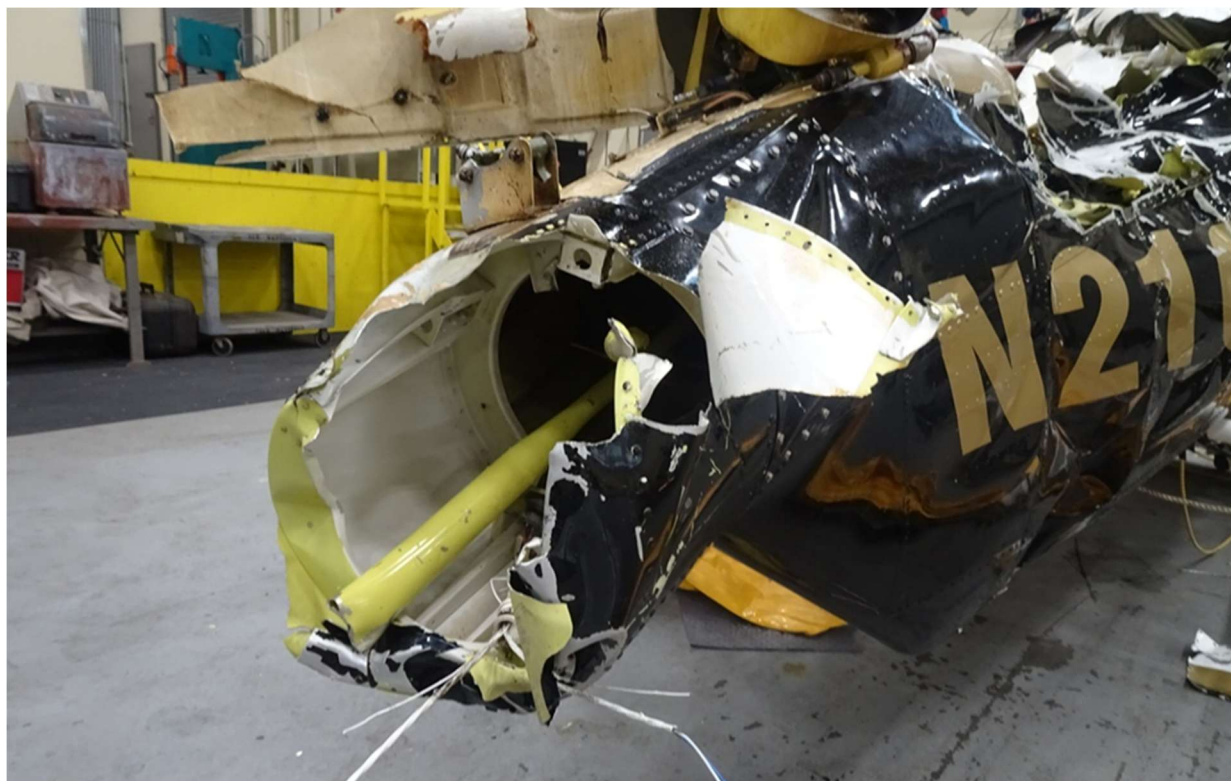
The forward end of the tail boom remained attached to the intercostal support of the intermediate section of the fuselage via its four attachment bolts, but was fractured (**figures 6 and 7**). The fracture was measured from the intercostal support (boom station (BS) 31.855) and was about 7.25 inches at the 12 o'clock position, about 13 inches at the 3 o'clock position, about 10.25 inches at the 9 o'clock position (along the rivet line), and about 14 inches at the 6 o'clock position. The fracture surfaces exhibited signatures of overload. On the upper right quadrant, the skin was deformed in the outboard and forward direction. Contact marks were observed on the upper surfaces of the tail boom's forward end. These contact marks had a lateral (left-and-right) directionality. These contact marks started about 3.5 inches from the hanger bearing support (co-located at the tail boom attachment point) and measured about 6 inches in length, and about 3 inches in width. The upper-right intercostal bolt joint longerons fractured at the aft end of the attachment fitting. The upper-left intercostal bolt joint attachment fitting separated from the upper-left longeron about 0.1 inch and the separation extended for about 2.3 inches. The upper-left intercostal bolt joint attachment fitting slightly separated from the lower longeron for about 0.5 inch on the aft end. Both upper-left intercostal longerons were deformed to the right.

**Figure 6.** The forward portion of the tail boom attached to the intermediate section.

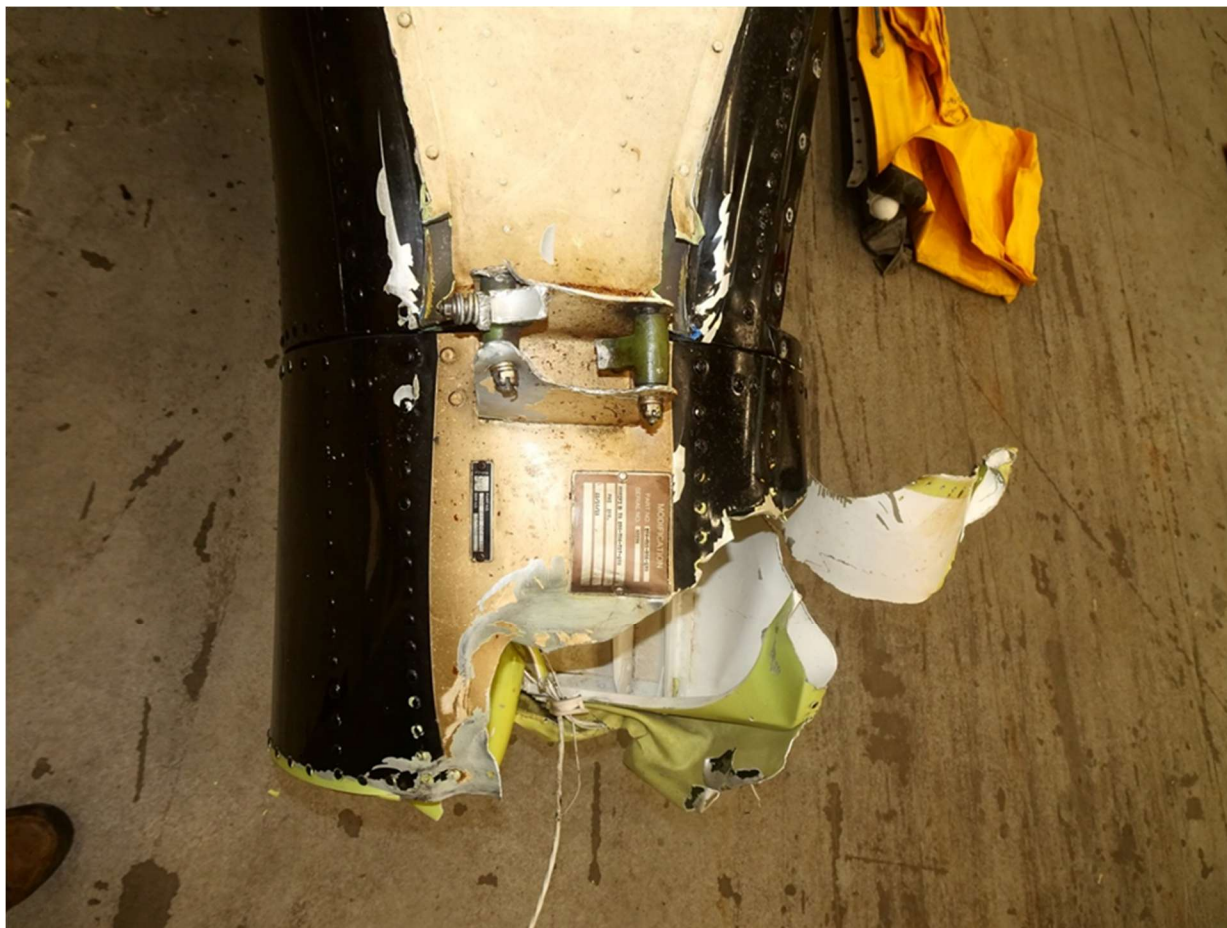
**Figure 7.** The fractured forward portion of the tail boom at its attachment point.

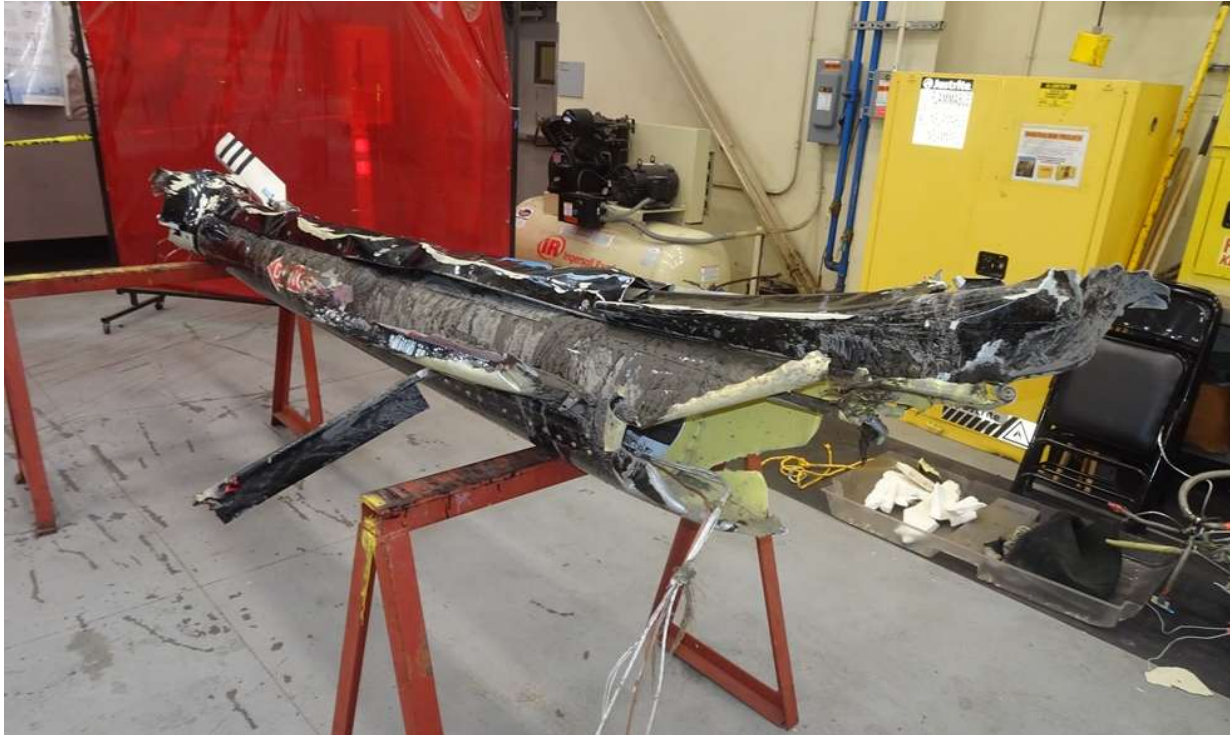
The tail boom assembly was recovered separated from the main fuselage with sections of the left and right horizontal stabilizers, right elevator, TRGB and tail rotor installed (**figure 8**). The forward end of the tail boom was fractured and bent upwards, the aft end had a slight bent to the left. The fracture at the forward end tail boom assembly (recovered separate from the main fuselage wreckage) had a straight-line appearance, possibly due to main rotor blade contact.

**Figure 8.** The recovered tail boom.

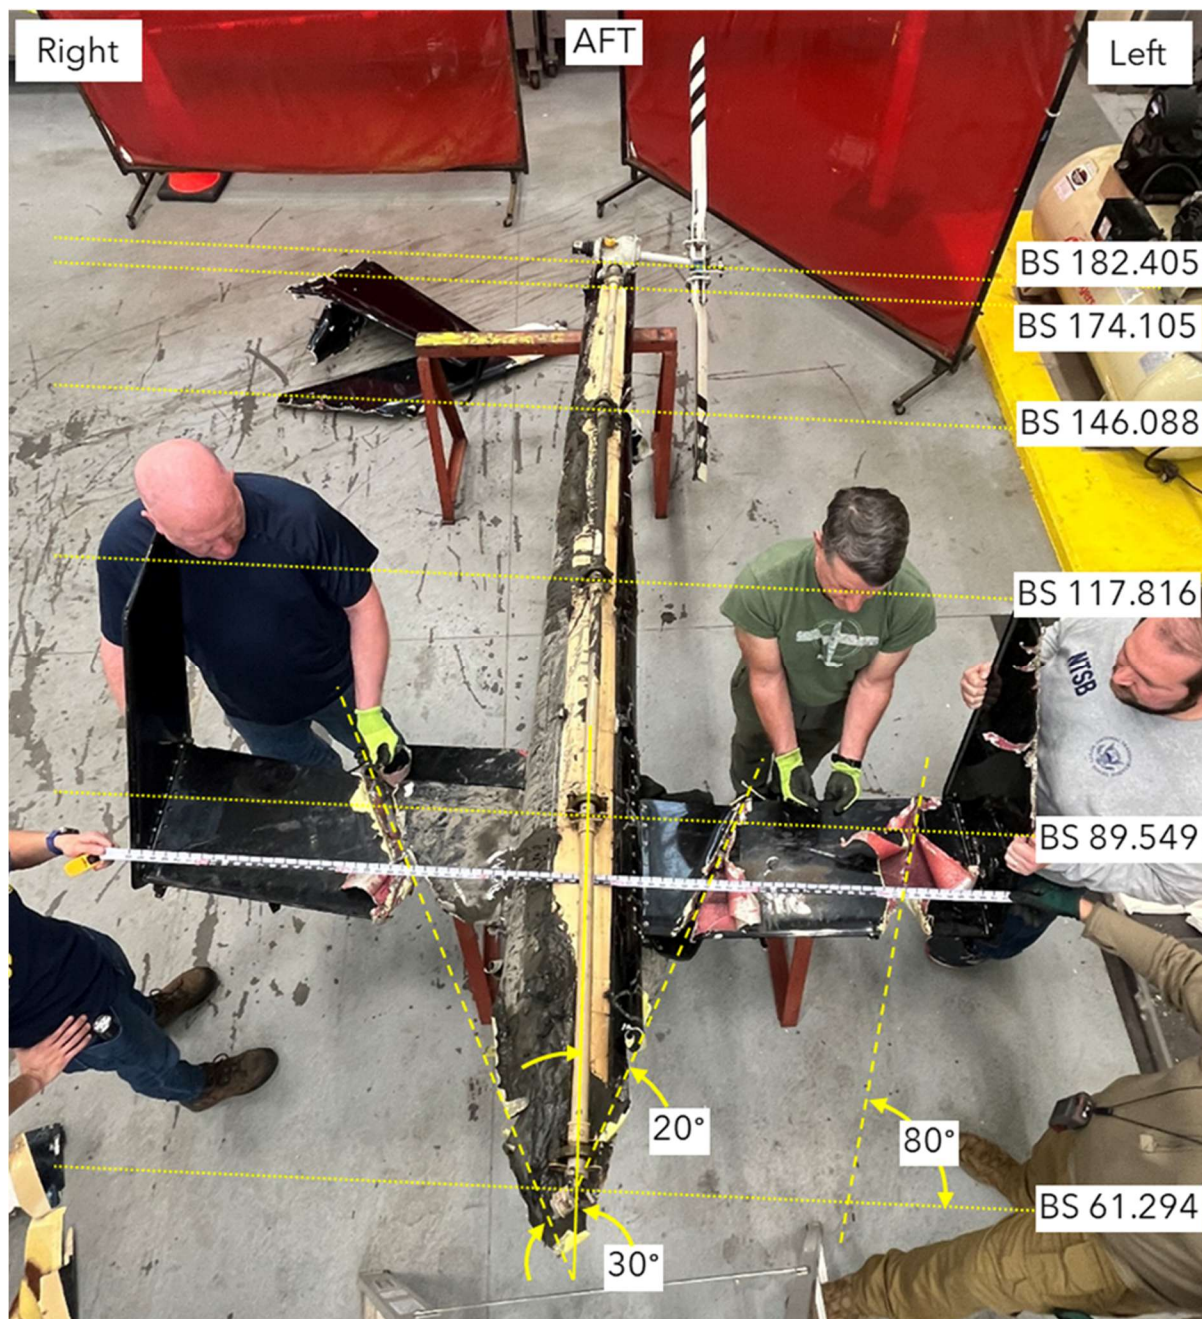
Two distinct fractures, one to the left and one to the right of the centerline of the tail boom, were found (**figure 9**). Both fractures had an up and aft directionality. At the 12 o'clock location of the fracture, the tail boom extended to about 7 inches forward of BS 61.294 (the No. 2 TRDS hanger bearing mount). At the 7 o'clock location of the fracture the tail boom extended to about 6 inches aft of BS 61.294. The cut to the right side had an angle of about 30° with respect to the tail boom center line and extended about 15 inches aft of BS 61.294. The cut to the left side had an angle of about 20° with respect to the tail boom center line and extended about 16 inches aft of BS 61.294. Both fractures at the forward end of the tail boom assembly were in alignment with the fractures on both horizontal stabilizers and the horizontal stabilizer sections recovered separately. There were no ballast weights on the mid tail boom location.

**Figure 9.** The location and angles of fractures observed on the tail boom.

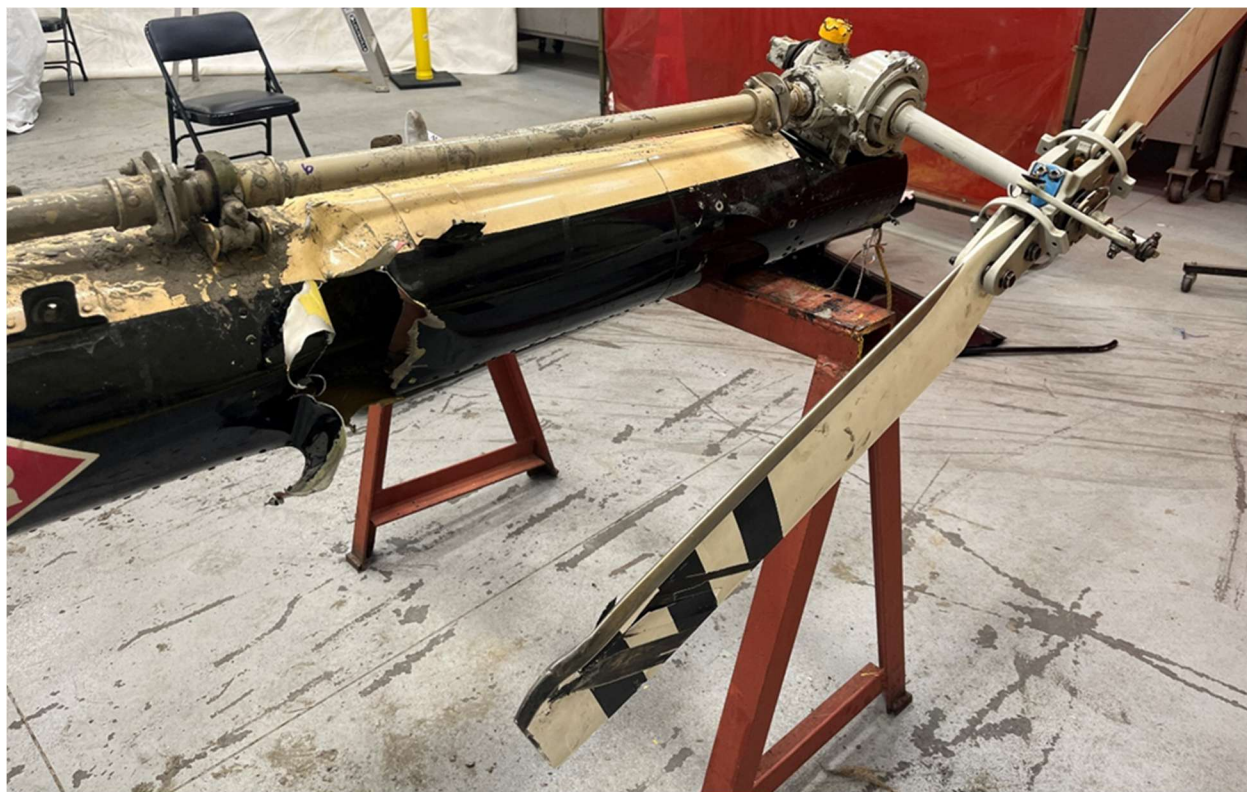
The tail boom had a large opening, consistent with tail rotor blade tip contact, at BS 146.088 that extended from the 7 o'clock to the 11 o'clock positions and was about 5 inches wide (**figure 11**). The skin was deformed forward and outboard on the forward edge and inboard on the aft edge. Adjacent to the opening was a dent about 5 inches wide that extended from the 7 o'clock edge of the opening to the 5 o'clock position.

**Figure 11.** The opening observed at BS 146.088 consistent with tail rotor blade contact.

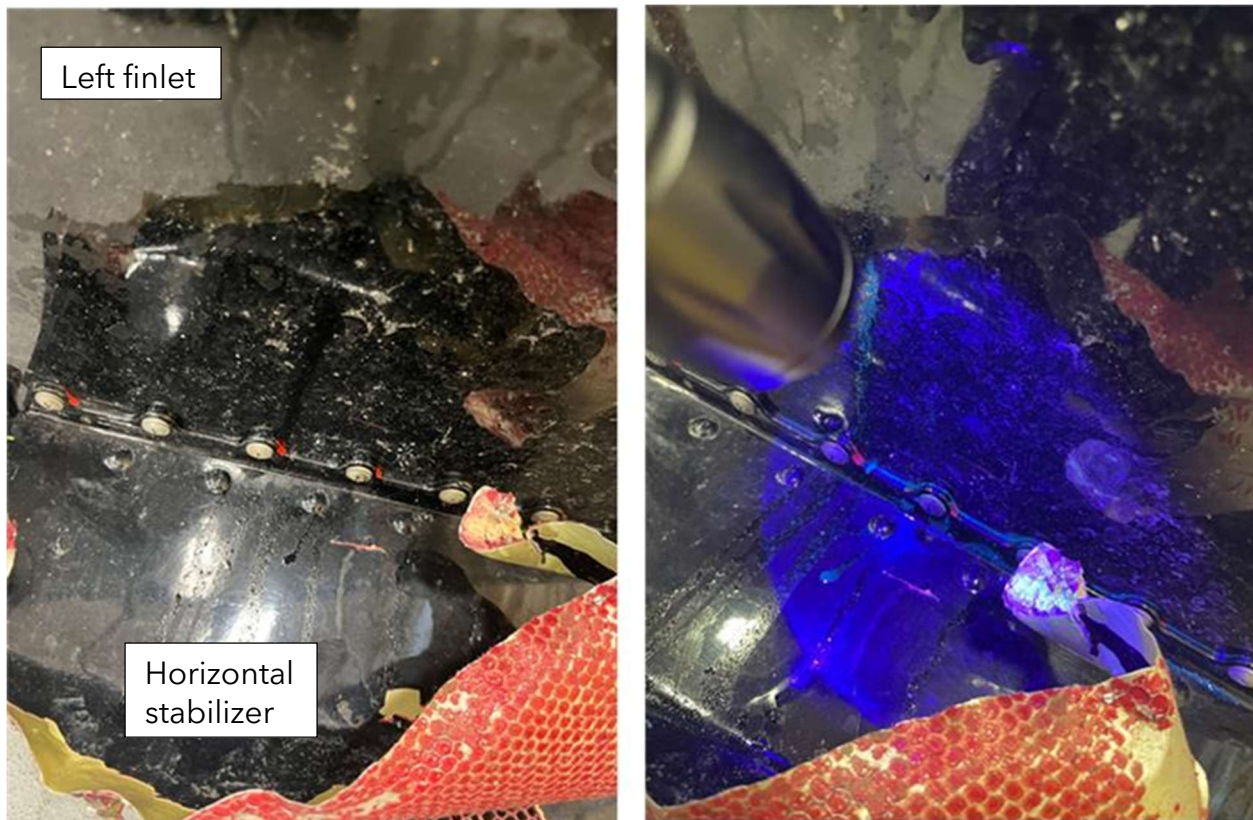
For the left finlet, the upper portion of the leading edge was fractured and separated from the finlet. The skin exhibited deformation and curling in the inboard direction. A feather was found on the upper surface of the left portion of the horizontal stabilizer attached to the left finlet. The left portion of the horizontal stabilizer attached to the left finlet was fractured at two locations. The outboard fracture was about 6-7 inches inboard of the finlet at the leading edge and about 3.5 inches inboard of the finlet at the trailing edge. The inboard fracture is about 18 inches apart from the outboard fracture on both the leading and trailing edges. These horizontal stabilizer fractures exhibited an upward directionality.

**Figure 13.** The inboard surface of the left finlet and upper surface of the horizontal stabilizer where the left finlet attaches to the horizontal stabilizer. The left image shows this area in normal light and black light illumination on the right image.

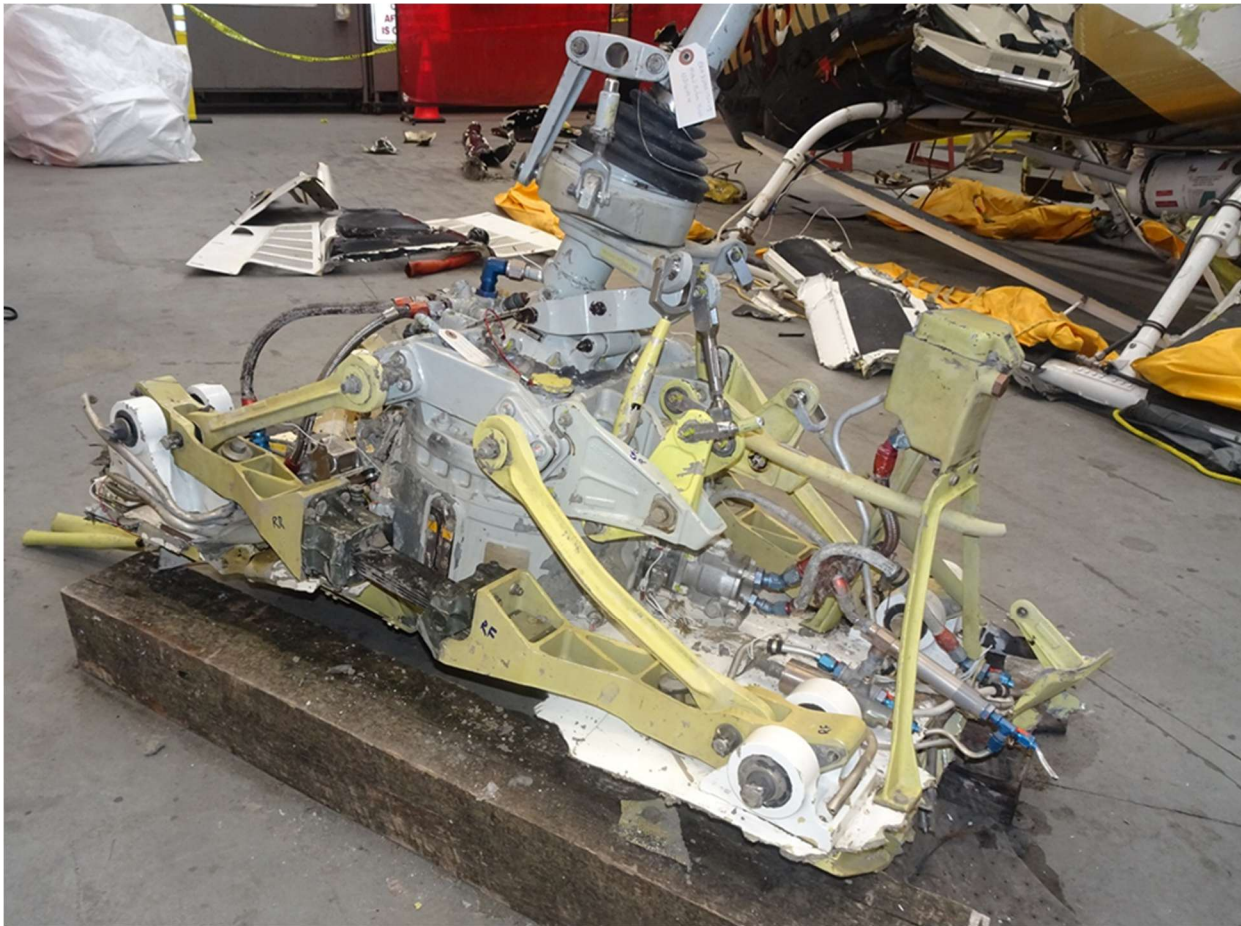
The bellcranks mounted to the main transmission housing's forward side remained installed (**figure 14**). For the lateral (left) cyclic and collective (center) control tubes, the clevis connections at their forward ends were fractured, but their aft clevis connections remained installed on their respective transmission-mounted bellcranks. The longitudinal (right) cyclic control tube had fractured and separated at its aft clevis connection, but the aft clevis connection remained installed on its transmission-mounted bellcrank. The control tube for longitudinal (right) cyclic remained installed between the transmission-mounted bellcrank and the stationary swashplate, but the stationary swashplate had rotated to the left from its normally installed orientation to about 45°. The control tube for lateral (left) cyclic remained installed on its transmission-mounted bellcrank but had fractured at the upper ends of the threads for the clevis connection at the stationary swashplate. The collective (center) control tube remained installed between its transmission-mounted bellcrank and the collective lever. The collective lever had separated from its pinned connection to the collective sleeve, but the collective lever had rotated to the left from its normally installed orientation by about 30°. The swashplate and support assembly data plate showed P/N 206-010-450-123 and S/N REFS-37.

**Figure 14.** The bellcranks installed on the forward side of the main transmission housing.

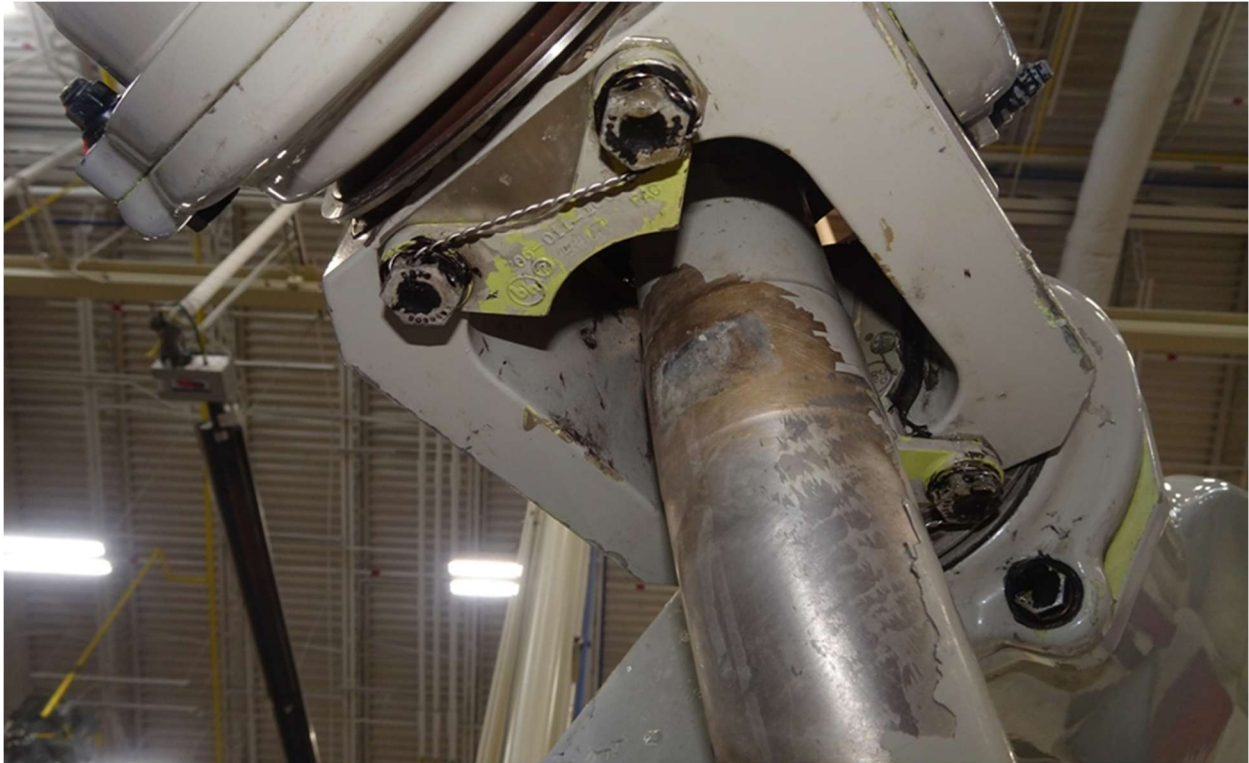
The total length of the mast was measured 23.5 inches from the base of the mast to the main rotor hub. Scratching of the paint layer was observed through the mast. The swashplate support was fractured at the tube underneath and concentric with the collective lever. The collective lever pins remained installed on the collective lever but were not connected to the collective sleeve due to rotation of the collective lever to the right from its normally installed position. The mast deflection at its bottom end was approximately 18° forward. The mast deflection at the top of the main rotor hub was approximately 23° aft.

**Figure 16.** The main rotor mast showing contact with the bump stop adjacent to the red main rotor blade.

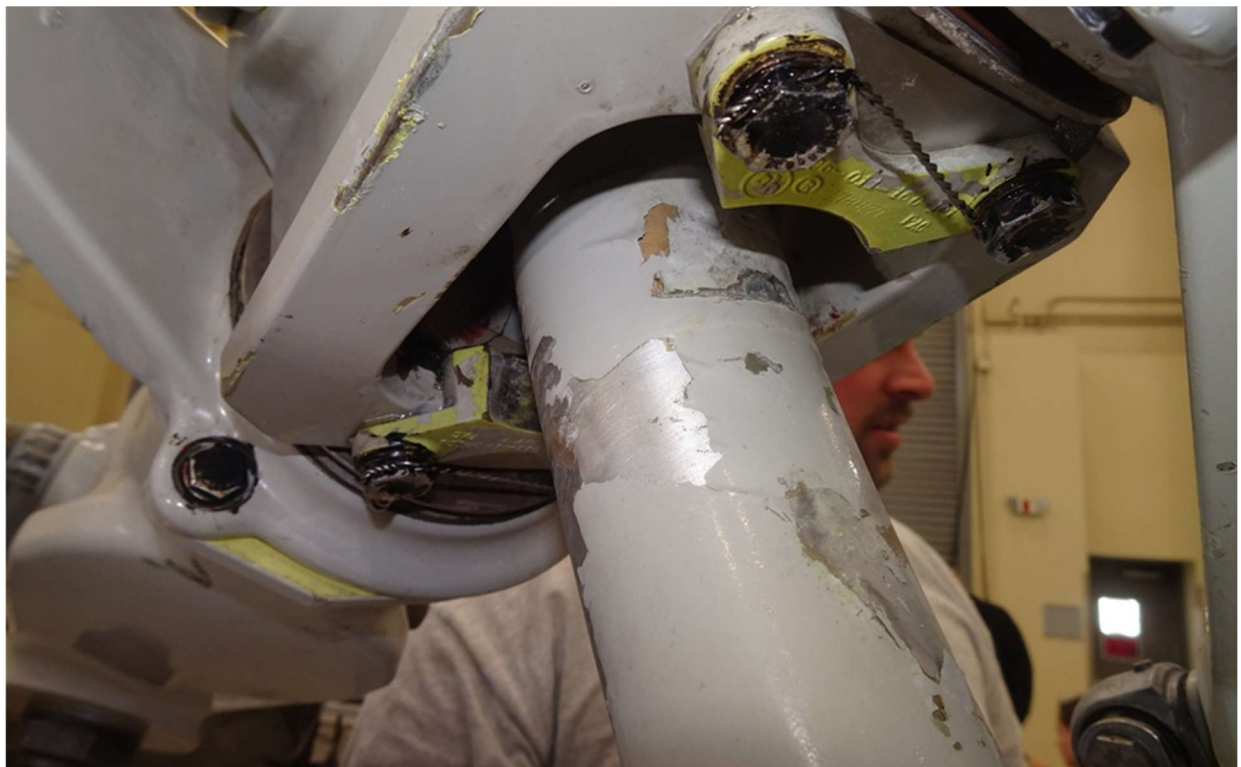
**Figure 17.** The main rotor mast showing contact with the bump stop adjacent to the blue main rotor blade.

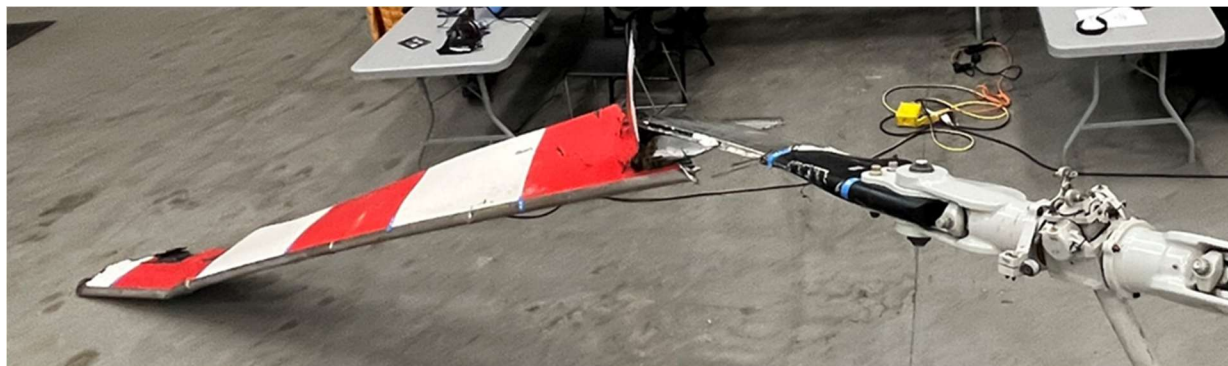
The red main rotor blade, P/N 20633000-101 and S/N A304, remained attached to the main rotor assembly but partially fractured (**figure 18**). The full length of the trailing edge had separated, splitting the blade spanwise, allowing most of the foam core to separate from the blade. Pieces of foam core were recovered from the river and from the rooftop debris location. The trailing edge strip had separated from the red main rotor blade and was not found.

**Figure 18.** The red main rotor blade.

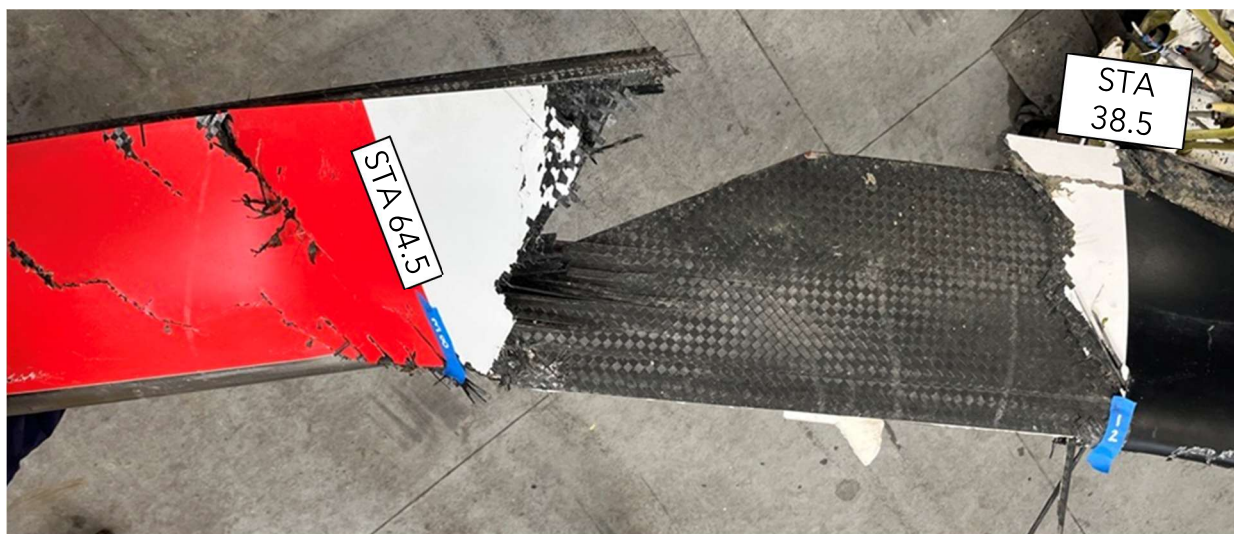
The red blade had partially fractured at STA 64.5, which coincided with the outboard end of the doubler stack where the red blade remained attached by a section of spar laminate, about 3 inches wide (**figure 19**). The leading edge abrasion strip fractured at STA 64.5, but the section up to the inboard end of the abrasion strip was not recovered. The top and bottom skins separated from the doubler stack at red blade STA 38.5 up to red blade STA 64.5. The fracture had an angle of 60° with respect to the abrasion strip outboard of the fracture.

**Figure 19.** The separation of the red main rotor blade between STA 38.5 and STA 64.5.

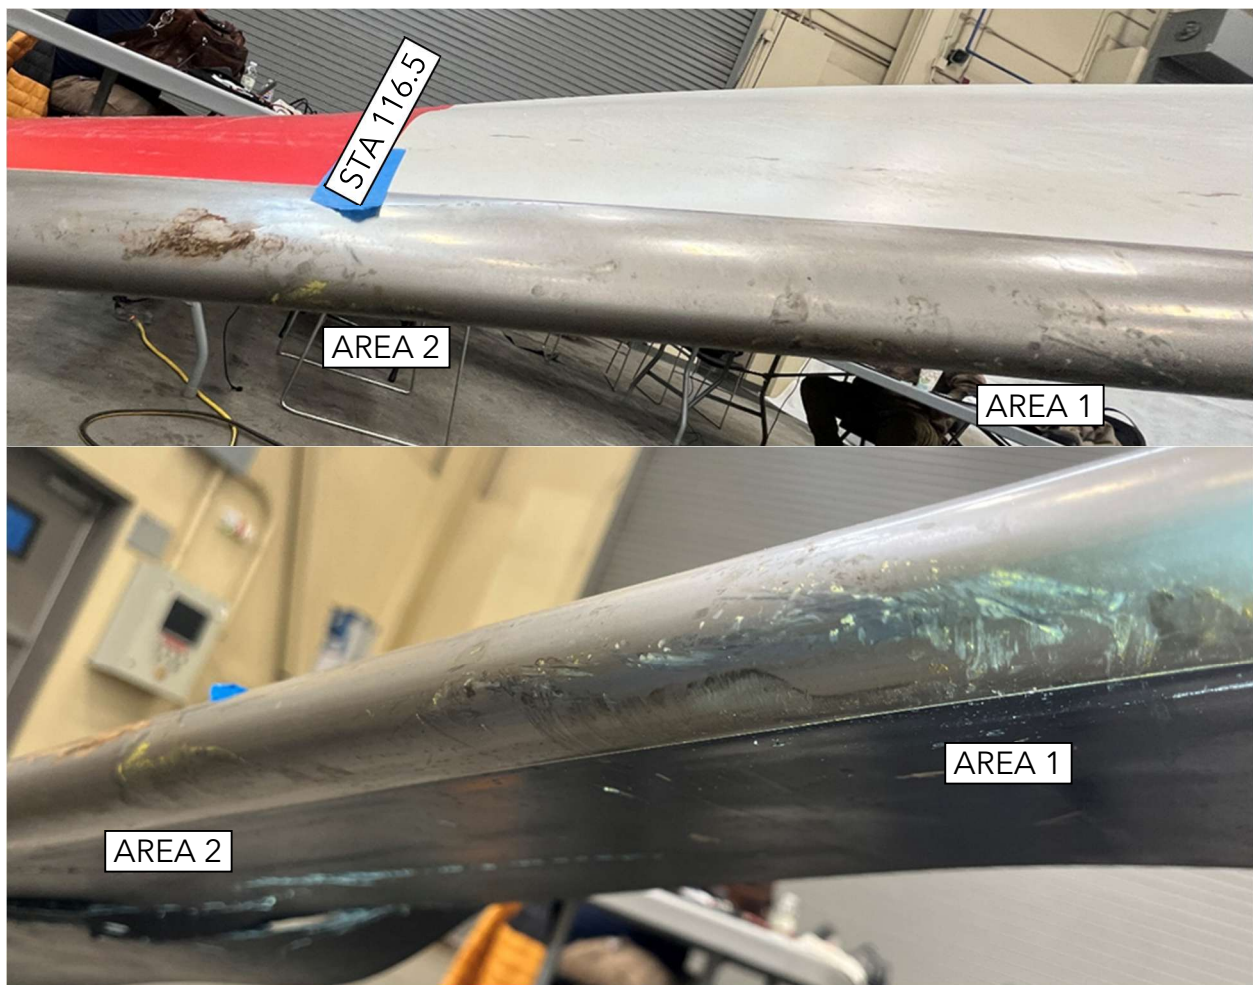
At red blade STA 102.5 to STA 116.5 there were 2 areas of black, white and yellow-green paint transfer (**figure 20**). The inboard area was 7 inches wide (inboard-to-outboard) and extended from the leading edge to the trailing edge on the bottom skin. The second area was about 2.5 inches wide (inboard-to-outboard) and was contained to the abrasion strip with some streak extending to the trailing edge.

**Figure 20.** Damage at STA 112.5 to STA 116.5 on the red main rotor blade.

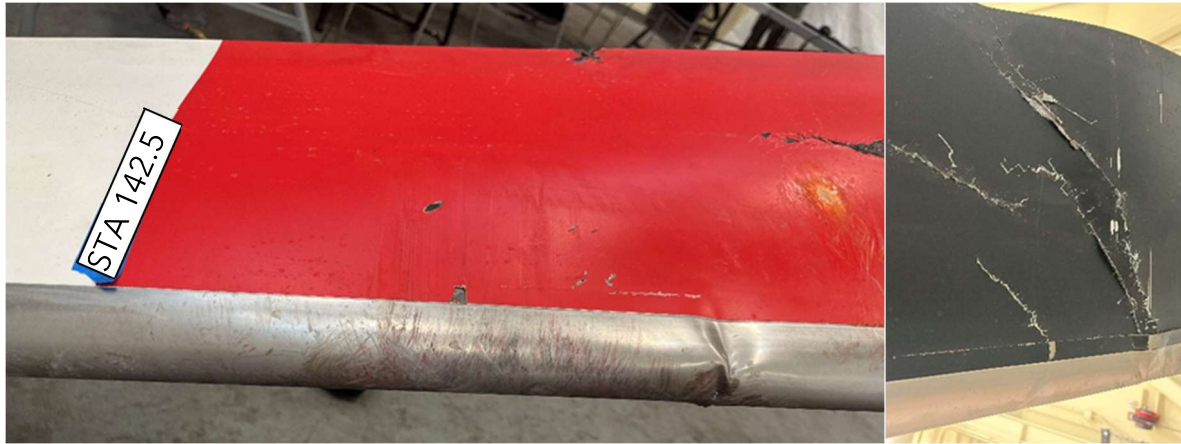
At red blade STA 128.5 there was deformation of the abrasion strip that extended to aft edge of the abrasion strip on the top and bottom skins (**figure 21**). The bottom skin fibers deformed and frayed chordwise along STA 128.5 towards the trailing edge. Starting at this station, there was an area of black, white and red paint transfer 21 inches wide (inboard to outboard) and was mostly contained to the abrasion strip, with some streaks extending to the trailing edge on the bottom skin and about 7 inches on the top skin.

**Figure 21.** Damage at STA 128.5 on the red main rotor blade.

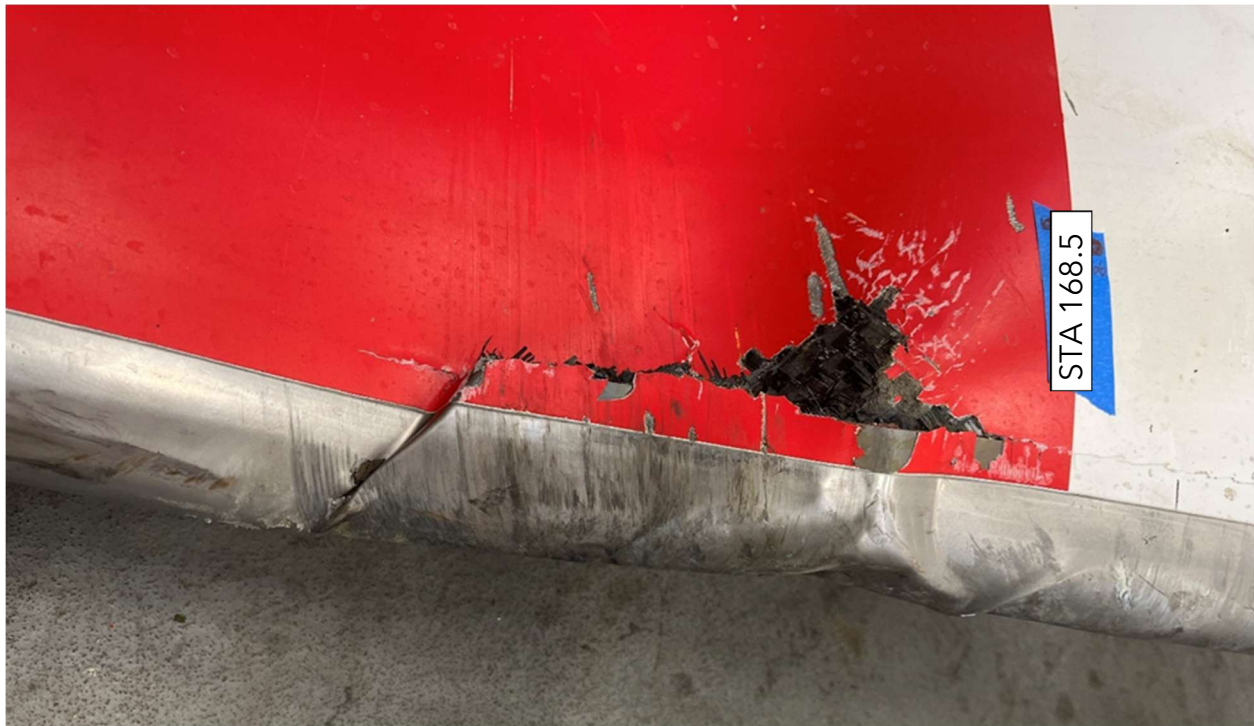
At red blade STA 163.5 there was an area of black and yellow-green paint transfer 5 inches wide (inboard to outboard) and was mostly contained to the abrasion strip top and bottom skins. Adjacent to the paint, starting at red blade STA 168.5 there was a dent about 9 inches wide and 0.5 inch deep into the leading edge (**figure 21**). The dent bent the blade in an s-shape downwards and then upwards. The abrasion strip disbonded on the top and bottom skins and fractured at the outboard edge of the dent. The abrasion strip at the s-shape bend had black paint transfer 9 inches wide (inboard to outboard) and was mostly contained to the abrasion strip with some streaks extending to the trailing edge on the bottom skin and about 7 inches on the top skin.

**Figure 22.** Damage at STA 168.5 on the red main rotor blade.

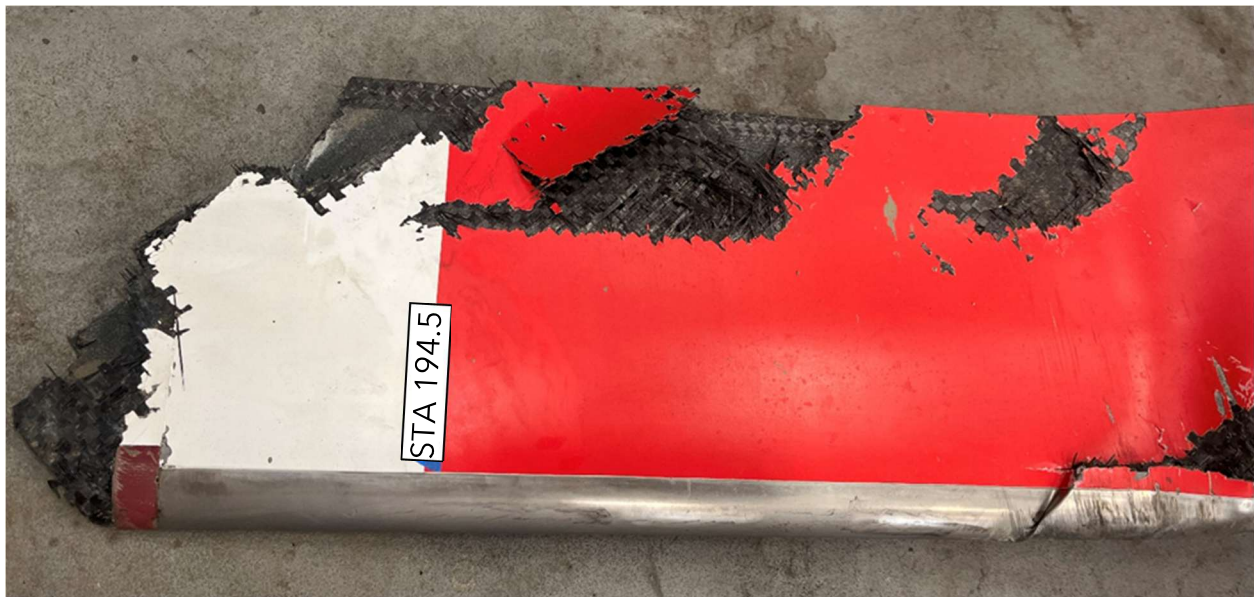
At red blade STA 201 there was abrasion strip damage from the leading edge to the trailing edge (**figure 23**). About 21 inches of the blade tip, including the tip abrasion strip, was not found. The trailing edge had significant fraying on the top skin from red blade STA 179.5 to the edge at red blade STA 201.

**Figure 23.** Damage at STA 194.5 on the red main rotor blade.

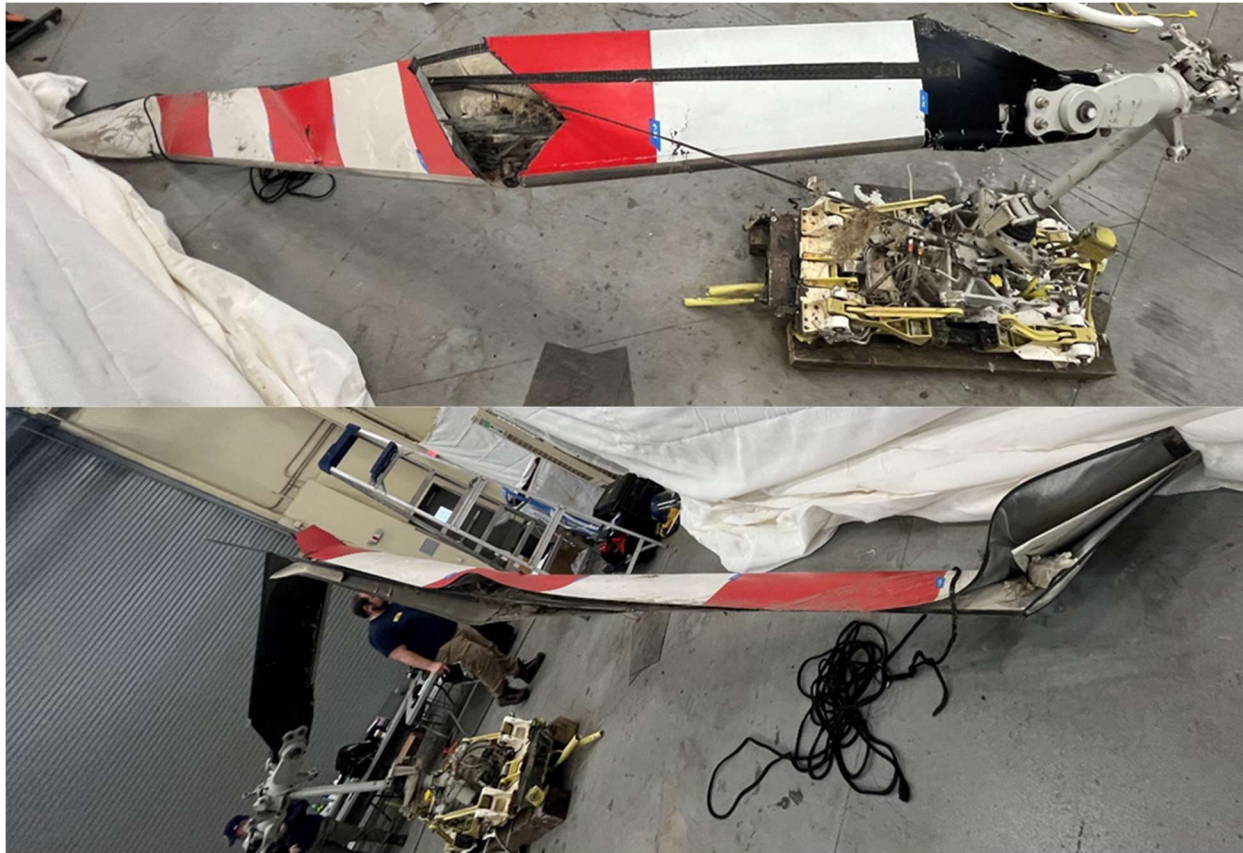
The blue blade data tag was not found on the blade. According to records, the main rotor blade was P/N 20633000-101 and S/N A303. The blue blade remained attached to the main rotor assembly but had partially fractured (**figure 24**). The full length of the trailing edge had separated, splitting the blade open spanwise, allowing some of the foam core to separate from the blade. The trailing edge strip was present.

**Figure 24.** The blue main rotor blade.

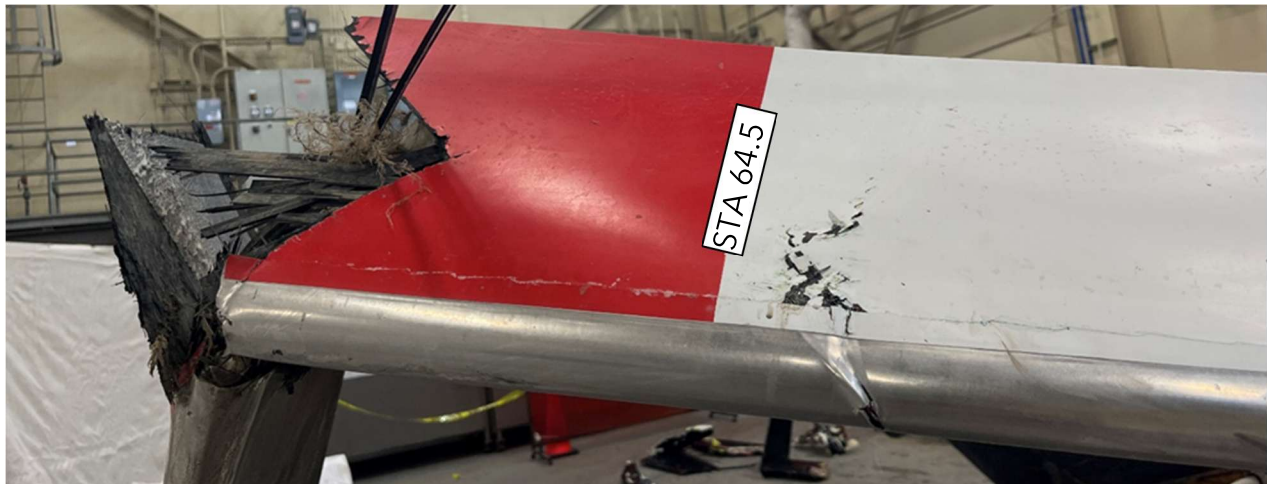
At blue blade STA 61.5 the abrasion strip was fractured and gouged (**figure 25**). The damage extended to the blade upper skin in an angle consistent with the outboard end of the double stack. The abrasion strip disbonded on the lower skin from the inboard end to blue blade STA 63.5.

**Figure 25.** Damage on the blue main rotor blade at STA 61.5.
