# National Transportation Safety Board

ERA25MA171

Group Chair's Factual Report

Location:     Jersey City, New Jersey  
Date:          April 10, 2025  
Time:          1515 eastern daylight time  
Helicopter:   Bell 206L-4, registration N216MH

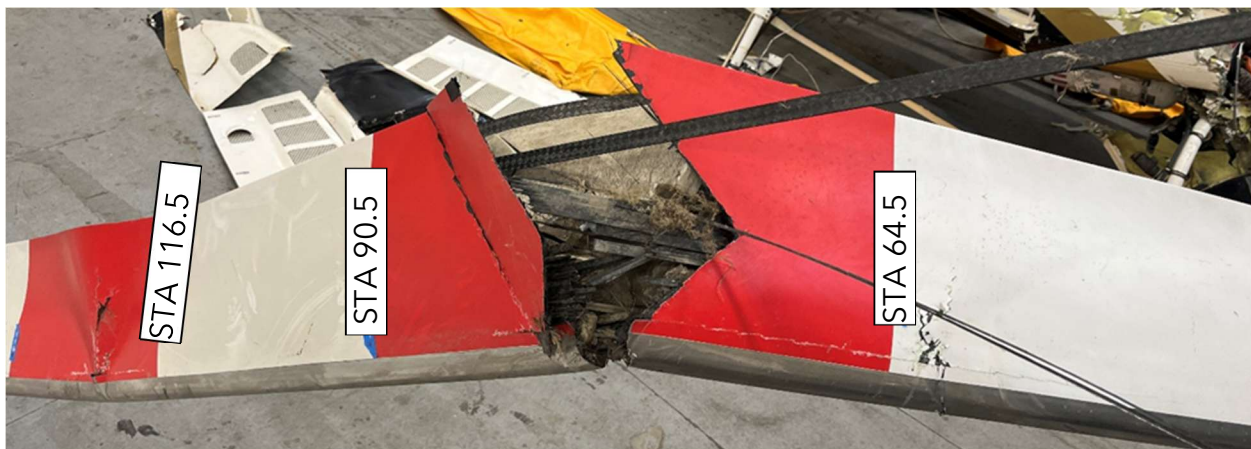
The blue blade partially fractured at STA 76 but remained attached by the bottom skin (**figure 26**). The fracture had an angle of 45° with respect to the abrasion strip outboard of the fracture and extended 6 inches toward the trailing edge where the fracture changed direction by 90° degrees outboard. The fracture maintained this direction until it reached the trailing edge. The top skin fibers deformed and frayed along the fracture.

**Figure 26.** Damage at STA 76 on the blue main rotor blade.

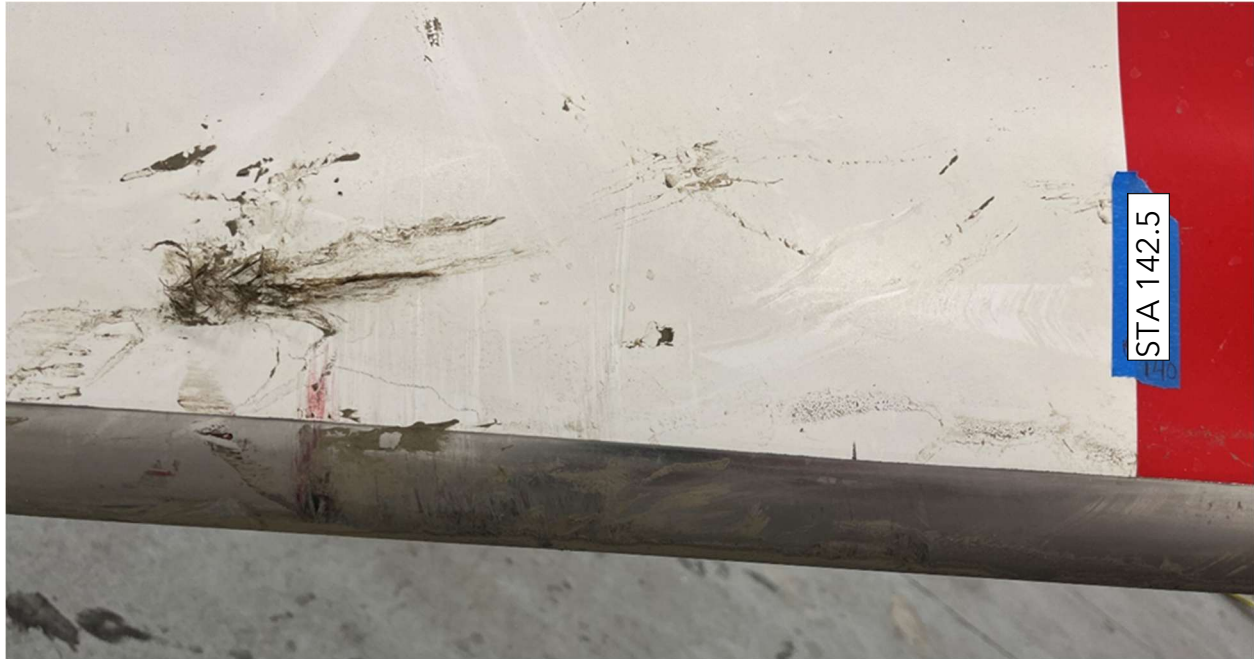
At blue blade STA 149.5 there was an area of black, white and red paint transfer 5 inches wide (inboard to outboard) that was mostly contained to the abrasion strip with some streak extending about 5 inches to the trailing edge on the top skin and to the trailing edge on the bottom skin (**figure 27**).

**Figure 27.** Damage at STA 149.5 on the blue main rotor blade.

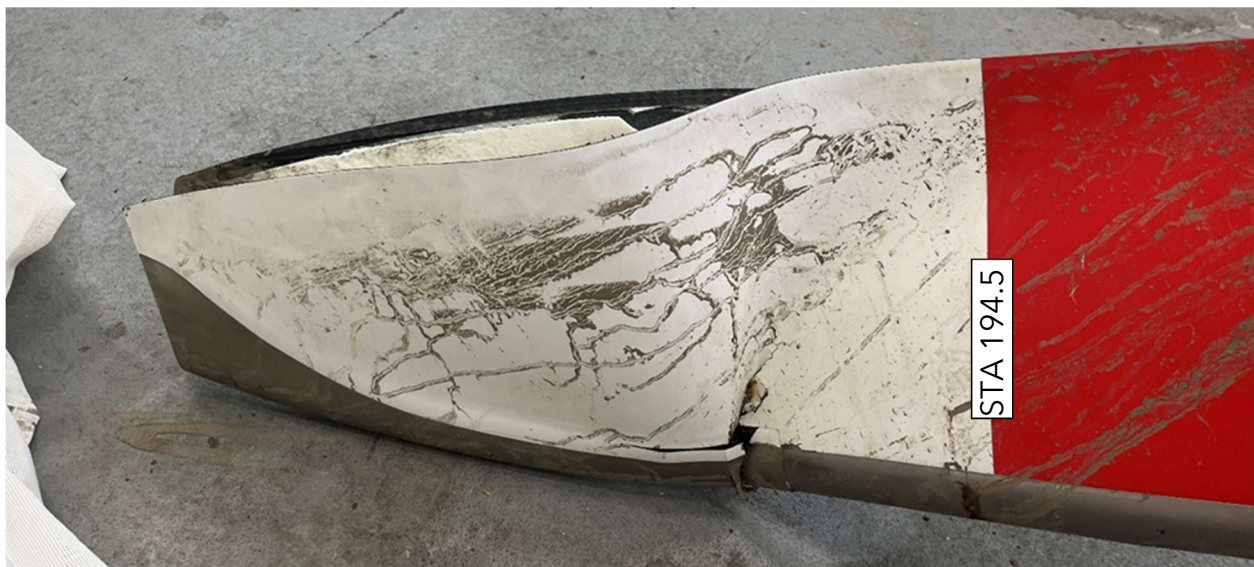
At blue blade STA 202.5 there was fracture and deformation of the abrasion strip that extended 7.5 inches to the trailing edge on the top skin and to the abrasion strip trailing edge on the bottom skin (**figure 28**).

**Figure 28.** Damage at STA 202.5 on the blue main rotor blade.

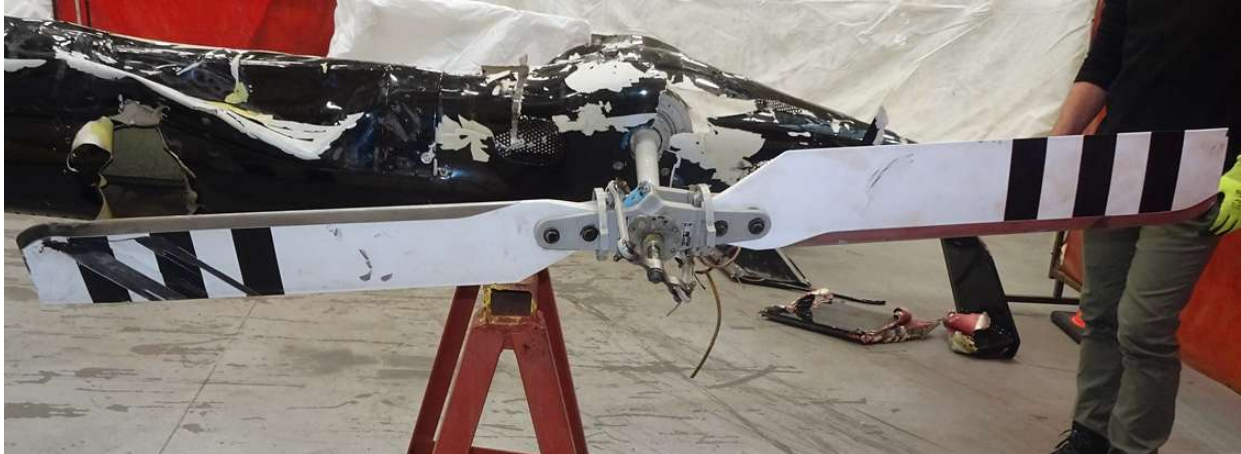
observed on the inboard end of tail rotor serial number F215. Tail rotor blade S/N F220 had a nick on the blade tip trailing edge and a gouge on the blade tip at the transition between the metal leading edge and composite blade. No other anomalous damage was observed on S/N.

**Figure 29.** Tail rotor blade S/Ns F215 (left) and F220 (right).

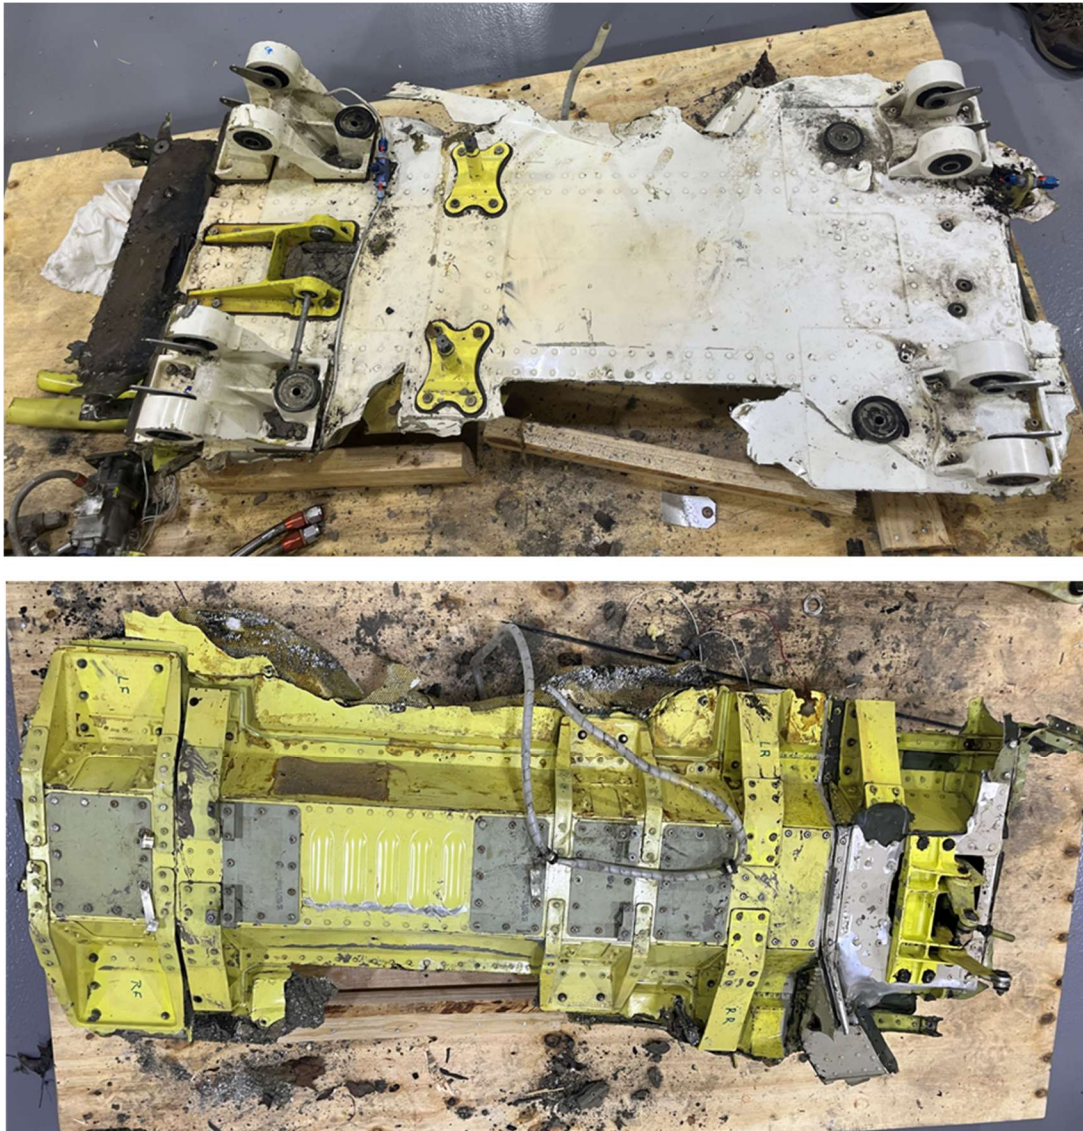
After teardown the roof structure, two repairs relating to the roof structure which were documented in the accident helicopter maintenance records, were identified by investigators. One of the repairs was determined to be outside of the recovered wreckage. The group examined the location of the other repair, specifically the roof upper skin between the cabin bulkhead and the aft bulkhead. There was no evidence of pre-existing cracks or anomalies associated with this repair.

**Figure 32.** The upper and lower surfaces of the roof structure.

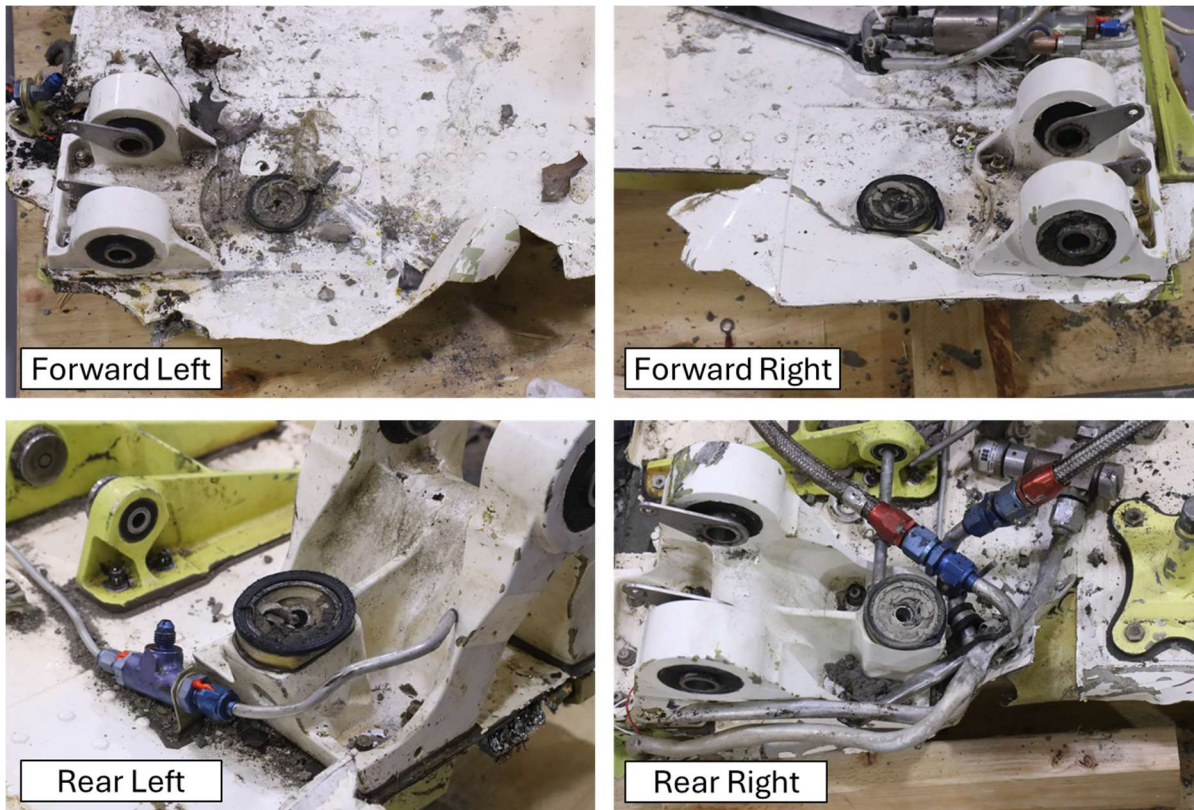
nodal beams had evidence of contact (**figure 33**). The forward right stop exhibited evidence of hard contact on the forward right quadrant and the rubber pad was broken. The rear right rubber pad was nicked.

**Figure 33.** The lower stops of the left and right nodal beams.

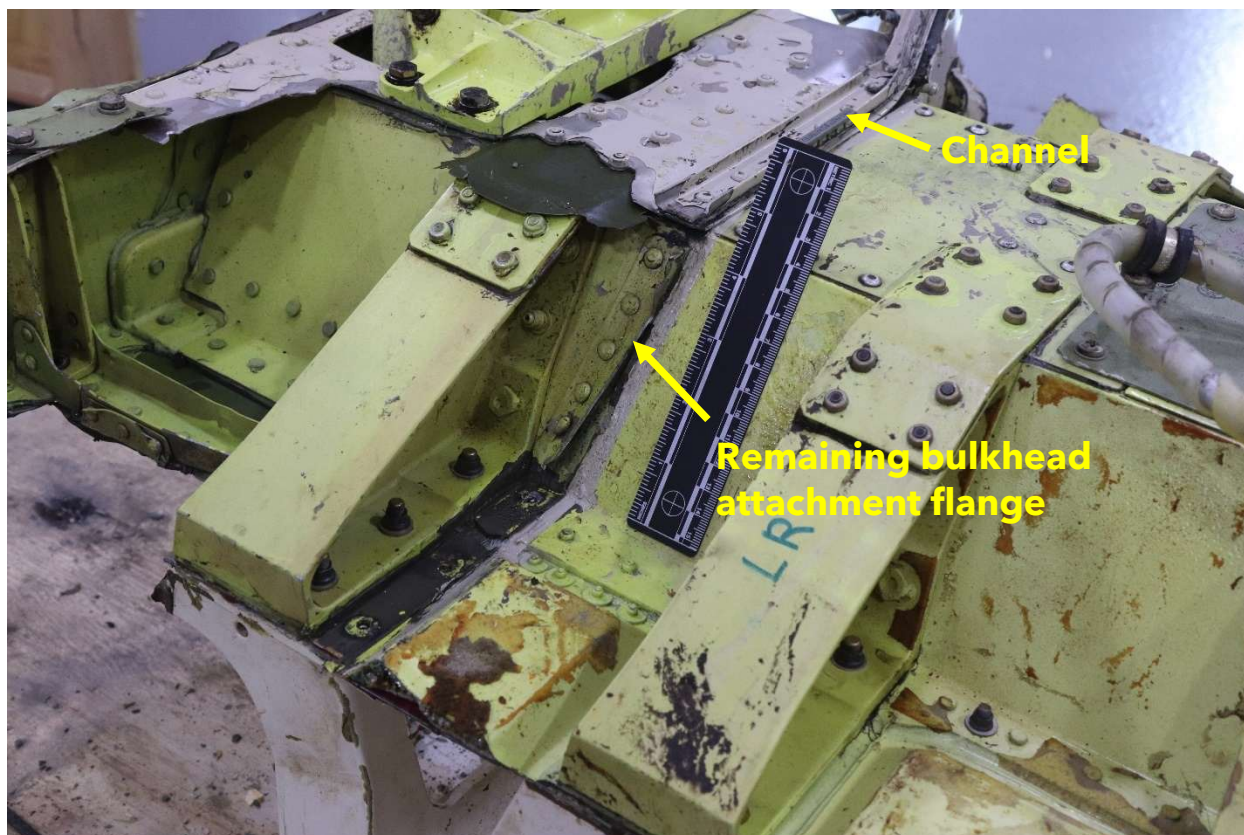
The fractured surfaces were visually inspected, and they had a dull, grainy appearance consistent with overstress fractures. The directionality of the fracture was consistent with initiation near the rear left side with final separation at the forward right side. The cabin bulkhead separated completely from the roof beam structure at the left rear side except for an attachment flange (**figure 34**). The channel at the cabin bulkhead station was fractured in downward bending.

**Figure 34.** Roof beam structure left rear side.

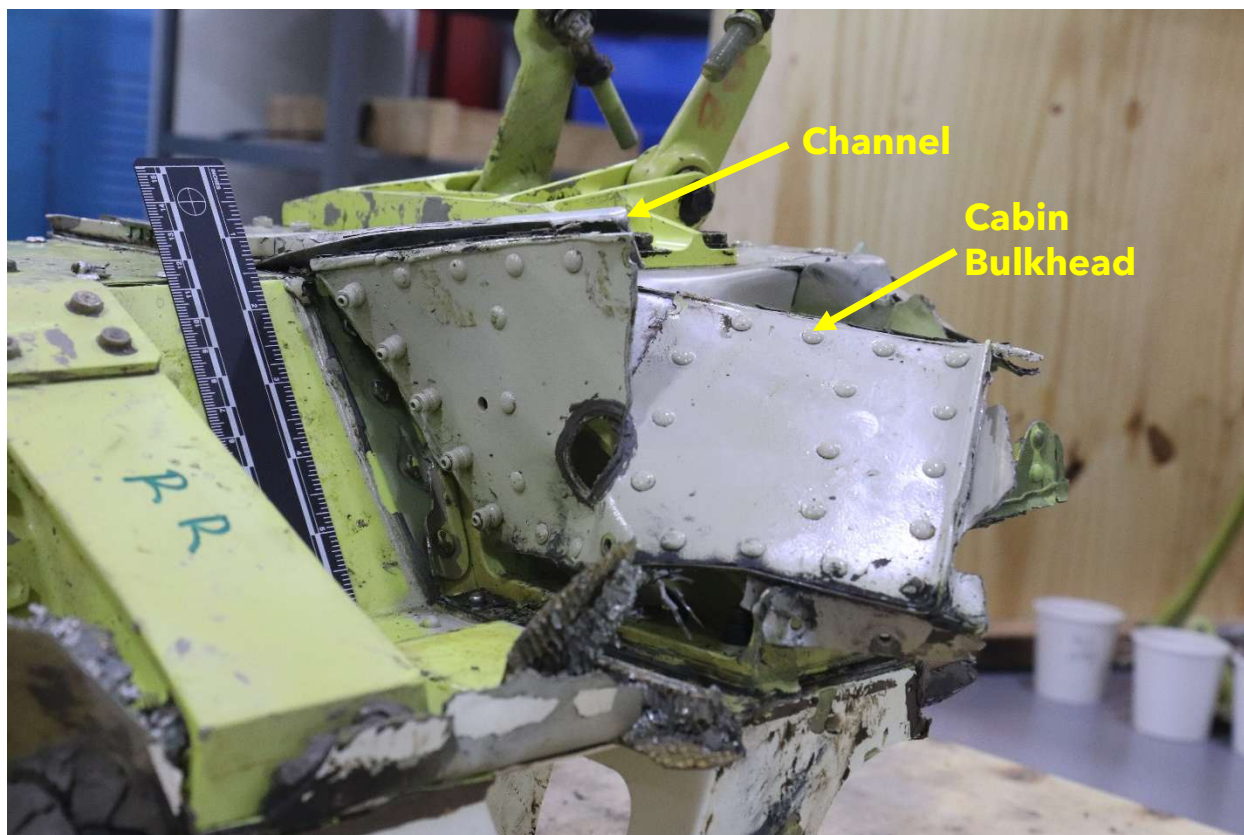
The cabin bulkhead on the right side separated from the roof and the side of the roof beam but remained attached to the channel. The channel remained attached to the bottom of the roof beam (**figure 35**). The channel was deformed in the downward and aft direction. All of the fractured rivets were examined and found to be consistent with tensile or shear overstress. The remaining attached bulkhead exhibited aft bending and torsion.

**Figure 35.** Roof beam structure right rear side.

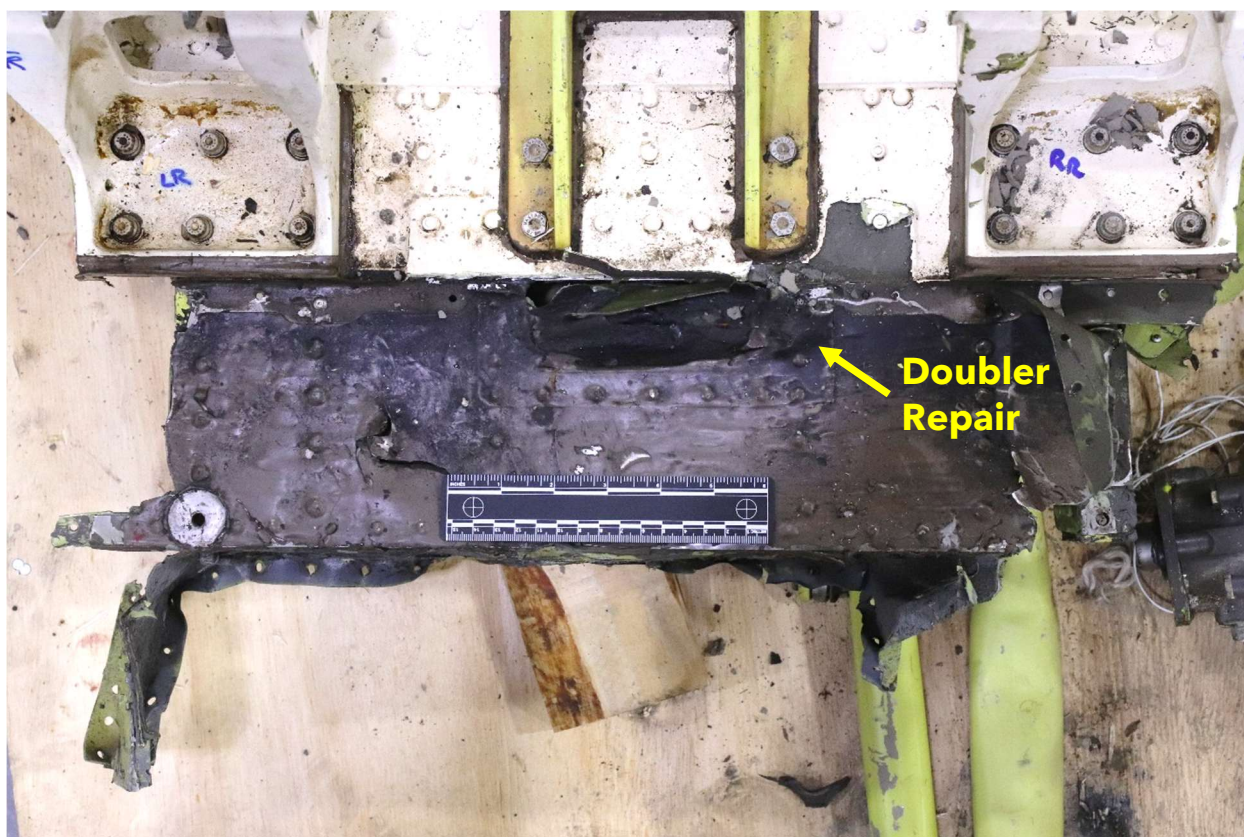
The remaining section of the aft bulkhead on the outboard ends of the roof beam assembly (both sides) were bent aft (**figure 36**). A doubler repair on the top skin of the aft bulkhead was located about centerline and was deformed downward.

**Figure 36.** Aft bulkhead deformation and the doubler repair.

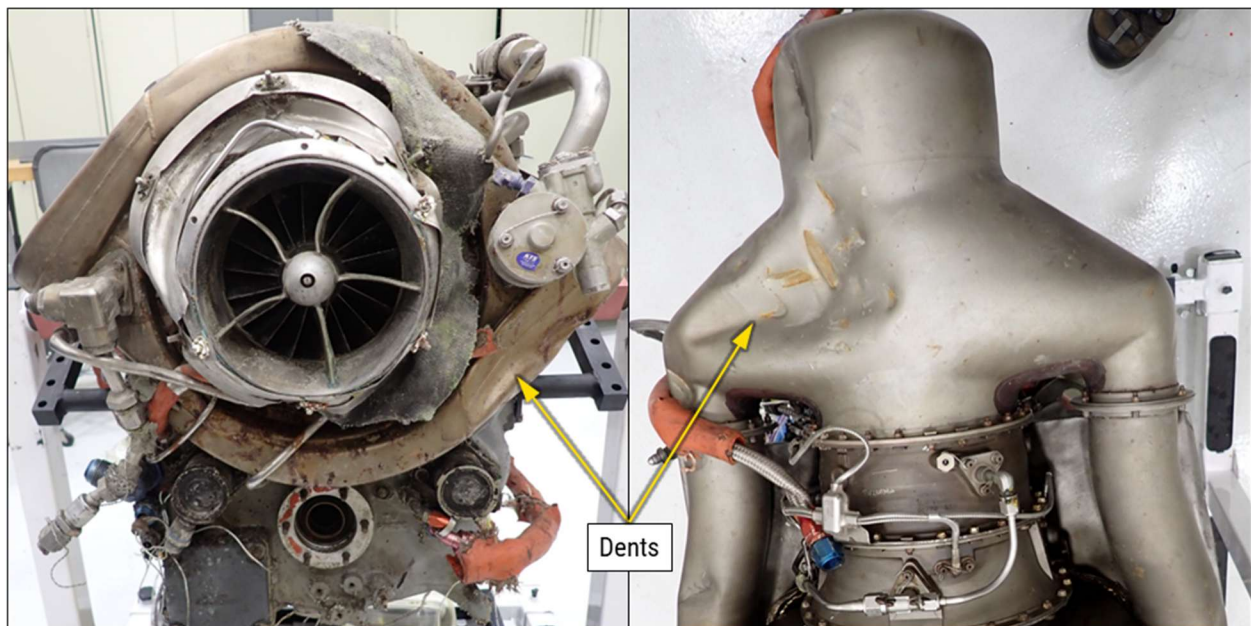
The top right and aft surfaces of the outer combustion case were dented. The forward side of the left scroll channel and both left and right compressor discharge air tubes were also dented. The compressor front support vanes were deformed. One inducer blade appeared bent when viewed through the front support. The compressor front assembly, an airframe component attached to the front support, was deformed around the front of the engine and had to be cut for removal. Earthen debris was found lodged between the front assembly and the engine (**figure 37**).

**Figure 37.** Dents in the left scroll channel (left) and outer combustion case (right)

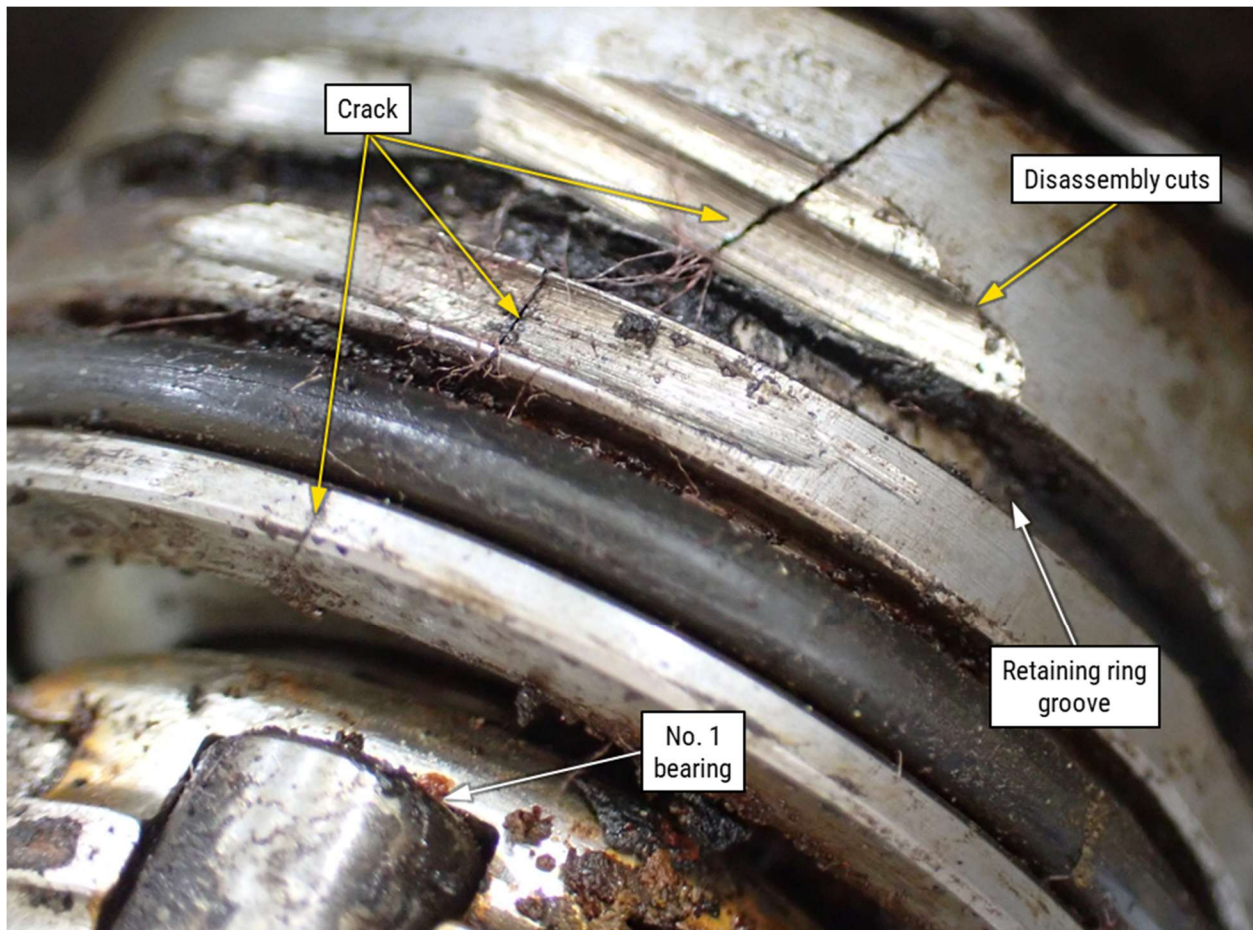
**Figure 42.** Cracked no. 1 bearing oil seal assembly
