# National Transportation Safety Board

ERA25MA171

## VIDEO STUDY

Description: Rotorcraft Inflight Breakup  
Location: Hudson River, Adjacent to Jersey City, NJ  
Date: April 10, 2025  
Time: 1515 Eastern Daylight Time (EDT)  
Operator: New York Helicopters Charter, Inc.  
Aircraft: Bell 206L-4, N216MH, Serial Number 52296

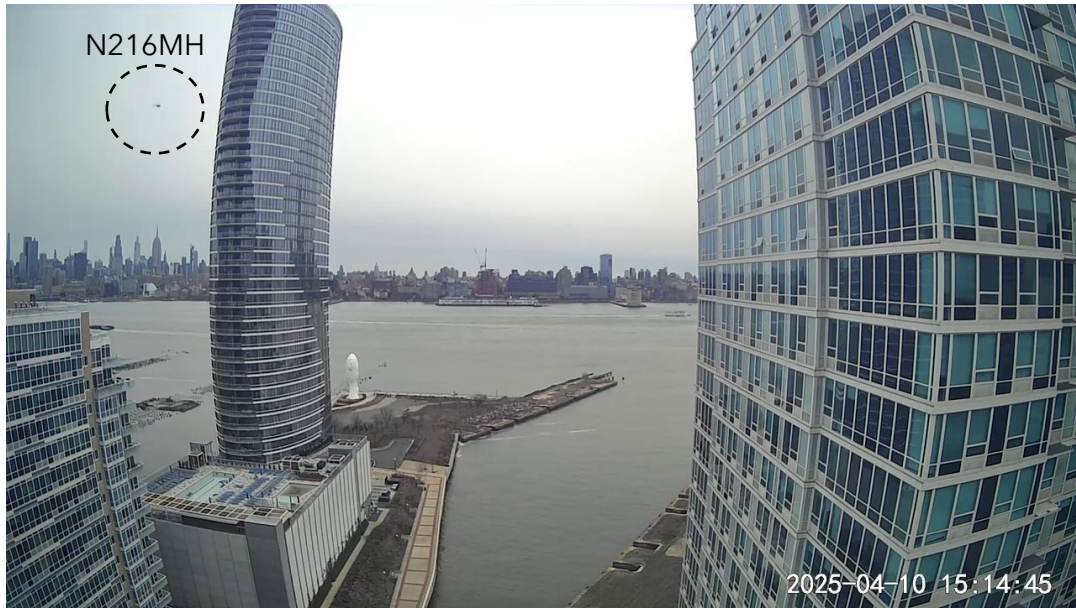
Figure 1: Exemplar N216MH image (1280x720 pixels, encoded date and time, as recorded distortion, 20 fps) extracted from source video 2CAA8EEFA70F20250411131652\_album\_local\_cache.mov. Helicopter direction of travel is left to right. The same source video was used to construct the cropped and zoomed image sequence content shown in Attachments 1-3.

The source video for Figure 1 and Attachments 1–3 was used to document the helicopter breakup sequence and timing. The results in Table 2 identify the primary events in chronological order, including the corresponding image sequence summary frame, video frame, video time in HH:MM:SS.00 format, delta time between events in seconds, and time calculation method. The data in Table 2 indicate that tail boom, main rotor, and fuselage separation were completed about 3.65 seconds after the initial tail boom rotation event.

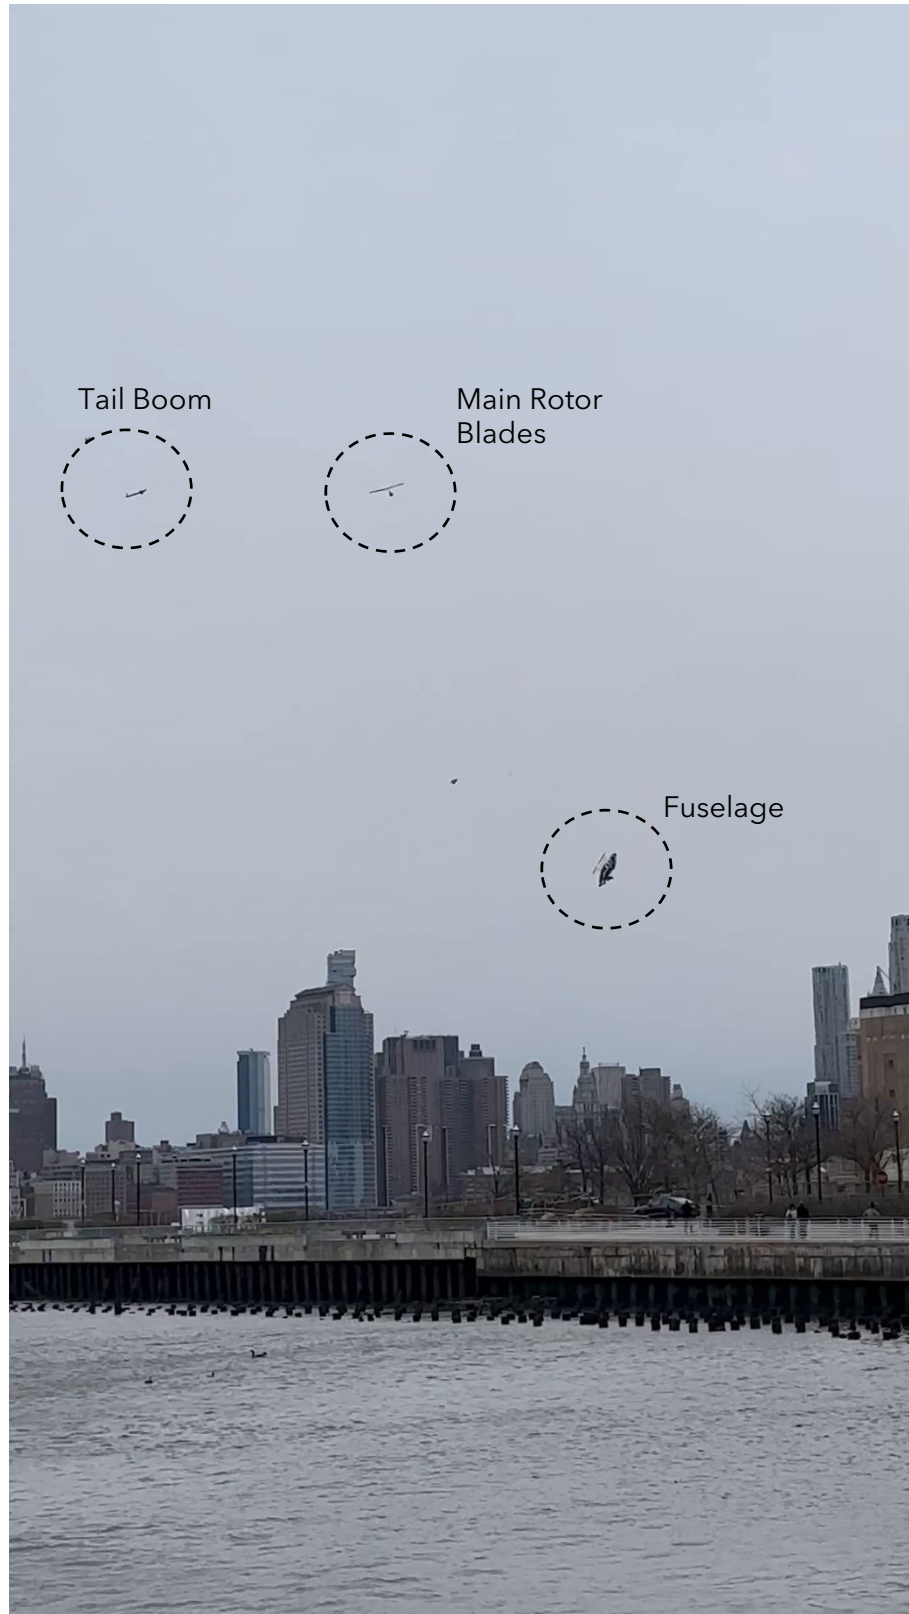
Figure 3: Exemplar N216MH fuselage, main rotor blades, and tail boom image (2160x 3840 pixels, 30 fps) extracted from source video IMG\_0243.MOV. The same source video was used to construct the cropped and zoomed image sequence content shown in Attachments 5 and 6.

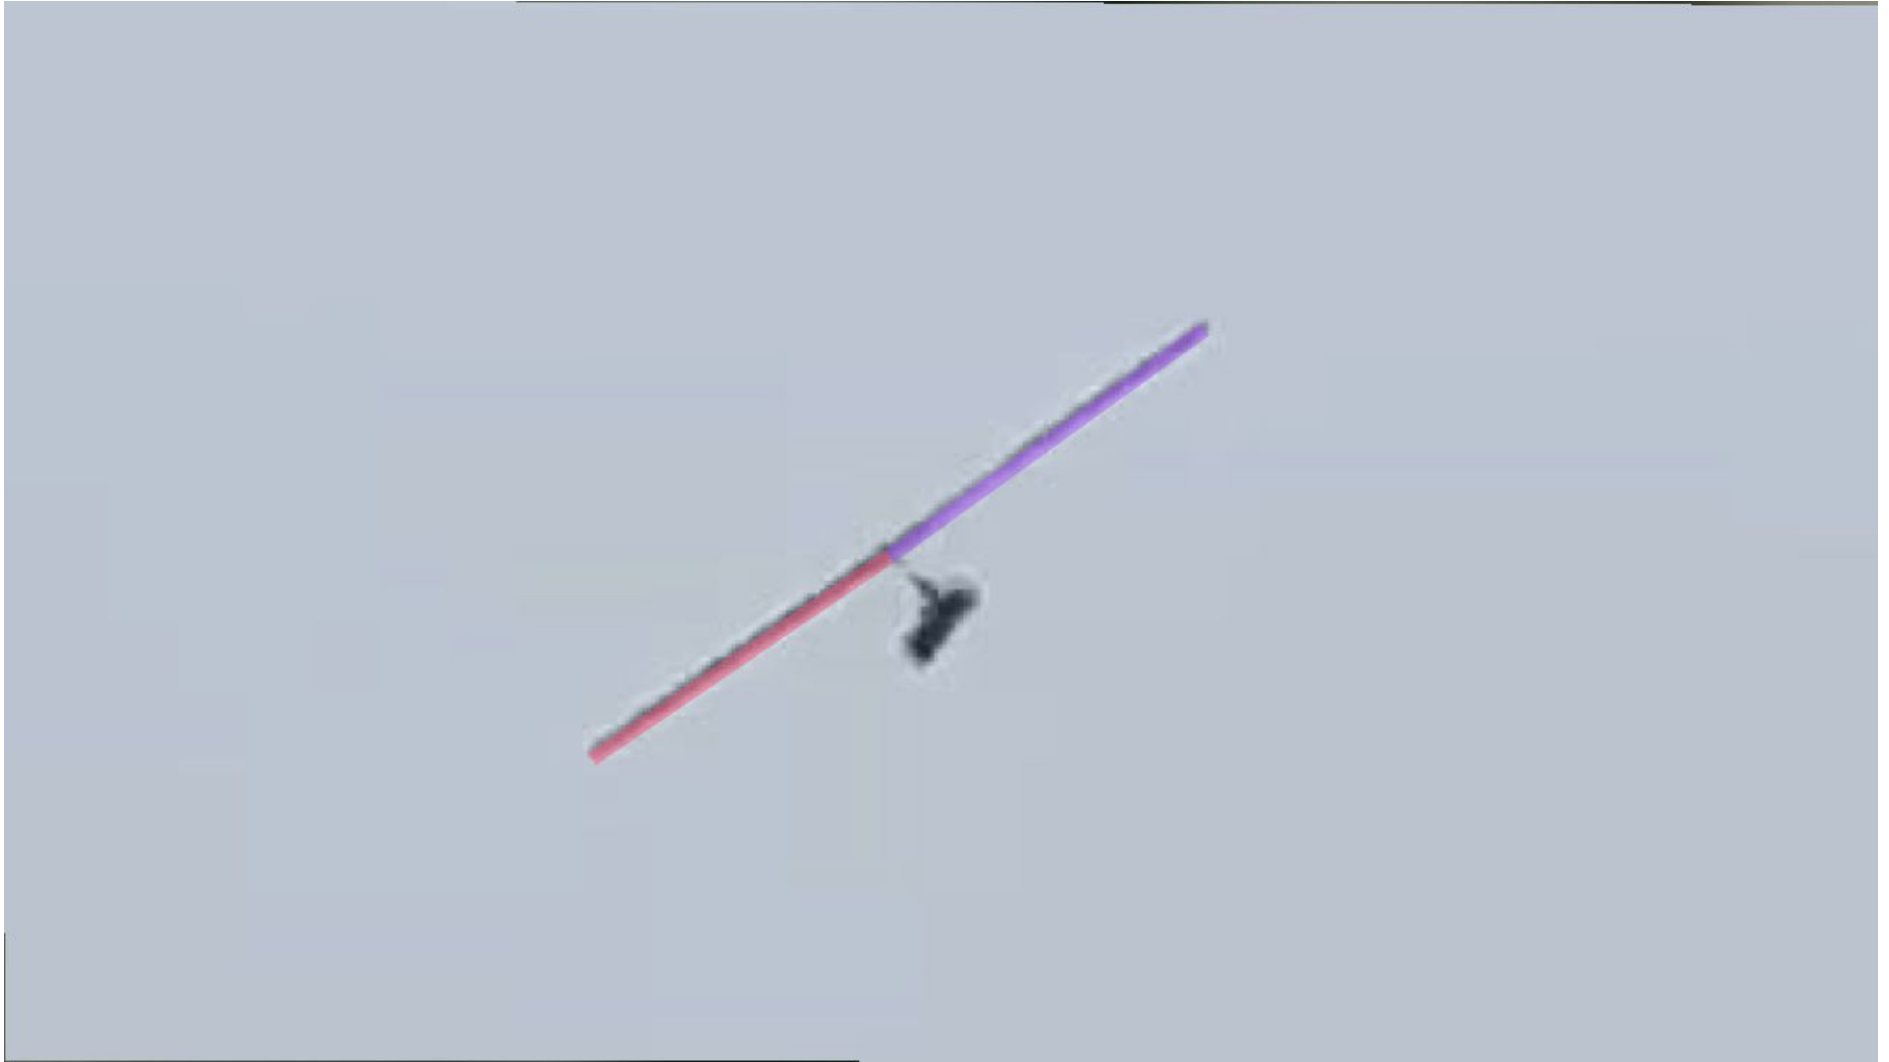
The NTSB *Airworthiness Group Chair's Factual Report* documents a missing main rotor blade tip length of about 21 inches. The nominal main rotor blade radius was assumed to be 18.5 feet. The source video for Figure 3 and Attachments 5–6 was used to track the descent path of the main rotor blades and extract frames when 1) both apparent main rotor blade tips were visible and 2) the main rotor blades were most closely aligned to the image plane. Image blade content was measured in the three image subsets shown in Figures 6–8 (which correspond to Attachment 5 frames 29, 33, and 37). The source video evidence and measurement data in Table 3 indicate that the two main rotor blade length estimates were consistently unequal prior to water impact, with the shorter blade length estimate varying between 16.3 and 19.3 inches less than the longer blade length.

| Frame & Figure # | Left Blade units | Right Blade units | max(L,R)/18.5 ratio | min(L,R)/max ratio<br>Shorter blade length feet | 18.5-min_value<br>Est. missing tip feet | 18.5-min_value<br>Est. missing tip inches |
|---|---|---|---|---|---|---|
| 29 / 6 | 9670 | 10434 | 564.0 | 17.15 | 1.35 | 16.26 |

Figure 6: Exemplar frame 29 image subset showing N216MH main rotor blade (zoomed in and cropped from original 2160x3840 pixel image source) annotated with red and purple lines to estimate respective blade lengths.

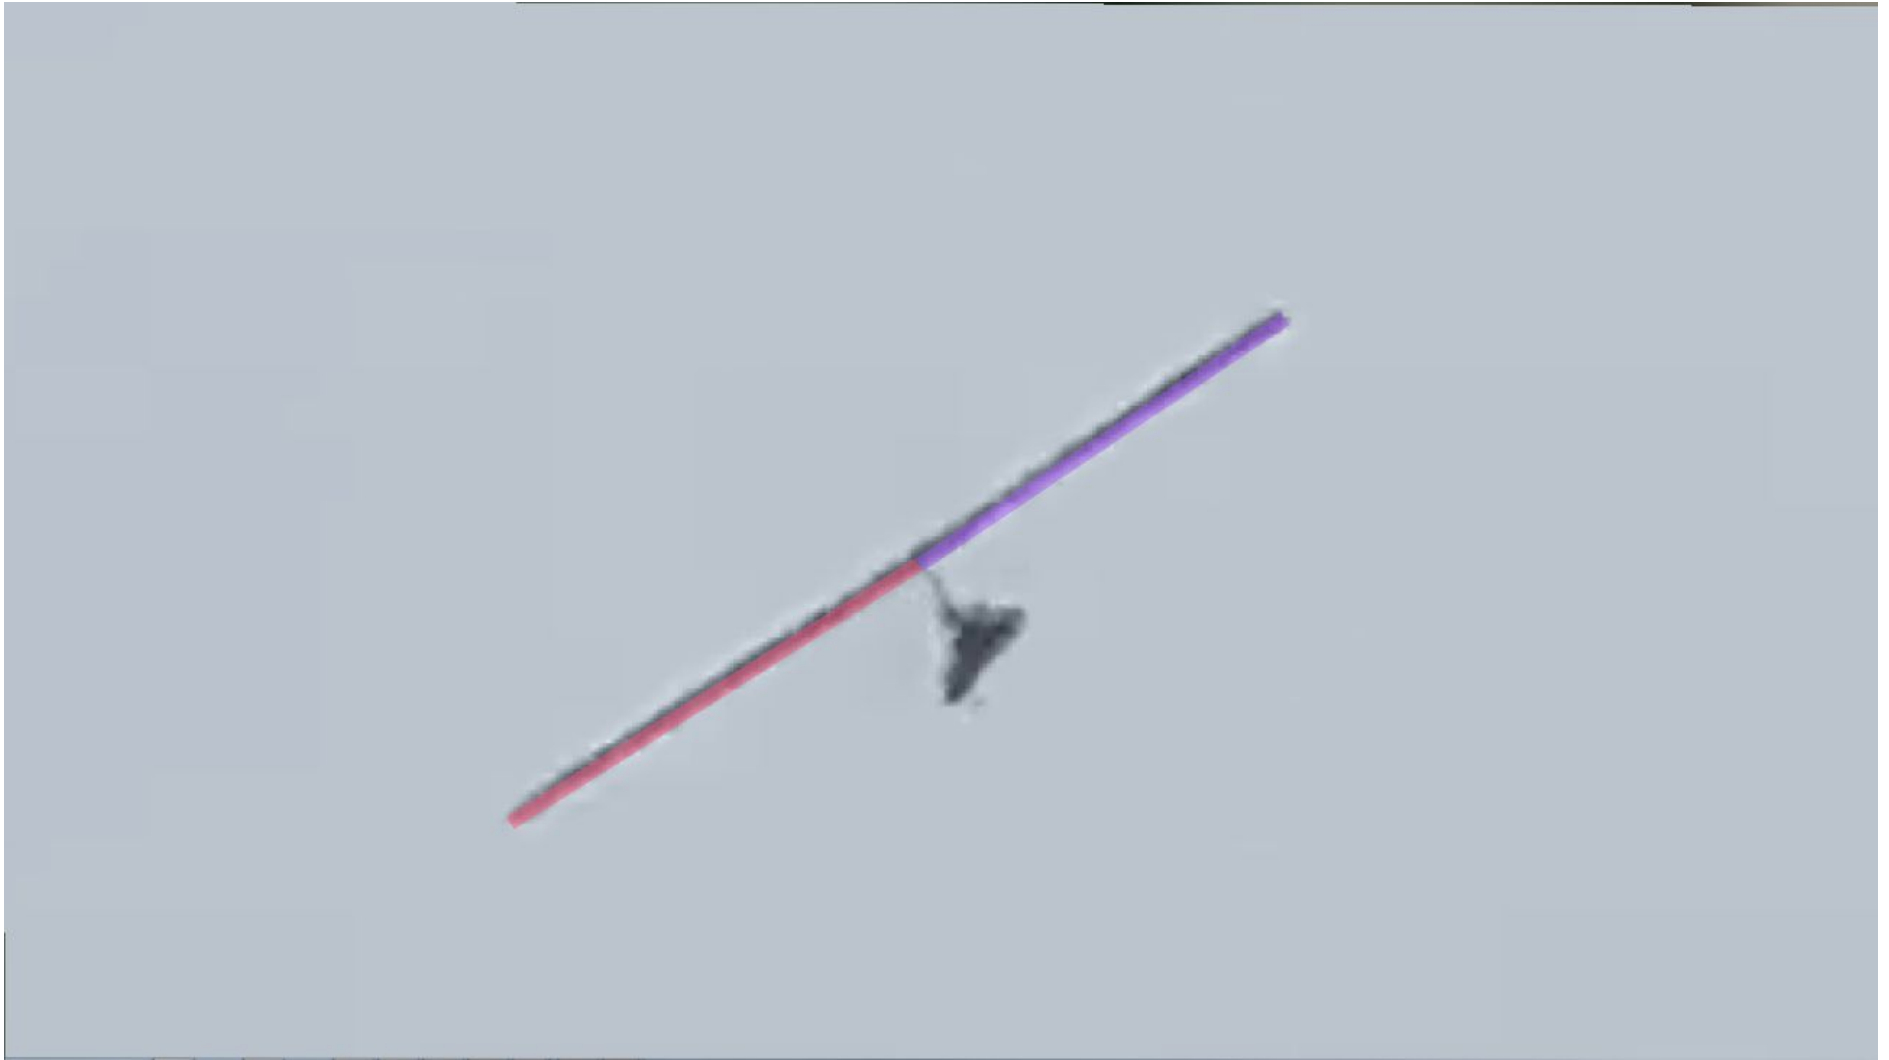
| Frame & Figure # | Left Blade units | Right Blade units | max(L,R)/18.5 ratio | min(L,R)/max ratio<br>Shorter blade length feet | 18.5-min_value<br>Est. missing tip feet | 18.5-min_value<br>Est. missing tip inches |
|---|---|---|---|---|---|---|
| 33 / 7 | 12966 | 11837 | 700.9 | 16.89 | 1.61 | 19.33 |

Figure 7: Exemplar frame 33 image subset showing N216MH main rotor blade (zoomed in and cropped from original 2160x3840 pixel image source) annotated with red and purple lines to estimate respective blade lengths.

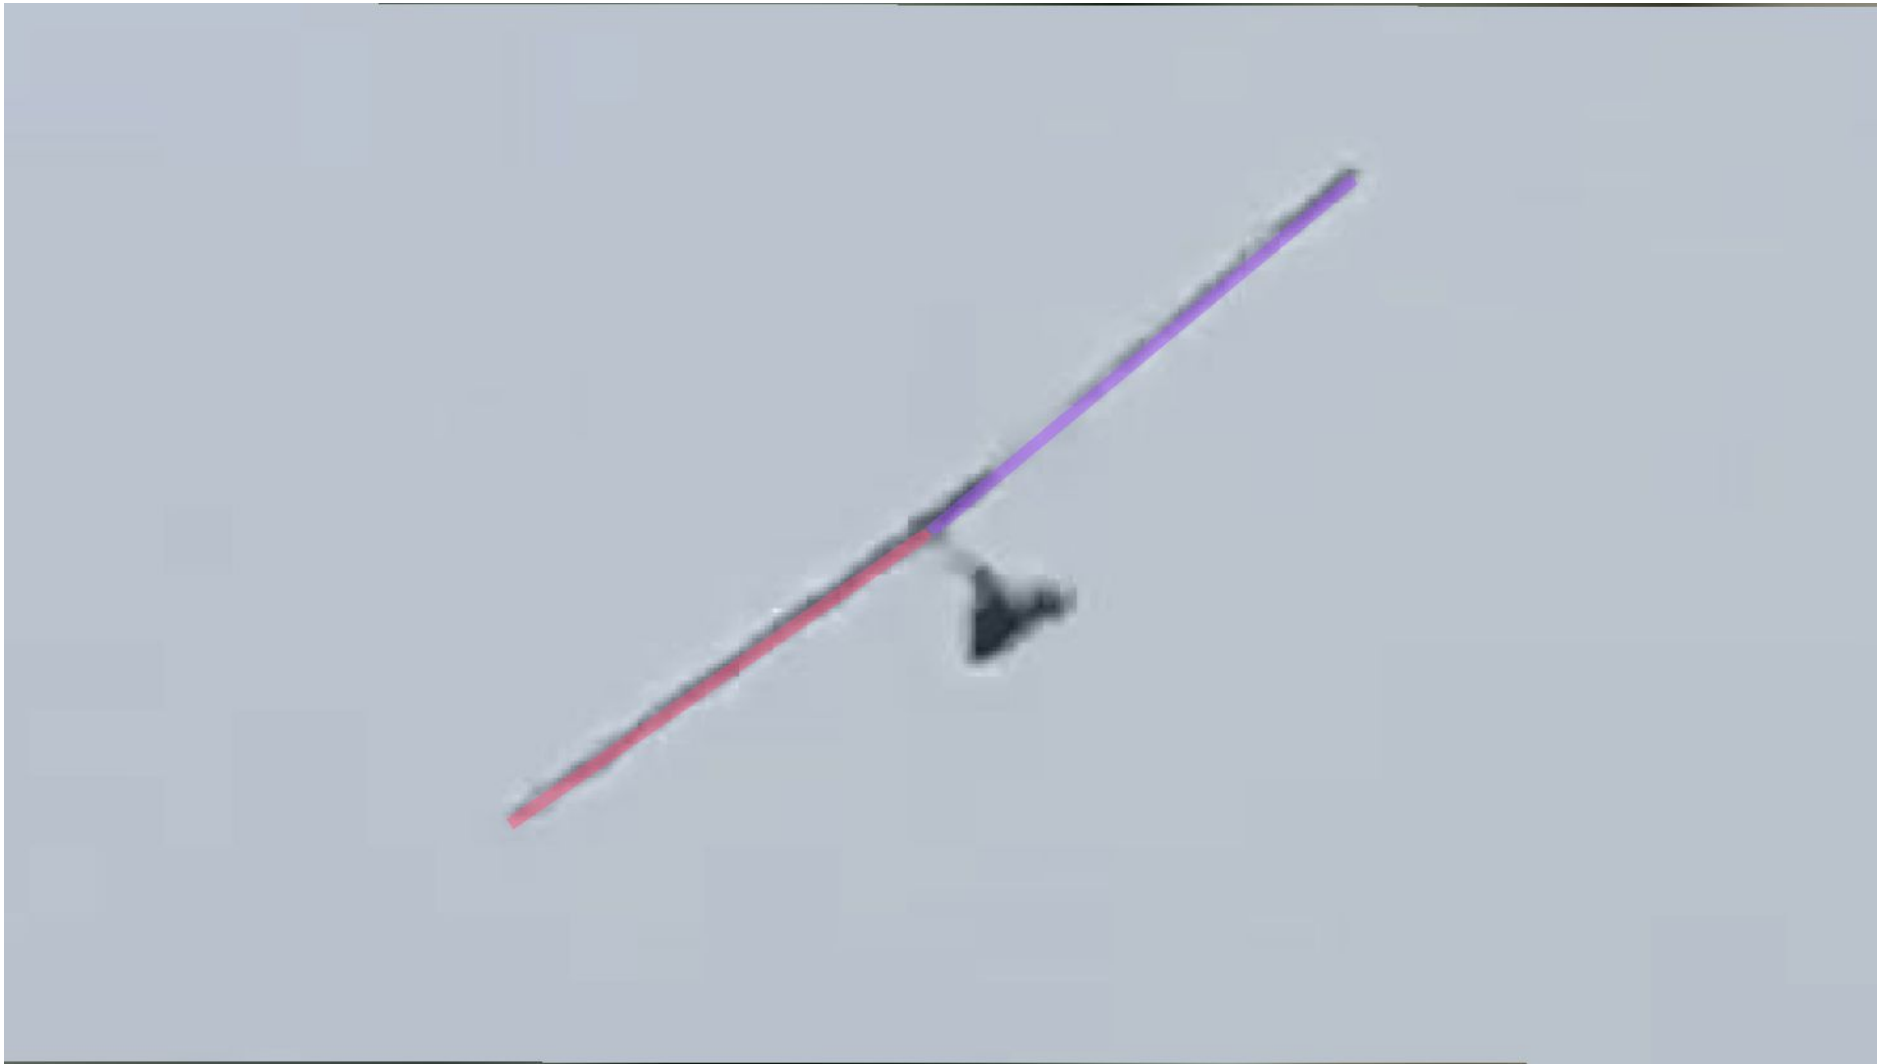
| Frame & Figure # | Left Blade units | Right Blade units | max(L,R)/18.5 ratio | min(L,R)/max ratio<br>Shorter blade length feet | 18.5-min_value<br>Est. missing tip feet | 18.5-min_value<br>Est. missing tip inches |
|---|---|---|---|---|---|---|
| 37 / 8 | 13692 | 14818 | 801.0 | 17.09 | 1.41 | 16.87 |

Figure 8: Exemplar frame 37 image subset showing N216MH main rotor blade (zoomed in and cropped from original 2160x3840 pixel image source) annotated with red and purple lines to estimate respective blade lengths.

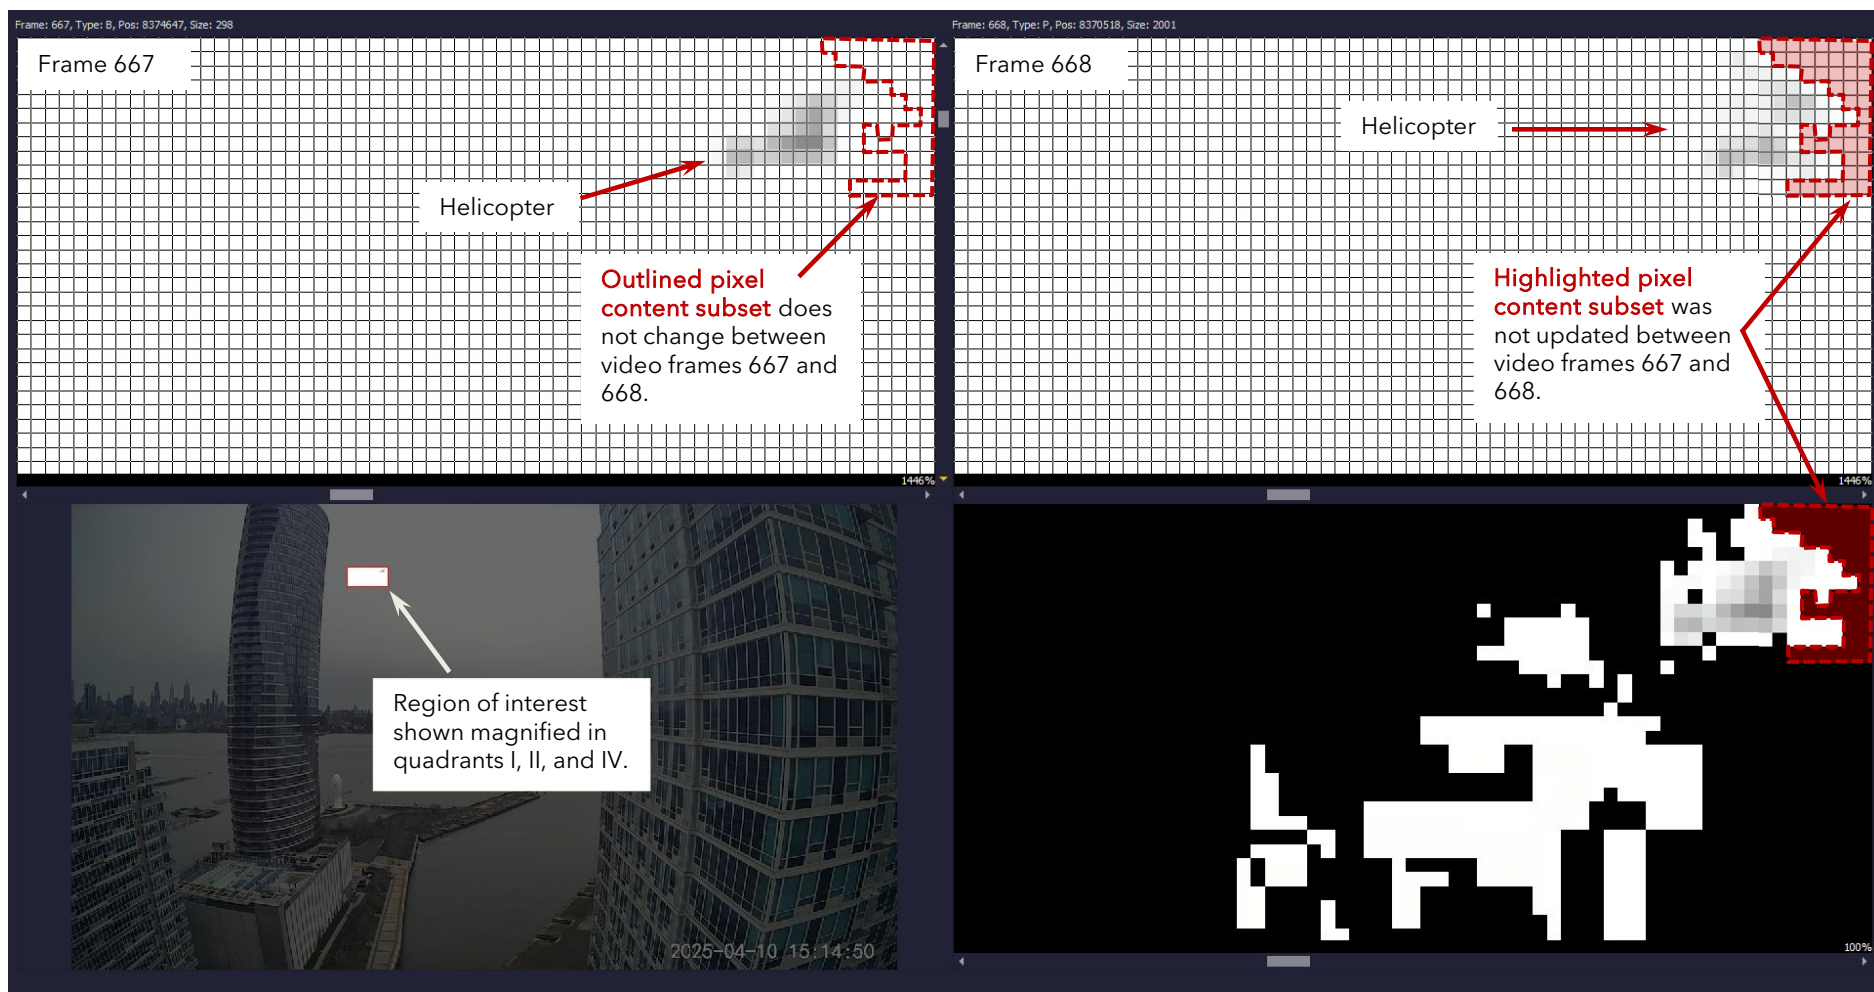
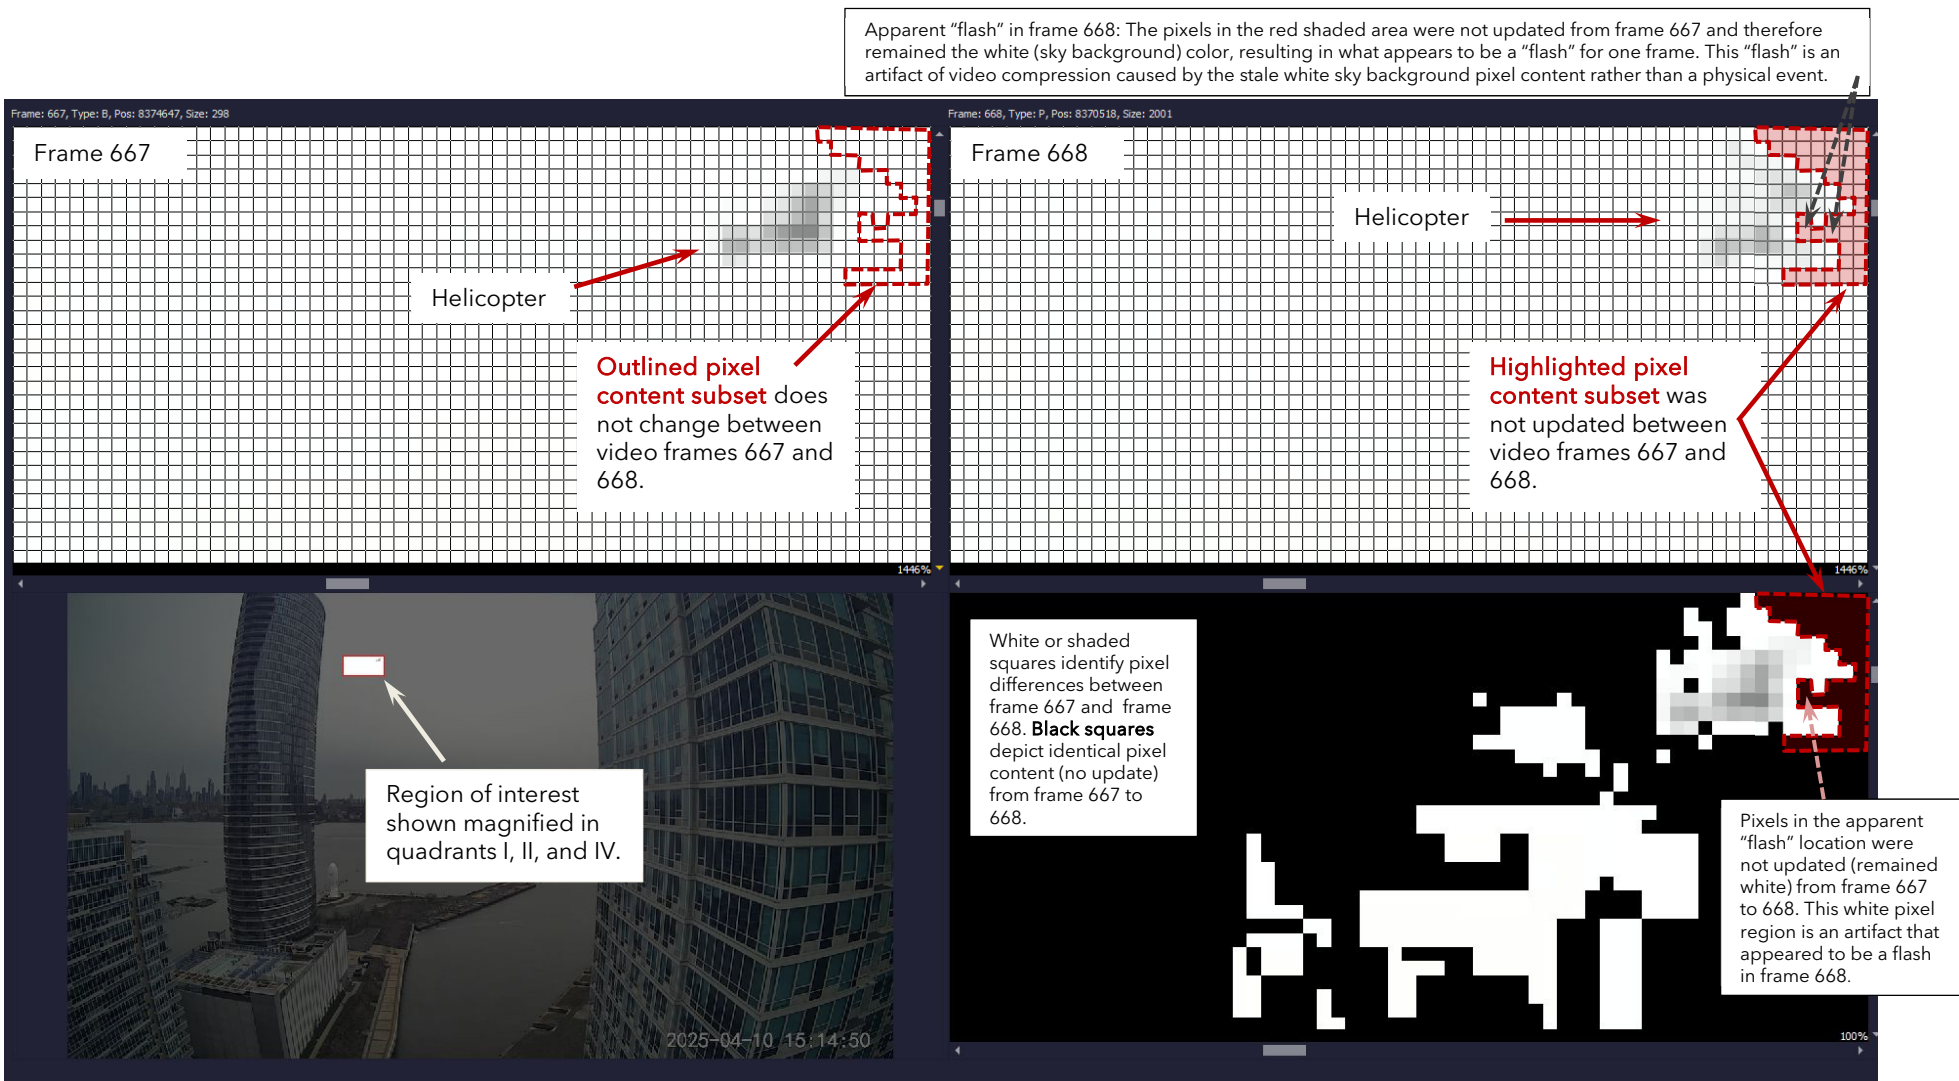
Video content in frames 667 and 668 are compared in Figures 9 and 10. Frame 667 is shown in the lower left with a zoomed in subset of frame 667 content (upper left) compared to a zoomed in subset of video frame 668 content (upper right). Frame content differences are shown in the lower right pane. Black pixels in the lower right region identify pixel content that is identical between the adjacent video frames. The frame 668 pixel content mapping to the candidate “flash of light” is the result of stale (not updated) white sky background pixel content outlined in red (upper left) and shaded in red (upper right) carried over from video frame 667 to video frame 668.

In summary, the apparent “flash of light” in frame 668 is due to pixels in the red shaded area that were not updated from frame 667 and therefore remained the white (sky background) color, resulting in what appears to be a “flash of light” for one frame. This “flash of light” is an artifact of video compression caused by the stale (not updated) white sky background pixel content rather than a physical event.

Figure 9: Exemplar video frame 667 image (lower left) with zoomed in subset (upper left) compared to zoomed in subset of video frame 668 content (upper right) and content update differences (lower right). Black pixels in the lower right region identify pixel content that was not updated between adjacent video frames. The frame 668 pixel content mapping to the candidate "flash of light" is the result of stale (not updated) white sky background pixel content outlined in red (upper left) and shaded in red (upper right) carried over from video frame 667 to video frame 668.

Figure 10: Exemplar video frame 667 image (lower left) with zoomed in subset (upper left) compared to zoomed in subset of video frame 668 content (upper right) and content update differences (lower right). Black pixels in the lower right region identify pixel content that was not updated between adjacent video frames. The frame 668 pixel content mapping to the candidate "flash of light" is the result of stale (not updated) white sky background pixel content outlined in red (upper left) and shaded in red (upper right) carried over from video frame 667 to video frame 668

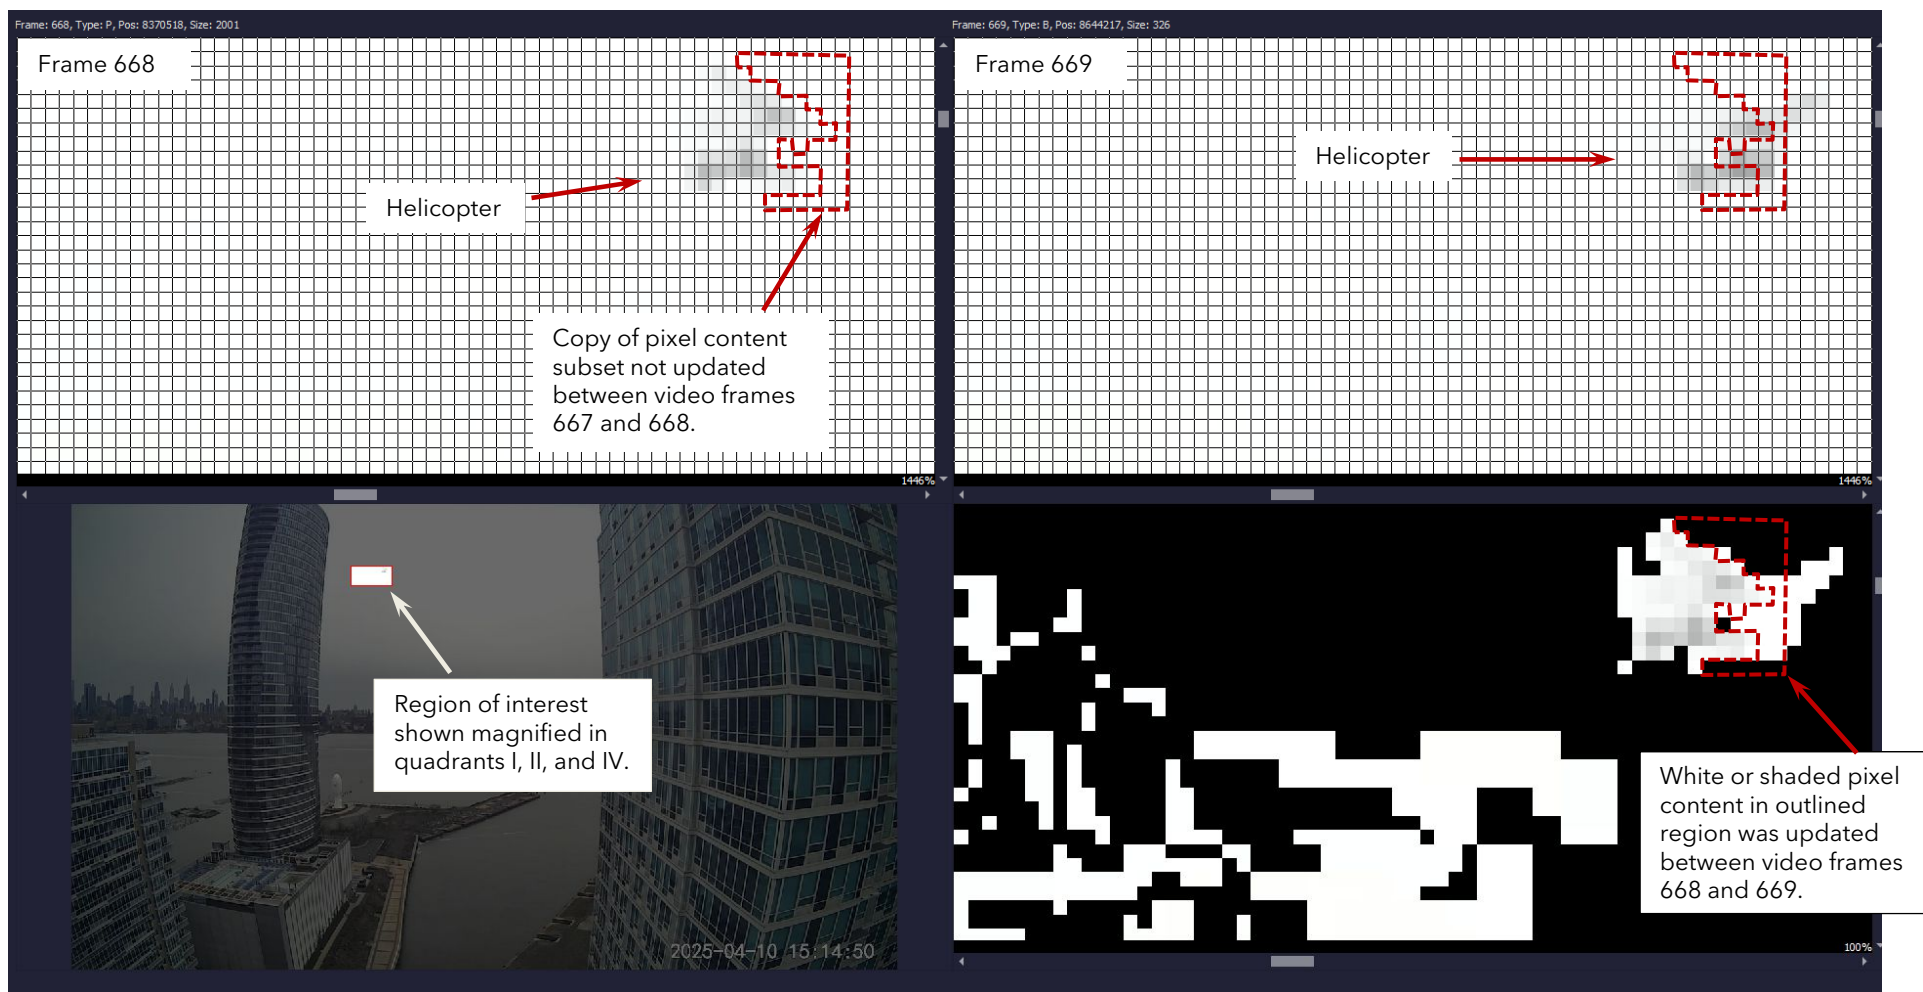
Similarly, video content in frames 668 and 669 are compared in Figure 11. Frame 668 is shown in the lower left with a zoomed in subset of frame 668 content (upper left) compared to a zoomed in subset of video frame 669 content (upper right). Frame content differences are shown in the lower right pane. Black pixels in the lower right region identify pixel content that is identical between the adjacent video frames. The frame 668 stale pixel content mapping to the candidate “flash of light” is updated in video frame 669.

Figure 11: Exemplar video frame 668 image (lower left) with zoomed in subset (upper left) compared to zoomed in subset of video frame 669 content (upper right) and content update differences (lower right). Black pixels in the lower right region identify pixel content that was not updated between adjacent video frames. The frame 668 stale pixel content mapping to the candidate “flash of light” is updated in video frame 669.

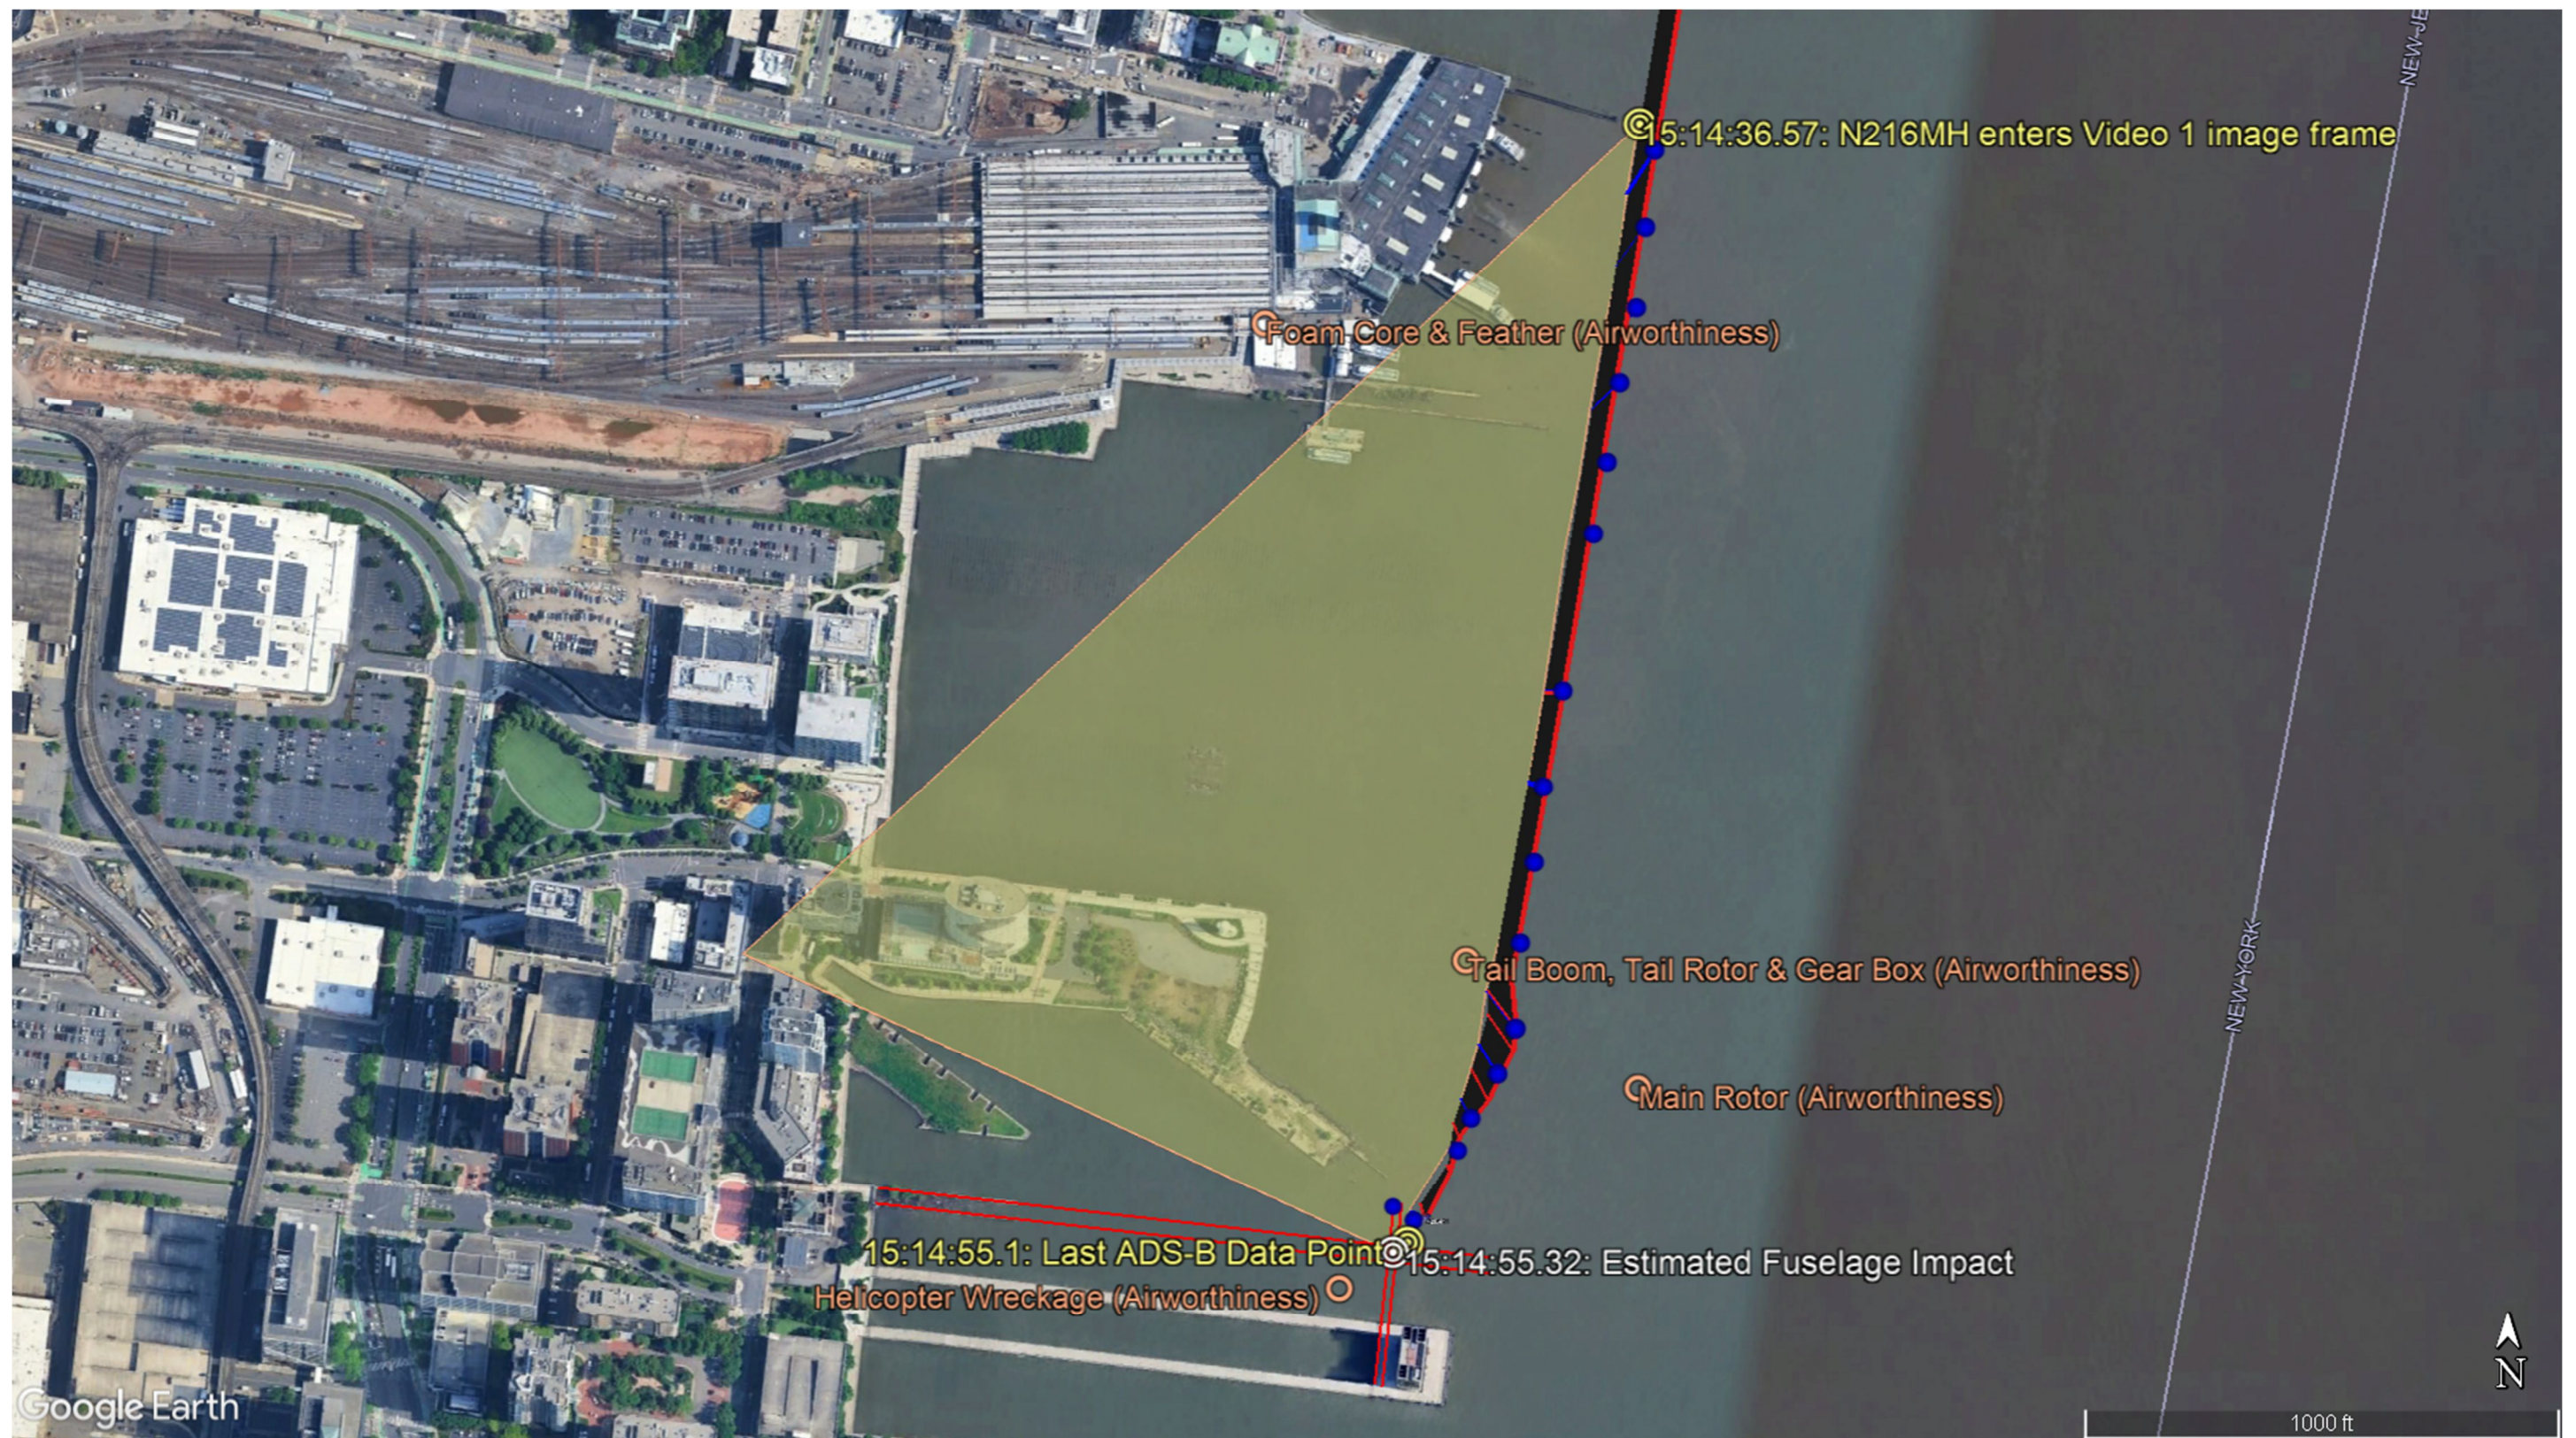
Figure 12: Planform view showing N216MH flight path, ground track, time alignment (with Video 1, Figure1, and Attachment 1-3 content), and helicopter fuselage, main rotor, and tail boom component recovery locations. The helicopter direction of travel was North (top of page) to South. The length of the yellow shaded region adjacent to the ground track corresponds to 18.75 seconds of flight time prior to fuselage water impact.
