# National Transportation Safety Board

ERA25MA171

## **STRUCTURES**

Group Chair's Factual Report

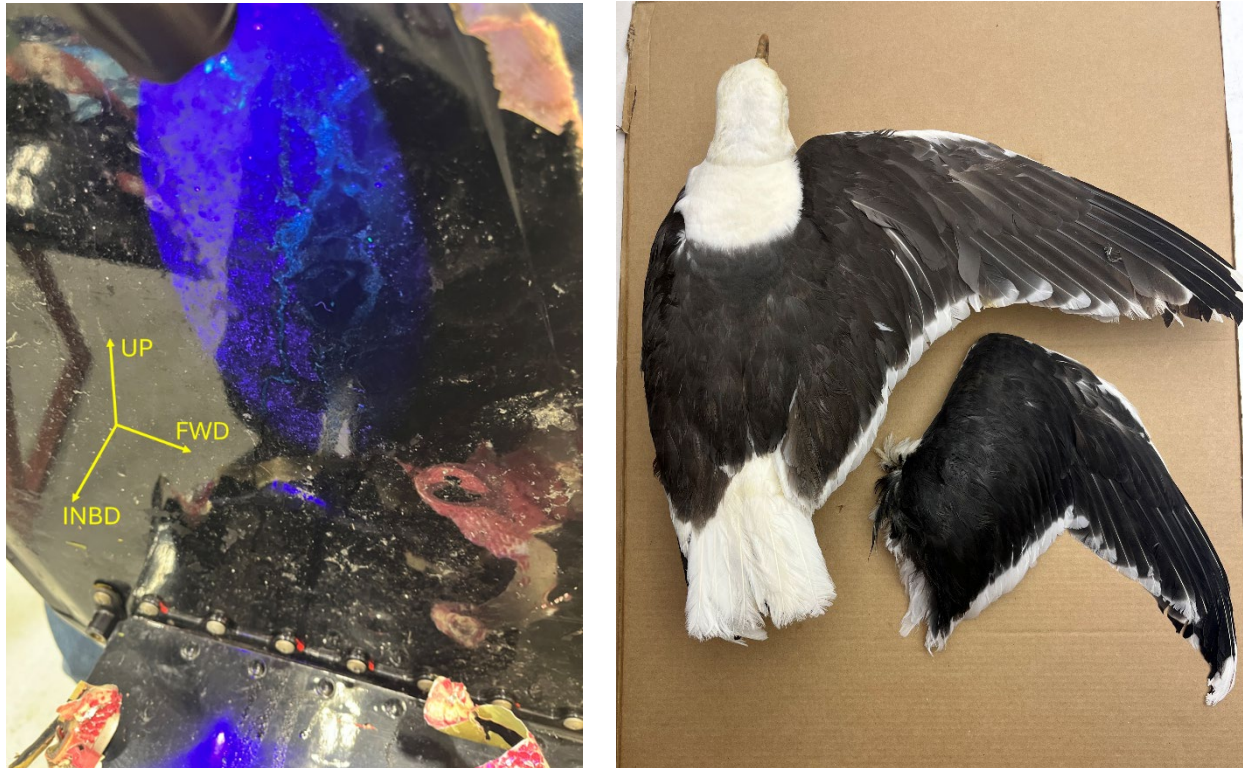
on a building rooftop was consistent with a Great Black-backed Gull (*Larus marinus*) (Figure 3). The damage to the bird wing was consistent with it being impacted by high-speed, flying debris from the helicopter during the break-up sequence.

**Figure 3.** Snare observed on the left horizontal stabilizer and left finlet (left), recovered wing next to Smithsonian Institution's Feather Identification Lab's specimen of Great Black-backed Gull (right)

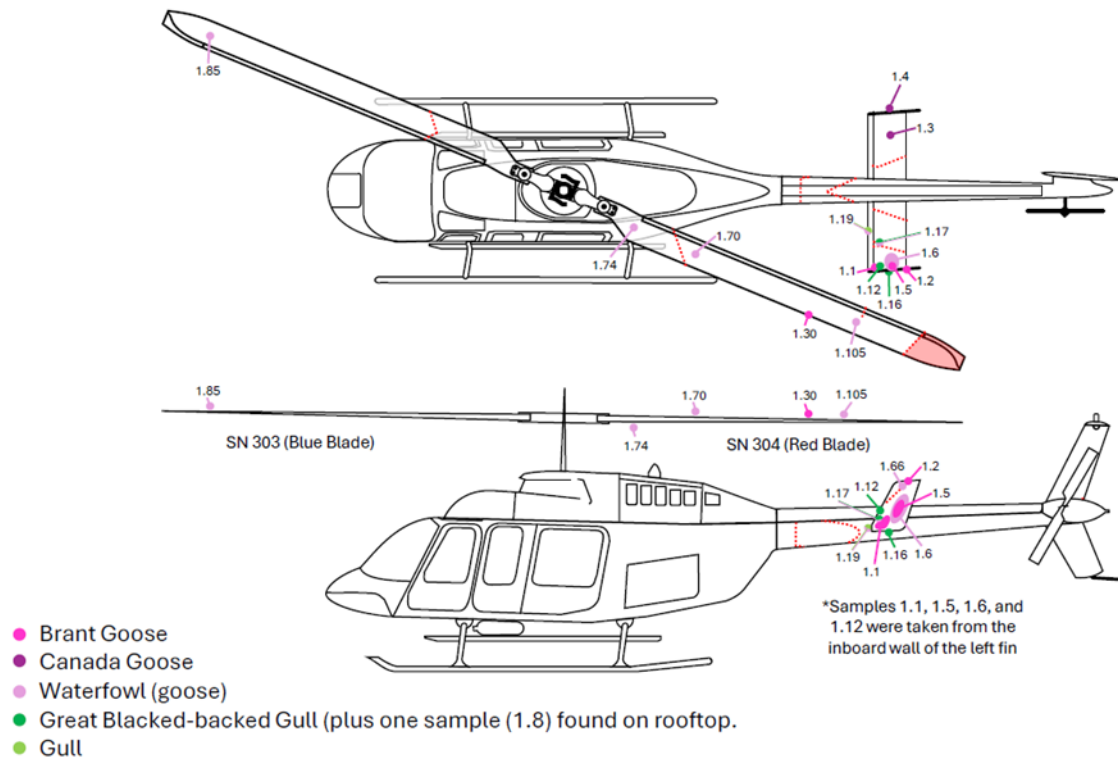
**Figure 4.** Validated Bird Evidence Sample Locations (provided by the Smithsonian Institution's Feather Identification Lab report Attachment 2)

Male and female samples of Brant Goose were collected from the helicopter rotor blades, left horizontal stabilizer, and left finlet. The samples for Canada Goose and Great Black-backed Gull were all female, with Canada Goose found on the right horizontal stabilizer and Great Black-backed Gull found on the left horizontal stabilizer. Bird weight is directly correlated with the severity of impact damage to aircraft in a bird strike event. The mean weight of a Brant Goose is 3.1 lbs. (male) and 2.7 lbs. (female). The mean weight of a female Canada Goose is 7.7 lbs. The mean weight of a female Great Black-backed Gull is 3.3 lbs.

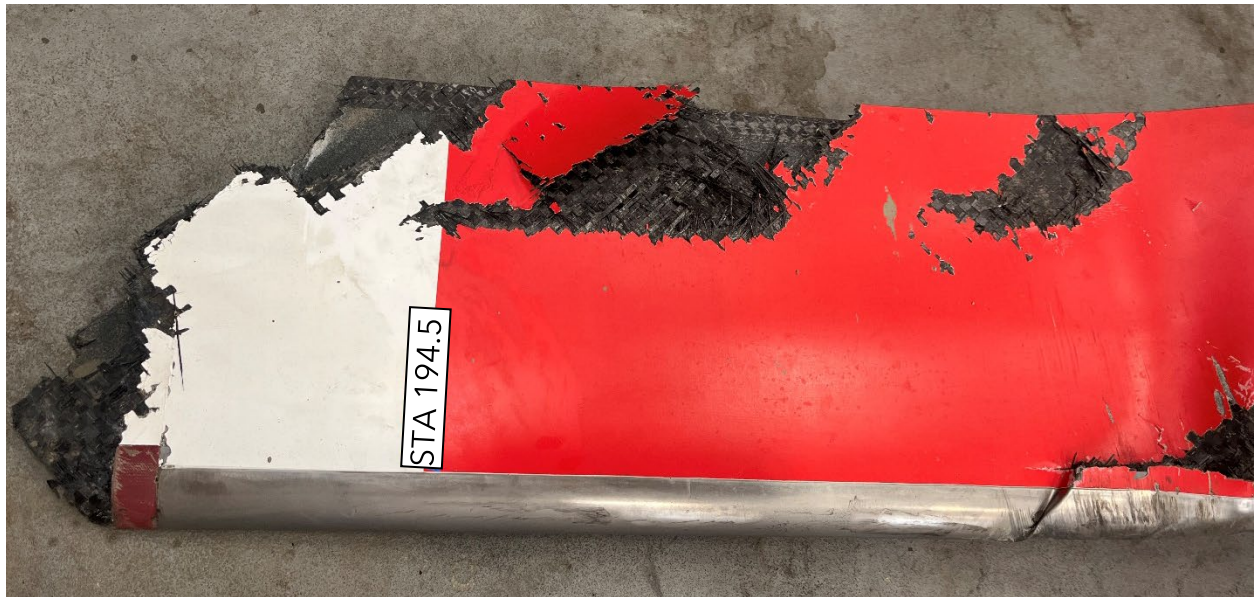
The red blade, part number 20633000-101 and serial number A304, remained attached to the main rotor assembly but was partially fractured. The full length of the

trailing edge had separated, allowing most of the foam core to separate from the blade. The trailing edge strip was not recovered. Abrasion strip damage from the leading edge to the trailing edge was found on the red blade at STA 202 (Figure 5). About 21 inches of the blade tip was missing including the tip abrasion strip and tip trailing edge strip. The blade skins were fractured chordwise immediately outboard of the main abrasion strip, transitioning to a 45 degree fracture immediately aft of the weight receptacle region. The separated blade tip was not recovered.

**Figure 5.** Red blade STA 202 damage

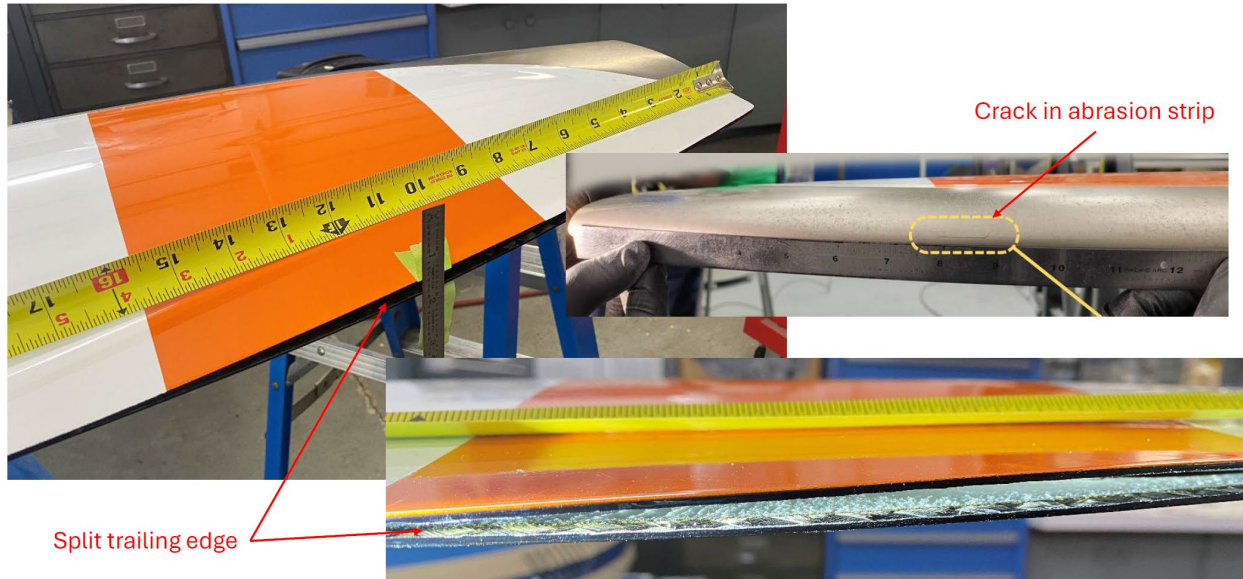
The main rotor blade tip damage was due to inflight impact with an unknown object (Figure 13). The strike resulted in an approximately 1 inch crack in the leading edge of the abrasion strip approximately 8 inches inboard from the end of the blade. The strike caused the delamination of the trailing edge strip from the blade tip upper skin which propagated inboard and outboard from the strike location.

**Figure 13.** Blade tip impact damage resulting from blade strike with unknown object (provided by Van Horn Aviation)

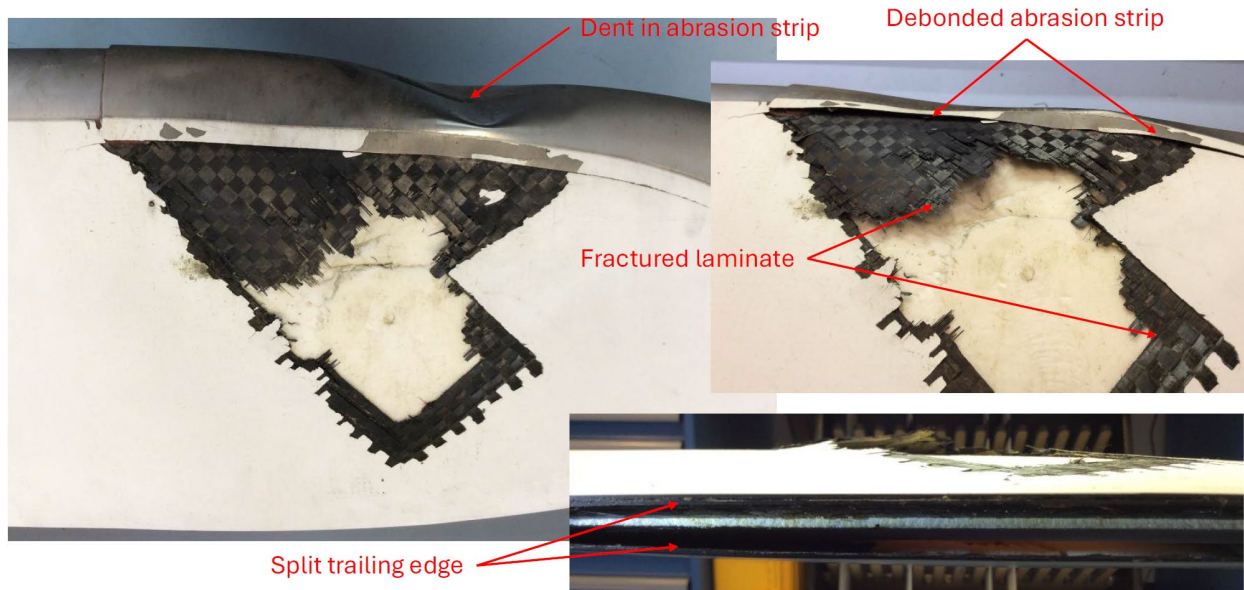
The main rotor blade tip damage was due to inflight impact with a vulture (Figure 14). The strike caused a significant inward deformation of the blade tip leading edge abrasion strip, with the aft edges of the abrasion strip debonding from the skin laminate as well as the inboard edge of the abrasion strip debonding from the main blade leading edge abrasion strip. The laminate upper skin was fractured directly aft of the leading edge deformation, with a section of the structural foam core visible where the laminate skin had separated from the blade. The strike caused the delamination of the trailing edge strip and structural foam core from the blade tip upper and lower skins which propagated inboard and outboard from the strike location.

**Figure 14.** Blade tip impact damage resulting from blade strike with vulture (provided by Van Horn Aviation)

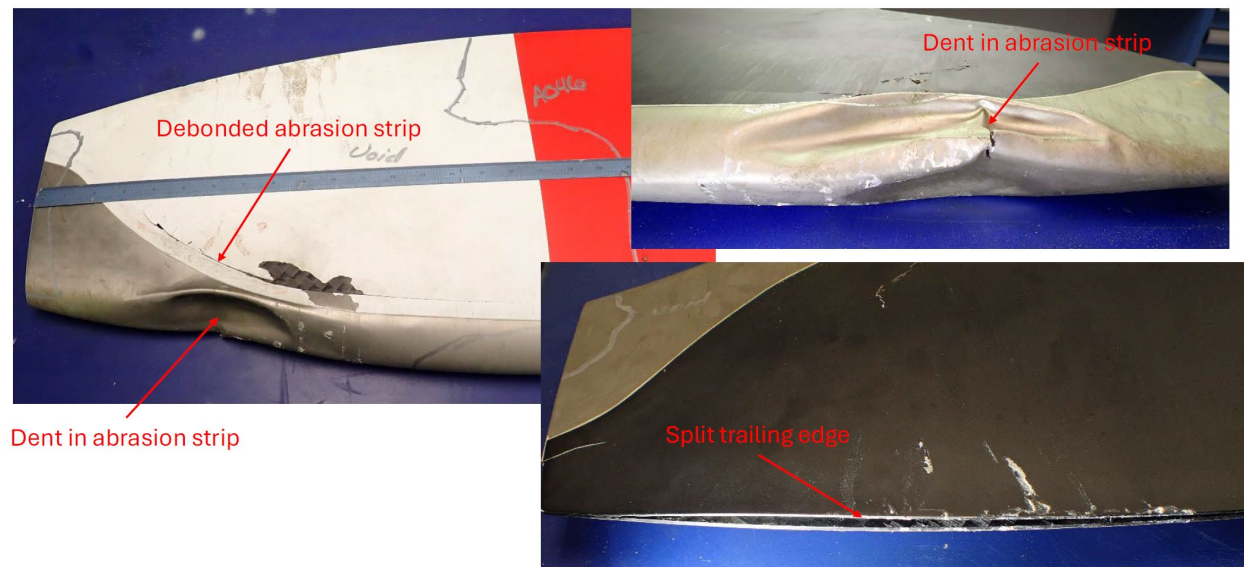
The main rotor blade tip damage was due to inflight impact with an oak tree (Figure 15). The strike caused a significant inward deformation of the blade tip leading edge abrasion strip, with the aft edges of the abrasion strip debonding from the skin laminate. The strike caused the delamination of the trailing edge strip and structural foam core from the blade tip upper and lower skins which propagated inboard and outboard from the strike location.

**Figure 15.** Blade tip impact damage resulting from blade strike with oak tree (provided by Van Horn Aviation)

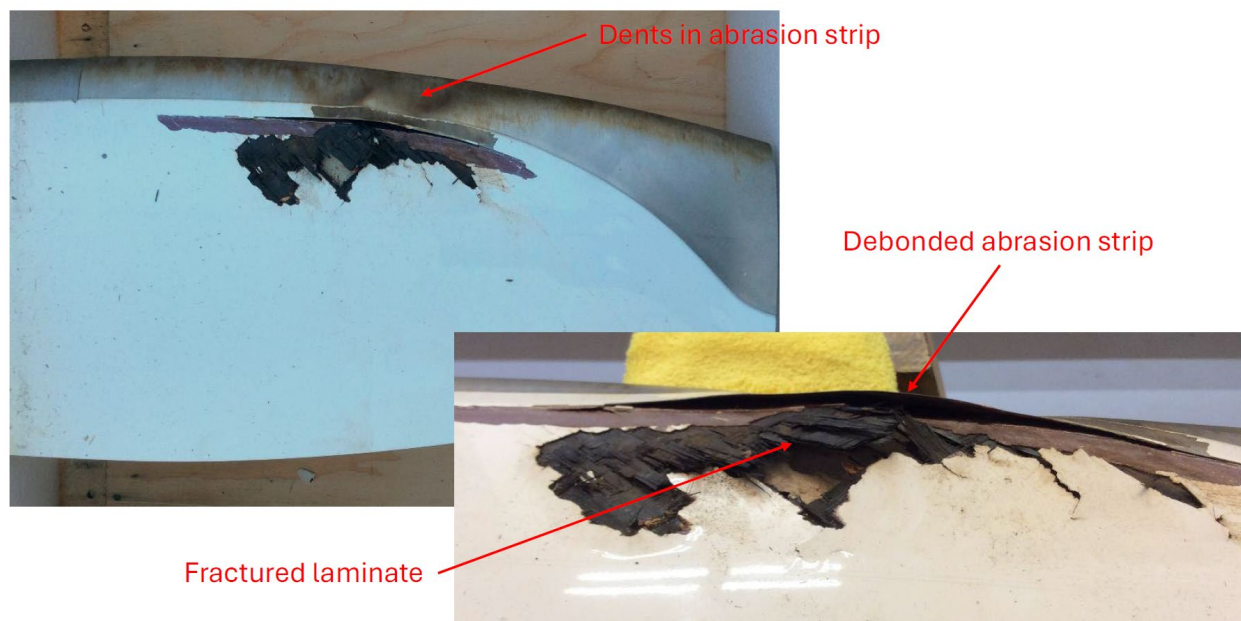
The main rotor blade tip damage was due to inflight impact with an unspecified tree (Figure 16). The strike caused denting in the blade tip leading edge abrasion strip, with the aft upper edge of the abrasion strip debonding from the skin laminate as well as an upwards deformation of the abrasion strip trailing edge. The laminate upper skin was fractured directly aft of the leading edge deformation, with a section of the structural foam core being visible where the laminate skin had separated from the blade.

**Figure 16.** Blade tip impact damage resulting from blade strike with unspecified tree (provided by Van Horn Aviation)
