# National Transportation Safety Board

ERA25MA171

## **OPERATIONS**

Group Chair's Factual Report

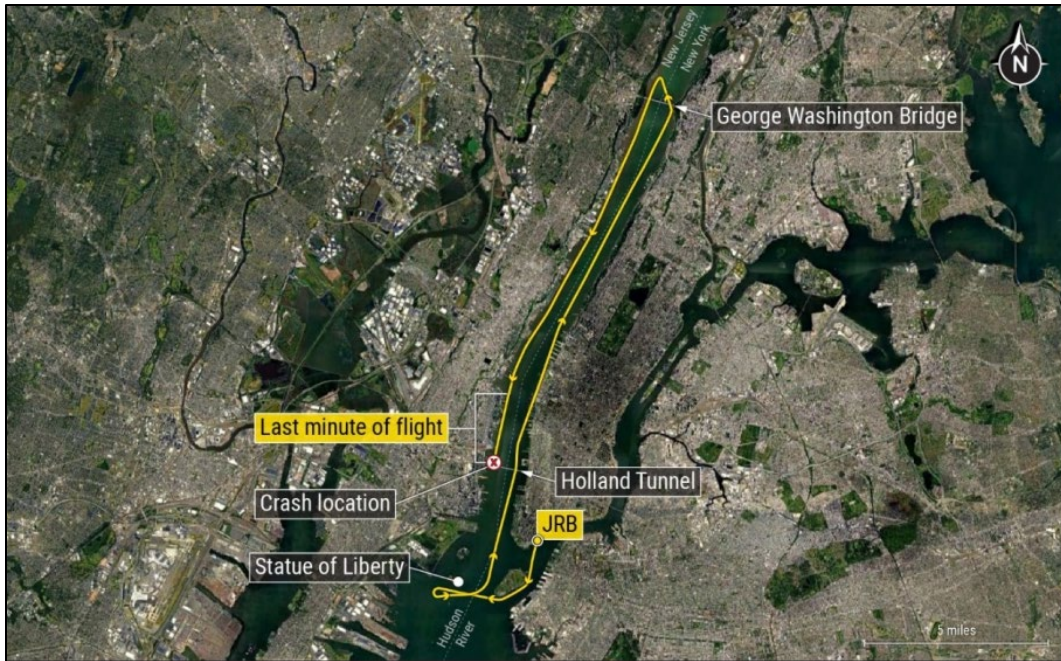
ADS-B data provided by the FAA (see figure 1) revealed the accident helicopter N216MH, departed JRB (Skyport Heliport) at 1458. The helicopter flew at a low altitude (~ 200 feet agl) on the south side of "Governors Island" and continued until it completed a teardrop pattern south of the Statue of Liberty, then proceeded north. The helicopter then proceeded up the east side of the Hudson River adjacent to Manhattan on a ground track of 025° at approximately 600 ft mean sea level (msl) /850 ft geometric altitude<sup>2</sup> and 109 kts groundspeed. The helicopter continued up the Hudson River to the George Washington Bridge and crossed over the bridge at 1,000 ft msl/1,275 ft geometric where the helicopter made a left 180° turn to the south (200°) on the west side of the Hudson River and crossed over the bridge again at 1,000 ft msl/1,275 ft geometric at 86 kts at 1509:08.

Figure 1. ADS-B flight track overview of entire route of flight from takeoff through loss of signal near the accident location.

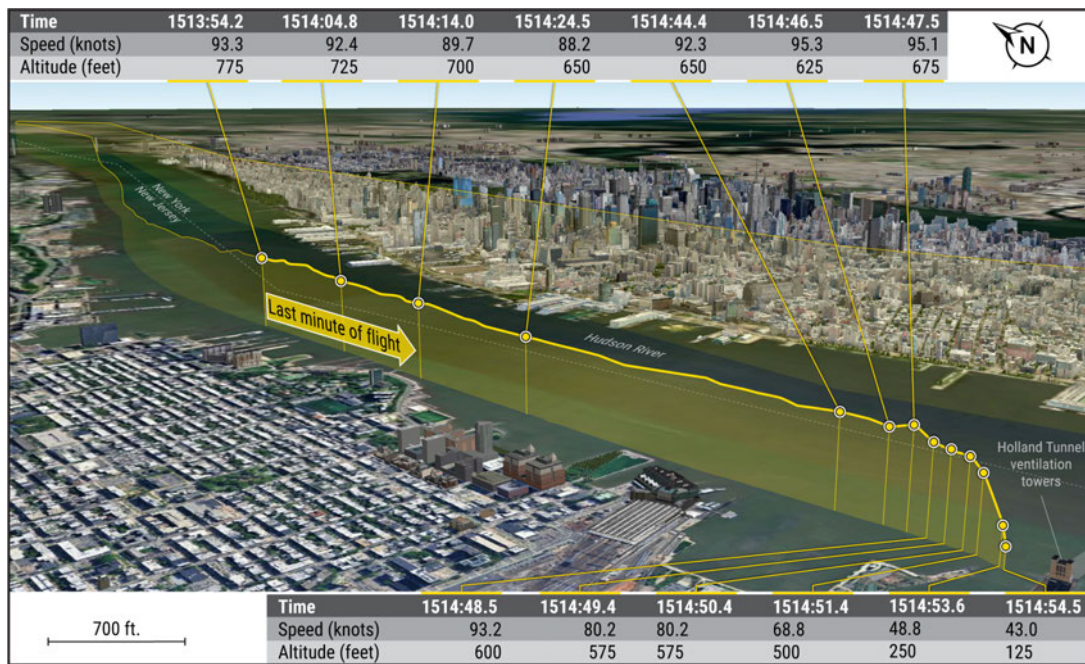
As the helicopter approached the Holland Tunnel ventilation towers near Jersey City, New Jersey, it was at a geometric altitude between 625 and 650 ft. Then helicopter's altitude increased rapidly to 675 ft before it entered an uncontrolled descent. The data ended at 1514:54.5 and the helicopter's last observed altitude was 125 ft. (see figure 2). For reference, an FAA helicopter chart shows the Hudson River and airspace boundaries. (see figure 3)

Figure 2. ADS-B flight track and geographic data highlighting the last minute of the flight through breakup, uncontrolled descent and loss of signal.

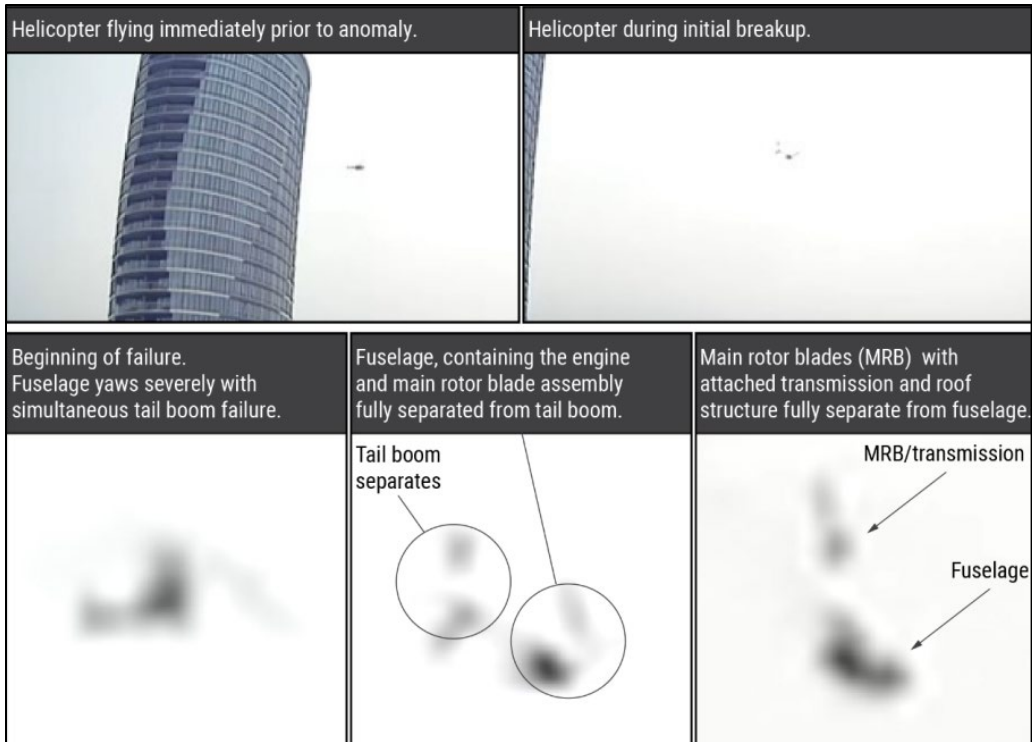
Multiple witnesses described hearing several loud “bangs” & “pops” emanating from the helicopter before it broke up and descended into the river. Surveillance video (with accompanying audio) captured the helicopter traveling south before it suddenly separated into three major sections: fuselage (including the engine), main rotor system (including both main rotor blades, transmission, and roof-beam structure), and the tail boom (including the tail rotor) (see figure 4)

Figure 4. Enhanced surveillance video with sequential images depicting the helicopter's flight and breakup.

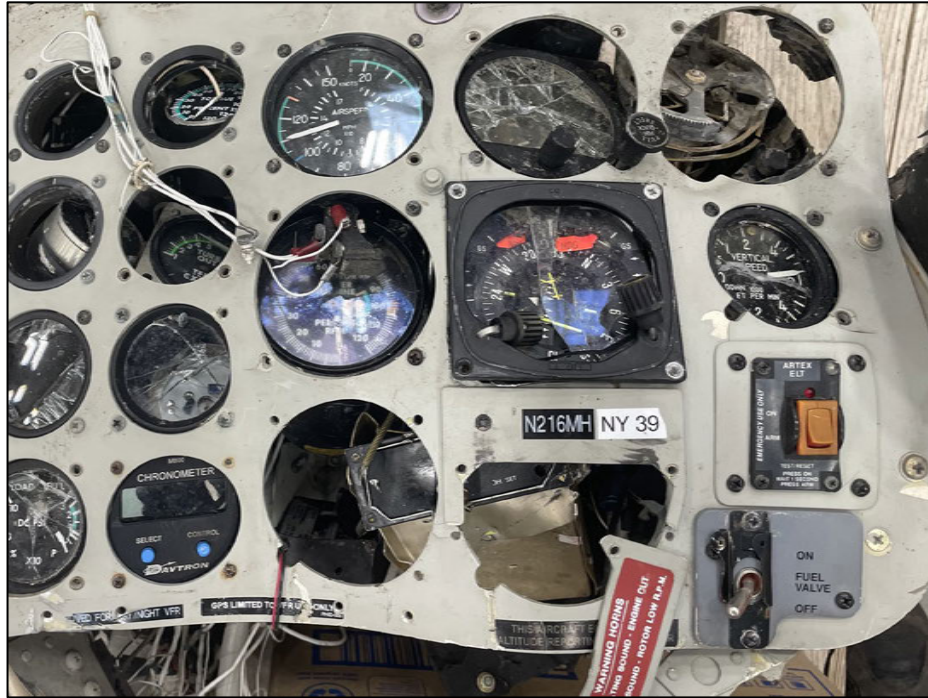
Figure 9. N216MH post-accident view of cockpit instrument panel.

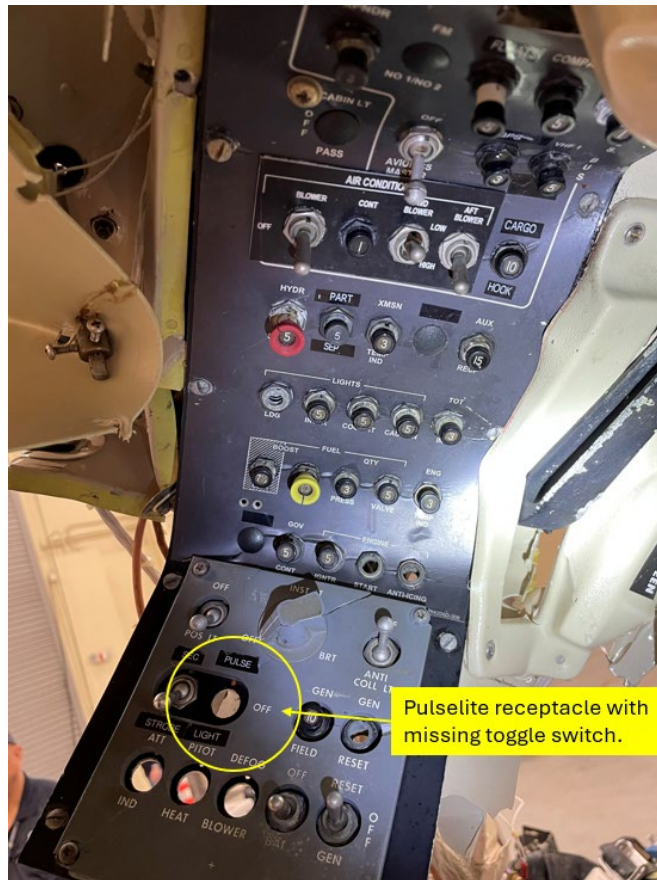
Above the pilot, on the overhead panel (see figure 11) which was damaged, circuit breakers and toggle switches for the avionics, air conditioning, position, strobes and anticollision lights were located. An open receptacle was discovered that was labeled "PULSE LIGHT" but the toggle switch was missing and not recovered. The Pulselite system was designed to flash the existing lights, in this case, the landing light for the Bell 206 accident helicopter. The system served two purposes - to reduce bird strikes and to increase aircraft recognition for collision avoidance with other aircraft. Video evidence provided to the NTSB shows a previous (not accident) flight, with the Pulselite system activated and "pulsating" during a pre takeoff flight condition. (see figure 12)

Figure 11. The accident helicopter overhead panel containing the circuit breakers and light switches, including the missing Pulselite switch on the lower left.

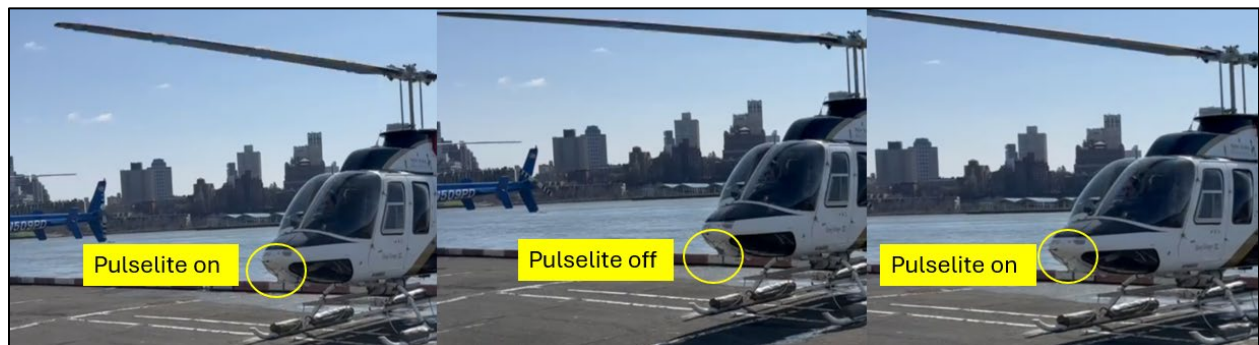
Figure 12. Sequential screen captures of video showing the Pulselite flashing. Full video in the docket shows the helicopter tail wag as reported by witnesses and pilots is listed as Attachment 10.<sup>10</sup>
